AAIB Bulletin: 3/2021 **G-KIDD** AAIB-27037 ACCIDENT Aircraft Type and Registration: Jabiru J430, G-KIDD No & Type of Engines: 1 Jabiru 3300A piston engine Year of Manufacture: 2006 (Serial no: PFA 336-14541) Date & Time (UTC): 24 March 2020 at 1400 hrs Location: High Cross Airfield, Hertfordshire Type of Flight: Private Persons on Board: Crew - 1 Passengers - None Injuries: Crew - None Passengers - N/A Damage to nose leg and landing gear, engine Nature of Damage: components and cowling, and wing mounts **Commander's Licence:** Private Pilot's Licence Commander's Age: 53 years 520 hours (of which 80 were on type) Commander's Flying Experience: Last 90 days – 0 hours Last 28 days - 0 hours Information Source: Aircraft Accident Report Form submitted by the pilot and further enquiries by the AAIB

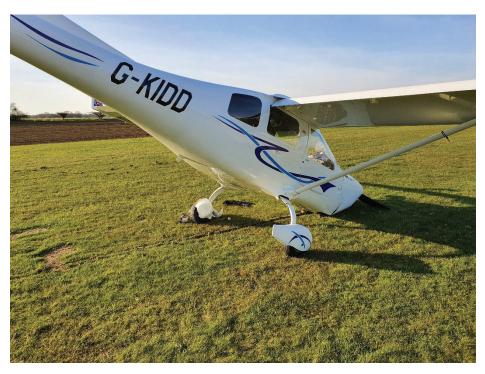
Whilst in an orbit the engine started to run roughly. The pilot throttled back the engine, checked the indications, selected carburettor heat ON and turned back towards the airstrip. The engine then "spluttered" and stopped; a restart was unsuccessful. Appreciating he was committed to a forced landing, the pilot selected best glide speed and continued towards the airstrip from the south-west. Realising he was too low to make an approach to Runway 23, he elected to land, with a tailwind, on Runway 05. Once over the runway the aircraft floated at about 8 to 10 feet. As the end of the runway was approaching, the pilot decided to pitch the aircraft's nose into the runway to stop the aircraft, during which the nose leg collapsed (Figure 1). The pilot vacated the aircraft uninjured.

**Figure 1** G-KIDD after the accident (Used with permission)

Upon draining the fuel, a significant amount of discoloured water was discovered. The carburettor float was also full of water.

The pilot believed that, given the amount of water, it was present in the fuel he last uplifted six weeks earlier. He had not performed a fuel drain check for water prior to departing; something he would not be omitting again.
