## ACCIDENT

<b>Aircraft Type and Registration:</b>	Reims Cessna F152, G-BHFI	
<b>No &amp; Type of Engines:</b>	1 Lycoming O-235-L2C piston engine	
<b>Year of Manufacture:</b>	1980 (Serial no: 1685)	
<b>Date &amp; Time (UTC):</b>	8 September 2020 at 1610 hrs	
<b>Location:</b>	Wards Stone, Forest of Bowland, Lancashire	
<b>Type of Flight:</b>	Training	
<b>Persons on Board:</b>	Crew - 1	Passengers - None
<b>Injuries:</b>	Crew - None	Passengers - N/A
<b>Nature of Damage:</b>	Damaged windscreen and right main landing gear	
<b>Commander's Licence:</b>	Pilot under training	
<b>Commander's Age:</b>	42 years	
<b>Commander's Flying Experience:</b>	49 hours (of which 48 were on type) Last 90 days - 13 hours Last 28 days - 12 hours	
<b>Information Source:</b>	Aircraft Accident Report Form submitted by the pilot

## Synopsis

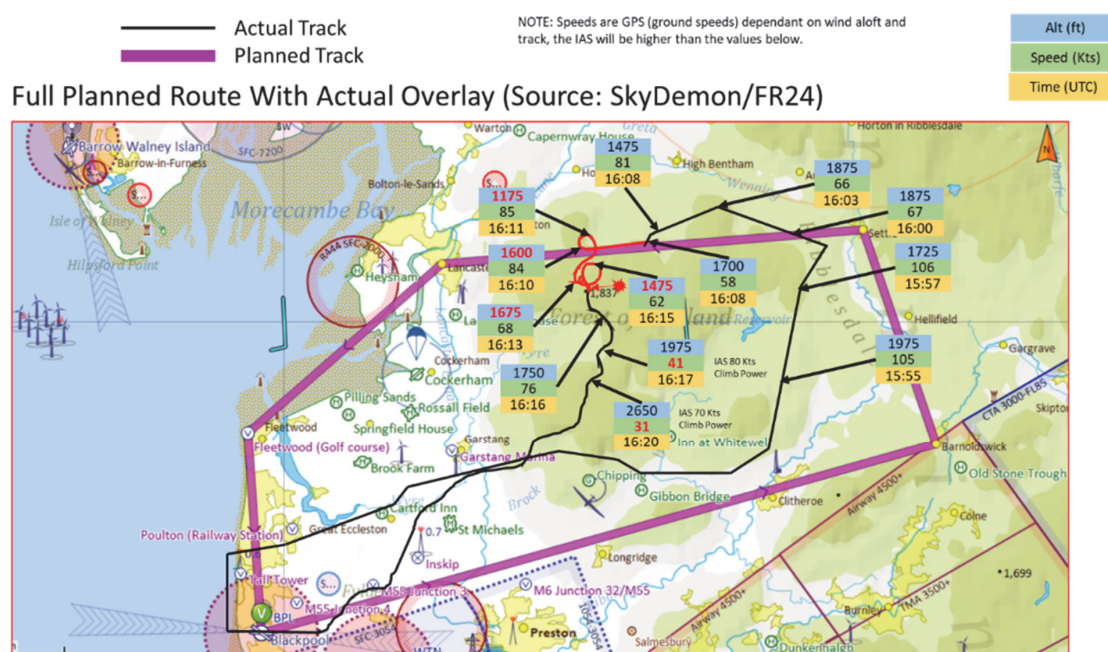
Figure 1

The planned route and actual track (courtesy SkyDemon and Flightradar24)

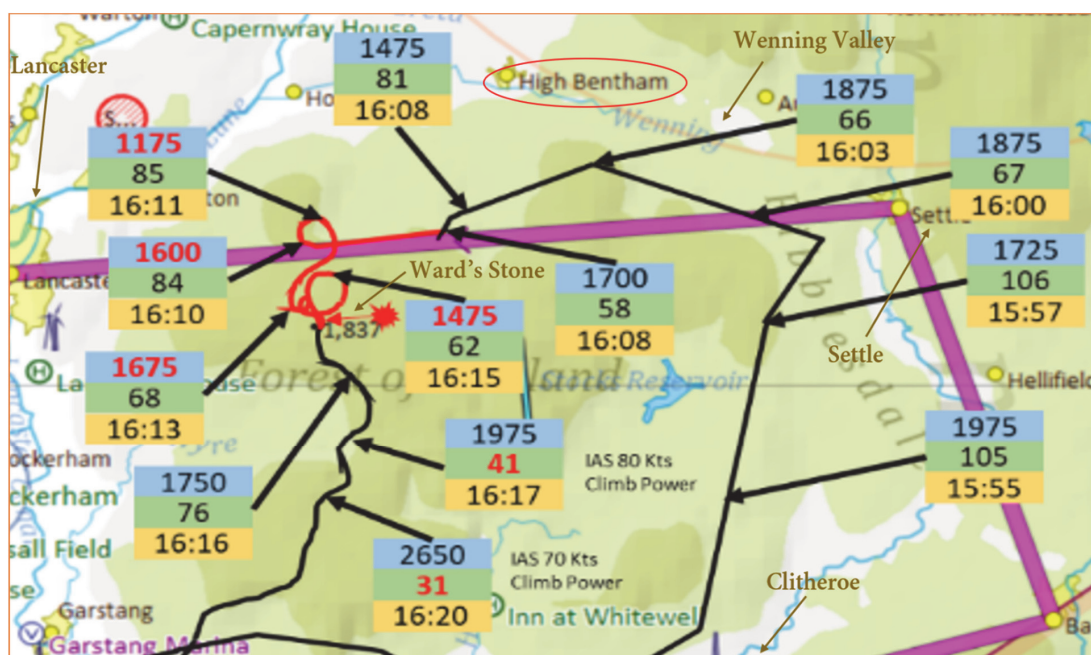
**Figure 2**

In reviewing the pilot's flight log, the instructor noticed that there were errors in the Minimum Safe Altitude (MSA) on three legs. One was corrected but the others were not, and the planned altitude on the accident leg was left as it was, which was below the MSA. The instructor authorised the flight and the student performed the pre-flight inspection before booking out with ATC. On the first leg from Blackpool to Barnoldswick, the pilot flew to the north of his planned track, to avoid poor weather in the area of Longridge, but remained clear of cloud and in sight of the surface and was able to regain a track for his first turning point. The planned route and the track flown are shown in Figure 1 with markers showing time and GPS height and groundspeed. Figure 2 shows an expanded view including the area of inadvertent flight in IMC.

An expanded area of the route with inadvertent flight in IMC indicated in red

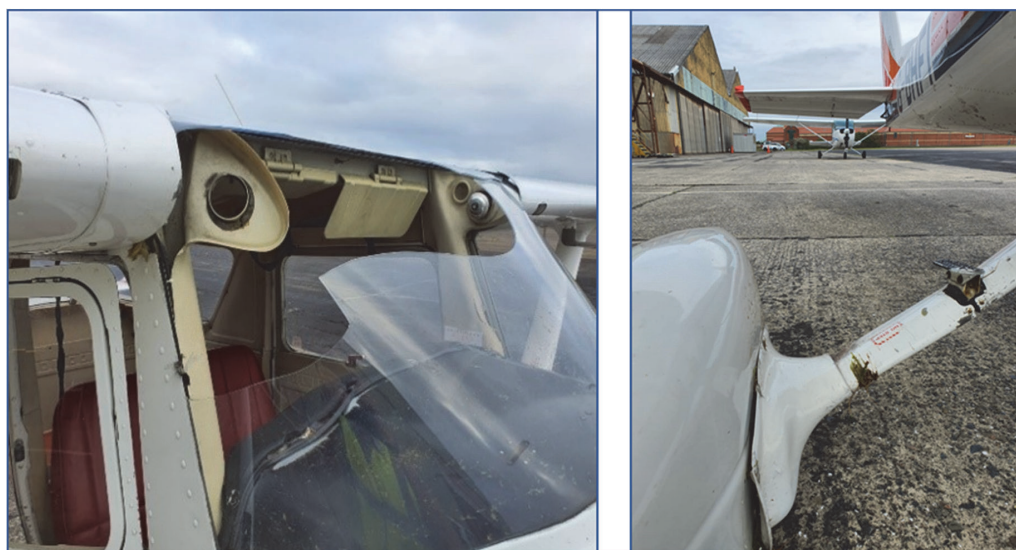
**Figure 3**

During the impact with the ground, the aircraft was damaged. The right main landing gear was disrupted and the top of the windscreen broke and detached. A significant increase in cabin noise made two-way radio communication almost impossible. The cabin noise was due to the wind caused by the combined effect of the damaged windscreen and the passenger door being blown open. The damage is shown at Figure 3 below.

Aircraft damage caused by the impact with the ground
