Accident

Aircraft Type and Registration:	Ikarus C42 FB80, G-CFHP	
No & Type of Engines:	1 Rotax 912-UL piston engine	
Year of Manufacture:	2008 (Serial no: 0805-6972)	
Date & Time (UTC):	13 September 2020 at 0900 hrs	
Location:	Porthtowan, Cornwall	
Type of Flight:	Training	
Persons on Board:	Crew - 1	Passengers - 1
Injuries:	Crew - None	Passengers - None
Nature of Damage:	Nose landing gear leg, both wings and engine cowling damaged	
Commander's Licence:	Private Pilot's Licence	
Commander's Age:	71 years	
Commander's Flying Experience:	6,516 hours (of which 2,916 were on type) Last 90 days - 15 hours Last 28 days - 5 hours	
Information Source:	Aircraft Accident Report Form submitted by the pilot

Synopsis

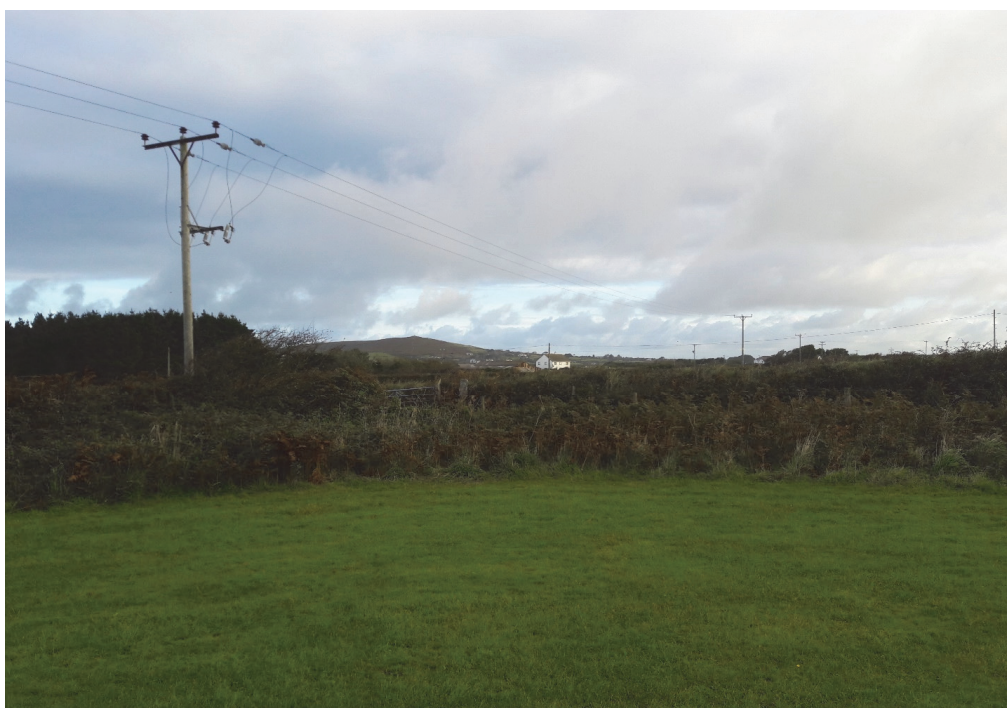
Figure 1

A set of domestic power cables runs past the threshold of Runway 22 (Figure 1) and these were at right angles to the aircraft’s into-wind track.

Power cables from approximately where the aircraft came to rest

The commander was familiar with the airstrip at Porthtowan and had operated there many times. He was aware of the cables that cross close to the runway 22 threshold. Once established on the base leg track the commander could clearly see the cables.

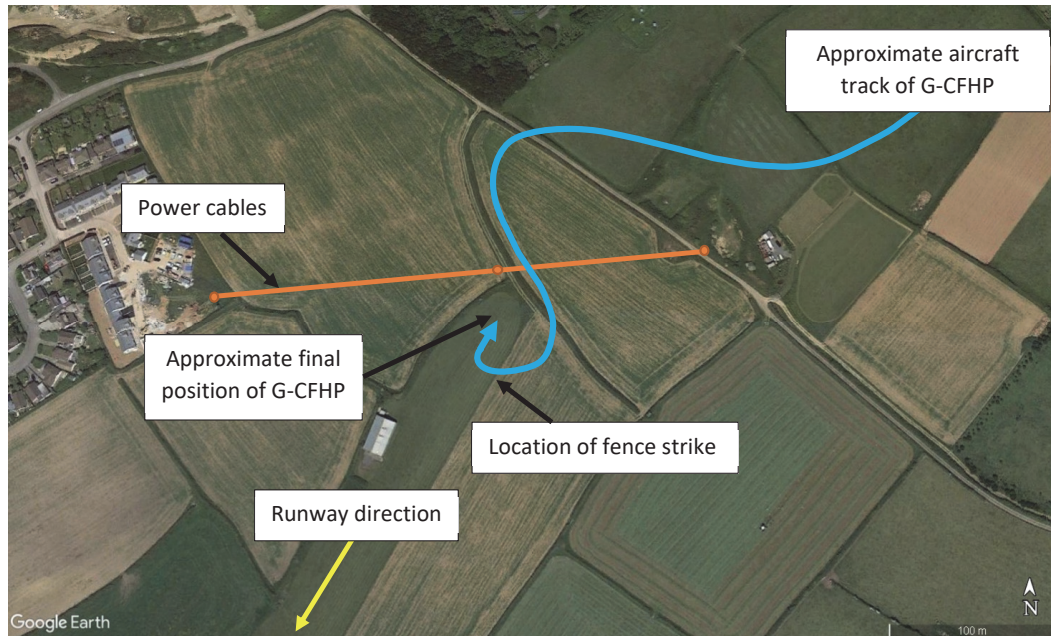
After clearing the wires, the commander made the right turn towards the airstrip using 30 to 35° angle of bank. During the turn the right landing gear struck a fence, approximately 5 ft tall, at the edge of the airstrip. The fence arrested the aircraft’s flight, turned it to the

right through 90° and caused it to strike the ground heavily, damaging both wings, the engine cowling and the nose landing gear. Neither occupant was injured, and both were able to exit the aircraft unaided. The approximate aircraft track and aircraft final position is shown at Figure 2.

Figure 2
Approximate aircraft track

As the aircraft cleared the cables it was already at a low height. The commander felt that the margin was safe, and his focus moved to landing near the threshold. Delaying the turn to remain wings level while crossing the cables had positioned the aircraft left of the intended approach track. Therefore, a turn through a greater number of degrees than intended was required to reach the airstrip. This turn was carried out with approximately 35° angle of bank at a height of less than 40 ft agl. This manoeuvre would have increased the rate of descent and the commander's workload. The commander believed the aircraft would clear the fence around the airstrip but the right landing gear struck the fence and the aircraft landed heavily.

The BMAA will review the advice to instructors regarding the conduct of PFLs, with particular emphasis on early initiation of a go-around if the plan is not working as expected.

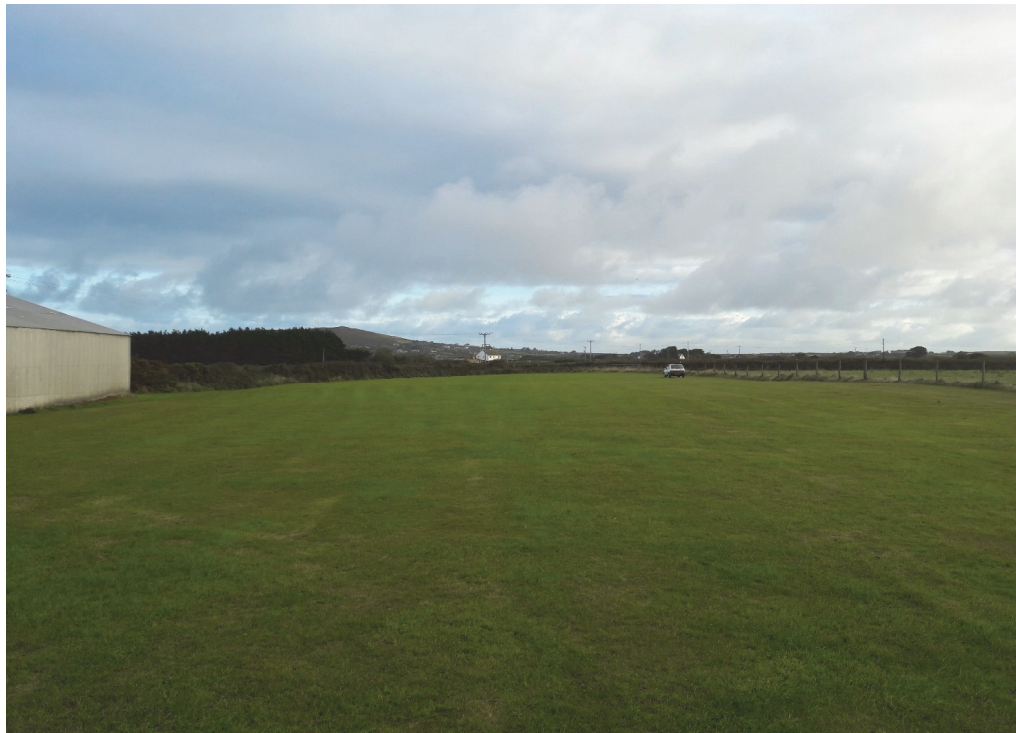
Figure3
View along Runway 03 showing boundary fence
