AAIB Bulletin

3/2021

Published 11 March 2021.

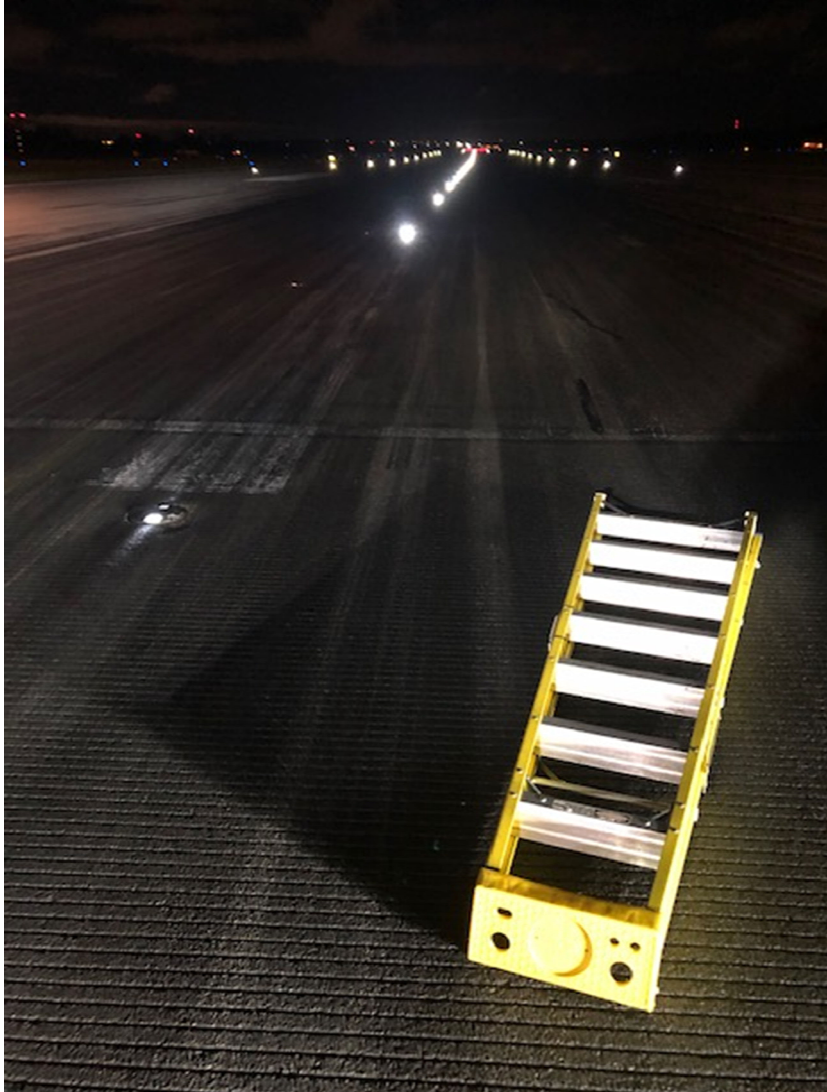
ATC ordered a runway inspection, which found a 7 ft A-frame step ladder on the runway.

View up Runway 33 with the ladder in the approximate position it was found

Figure 1 shows the position of the ladder as found on the runway. The ladder was removed from the runway by the ASU personnel before being collected by the technicians. The ladder was positioned to the right of the centreline of the runway in use (Runway 33) laying almost parallel with the centreline. It was lying beside touch down zone markings which are 550 m from the runway threshold and 150 m beyond the aiming point markings.

With landing speeds in excess of 120 kt, an aircraft hitting an object such as the ladder may have resulted in substantial damage. In this case, taking the position of the ladder on the runway into account, and the main and nose landing gear track width, all three aircraft narrowly missed the ladder.

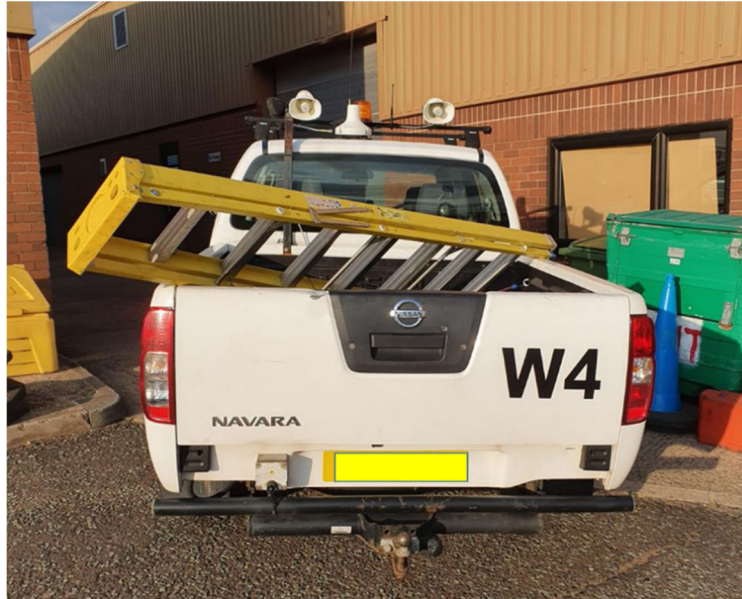
In preparation for the work on the approach light the stepladder was put into the load bay of WV4 and the elastic bungee strap used to secure it in place. Figures 4 and 5 show how the ladder was positioned and held in the load bay.

Figure 4
Ladder loaded onto WV4

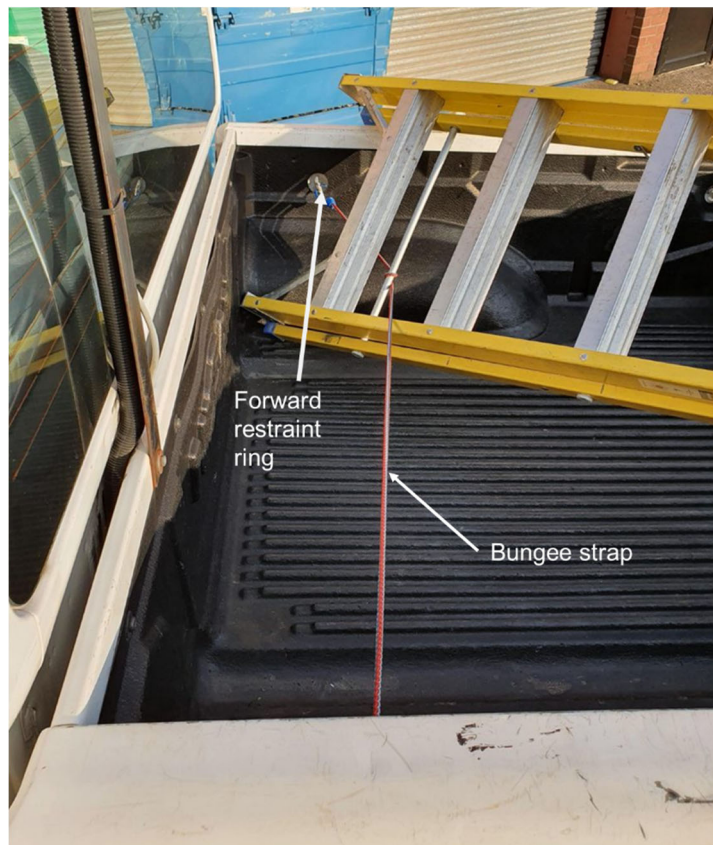
Figure 5
Ladder restraint method in WV4
(Picture taken after the event and reconstructed by one of the technicians)

At first sight the bungee may have seemed suitable to secure the ladder in WV4. However, when the actual method used was demonstrated, it could be seen why the bungee was unsuitable. The bungee had been stretched almost to its limits around a strut on the ladder and hooked to the right and left forward fixed rings in the load bay side panels (Figure 5). When the vehicle is stationary or moving slowly the method used would keep the ladder in place. Any gentle acceleration or moderate cornering would cause the ladder to move, and the remaining elasticity in the bungee would have provided sufficient restraint.

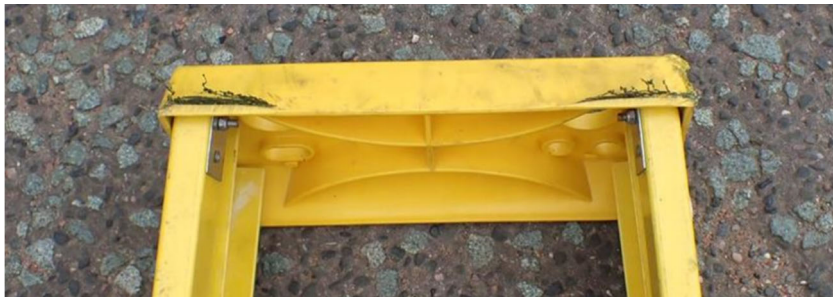
Figure 6

The ladder was recovered from the runway by the airport operations staff. Later examination of the ladder found minor scuff damage on the corner edges of the combined step and hinge plate. A small amount of material towards the edge of the scuff marks had been frayed and discoloured with a grey-black appearance (Figure 6). The bungee was examined, and this was in good condition except for the opening out of one of its hooks (Figure 7).

Scuff damage to the top of the ladder

It is likely that as WV4 accelerated, having passed the aiming point markings, the ladder was caused to move more rapidly, and its inertia resulted in a 'snatch' load on the bungee when it reached the limit of elasticity. At this point, the snatch load would have been transferred into the wire hooks fitted to the ends of the bungee. In this case one of the hooks opened out (Figure 7) making it less effective in the restraint ring. As a result it most likely unhooked, rapidly sprang back, and unravelled itself from the ladder strut. This left the now unrestrained ladder to topple rearwards from WV4. As it fell out and contacted the runway it slid a short distance before coming to a stop causing the abrasion to the edges of the plastic at the top of the ladder (Figure 6).

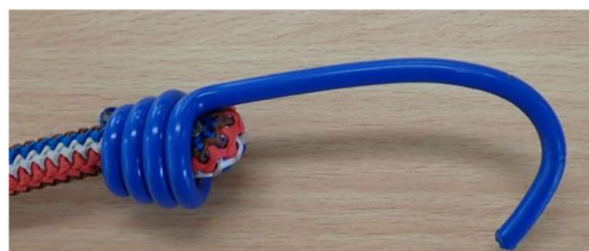
Figure 7

Bungee strap and damage to hook

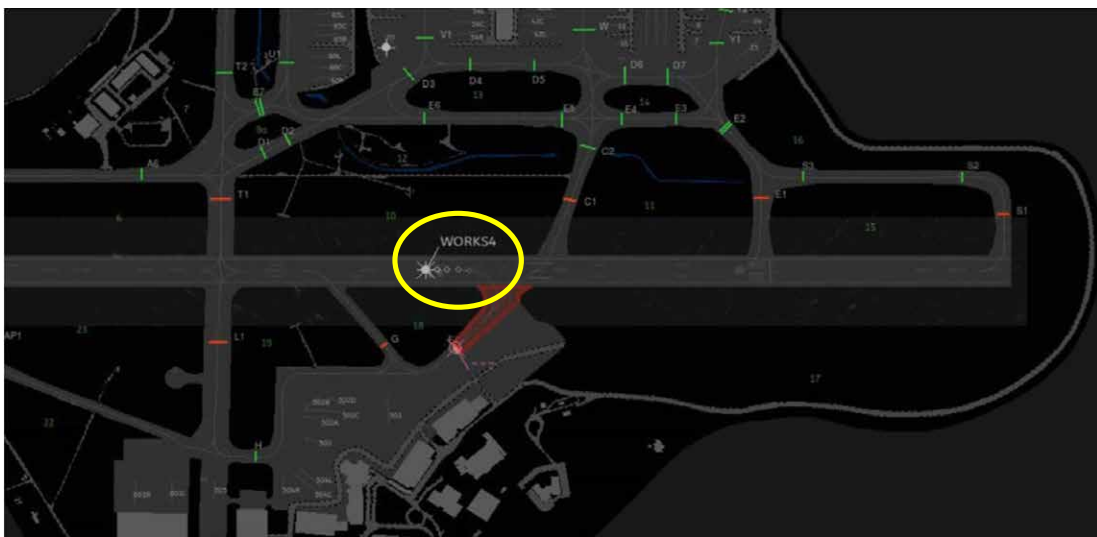
Figure 10

WV4 at the location where the ladder was found

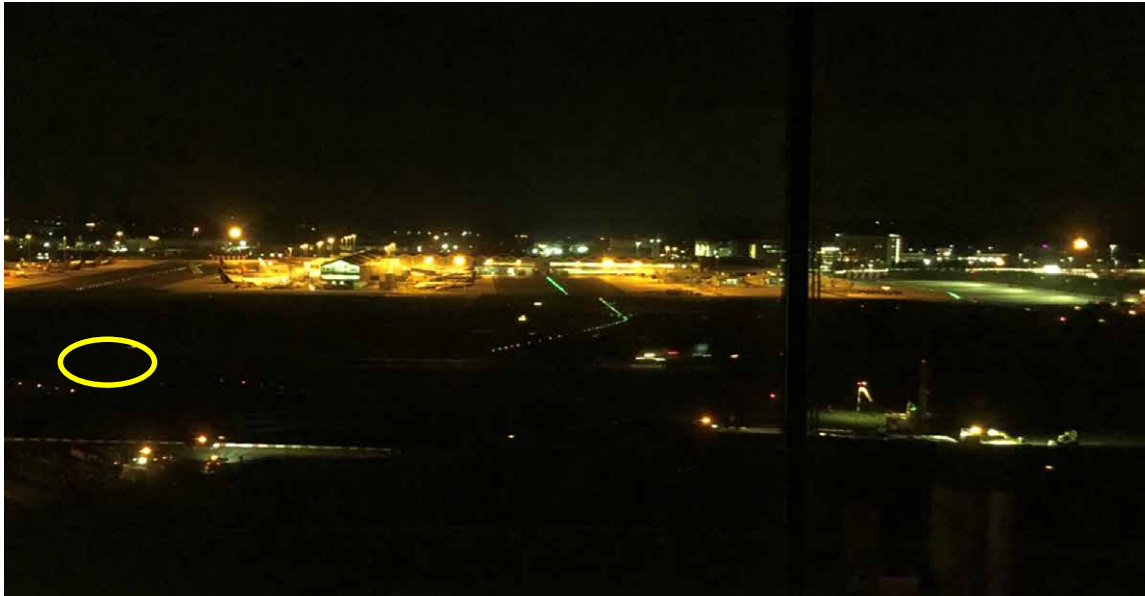
The visual control tower has a view of the whole manoeuvring area of the airport. At night this view is restricted simply because large parts of the airport, including the runway, are not illuminated by overhead lighting. Figure 13 shows the view from the visual control tower at night. It is clear from the picture that it was not possible for the tower controller to either see the ladder coming off WV4 or to spot it laying on the runway. The approximate area where the ladder was found is highlighted.

View from the visual control tower at night with the approximate area where the ladder was found highlighted

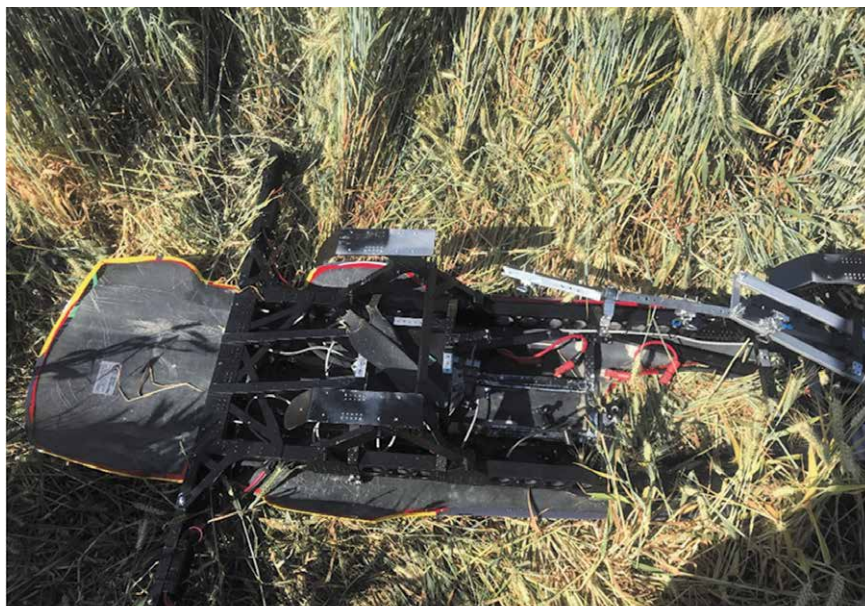
Figure 5

By the time the AAIB arrived, the operator had removed the main battery and placed it away from the crop (Figure 5).

UA as found (inverted) at the accident site

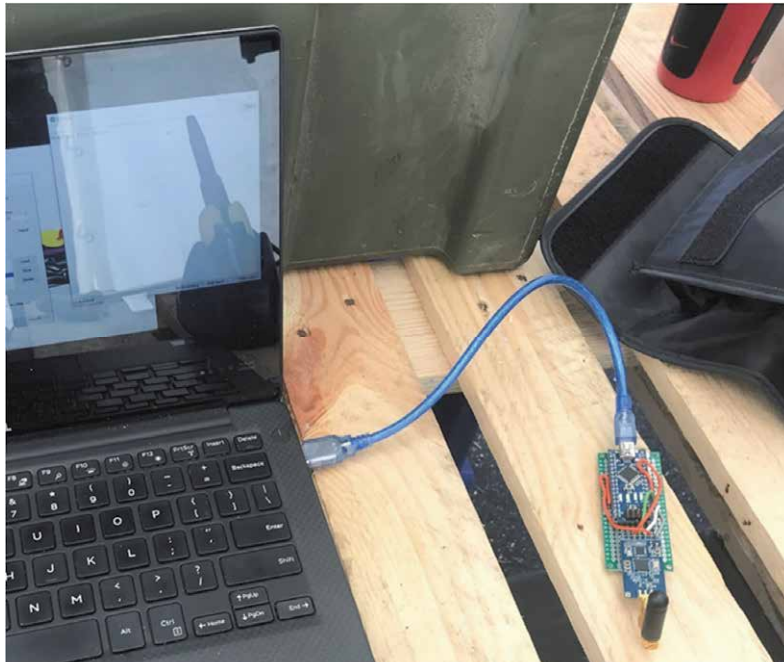
Figure 8

The ground-based part of the kill switch was a transmitter connected to a laptop via a trailing USB cable. All of the transmitter's electronics were exposed with no protective enclosure and, when used, the antenna and electronics hung underneath the laptop on the USB cable (Figure 8).

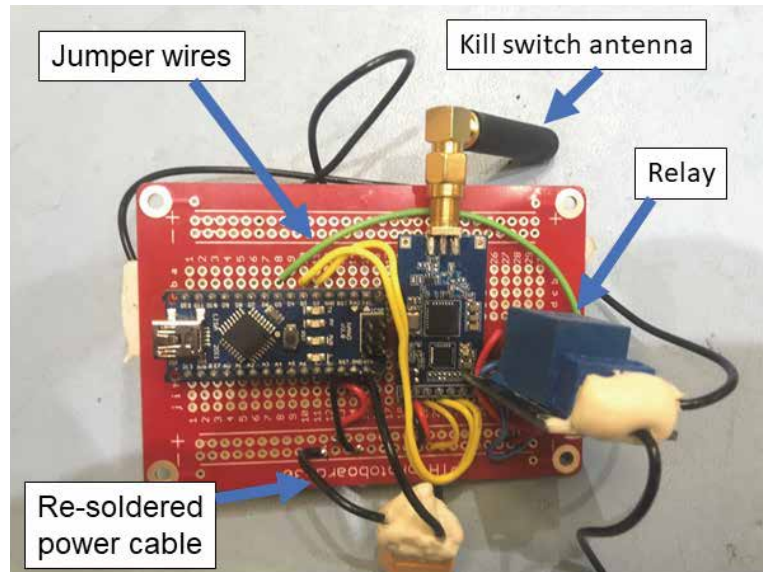
Figure 10

Initial examination of the circuit boards revealed some concerns regarding build quality and workmanship. The boards were populated with 'hobbyist' components with exposed wiring, large amounts of solder and lumps of adhesive. The kill switch used an electronics prototyping board with a number of jumper wires instead of a printed circuit. Failure of any of these wires would render the kill switch inoperative (Figure 10).

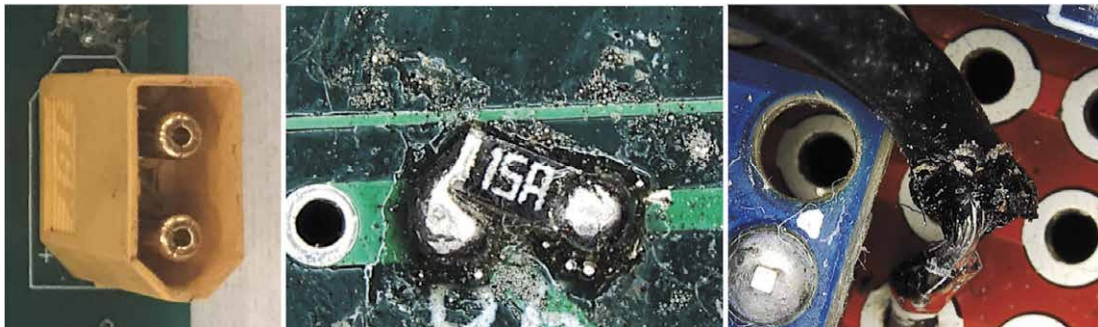
Figure 11

The examination revealed a number of issues with the flight control system and both the airborne and ground-based kill switch assemblies. All the assemblies failed an evaluation against all IPC A-610 classes due to quality and workmanship issues. Examples included misaligned components, burnt insulation, the use of solder bridges, excessive flux residues and a power connector that appeared to be installed in the incorrect orientation when compared to the drawn orientation on the circuit board (Figure 11).

Power connector installation, solder bridge and evidence of burnt insulation

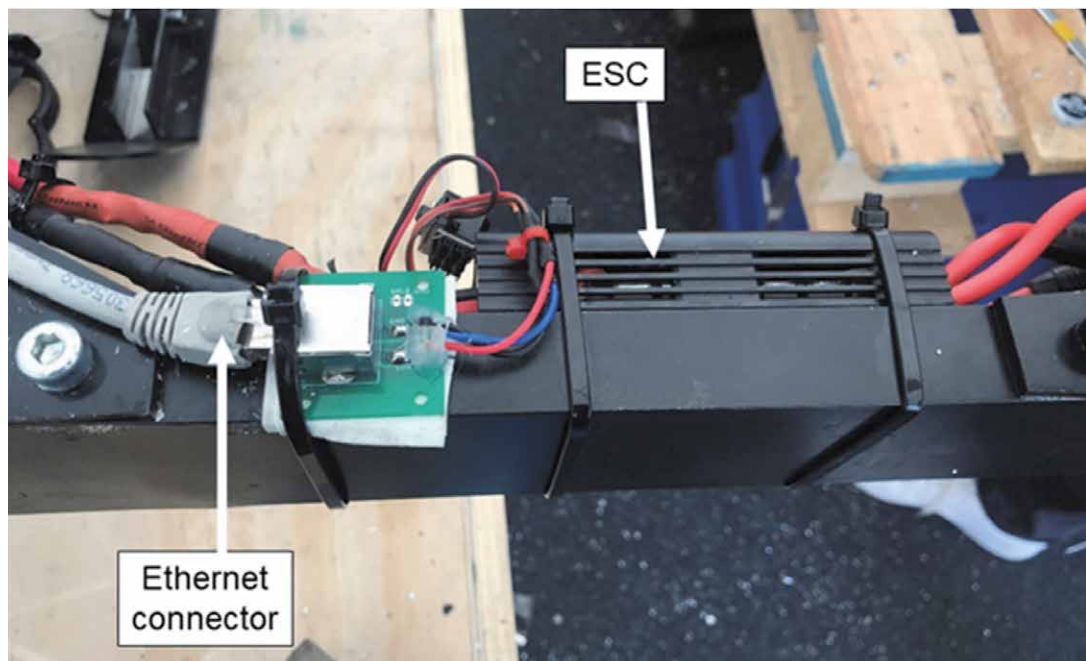
Figure 22

The construction of the aircraft used a large number of plastic tie-wraps to keep components in place. This included the ESCs, cabling and the connector plates from the control system ethernet cables to the ESCs (Figure 22). Failure of any of these connectors or cables would render the aircraft uncontrollable.
