Investigation Report

PEQAM 18 / 1526

Field failure: DFDS Finlandia Seaways; 12V 48/60; fracture of connecting rod head (PSHR-2018-008)

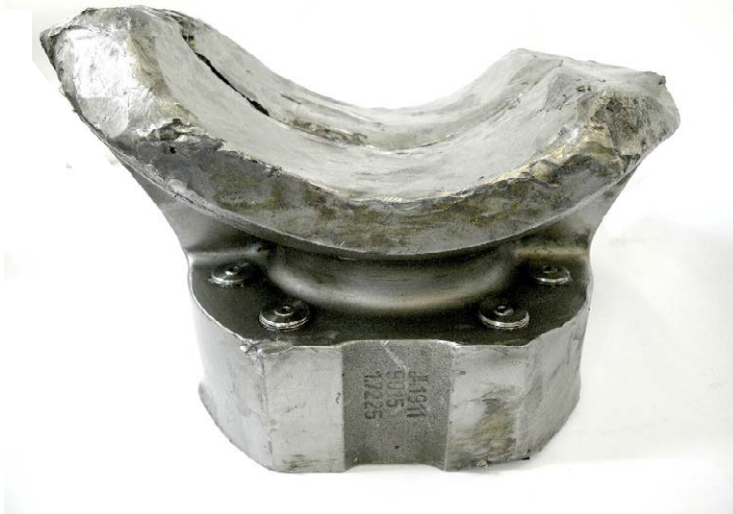
Picture 1:
Connecting rod head A5; lower piece

The fracture of the connecting rod head A5 occurred in the area of the top end of the stiffener. Due to fracture, the component suffered a lot of impact damage. Therefore, a detailed investigation of the component was not possible.

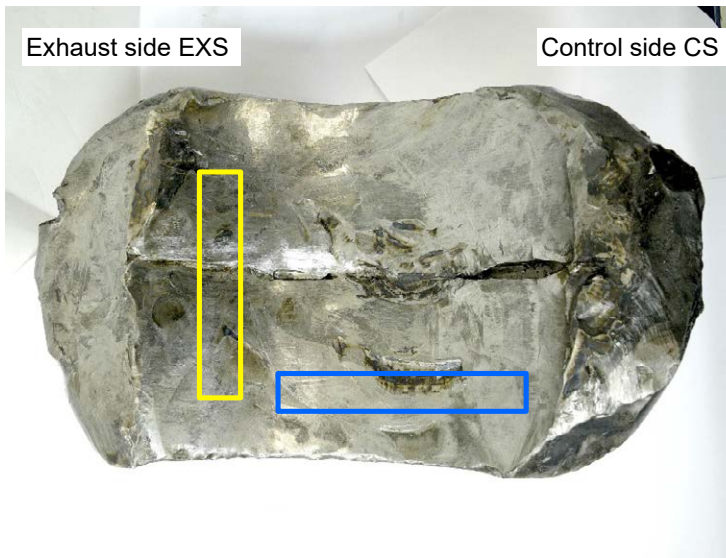
Picture 5:
Connecting rod head A5; lower piece

Both fracture surfaces as well as the area of the bearing bush showed heavy impact damage. A detailed investigation of these areas was not possible.

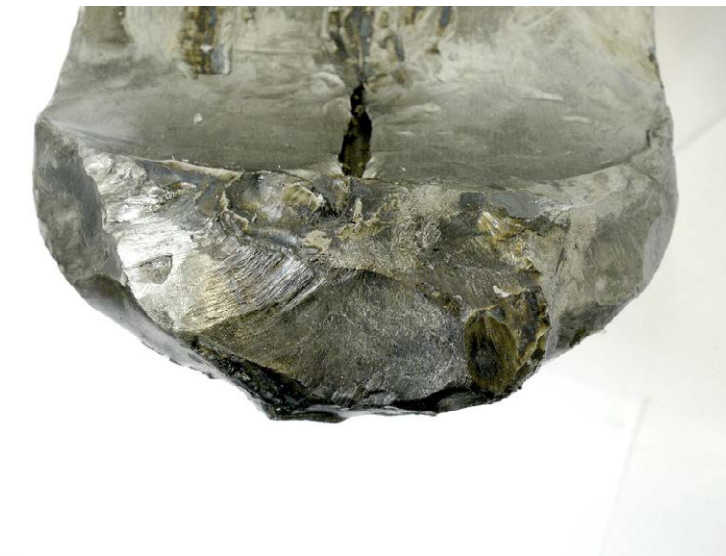
Picture 6:
Connecting rod head A5; fracture surface control side

The fracture surface was found completely destroyed by heavy impacts. Therefore, a detailed investigation was not possible.

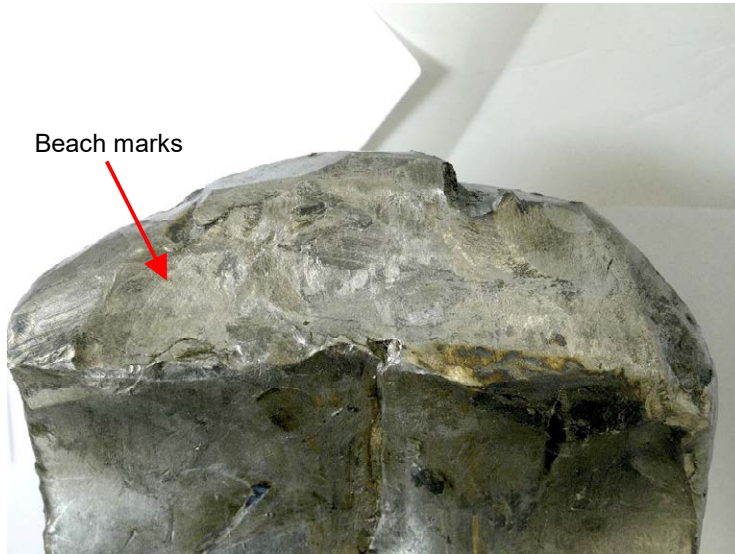
Picture 7:
Connecting rod head A5; fracture surface exhaust side

The fracture surface on the exhaust side also showed heavy impact damage. Only few weak signs of fatigue (beach marks) were visible.

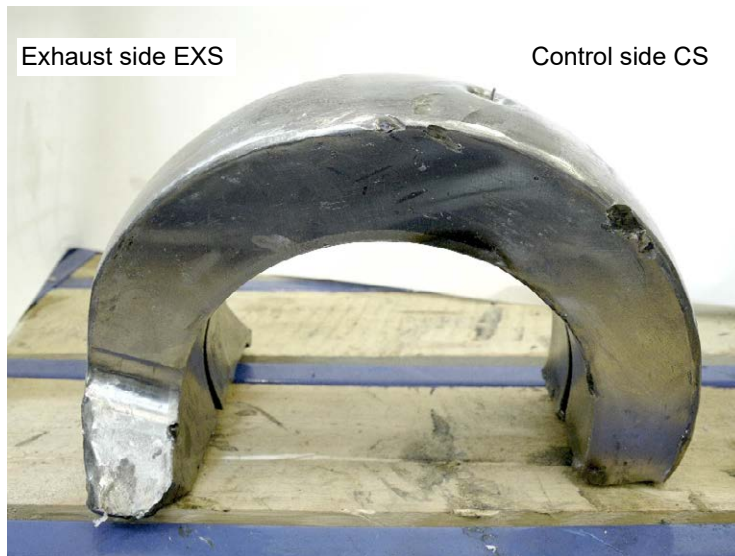
Picture 8:
Connecting rod head A5; upper piece

The broken upper piece of the connecting rod head showed also several impact marks.

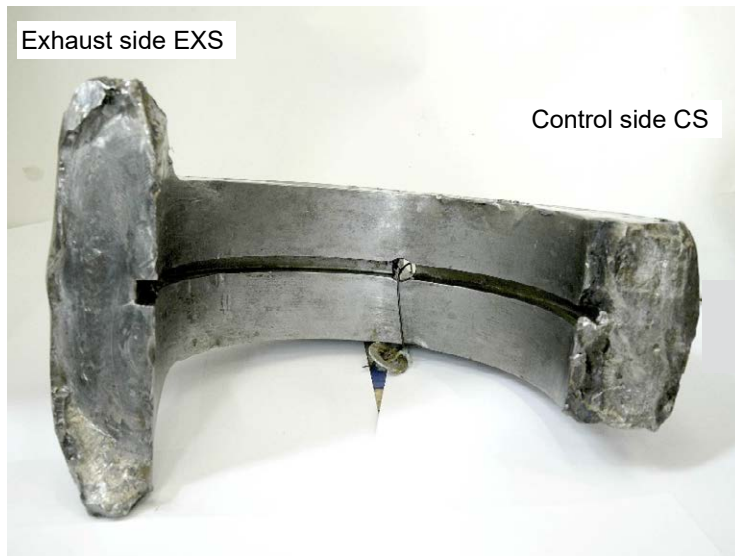
Picture 9:
Connecting rod head A5; upper piece

Both fracture surfaces were found to be heavy damaged. Despite the damage signs of fatigue crack propagation were observed on the fracture surface of the exhaust side. In the bearing area no sign of fretting was observed.

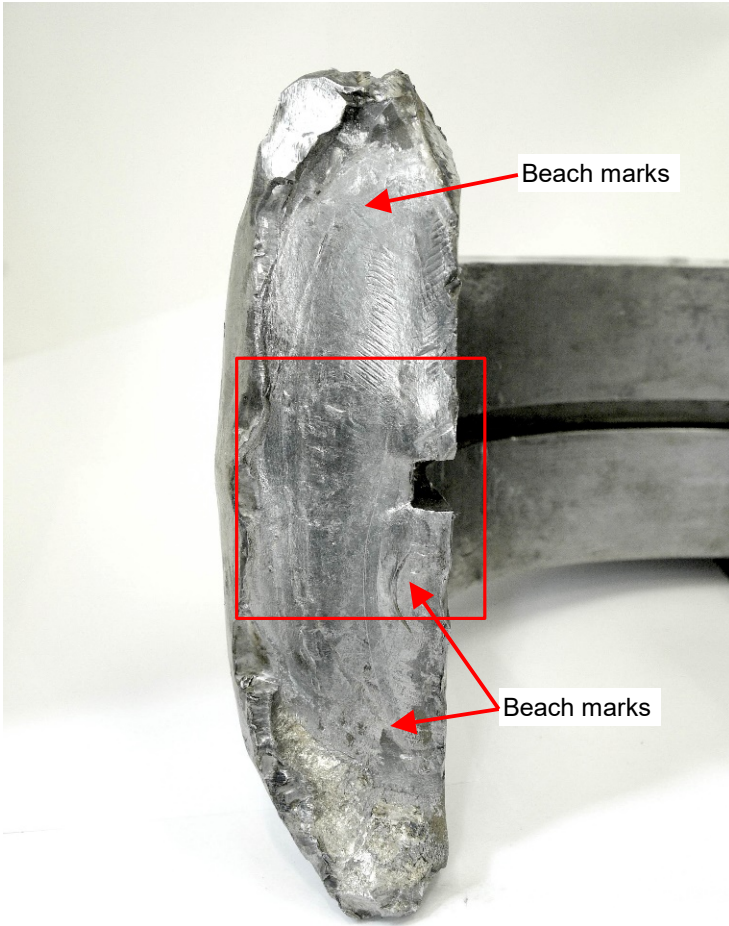
Picture 10:
Connecting rod head A5; fracture surface exhaust side (upper piece)

The fracture of the connecting rod head A5 was caused by a fatigue crack. Due to the heavy damage of the component, the exact position of the fatigue crack initiation could not be determined.

The fracture surface was also found to be damaged. However, signs of fatigue crack propagation (beach marks) were observed. Based on the location and extension of the fatigue crack it is assumed the crack initiation site is located around the oil channel.

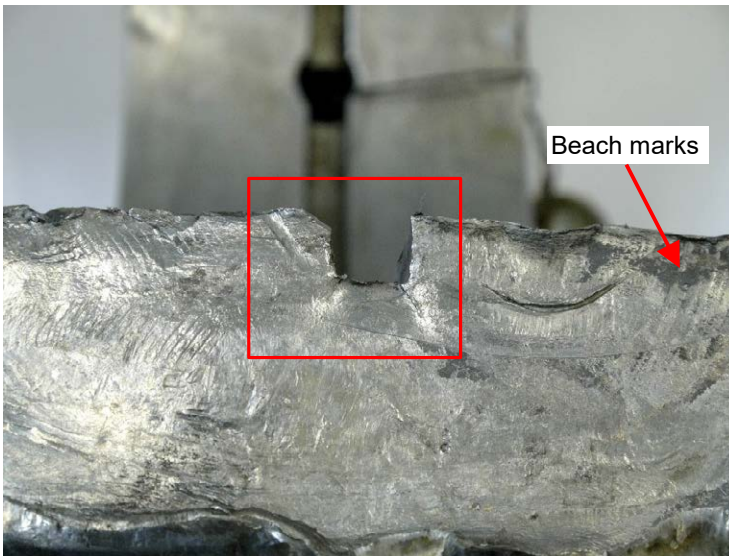
Picture 11:
Connecting rod head A5; fracture surface exhaust side (upper piece)

The fracture surface suffered multiple impacts, therefore no detailed investigation was possible. Unfortunately, the area around the oil channel was also affected by impact damage.

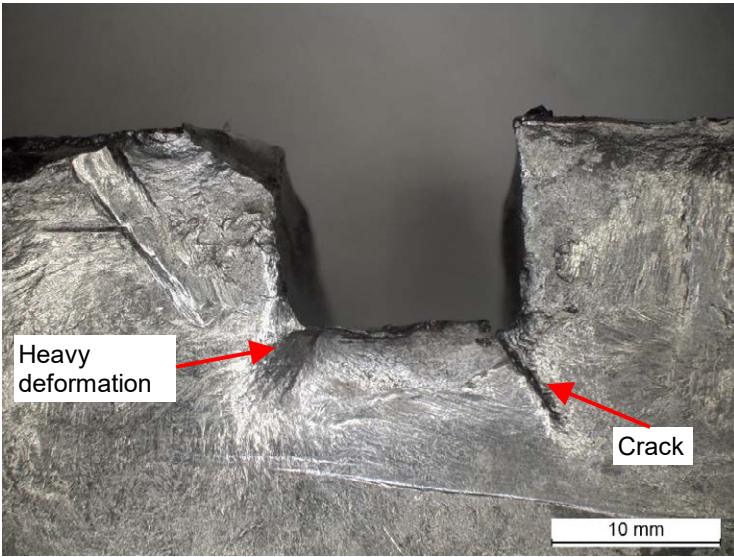
Picture 12:
Connecting rod head A5; fracture surface exhaust side (upper piece)

The fracture surface around the oil channel was found cracked and deformed. The exact position of the crack initiation site could not be determined.

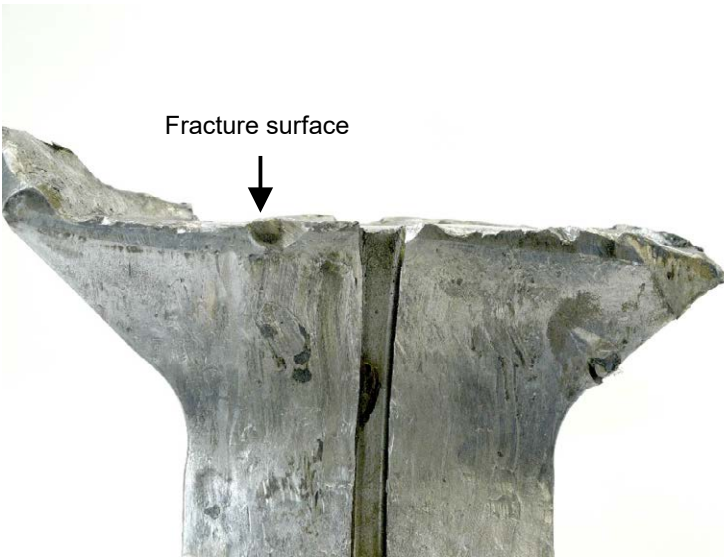
Picture 13:
Connecting rod head A5; bearing surface exhaust side (upper piece)

The bearing surface showed impact damage and deformation, especially at the edge of the fracture surface.

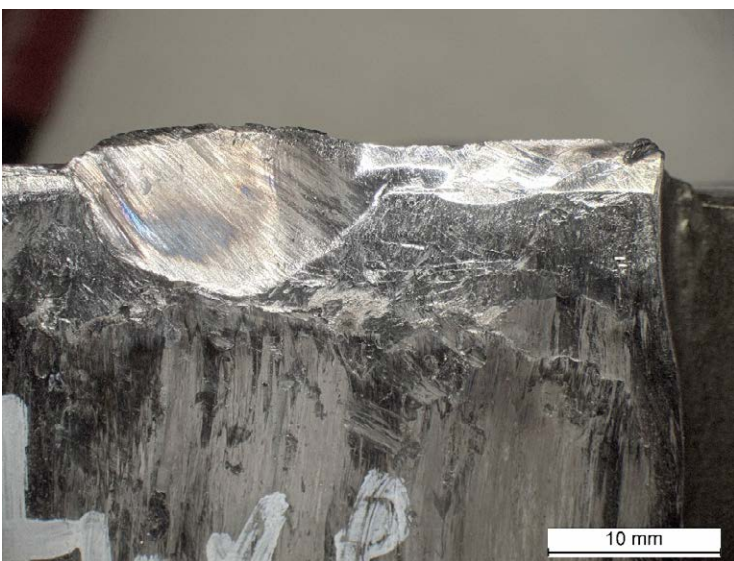
Picture 14:
Connecting rod head A5; bearing surface exhaust side (upper piece)

The bearing surface showed impact damage and deformation at the edge of the fracture surface. No investigation regarding fatigue crack initiation was possible.

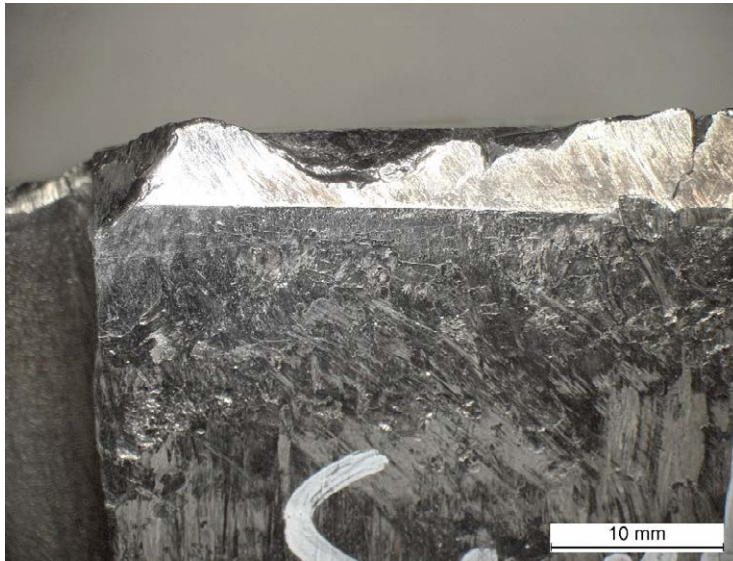
Picture 15:
**Connecting rod head A5; bearing surface
 exhaust side (upper piece)**

On the opposite side of the oil channel similar damage is visible.

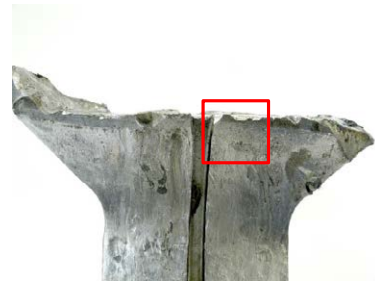
Picture 16:
**Connecting rod head A5; fracture surface
 control side (upper piece)**

The opposite fracture surface also showed heavy impact damage. Therefore, no further investigation was possible.

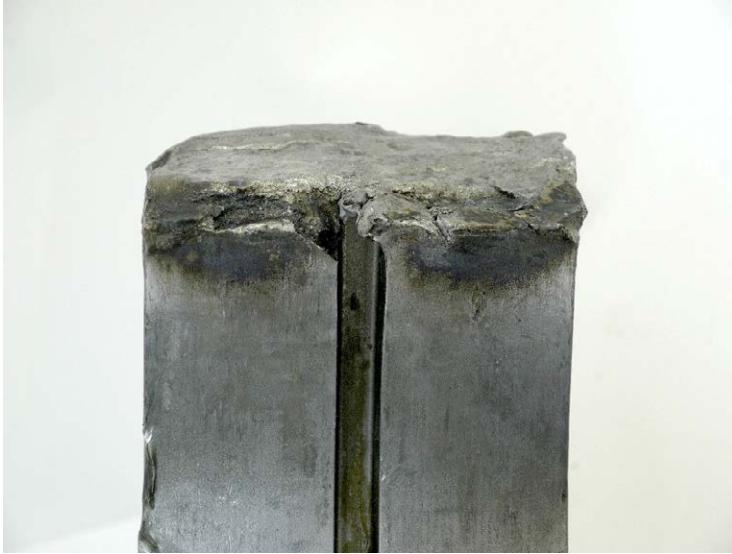
Picture 17:
Connecting rod head A5; bearing surface control side (upper piece)

The bearing surface showed heavy impact damage and deformation. Especially the edge of the fracture surface was found destroyed completely.

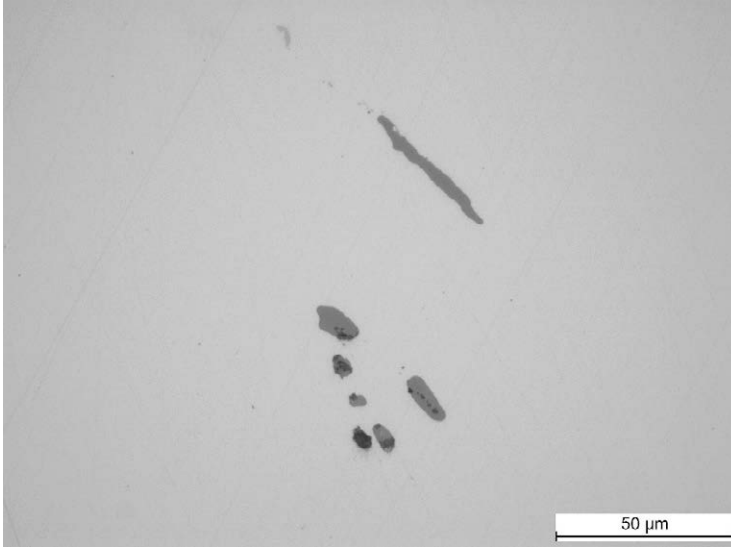
Picture 20:
Tensile Specimen A5 – trans No. 2;
microsection

The microsection showed many aggregations of non-metallic inclusions. The increased occurrence of such aggregations can reduce the ductility of the material.

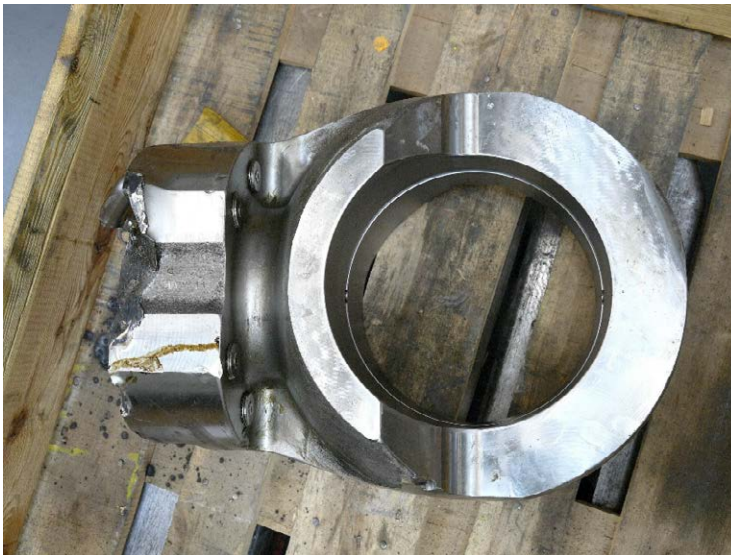
Picture 21:
Connecting rod head B5

The connecting rod head B5 suffered multiple impact damage. After disassembling the bearing bush the connecting rod head was measured regarding diameter and roundness of the bore. Furthermore, a magnetic crack testing was carried out. No cracks were detected.

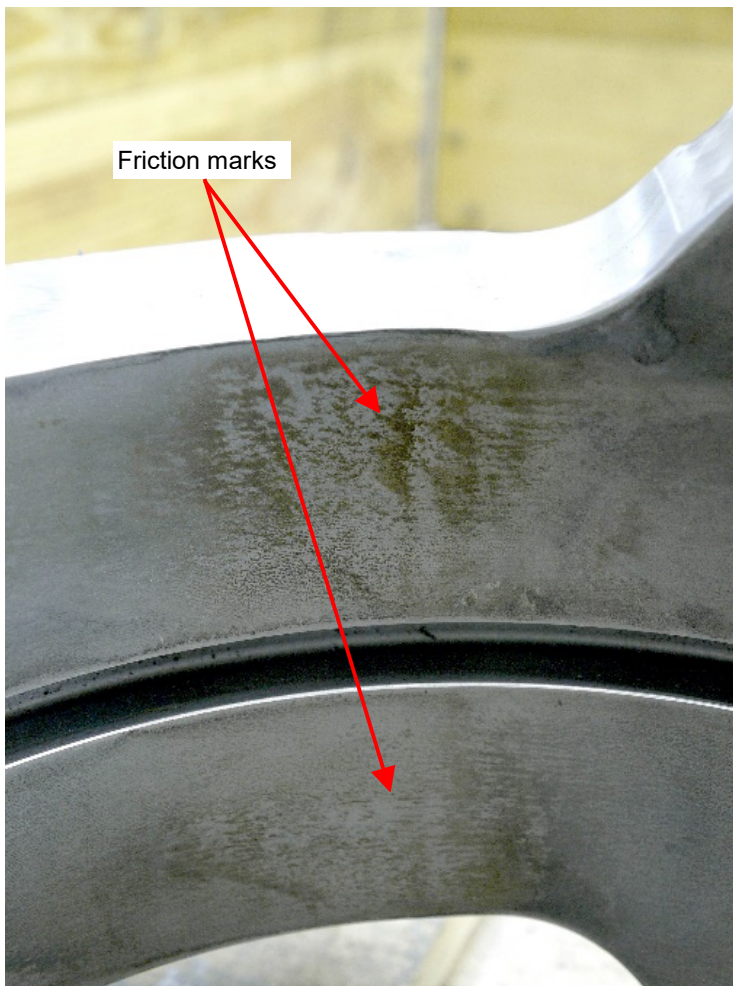
Picture 24:
Connecting rod head B5; bearing surface

On the bearing surface slight signs of friction between connecting rod head and bearing bush were visible. The friction marks were not considered as fretting. A magnetic crack testing in this area revealed no cracks.

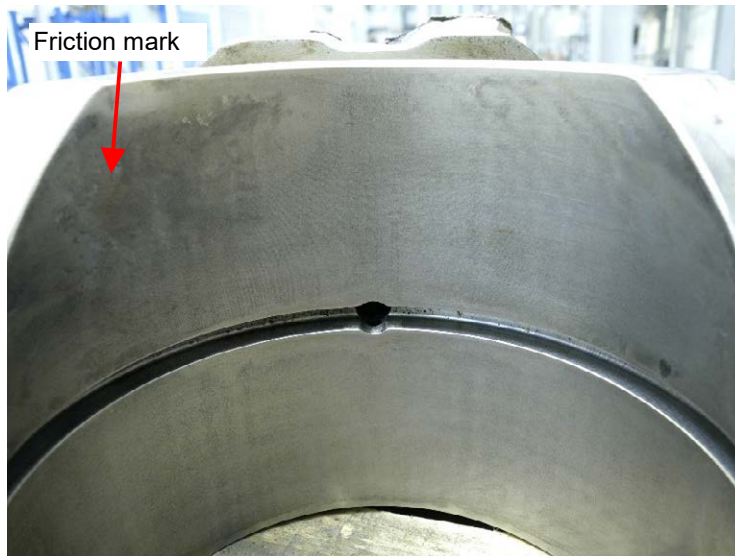
Picture 25:
Connecting rod head B5; bearing surface

On the bearing surface slight signs of friction between connecting rod head and bearing bush were visible. The friction marks were not considered as fretting. A magnetic crack testing in this area revealed no cracks.

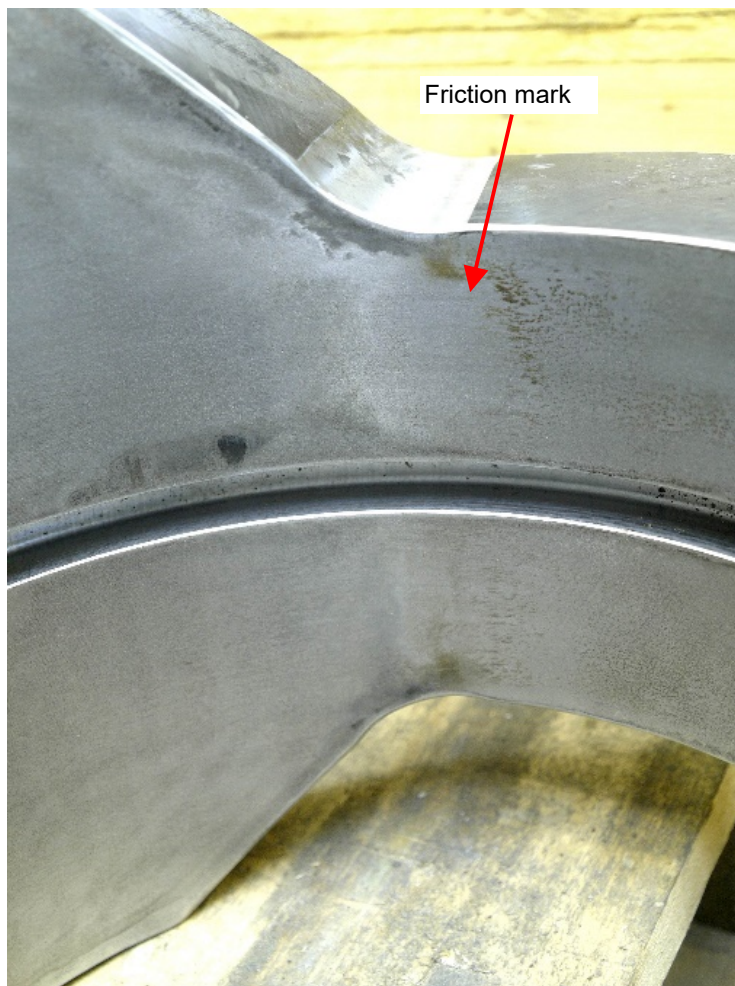
Picture 26:
Connecting rod head B5; bearing surface

On the bearing surface slight signs of friction between connecting rod head and bearing bush were visible. The friction marks were not considered as fretting. A magnetic crack testing in this area revealed no cracks.

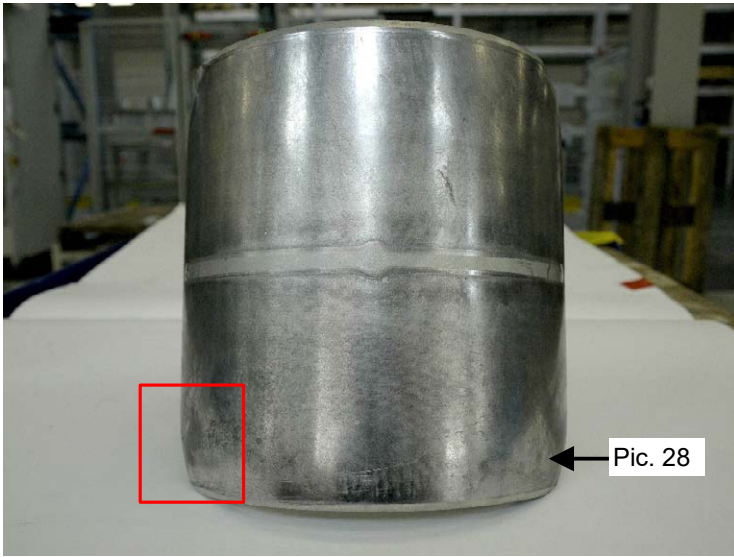
Picture 28:
Bearing bush B5; backside

The condition of the backside corresponds to the bearing surface of the connecting rod head. At several positions friction marks were observed.

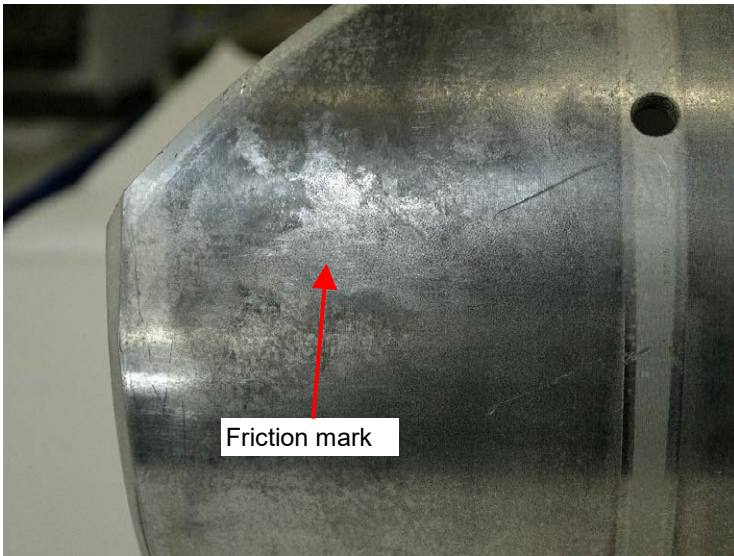
Picture 29:
Bearing bush B5; backside

On the backside several friction marks were observed. These spots were not considered as fretting.

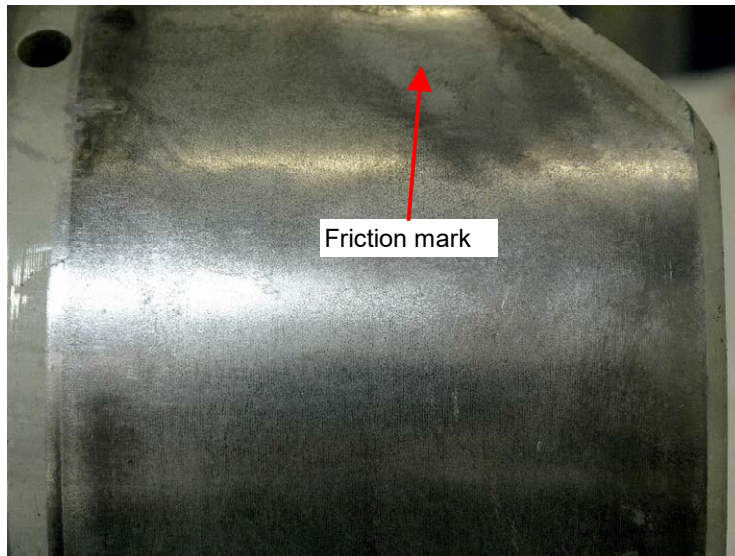
Picture 30:
Bearing bush B5; backside

On the backside several friction marks were observed. These spots were not considered as fretting.
