## Dunwich coastal defence demonstration project

Assessing the effectiveness of geomembrane structures filled with locally won beach shingle or sand material to reduce cliff erosion

Report – SC050071/R

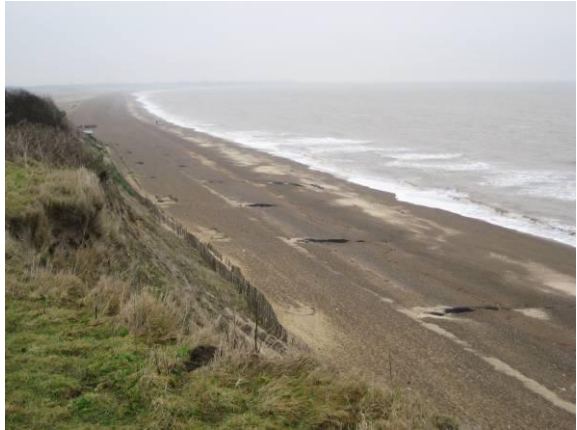
<b>Damage to structures</b>		
Backwall – July 2008

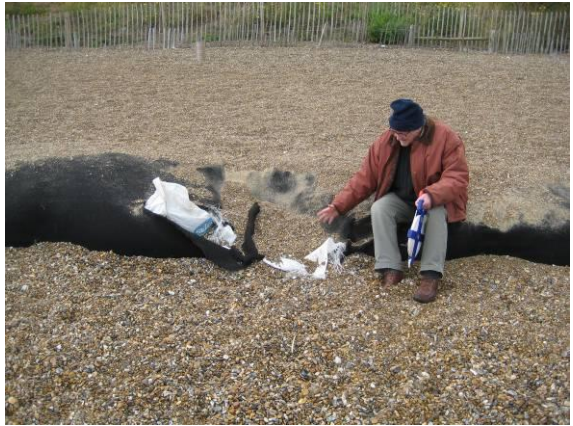
A consistent problem occurred during construction whereby difficulty was experienced in securing the geomembrane at the seaward end of each lateral 'hump'. This was caused by the limited time available to work at the bottom of the tide and by the difficulty in achieving the required depth of trench excavation in the saturated beach material. As a result, a severe storm shortly after the completion of construction loosened fabric in two of the hump groyne. When exposed, it is considered that these pose a hazard to bathers.

Detached geomembrane at seaward end of 'hump' 2008

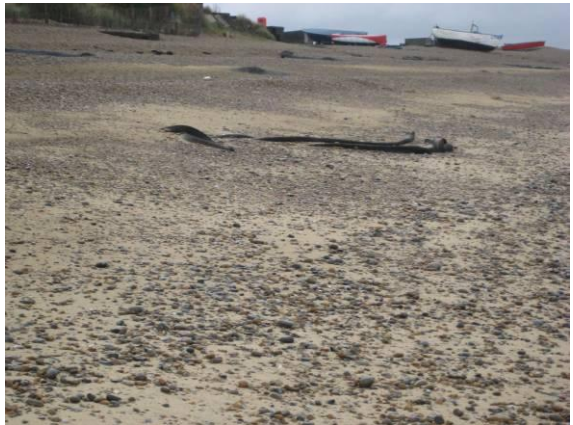
Seaward end of 'hump' A 2008

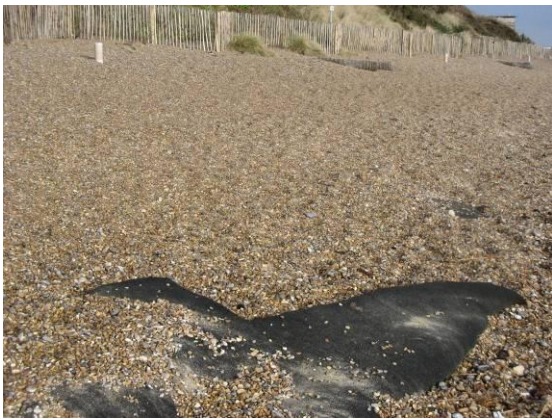
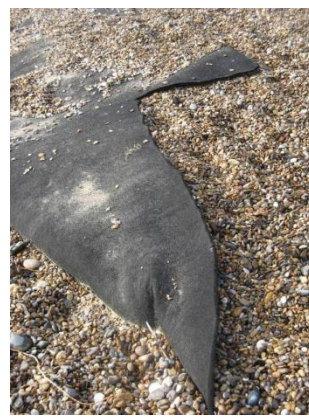
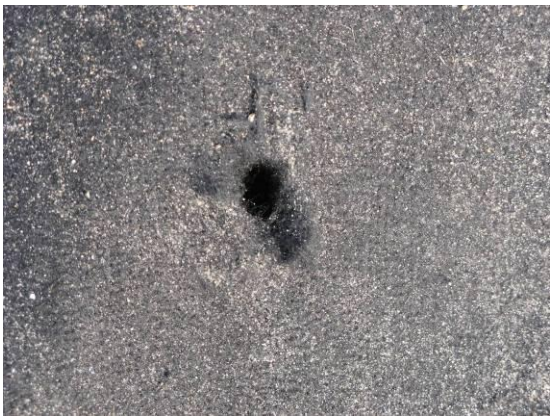
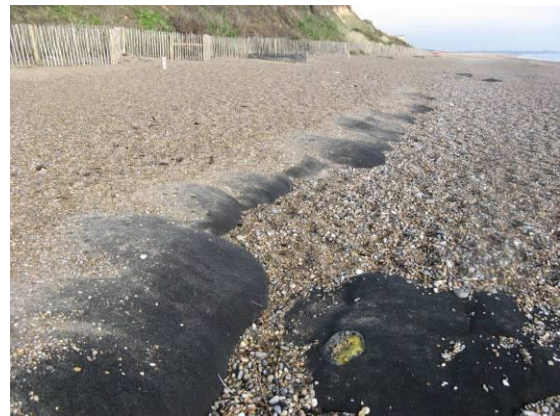
There were a small number of locations where the geomembrane has been holed or torn, with a suspicion that some of the damage may have been caused maliciously. In other instances, some tearing and fraying of the fabric edges indicated an abraded or tensile failure. In each case, a simple patch of fabric was welded over the damage with the repairs continuing to prove satisfactory over the subsequent period.

### Damaged fabric at February 2011
