Our ref: 101465
Your ref:

[REDACTED]
Historical Railways Estate
3rd Floor
37 Tanner Row
YORK
YO1 6WP
[REDACTED]

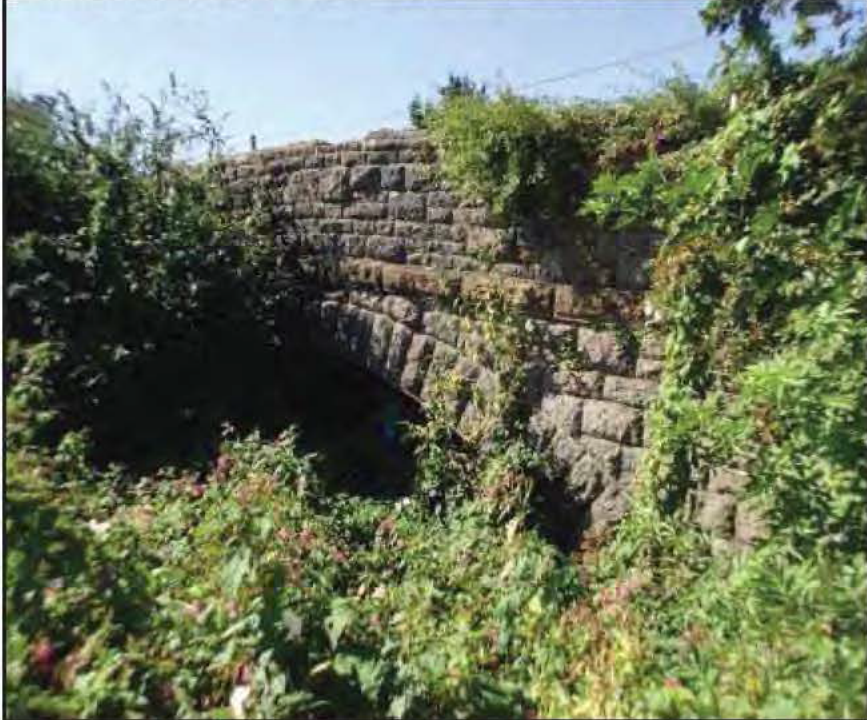
<u>EXAMINATION NOTE</u> The visual and frequent examinations coincide with each other; the examiner has therefore combined both the visual and frequent examinations within this report.
	<u>NEW DEFECTS</u> Failure of 1no stone has occurred at line of a long-standing displaced fracture located at the U/S quoin of the L/e parapet.
	<u>LONG-STANDING DEFECTS</u> Unless noted, all accessible long-standing defects show no evidence of change since the previous visual examination dated 20/03/18. Any changes within the structure have been highlighted with Red text. See pages 2 to 4 for details. See page 5 for frequent tables.

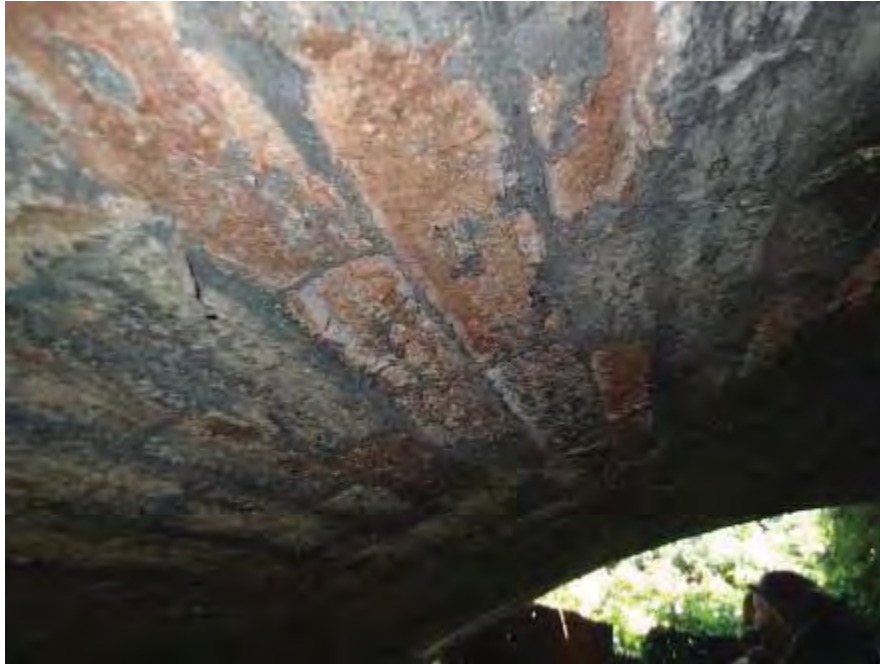
Photograph 13: example of long-standing spalling action within the soffit

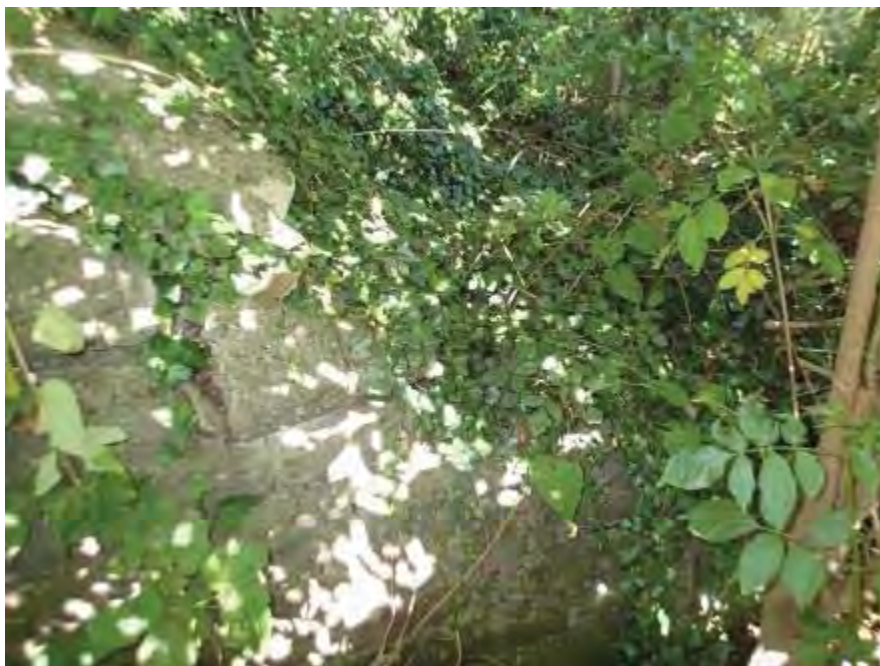
Photograph 14: long-standing coping loss is noted along the U/S, L/e wingwall

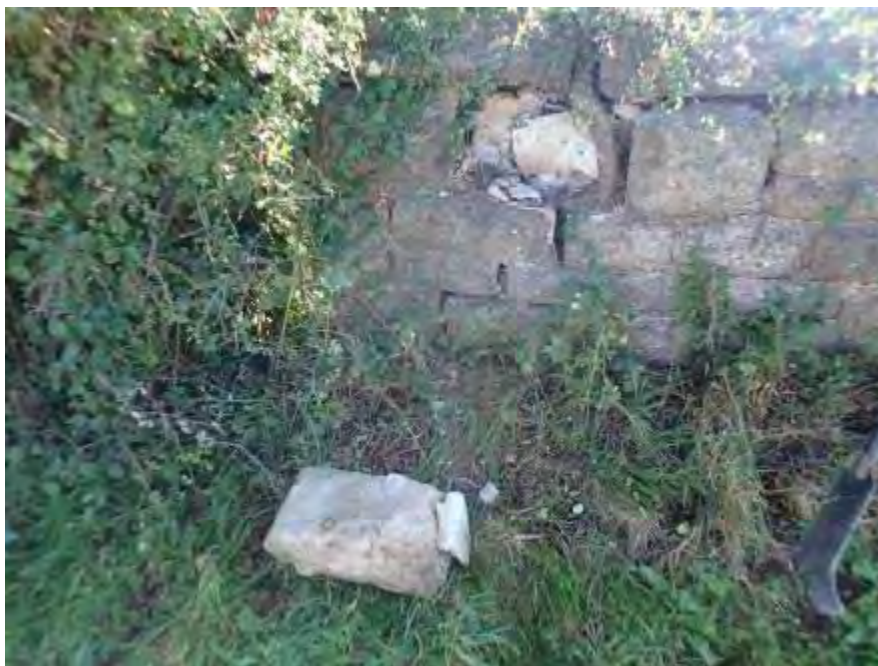
Photograph 20: failure of stone at line of displaced fracture at the U/S quoin of the L/e parapet occurred during the examination

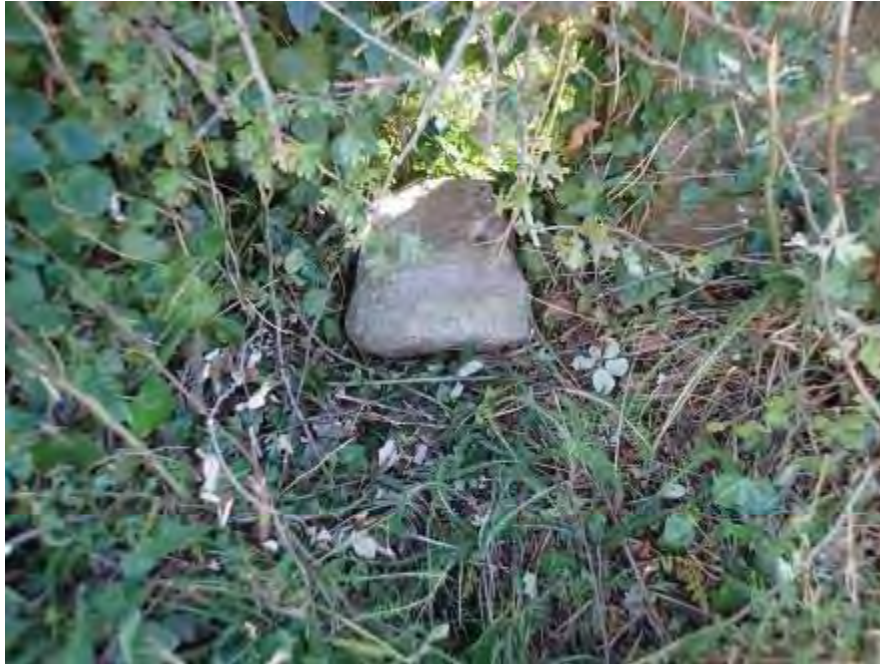
Photograph 21: the failed stone was placed adjacent to the U/S return of the parapet

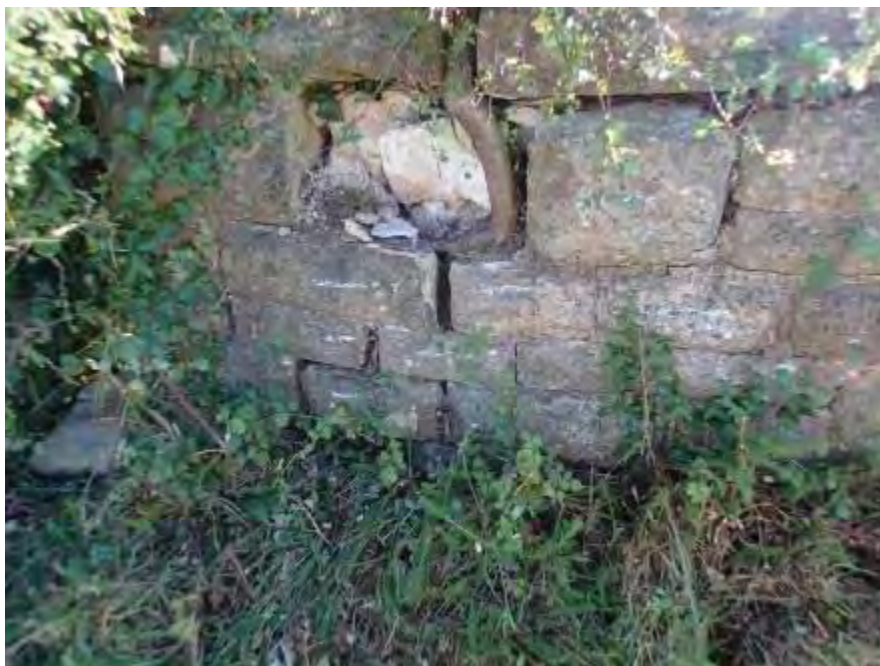
Photograph 22: long-standing displaced fracture located at the U/S quoin of the L/e parapet
 Stones marked with blue chalk are found loose

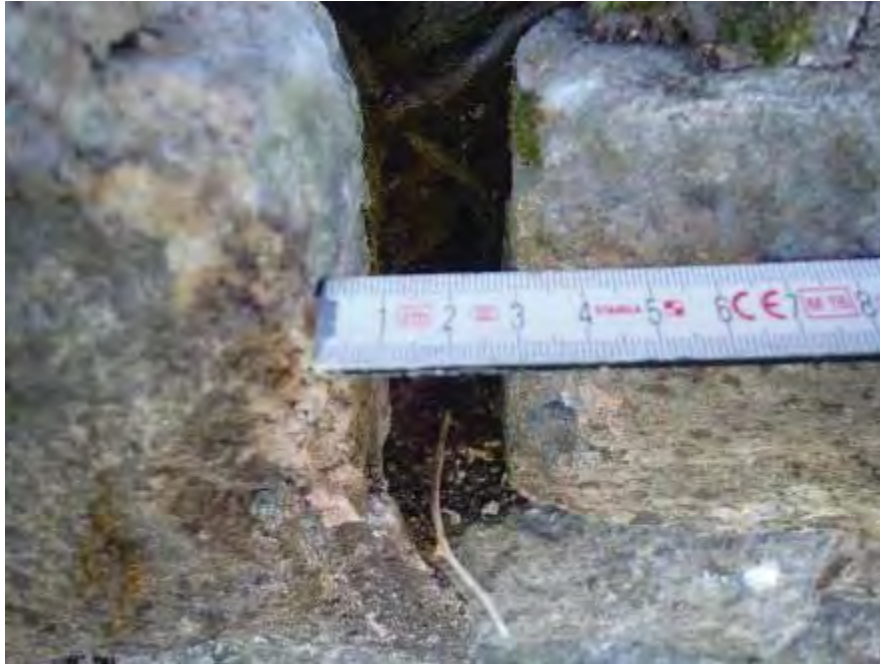
Photograph 23: the fracture at the U/S, L/e quoin is open to 30mm change from 28mm

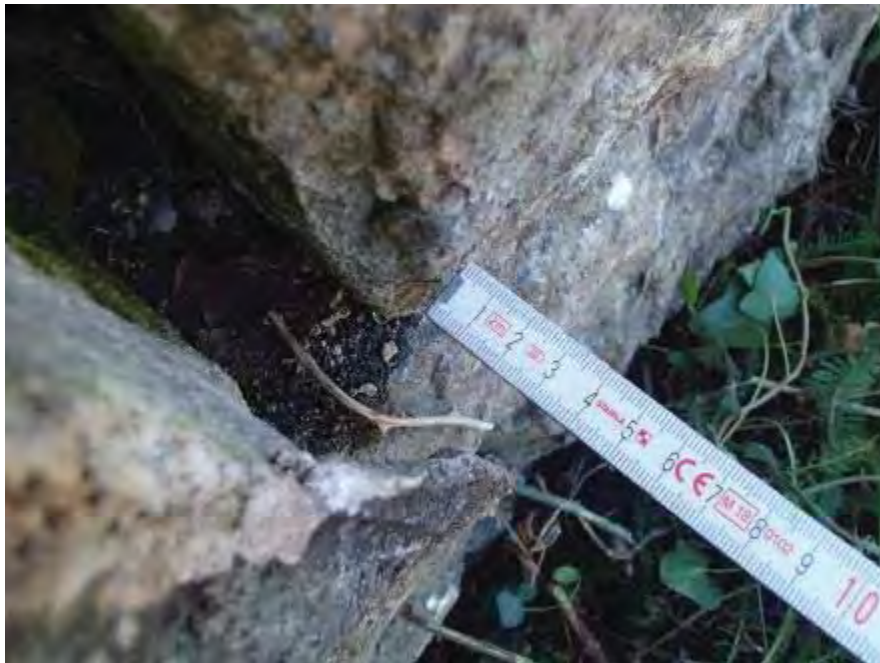
Photograph 24: displacement along the fracture is noted up to 40mm
 The examiner changed the monitoring point following failure of a stone

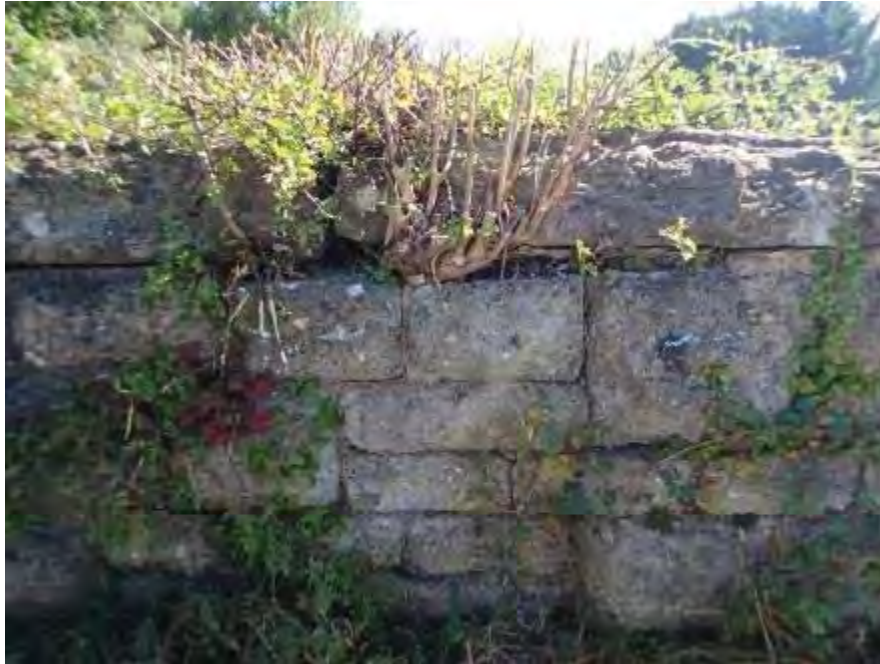
Photograph 25: long-standing root ingress is located below the L/e copings approx 2.6m from the U/S quoin
 Stones marked with blue chalk are found loose

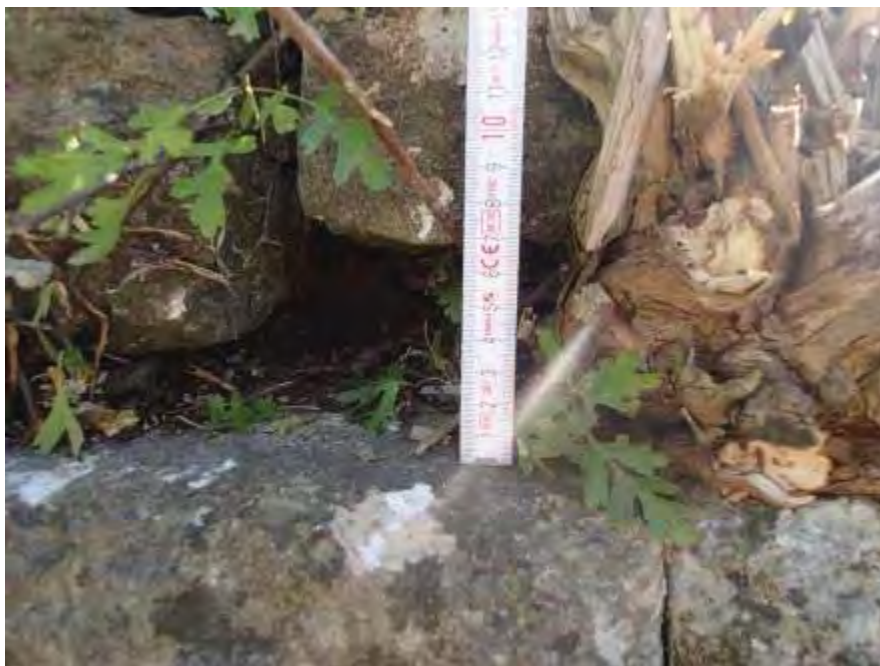
Photograph 26: copings are lifting up to 70mm due to the root ingress
 Change noted from 65mm

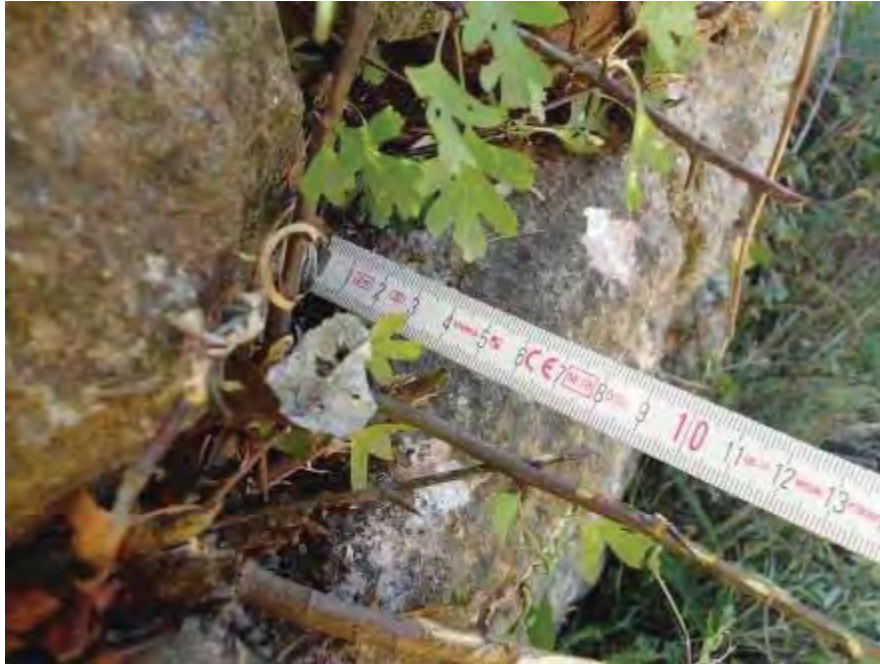
Photograph 27: long-standing inward displacement of the copings was noted up to 60mm

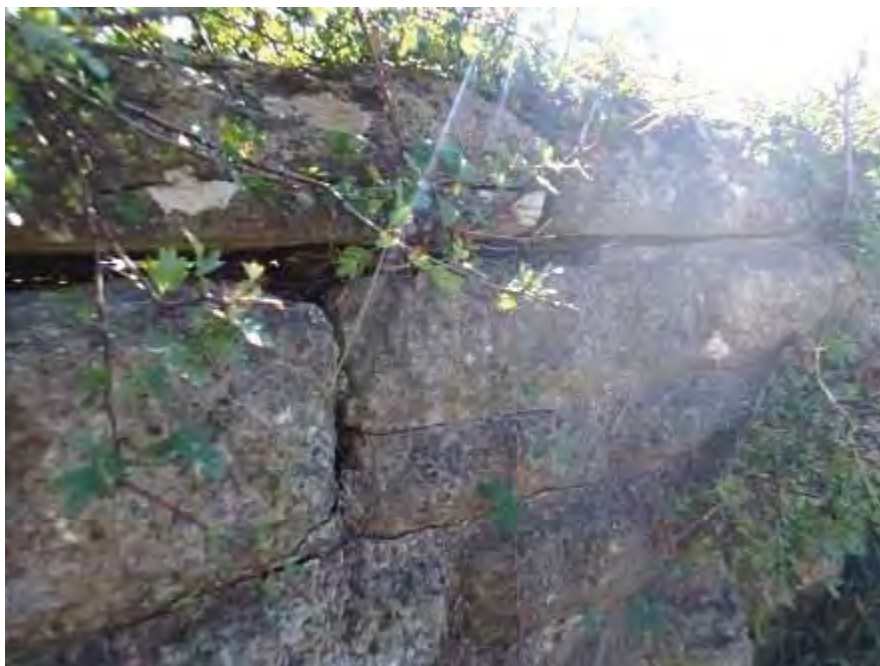
Photograph 28: evidence of root ingress extending below the copings towards the U/S quoin

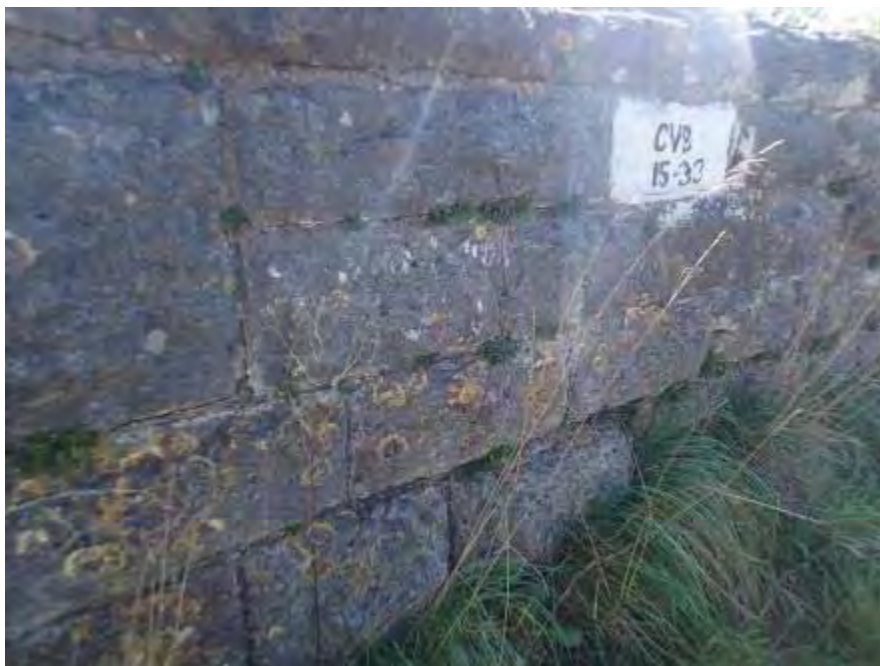
Photograph 30: example of lifting and cracking mortar noted along the L/e parapet

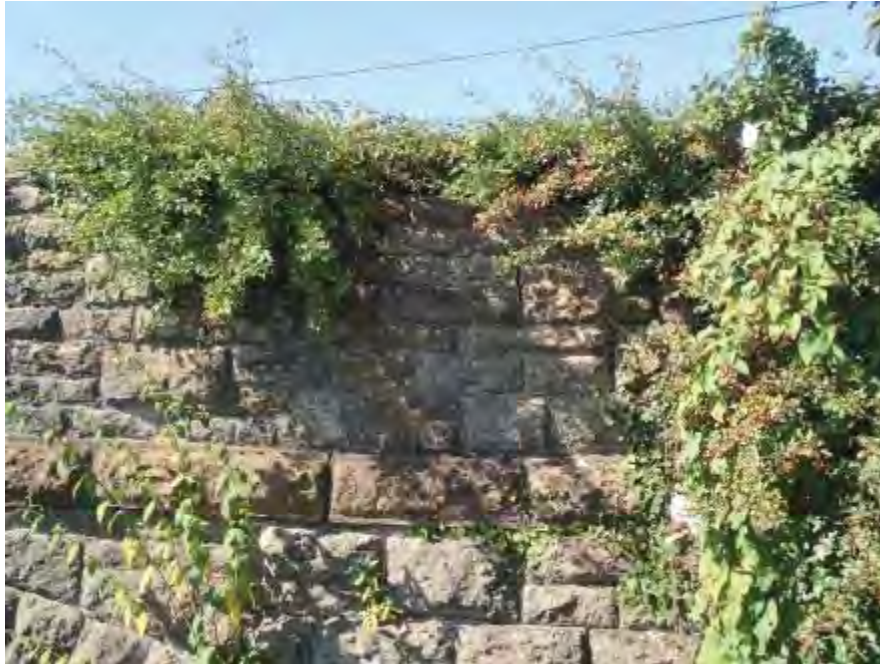
Photograph 31: a long-standing step fracture is located at the U/S quoin within the external face of the L/e parapet

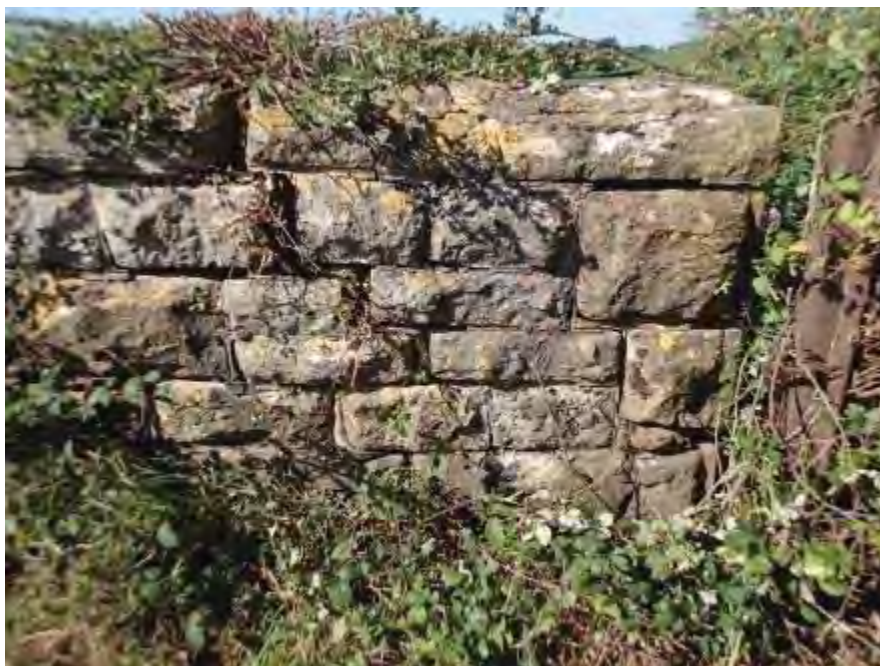
Photograph 32: a long-standing displaced fracture is located at the U/S quoin of the C/e parapet

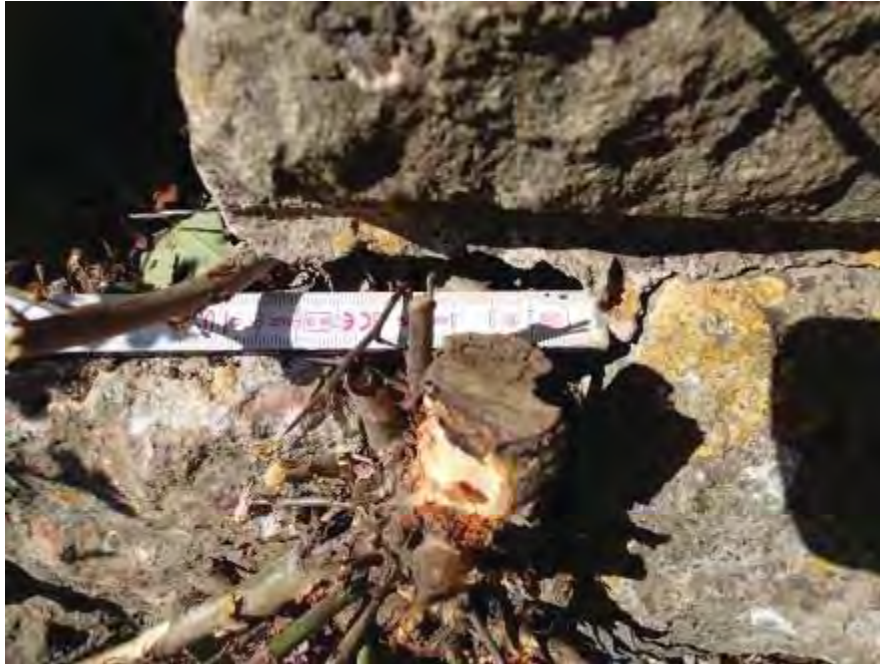
Photograph 33: displaced fracture at the U/S quoin of the C/e parapet is open to 60mm from 55mm

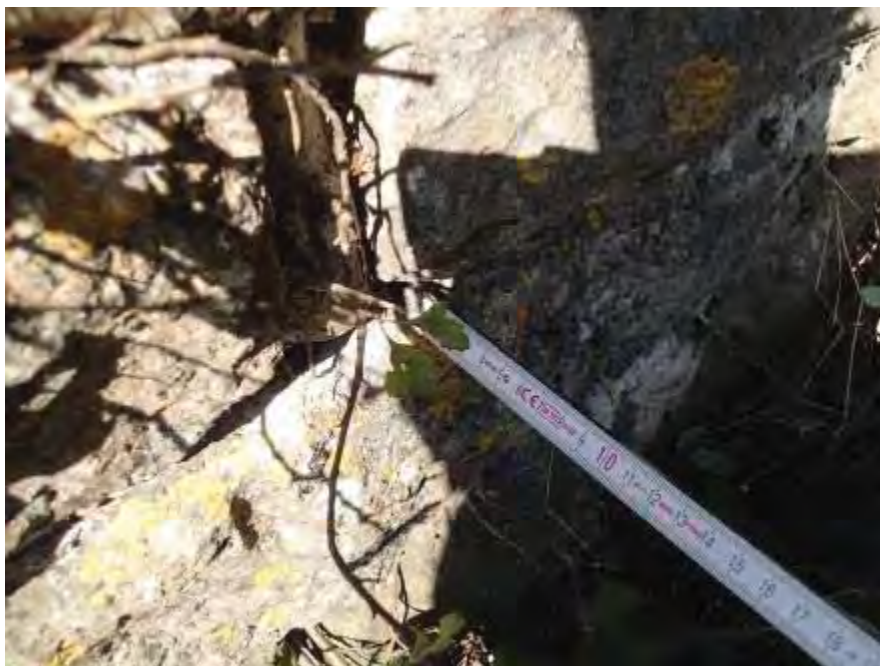
Photograph 34: displacement within the C/e parapet noted up to 20mm

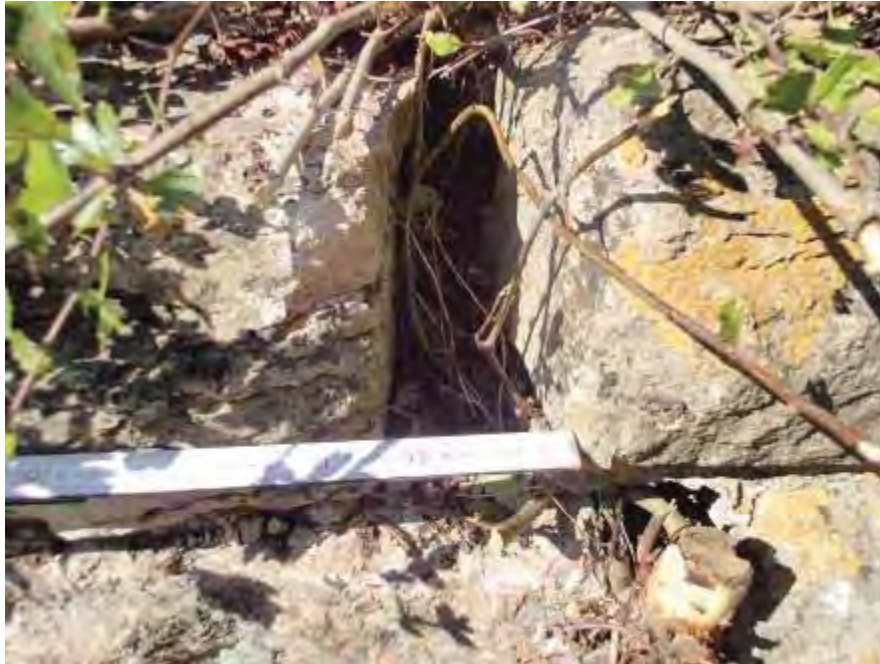
Photograph 35: fracture at coping within the C/e parapet open to 76mm from 70mm

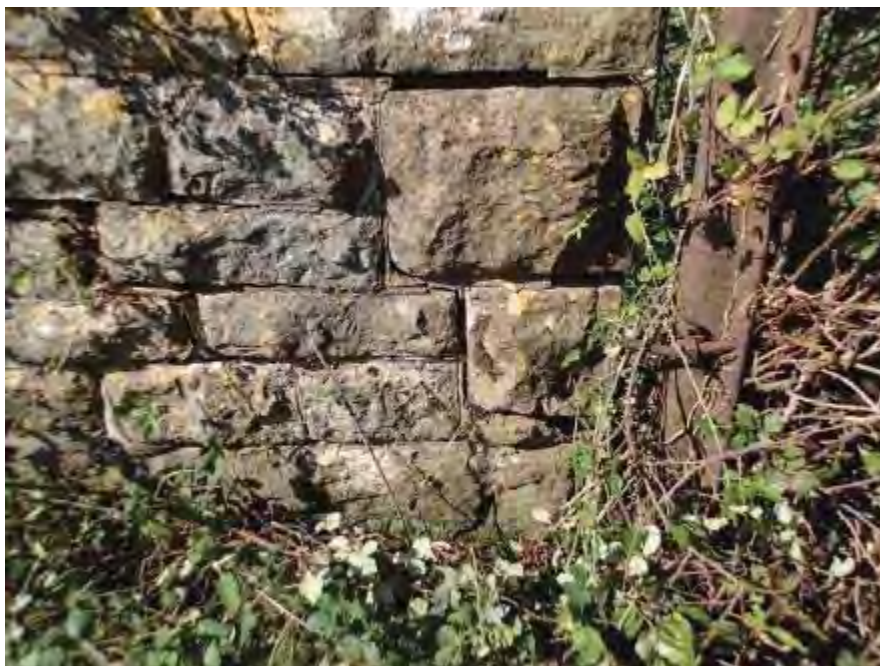
Photograph 36: step fracture at the U/S quoin within the C/e parapet

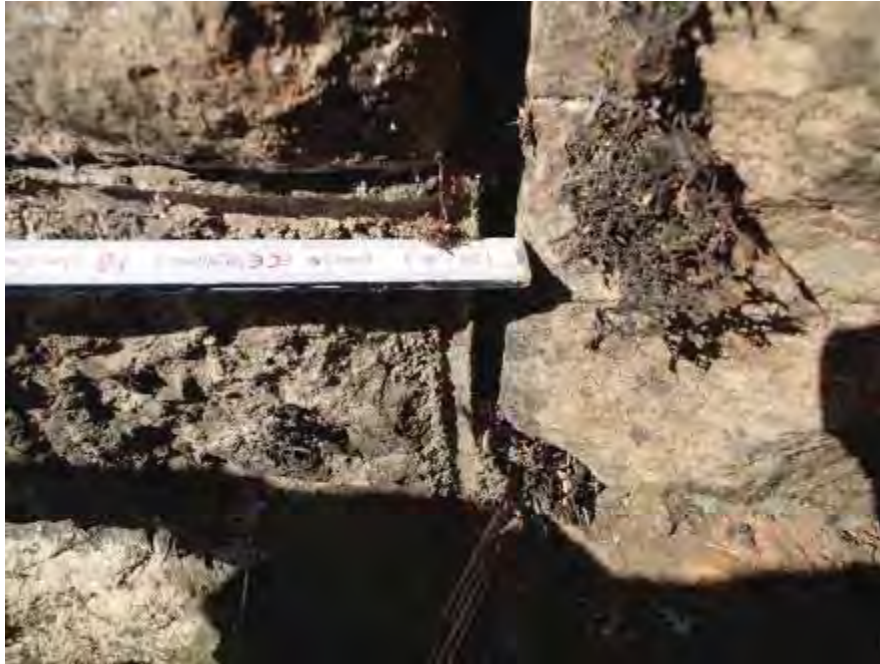
Photograph 37: the fracture is open to 12mm
Change noted from 10mm

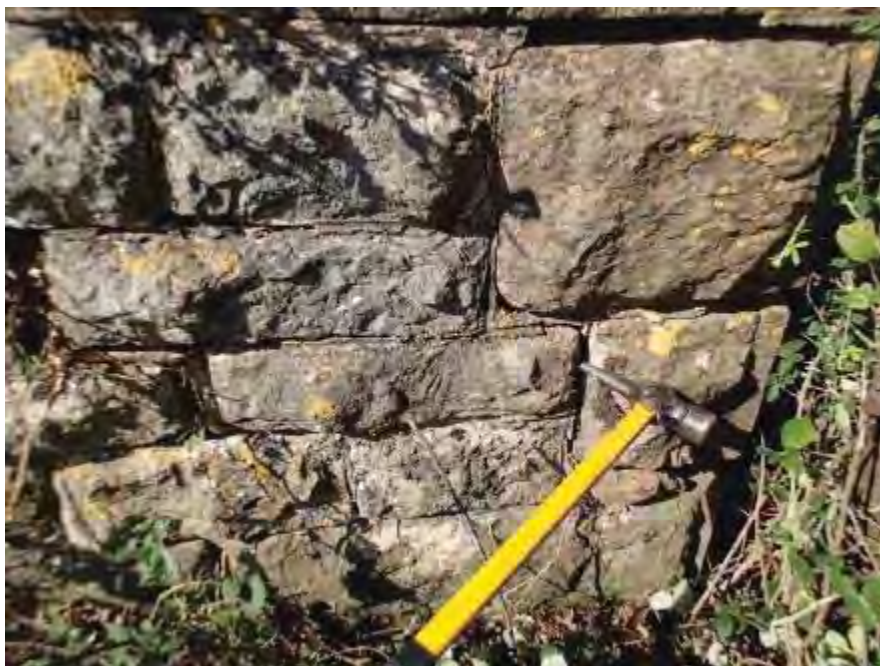
Photograph 38: loose stonework was noted on insertion of lever at line of fracture

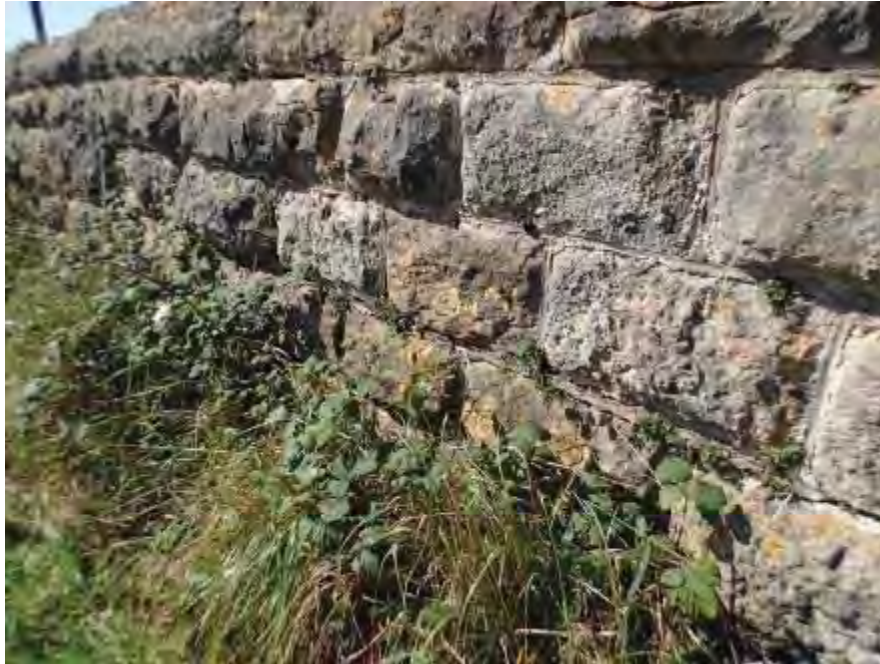
Photograph 39: example of lifting and cracking mortar noted along the C/e parapet

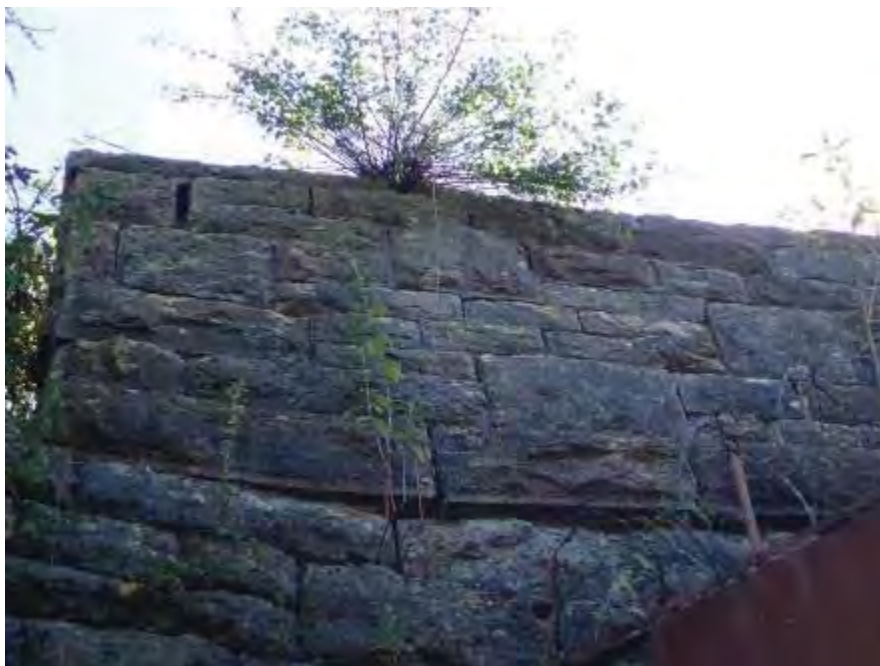
Photograph 40: long-standing loose and displaced stonework is noted within the external face of the C/e parapet at the U/S quoin

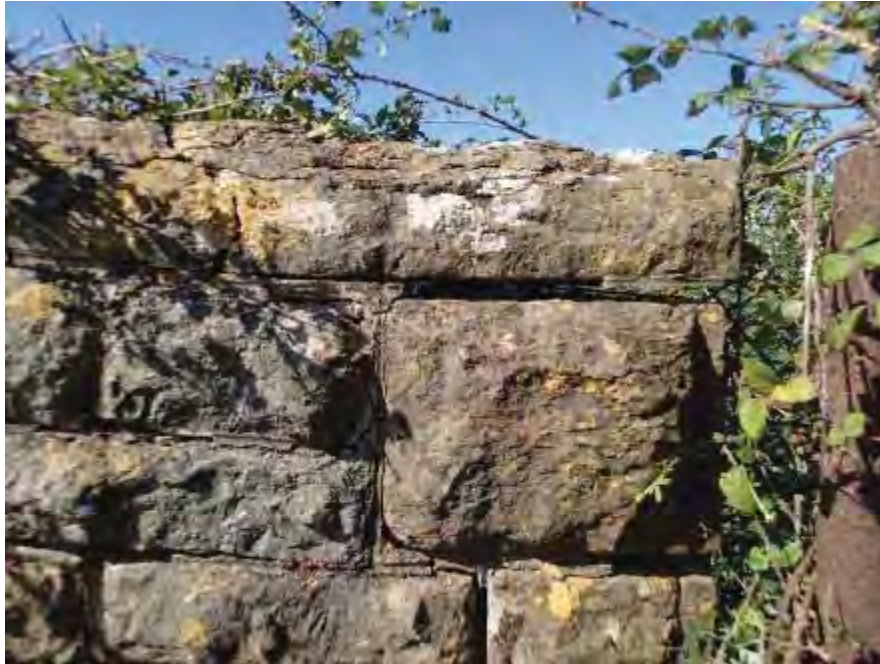
Photograph 41: fractured and loose coping is noted at the U/S quoin of the C/e parapet

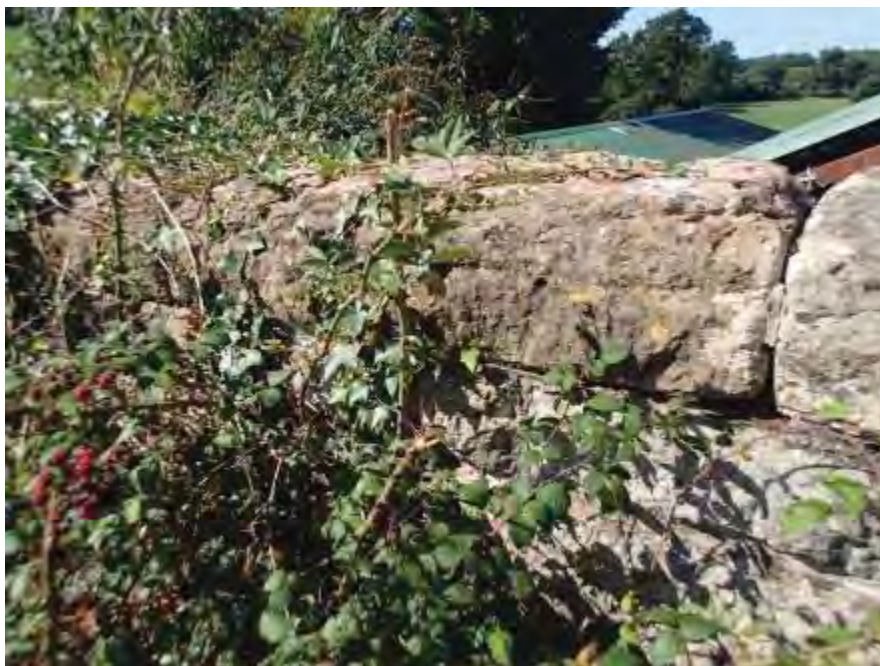
Photograph 42: a coping on the U/S of the parapet was found to lift on insertion of a lever

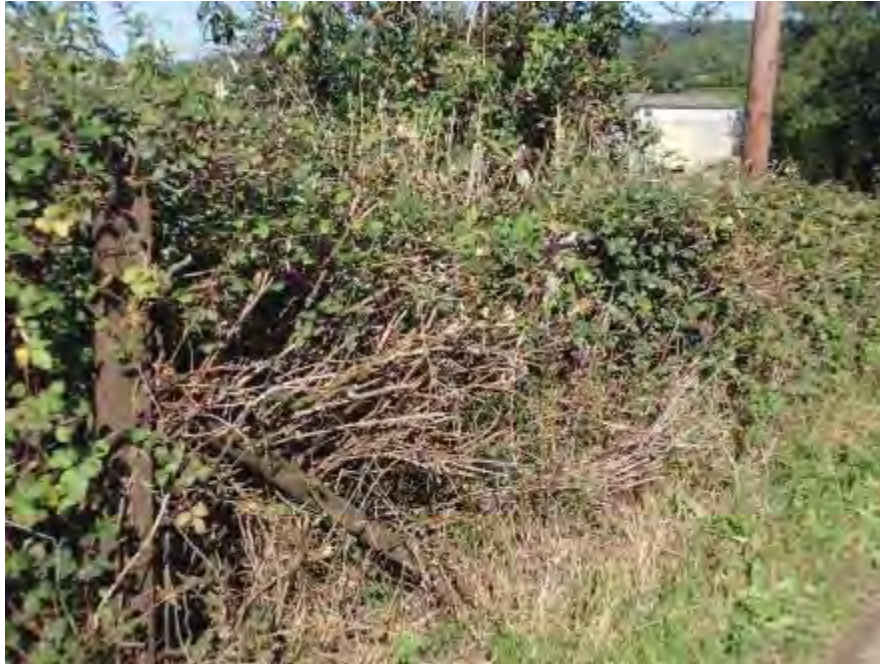
Photograph 43: long-standing failure of straining wires noted to the U/S, C/e approach fence

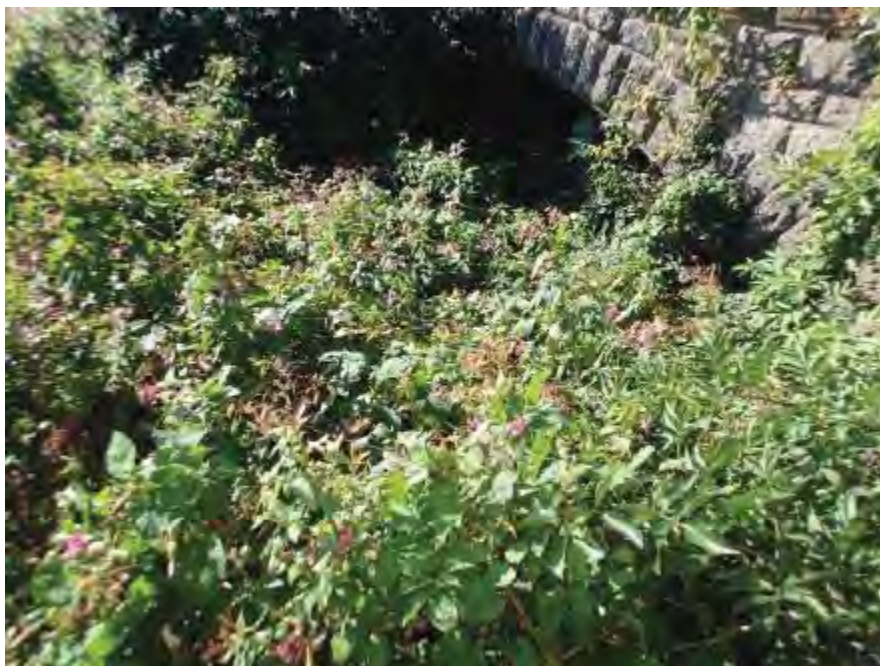
Photograph 44: widespread Himalayan Balsam is noted on the L/e of the structure

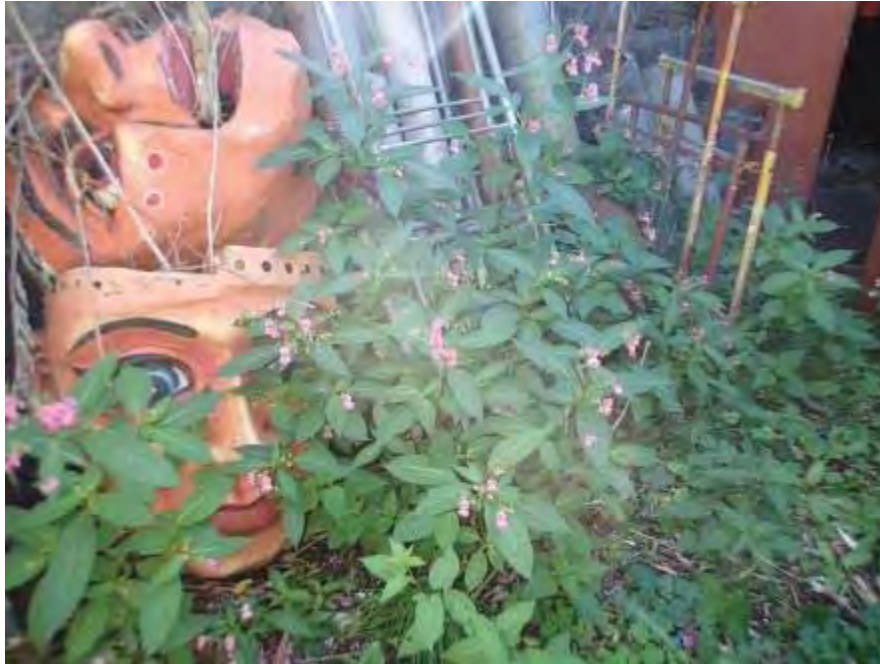
Photograph 45: odd areas of Himalayan Balsam are also noted on the C/e of the structure

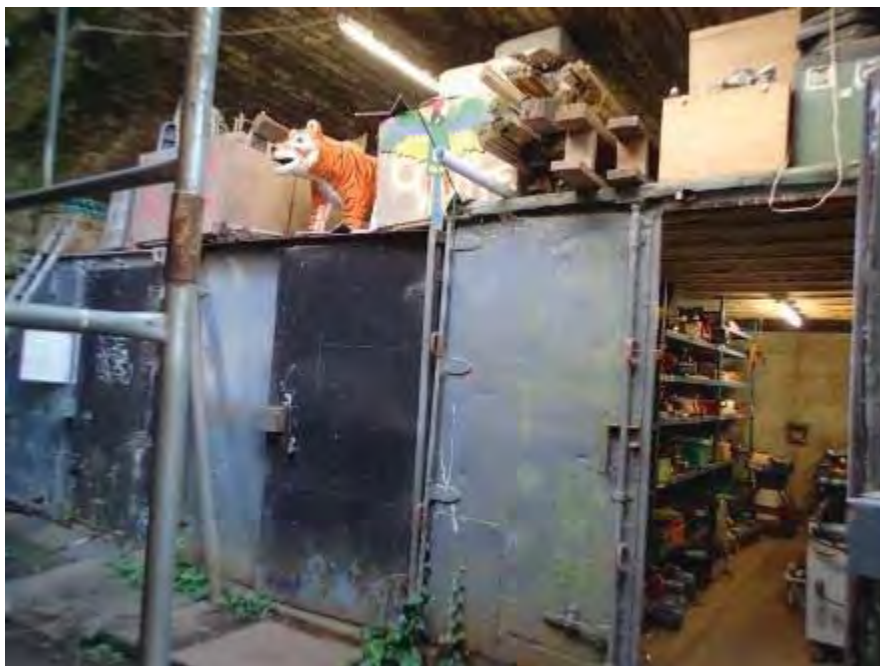
Photograph 46: metal storage containers below the structure restrict access

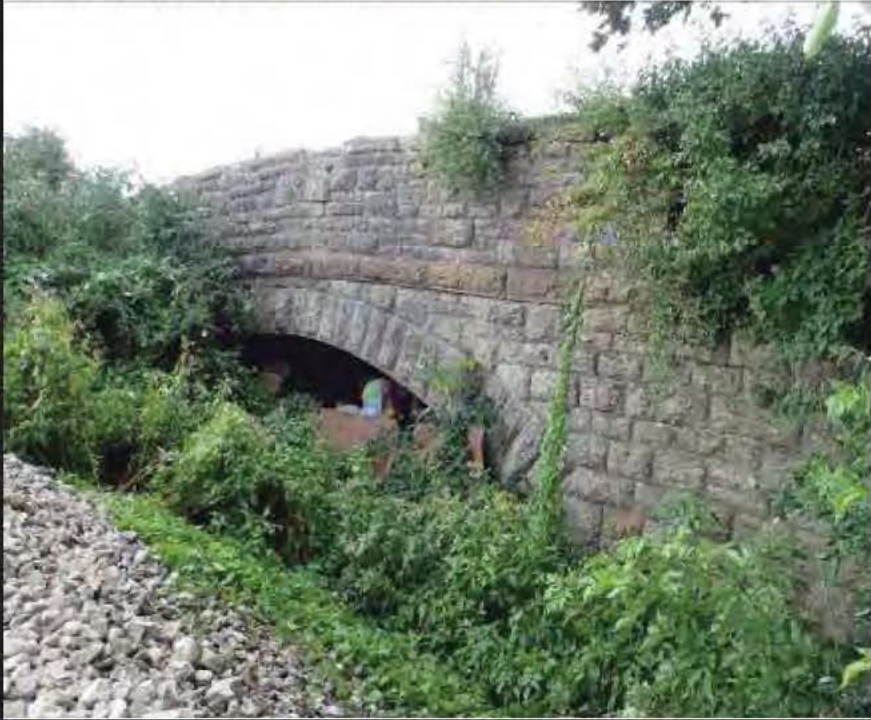
<p>Examiner comments</p> <p><u>NEW DEFECTS</u></p> <p>No new defects were identified at the time of examination.</p> <p><u>LONG-STANDING DEFECTS</u></p> <p>Unless noted, all accessible long-standing defects show no evidence of change since the previous detailed examination dated 12/09/17.</p> <p>See pages 2 & 3 for details.</p>
---	--

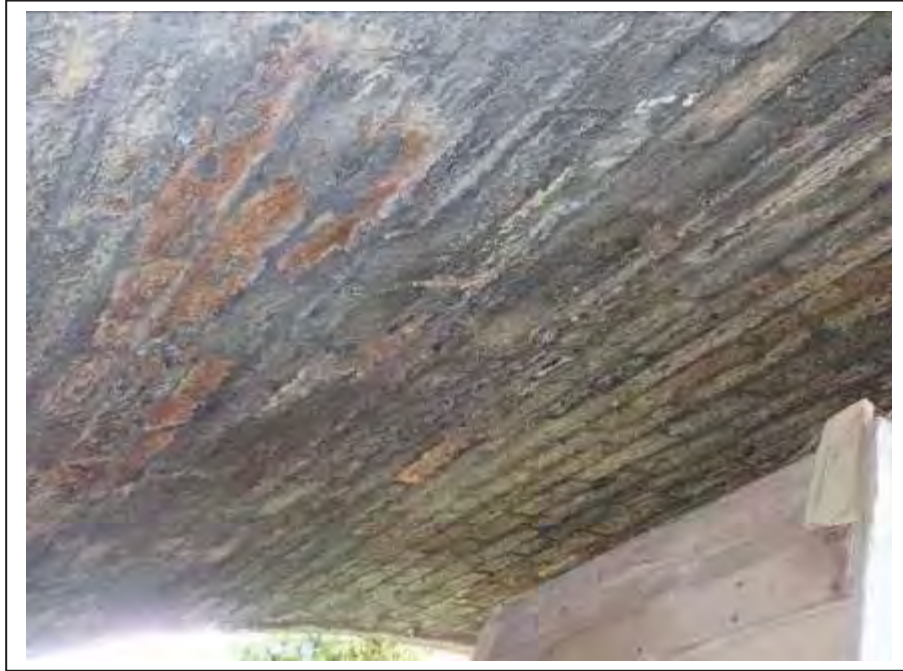
Photograph no 11: example of long-standing spalling action within the soffit

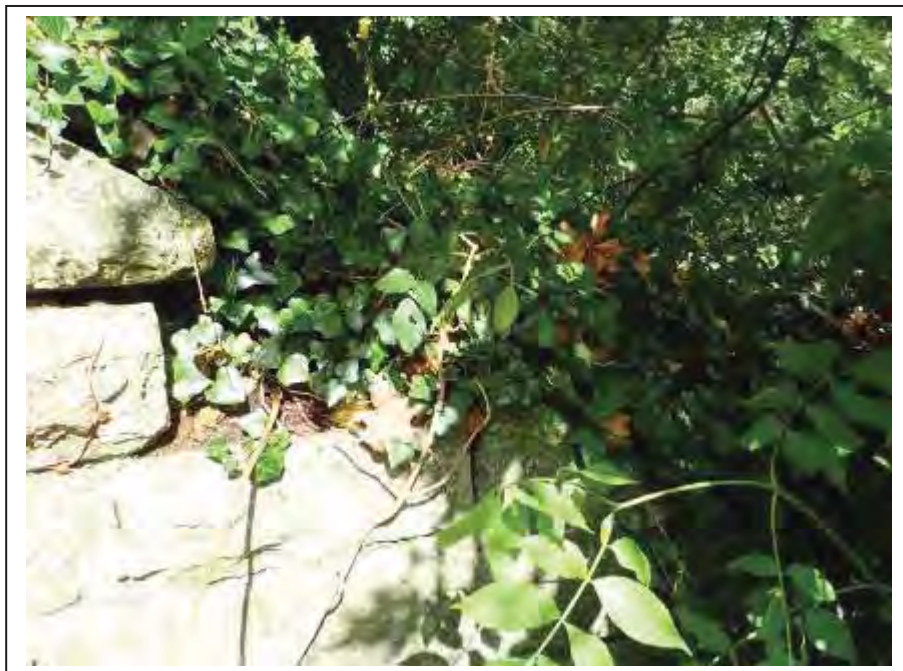
Photograph no 12: long-standing coping loss noted along the U/S, L/e wingwall

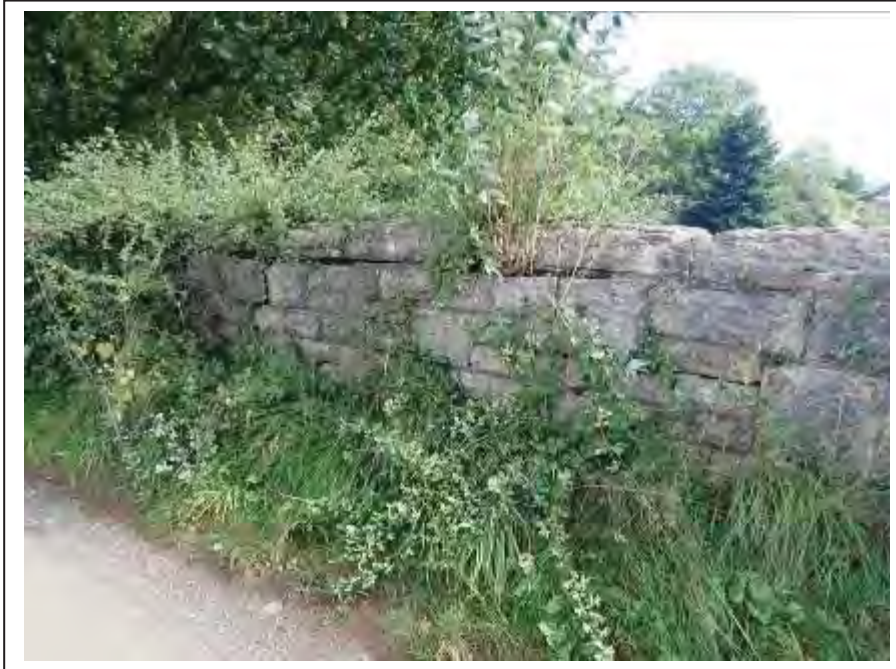
Photograph no 17: long-standing root ingress noted along the copings and within the L/e parapet towards the U/S quoin

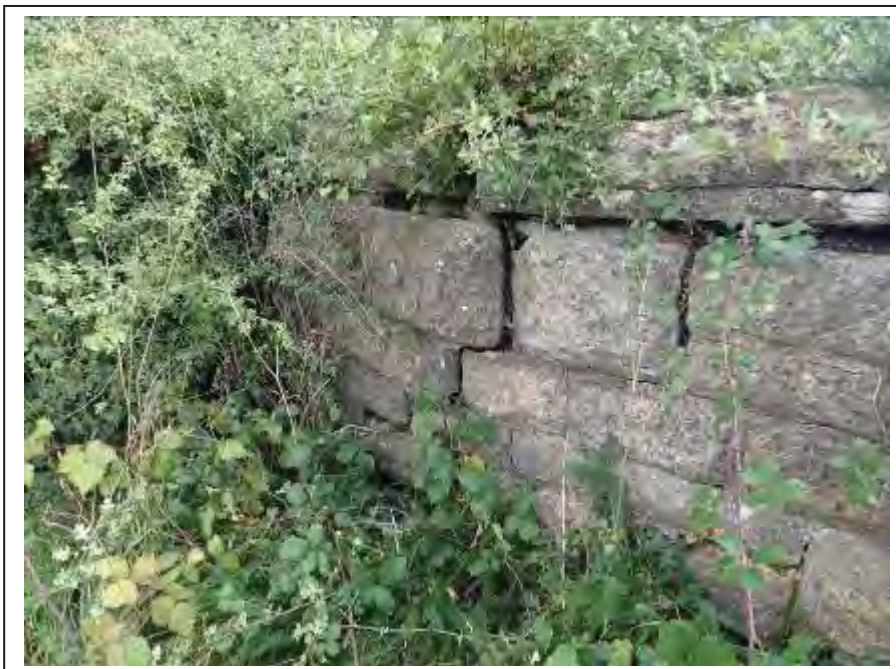
Photograph no 18: long-standing displacement of stonework at the U/S quoin of the L/e parapet

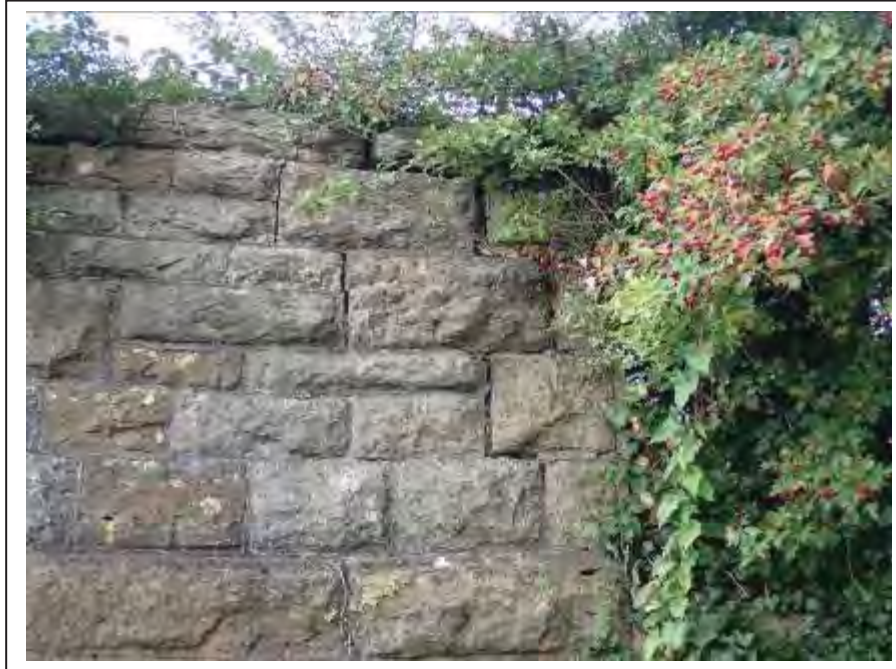
Photograph no 19: long-standing fracture located within the external face of the L/e parapet at the U/S quoin

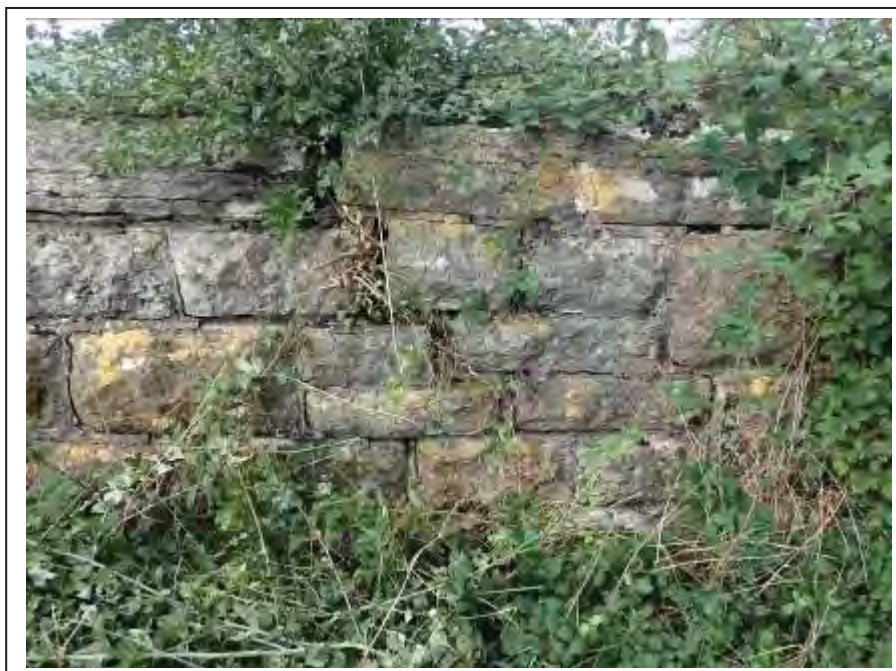
Photograph no 20: long-standing root ingress noted along the copings and within the C/e parapet towards the U/S quoin

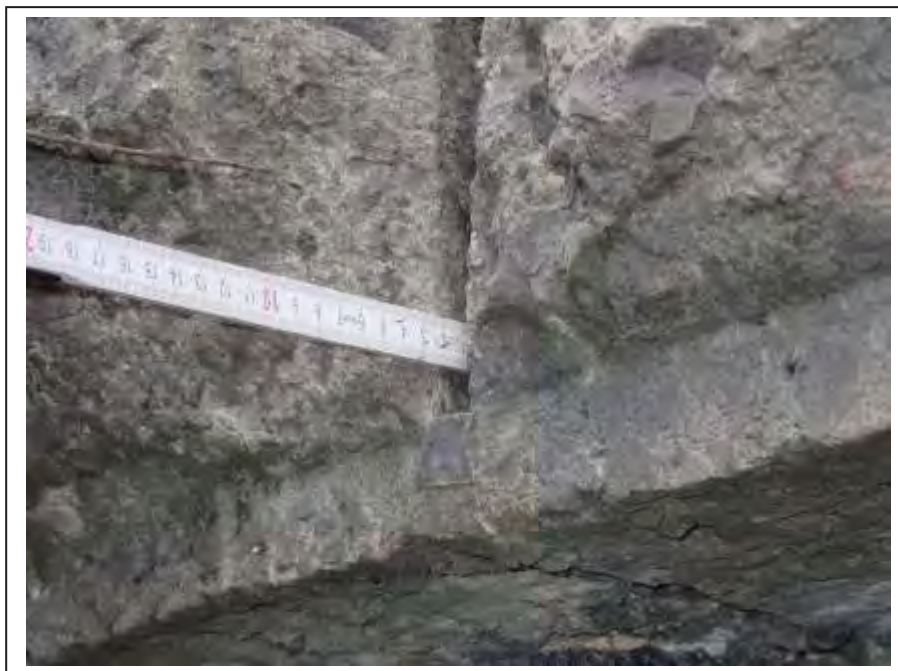
Photograph no 18: example of joint loss noted to individual perp joints within L/e voussoirs
