Our ref: 101465
Your ref:

[REDACTED]
Historical Railways Estate
3rd Floor
37 Tanner Row
YORK
YO1 6WP
[REDACTED]

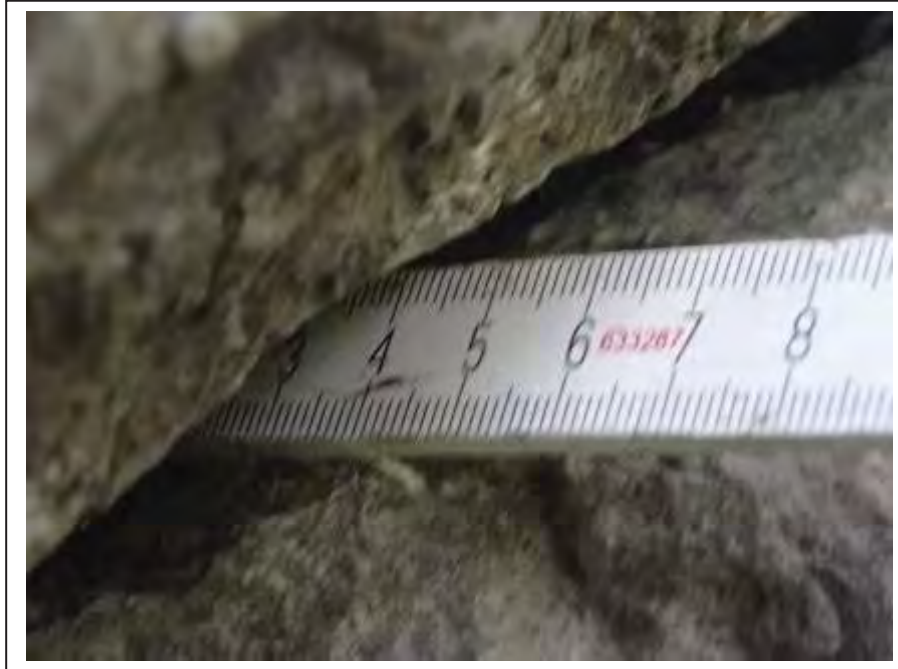
Photograph no 19: example of joint loss noted along the extrados joint on the L/e up to 50mm

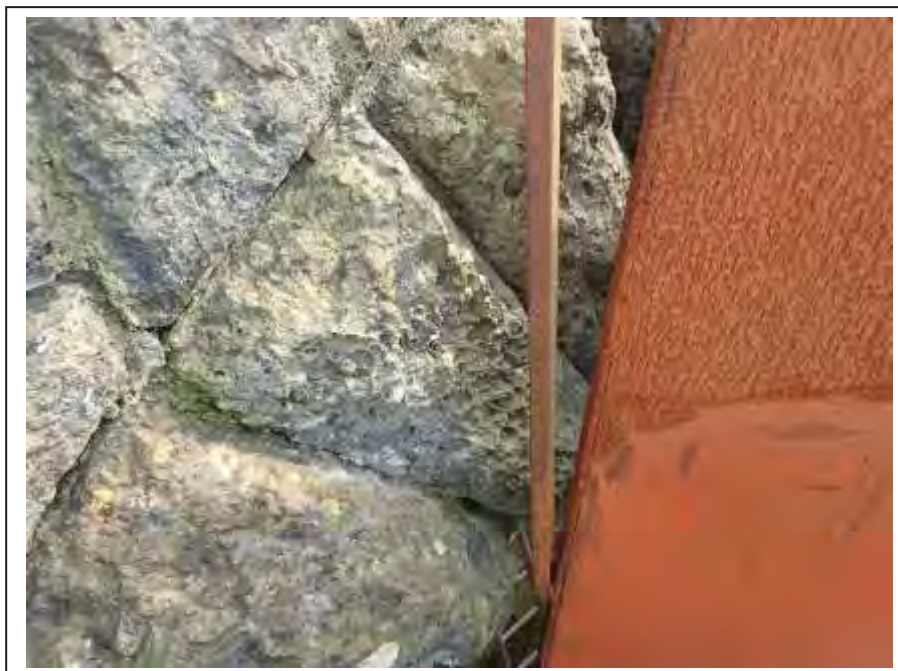
Photograph no 20: example of surface erosion within the C/e voussoirs

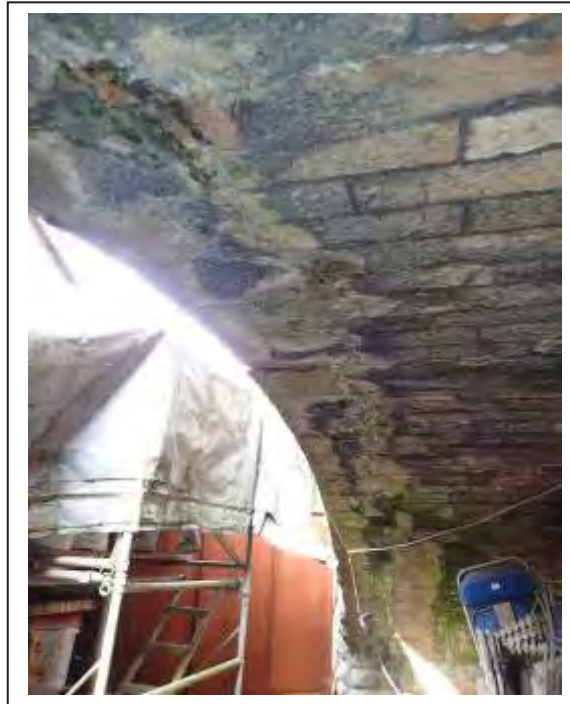
Photograph no 21: calcite deposits to rear of the C/e voussoirs may cover an underlying fracture.

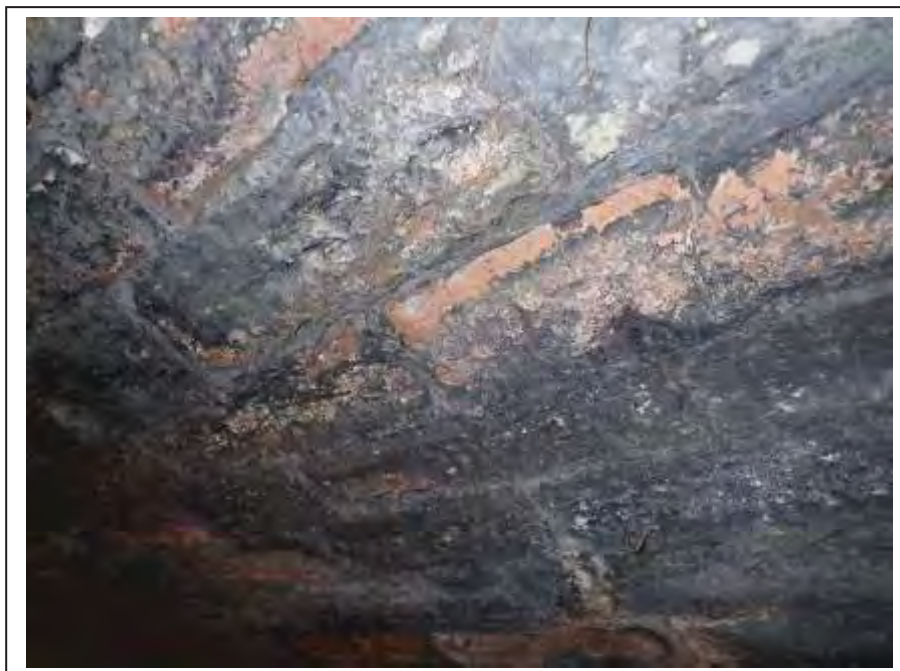
Photograph no 22: example of spalling noted within the soffit.

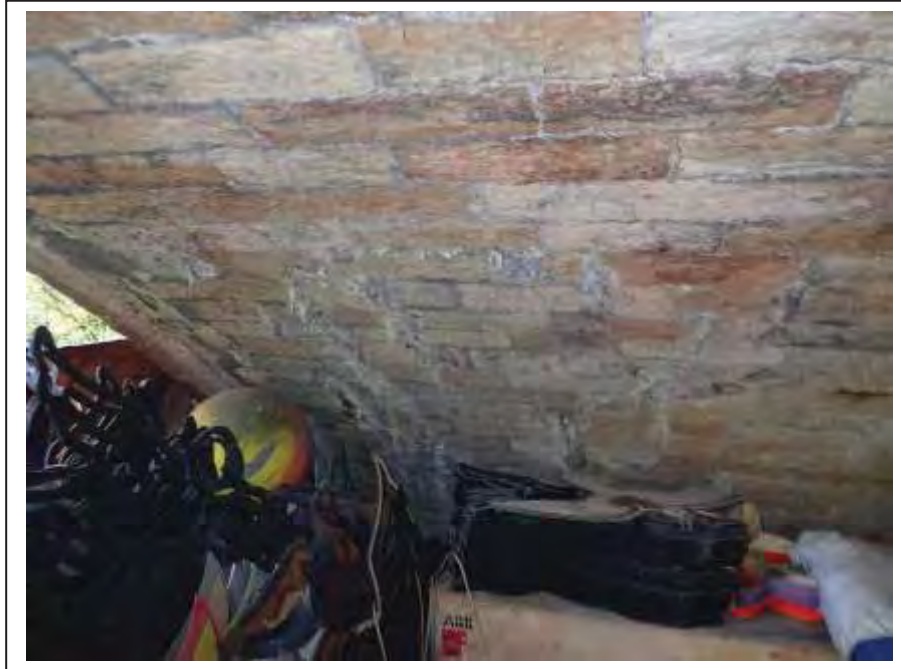
Photograph no 23: example of calcite/ efflorescence staining within the soffit

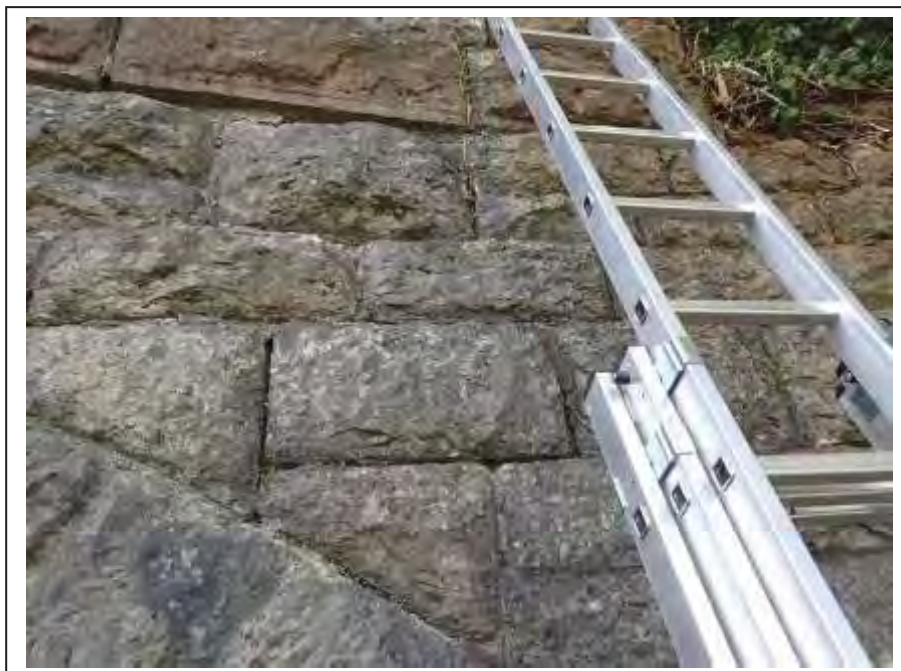
Photograph no 24: example of joint loss within the L/e spandrel noted up to 50mm U/S of the spandrel shown

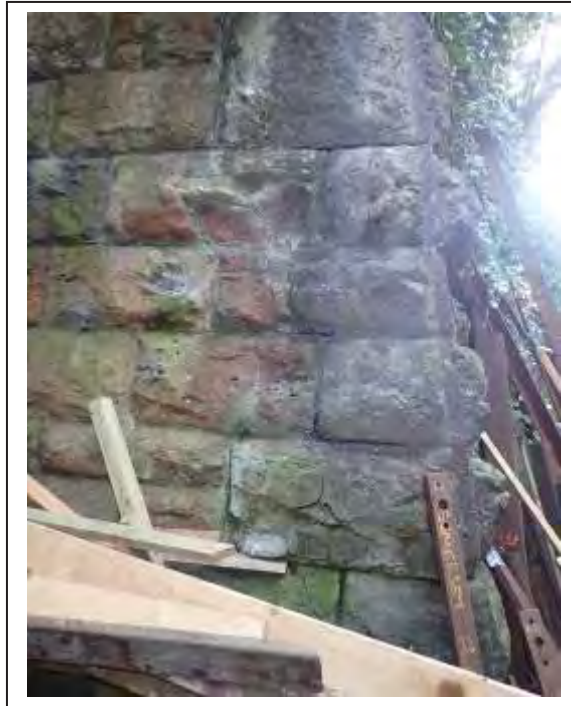
Photograph no 27: series of fractures noted within the C/e quoin stones of the D/S abutment

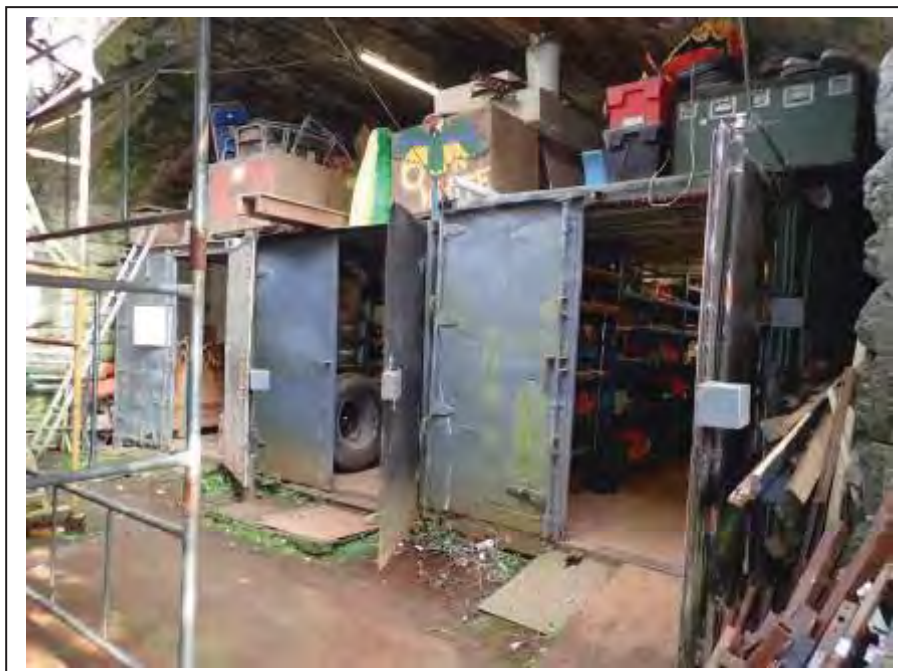
Photograph no 28: storage containers restrict access to the abutments.

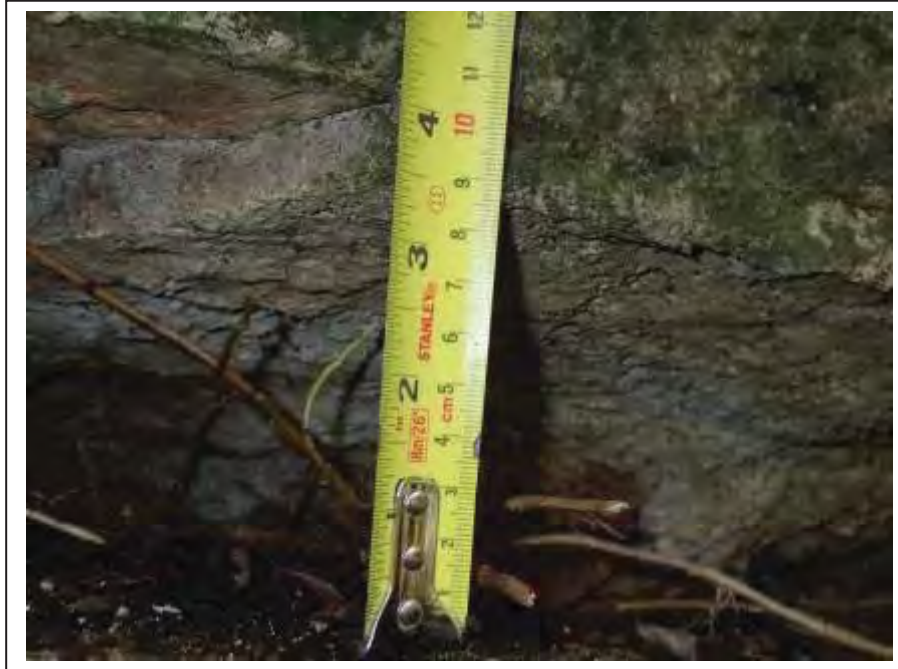
Photograph no 31: displacement noted up to 88mm

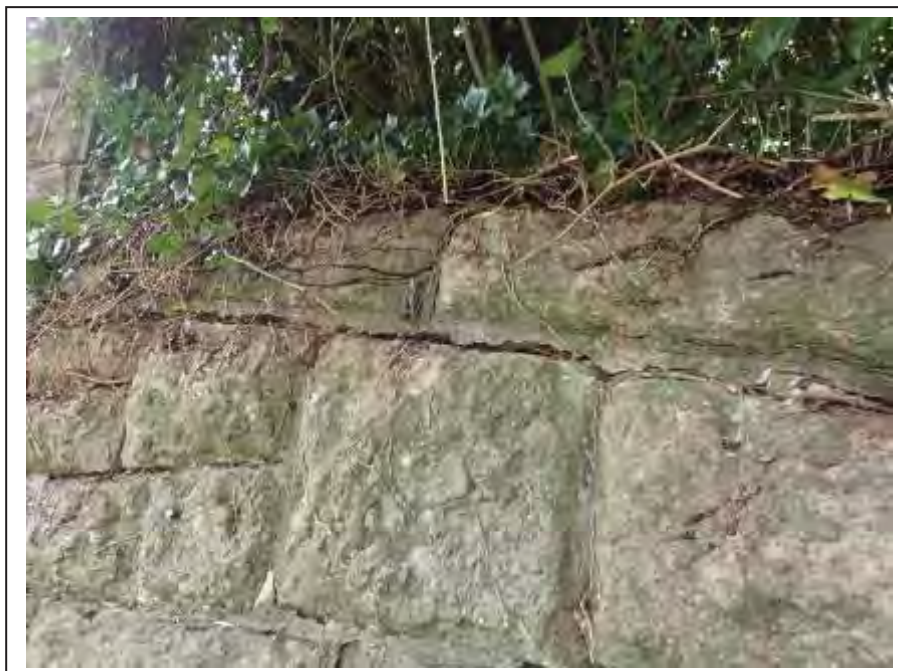
Photograph no 32: remaining copings to upper section of the U/S, L/e wingwall bed fractured to 20mm

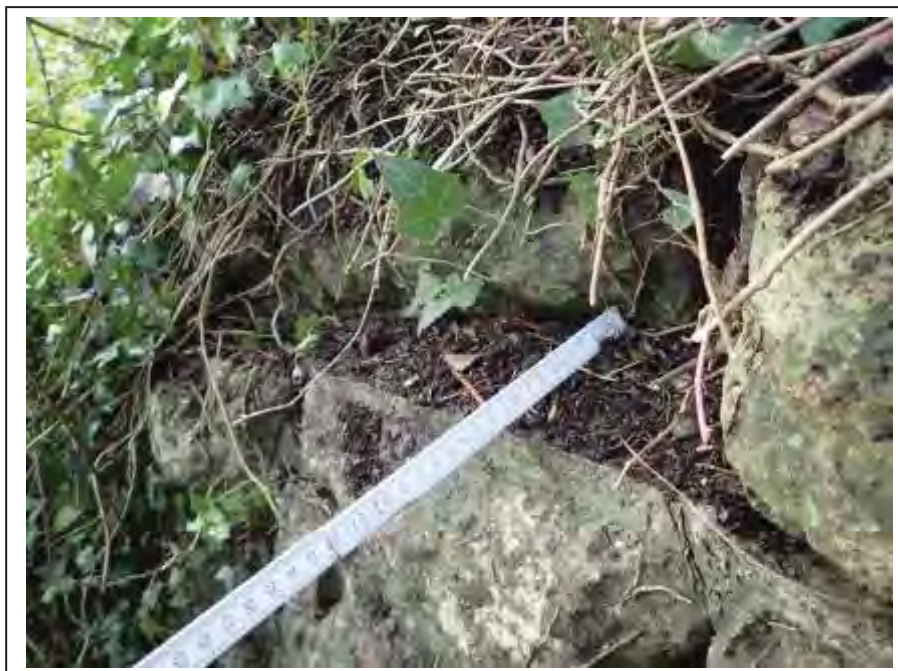
Photograph no 34: displacement of copings at the toe end of the D/S, L/e wingwall noted up to 110mm

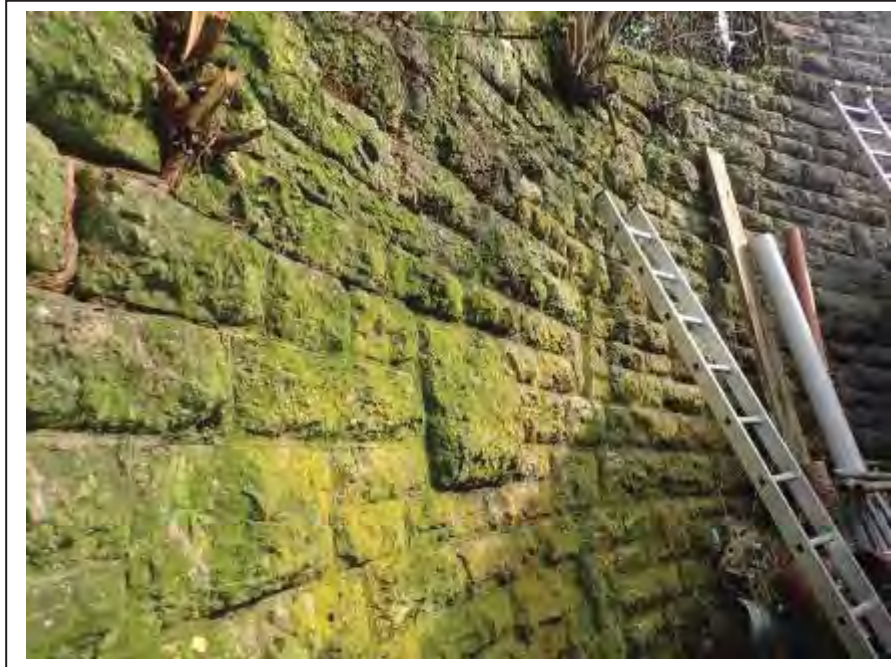
Photograph no 35: example of joint loss within 1m of the copings noted along the U/S, C/e wingwall

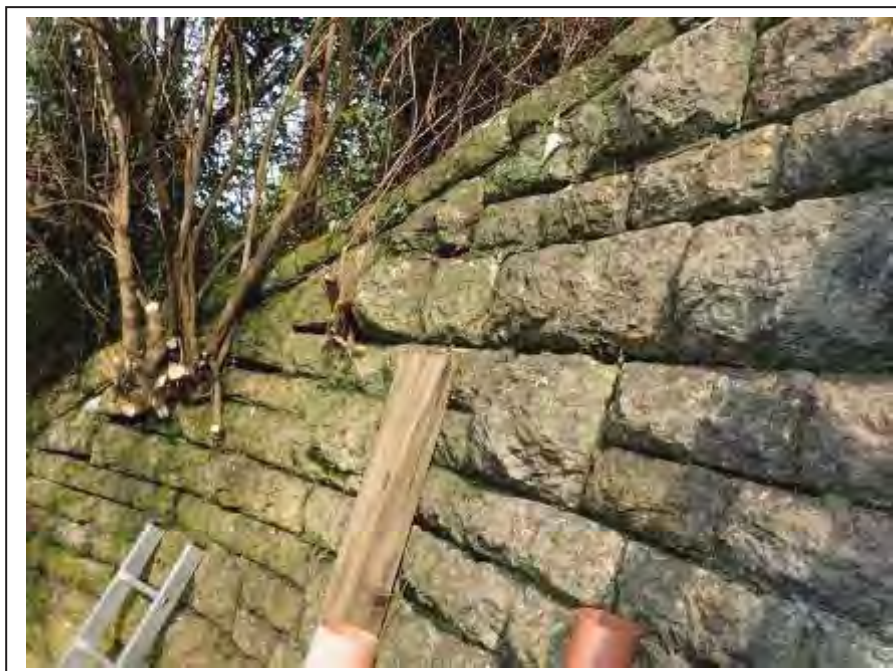
Photograph no 36: example of joint loss within 1m of the copings noted along the U/S, C/e wingwall

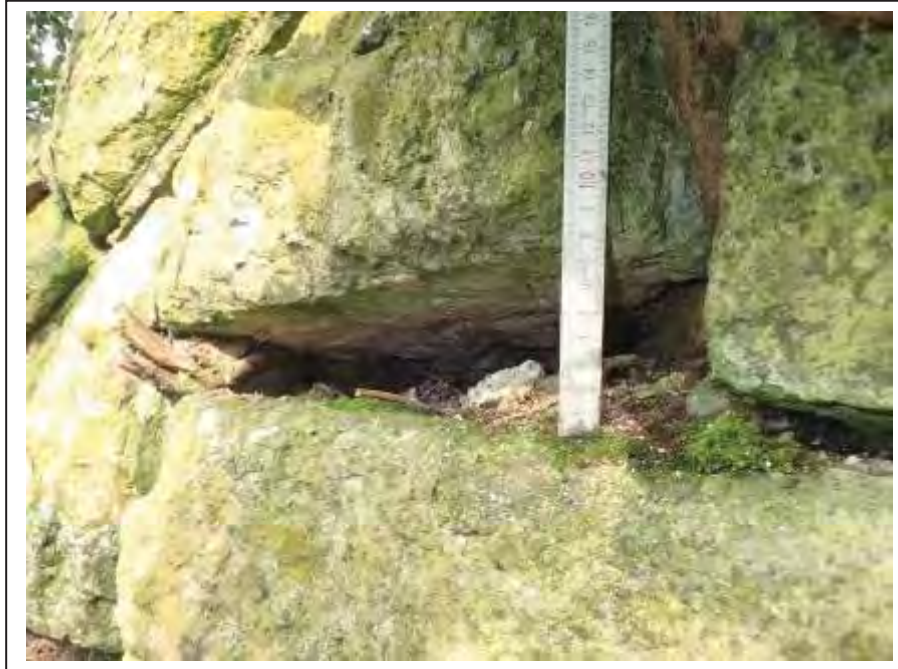
Photograph no 39: lifting stones noted up to 80mm at the root ingress at 1.9m

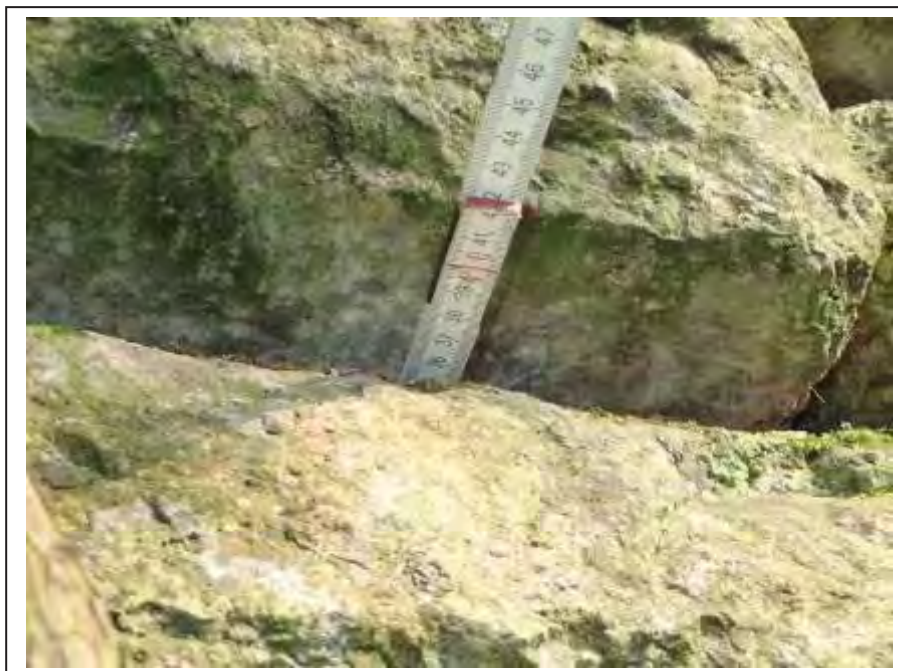
Photograph no 40: joint loss at the area of root ingress noted up to 420mm

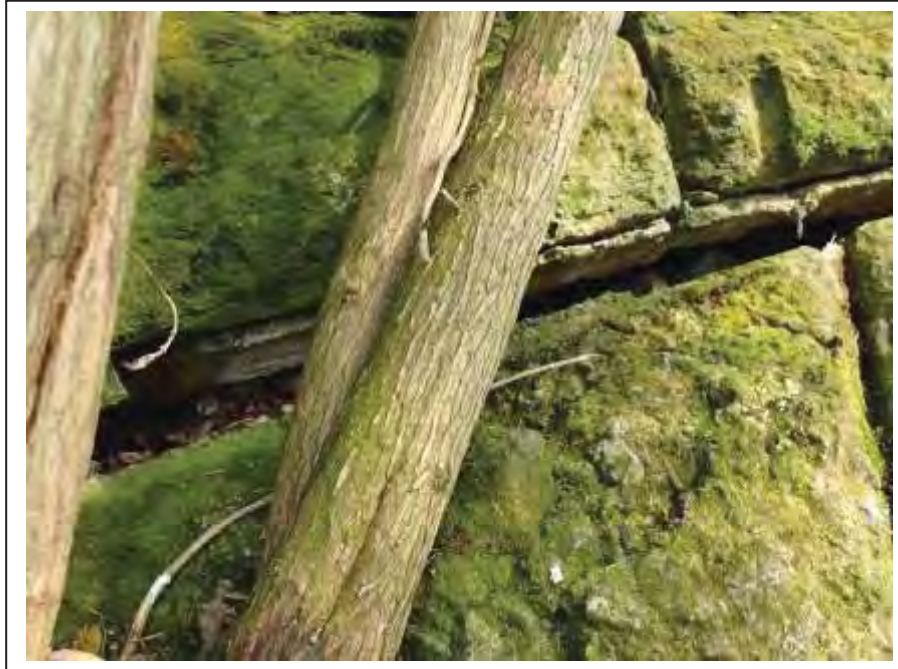
Photograph no 41: lifting of copings at the root ingress noted up to 50mm

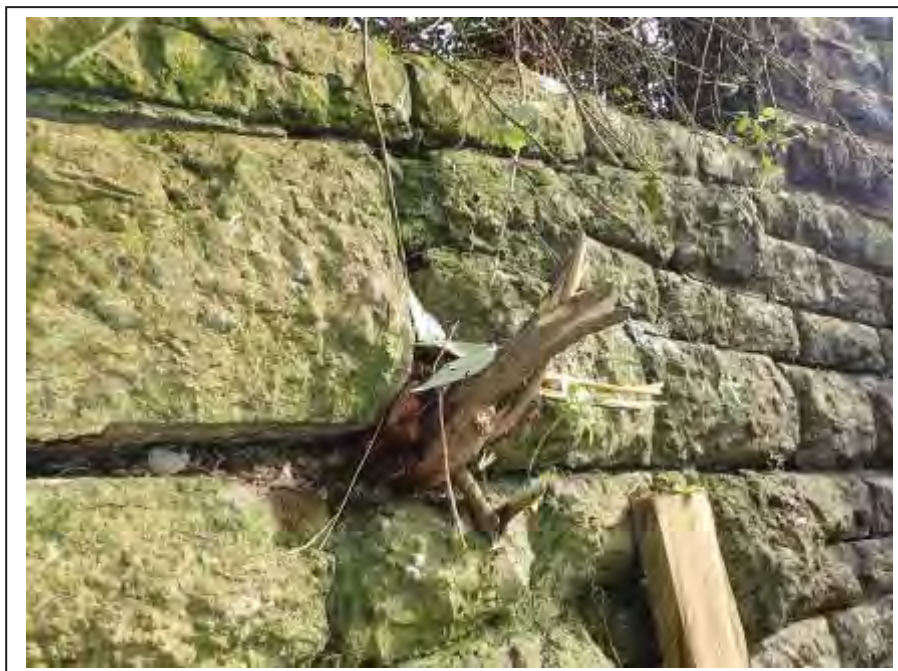
Photograph no 42: root ingress located approx 1.3m from the top of the U/S, C/e wingwall

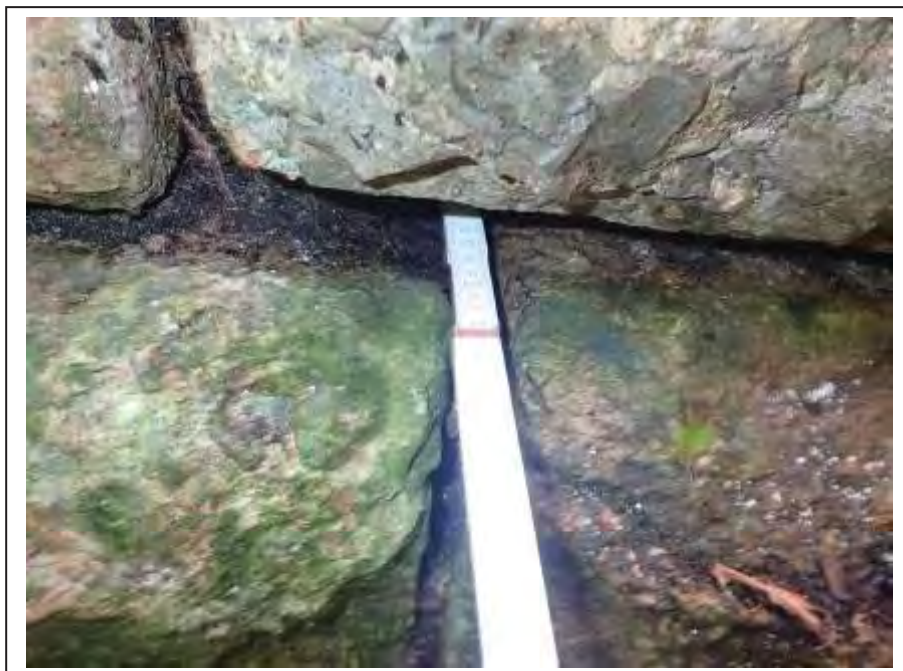
Photograph no 44: joint loss within the D/S, C/e wingwall noted up to 220mm

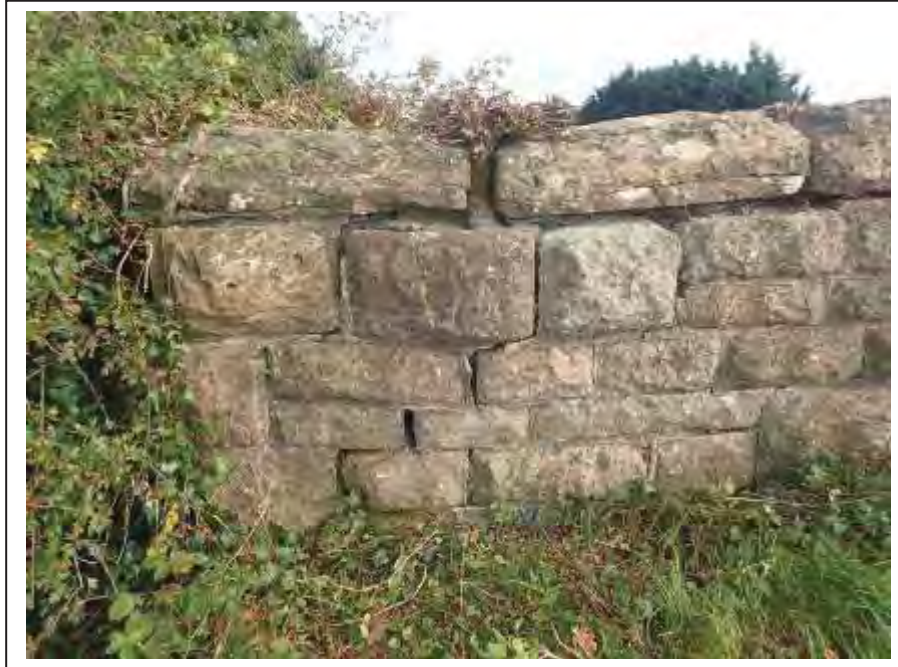
Photograph no 47: long-standing fracturing and displacement at the U/S quoin of the L/e parapet

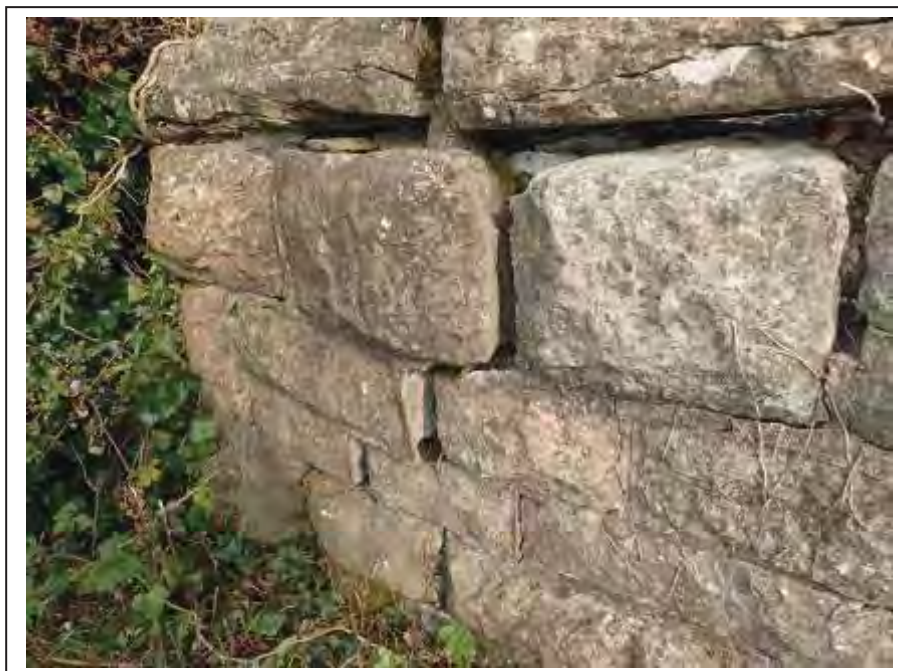
Photograph no 48: long-standing fracturing and displacement at the U/S quoin of the L/e parapet

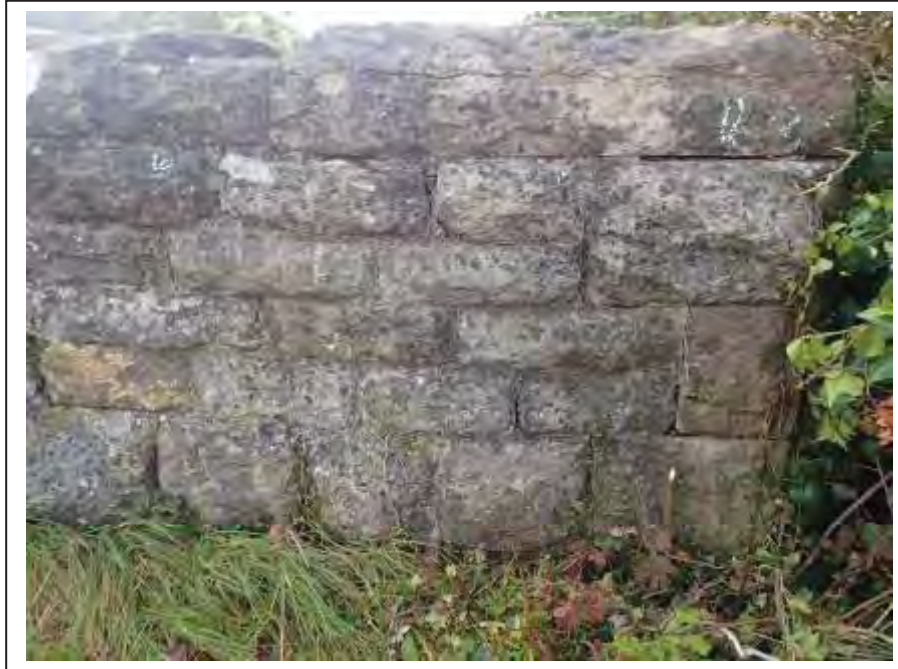
Photograph no 49: series of fractures noted at the D/S quoin of the L/e parapet

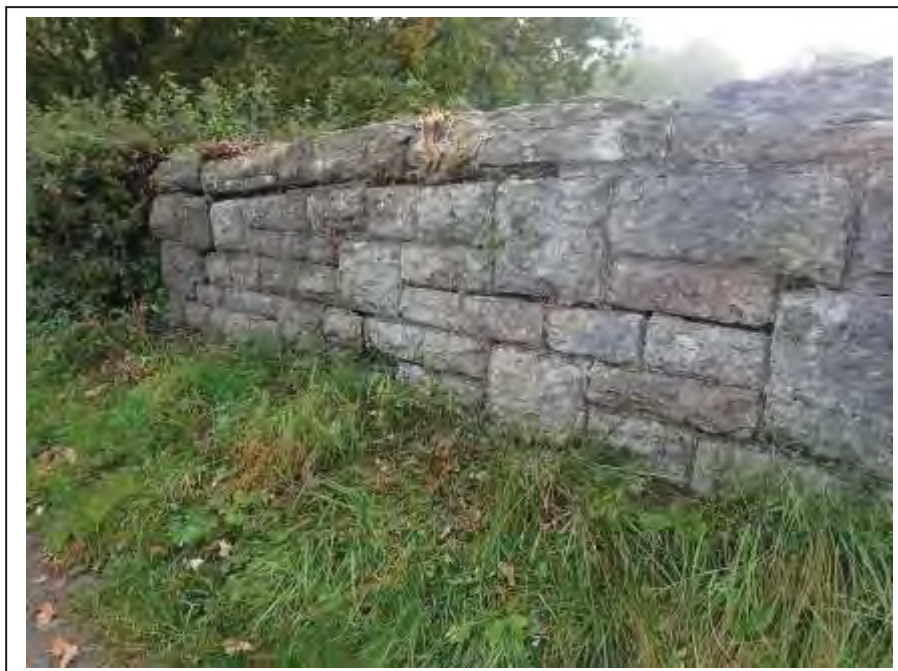
Photograph no 50: widespread joint loss within the L/e parapet noted from the U/S quoin through to 3.8m

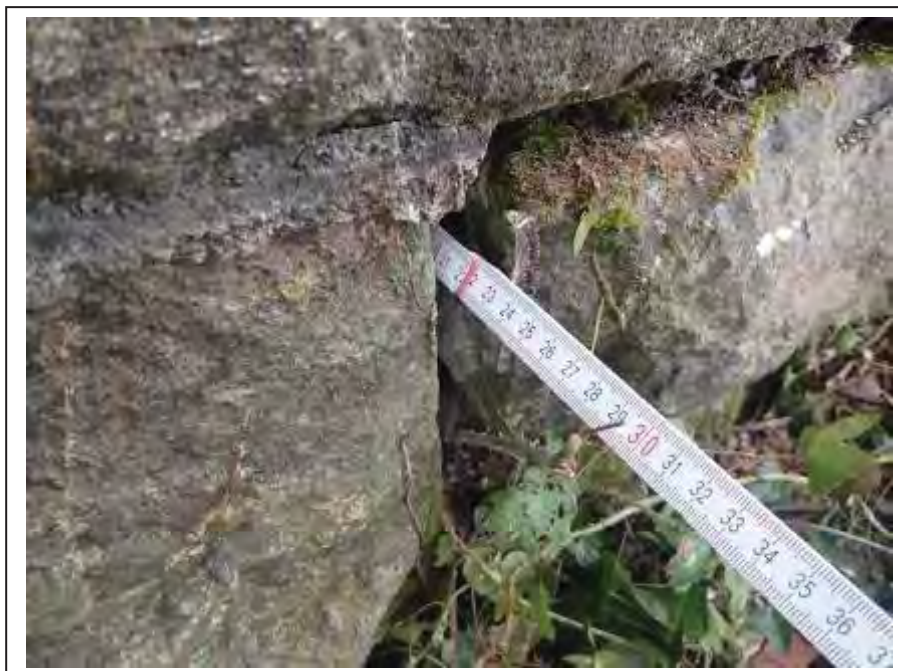
Photograph no 52: joint loss within the L/e parapet noted up to 220mm

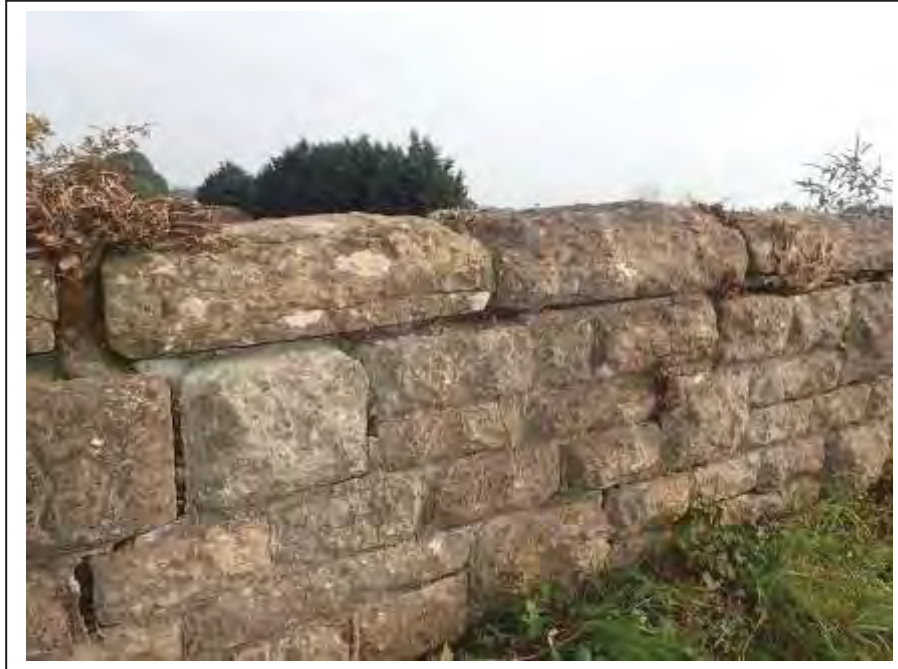
Photograph no 55: long-standing root ingress noted within the perp joints and along the coping bed of the L/e parapet

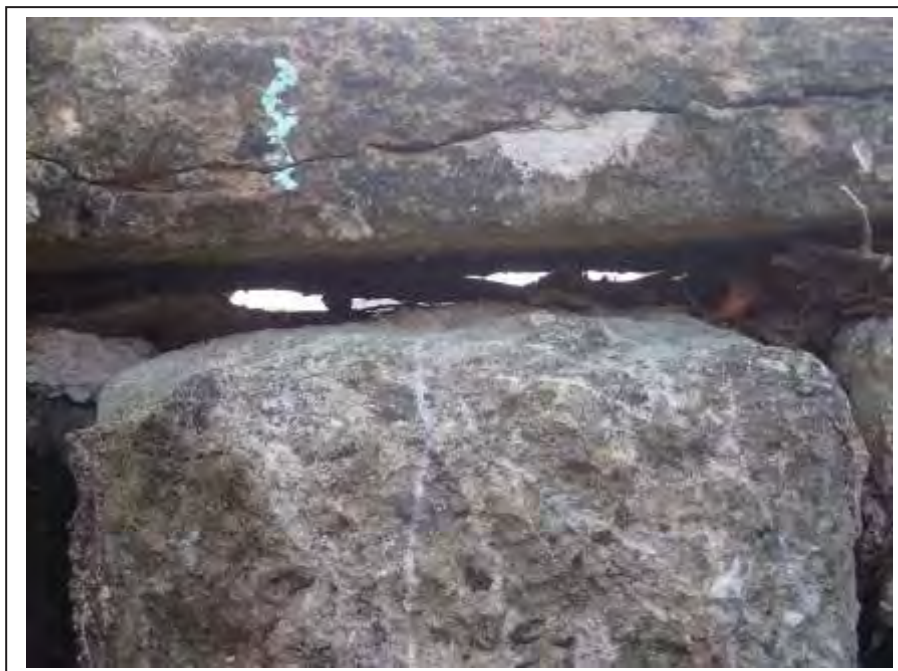
Photograph no 56: daylight visible through the copings along the L/e parapet

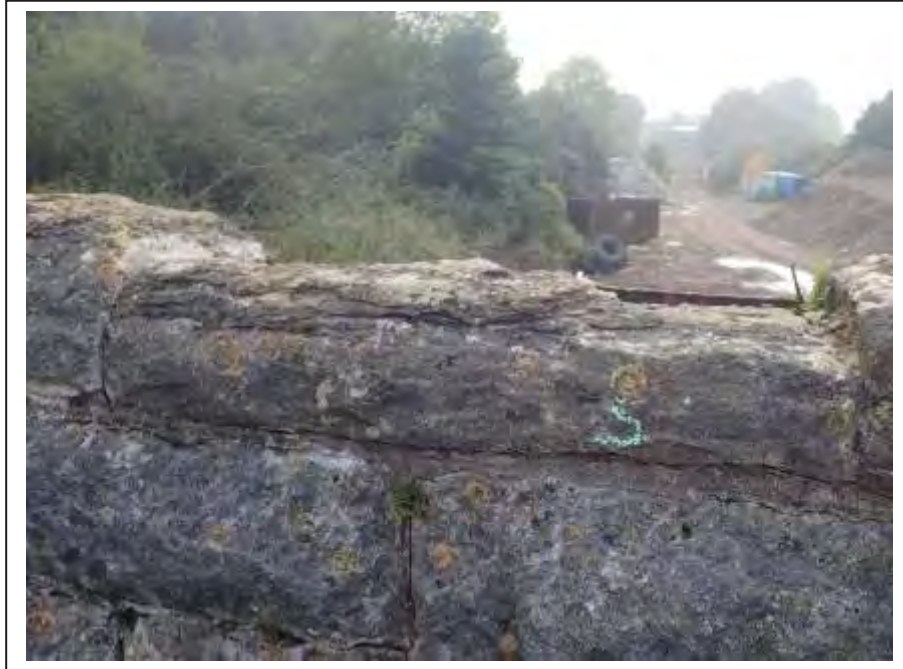
Photograph no 57: a coping upon the L/e parapet is spalled up to 80mm.

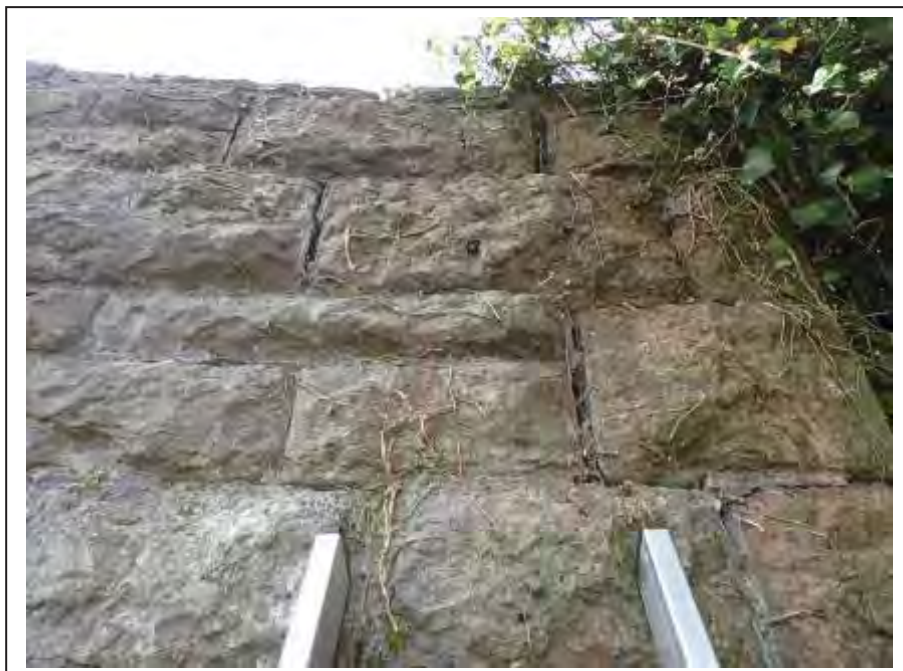
Photograph no 58: step fracture to the external face of the L/e parapet at the U/S quoin

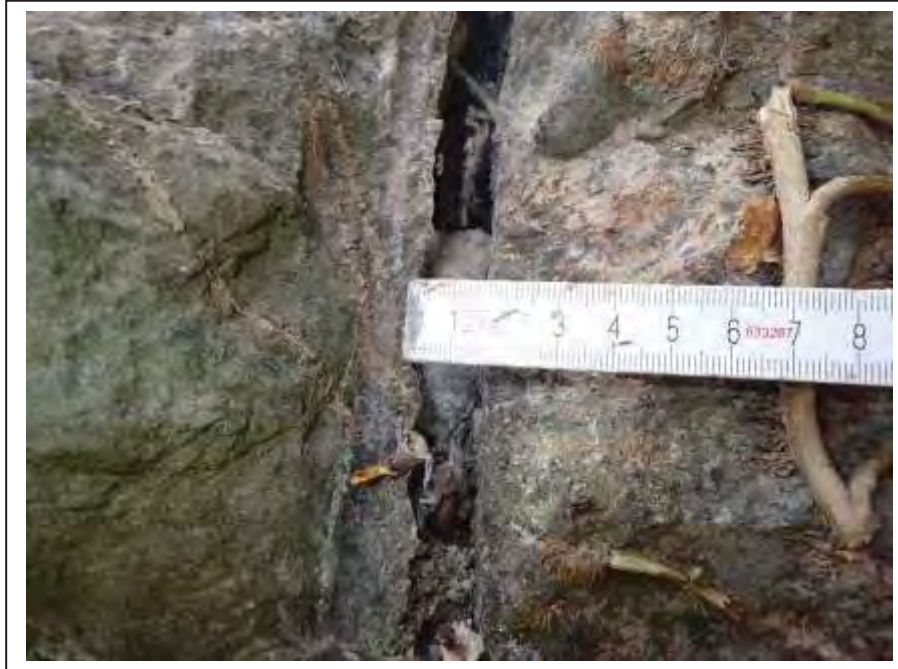
Photograph no 59: step fracture is typically open to 16mm

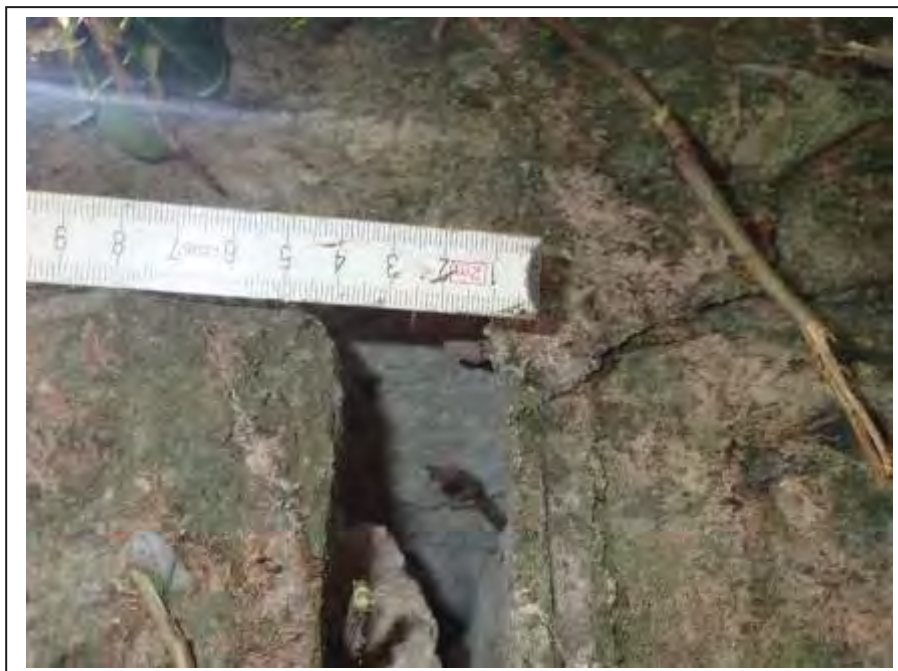
Photograph no 60: step fracture opens to a max of 40mm

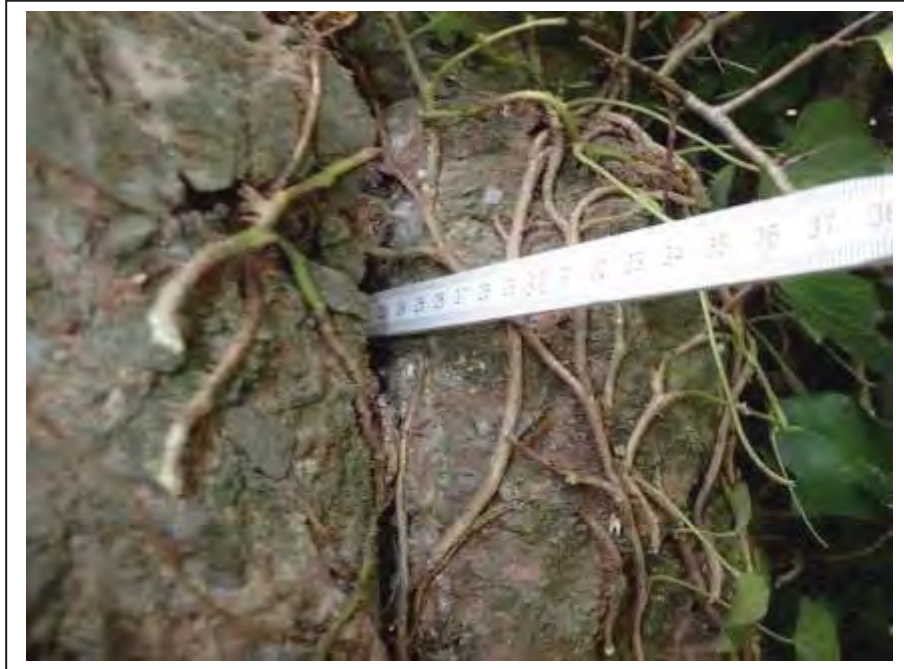
Photograph no 61: joint loss at the fracture line noted up to 240mm

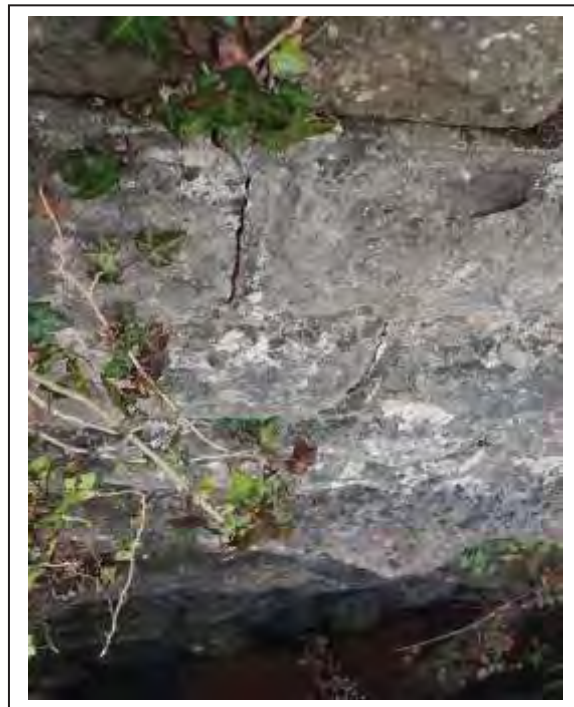
Photograph no 62: example of odd fractures noted within the external face of the L/e parapet

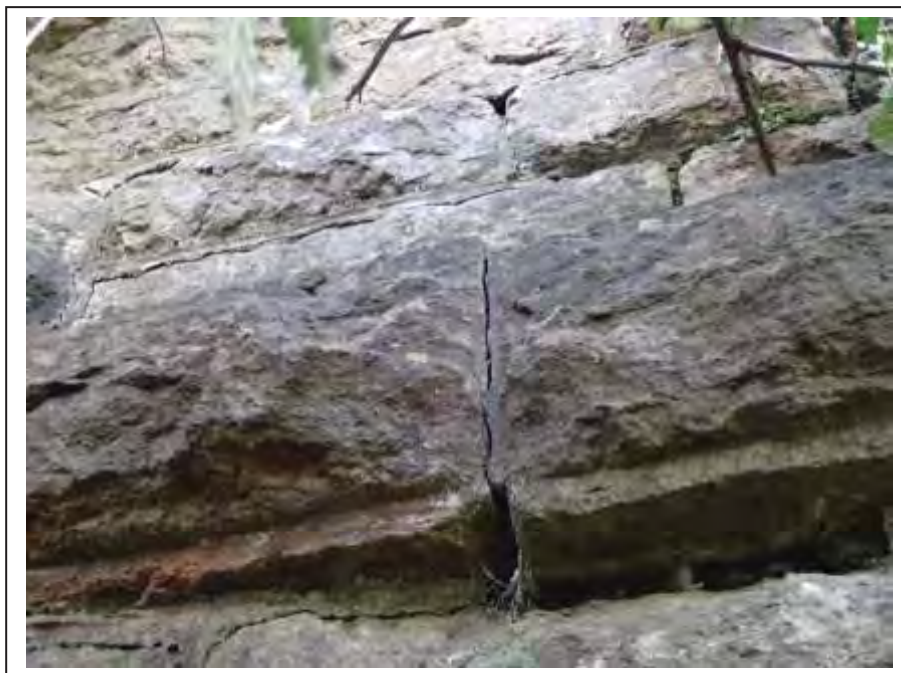
Photograph no 64: odd joints within the L/e stringcourse fractured up to 3mm

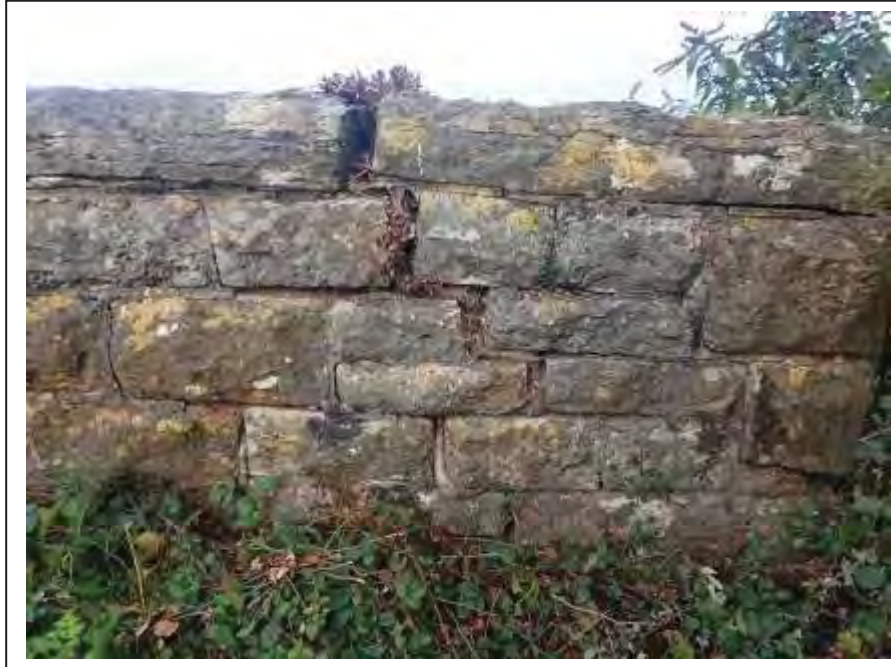
Photograph no 65: long-standing fracture and displacement noted at the U/S quoin of the C/e parapet
 Fractures/ displacement are caused by root ingress.

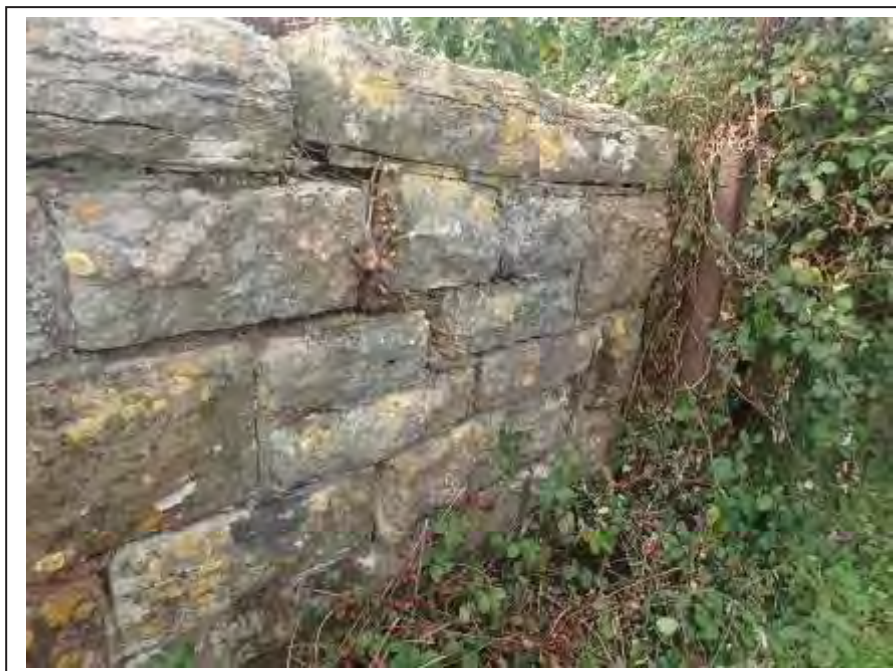
Photograph no 66: long-standing fracture and displacement noted at the U/S quoin of the C/e parapet

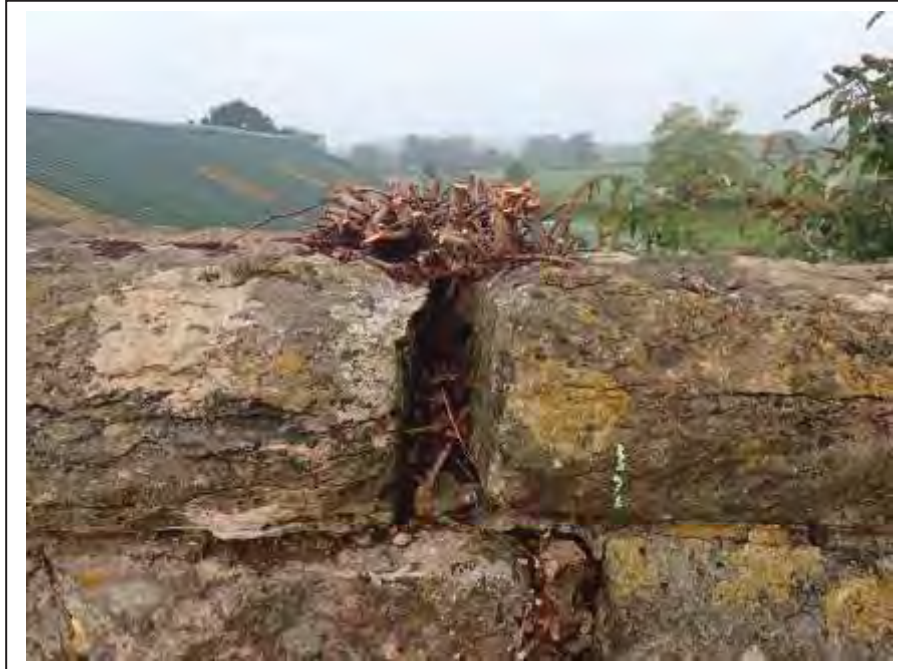
Photograph no 67: root ingress at the coping joint results in fracture open to 75mm

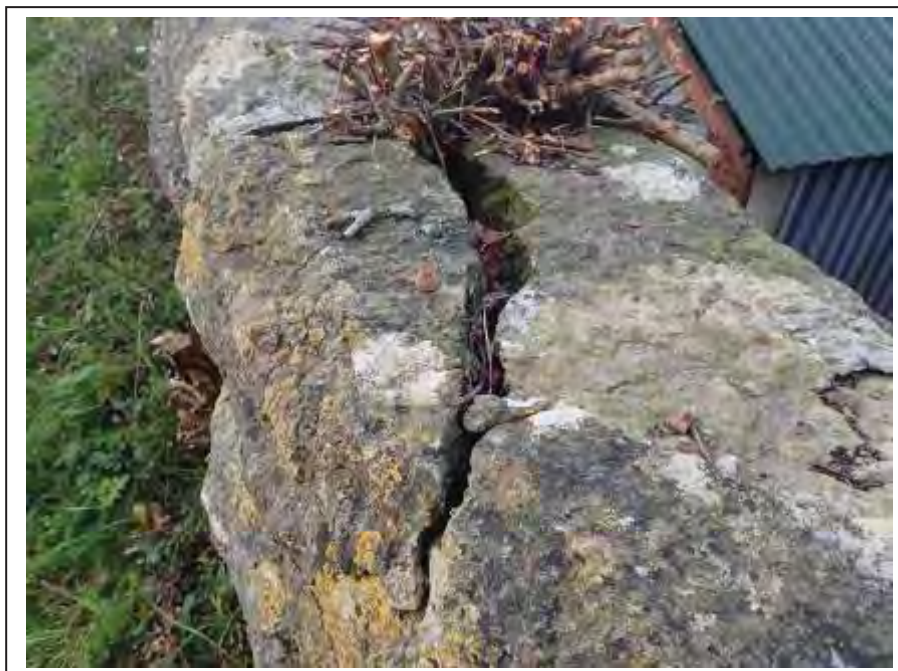
Photograph no 68: fracture within the coping at the U/S quoin of the C/e parapet

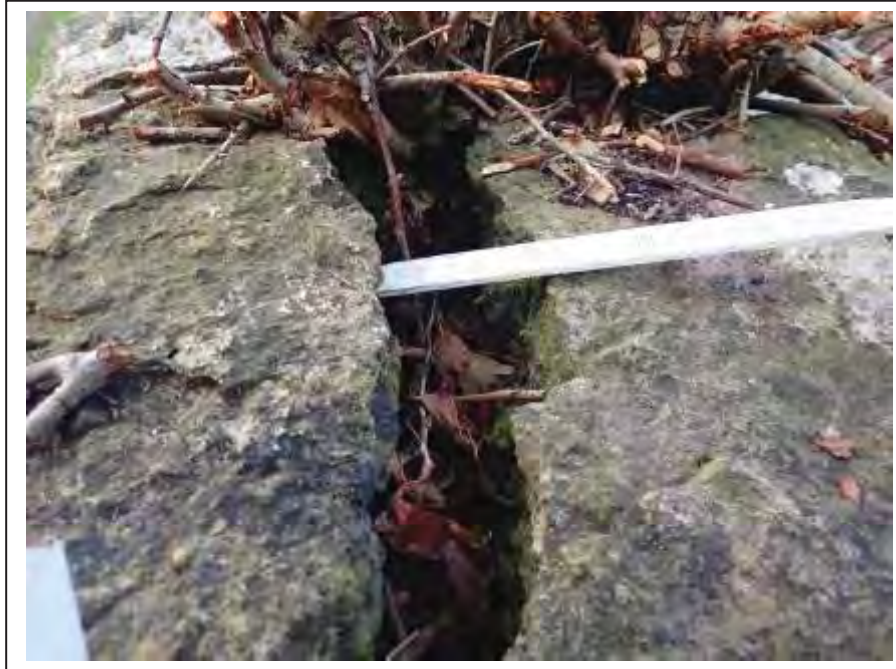
Photograph no 69: fracture within the coping noted to 65mm

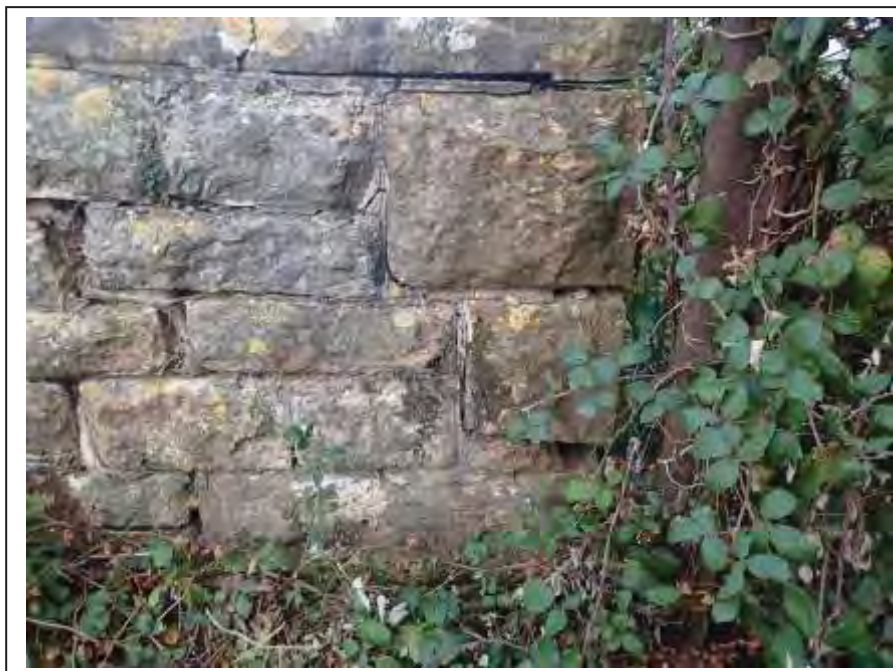
Photograph no 70: fracture at the U/S quoin of the C/e parapet open to 8mm
