Our ref: 101465
Your ref:

[REDACTED]
Historical Railways Estate
3rd Floor
37 Tanner Row
YORK
YO1 6WP
[REDACTED]

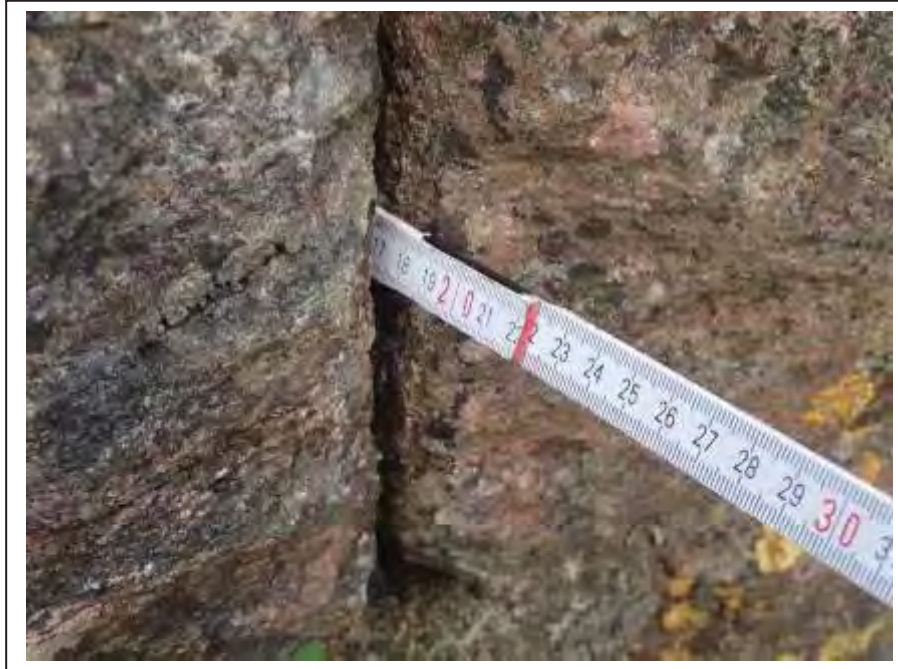
Photograph no 73: joint loss within the internal face of the C/e parapet noted up to 180mm

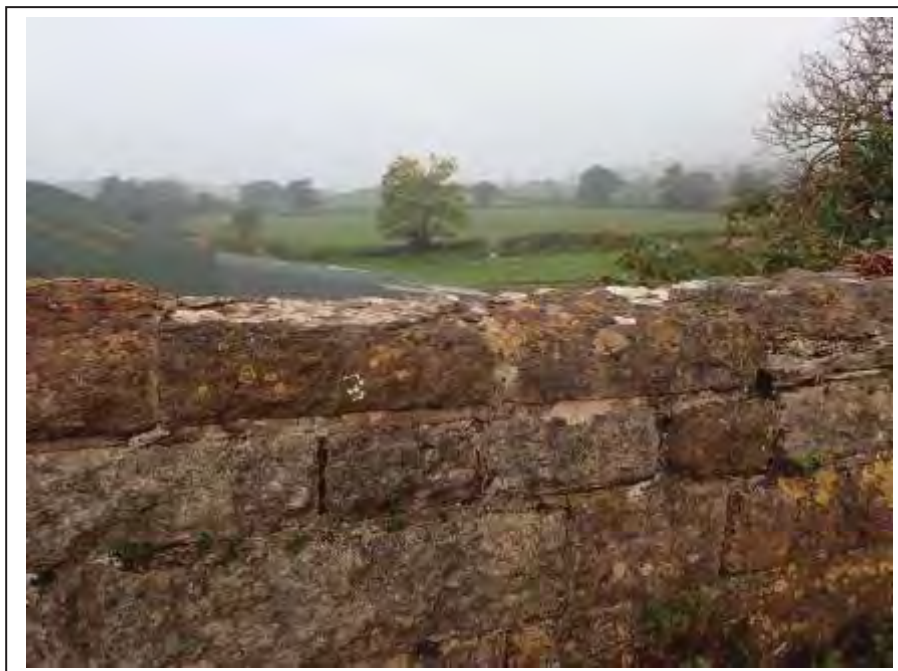
Photograph no 74: example of spalled copings noted along the C/e parapet

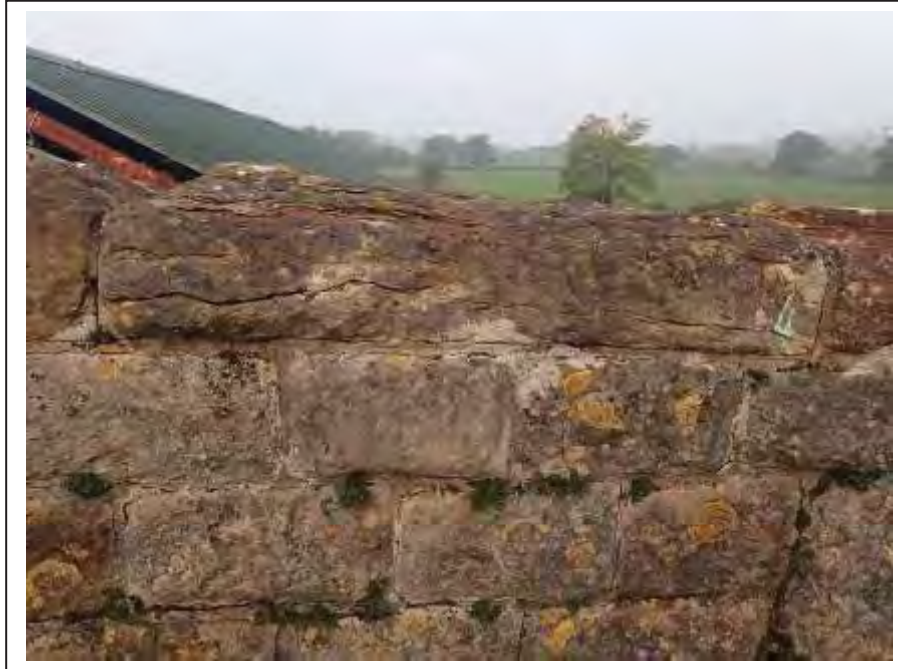
Photograph no 75: example of grain fractures within the C/e parapet copings

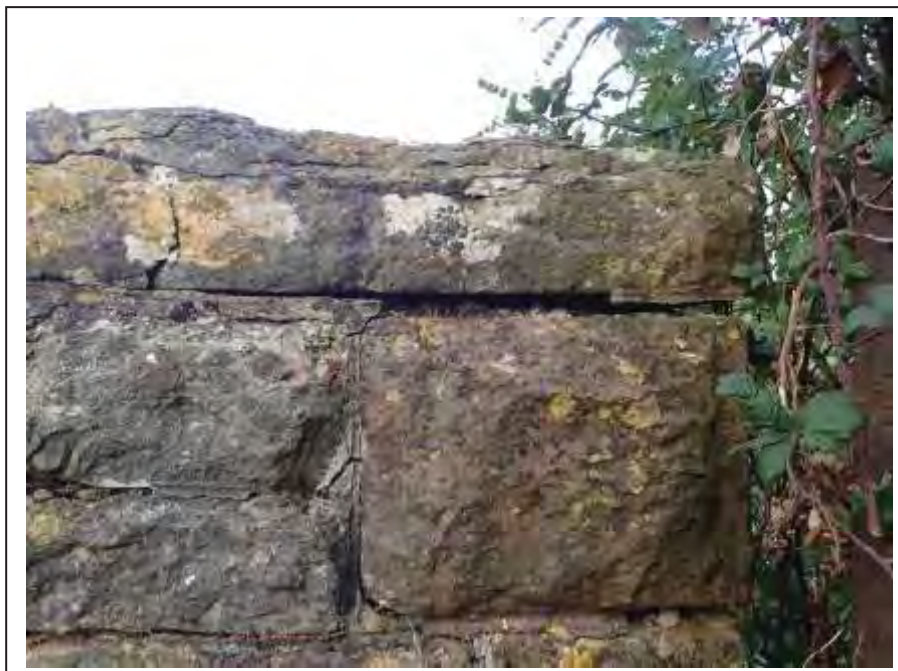
Photograph no 76: deep joint loss noted to full width of the coping at the U/S quoin of the C/e parapet

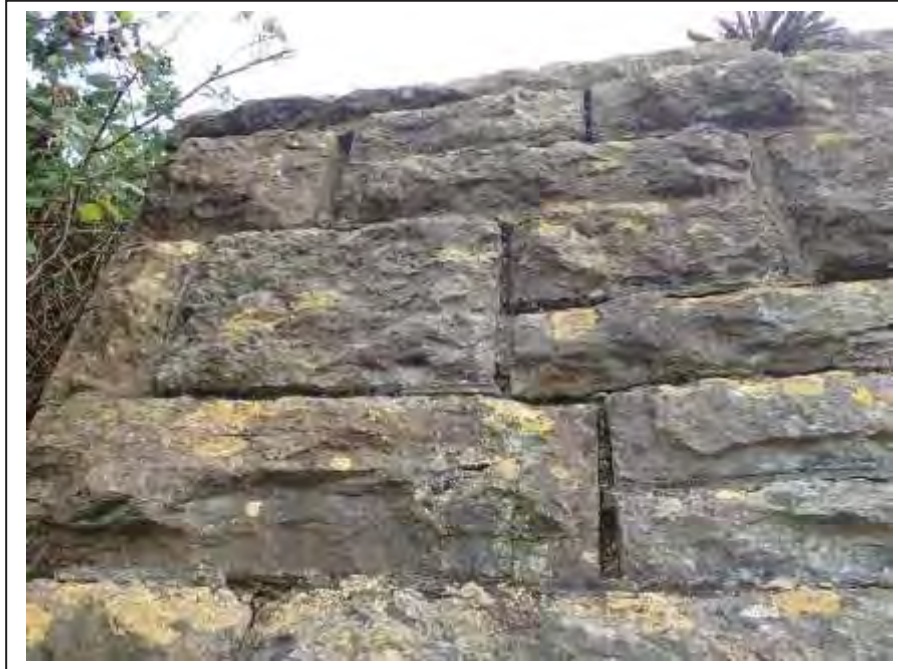
Photograph no 77: example of loose stonework located within 2.2m of the U/S quoin of the C/e parapet
 External face shown

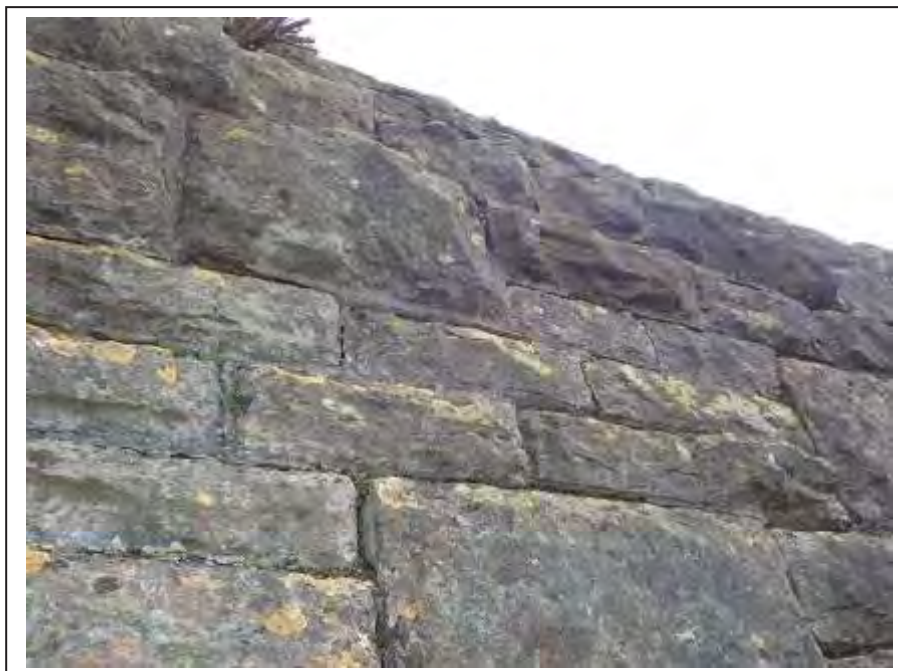
Photograph no 78: example of loose stonework located within 2.2m of the U/S quoin of the C/e parapet
 External face shown

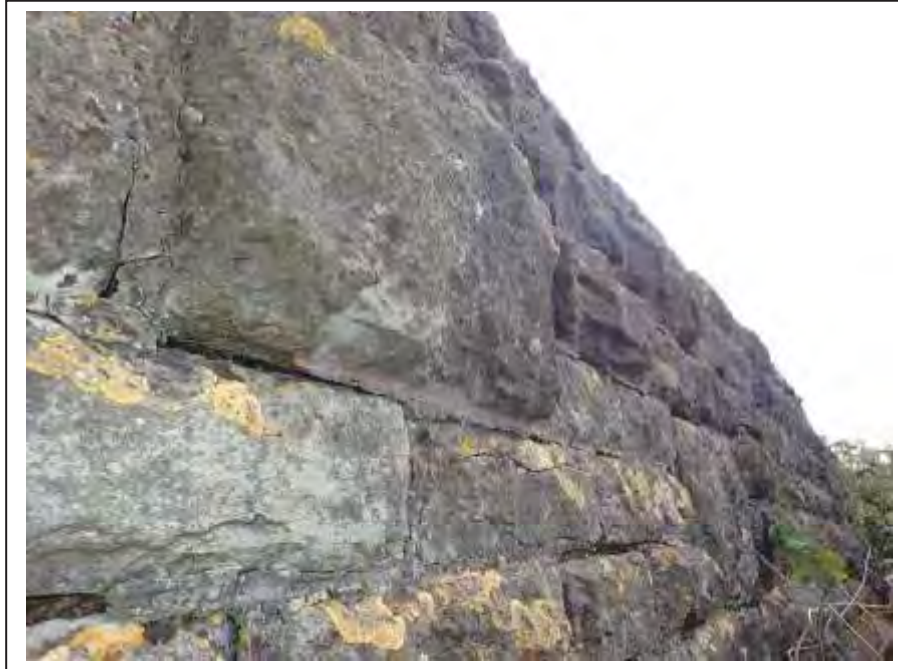
Photograph no 79: individual stones are found pushing within the loose stonework.

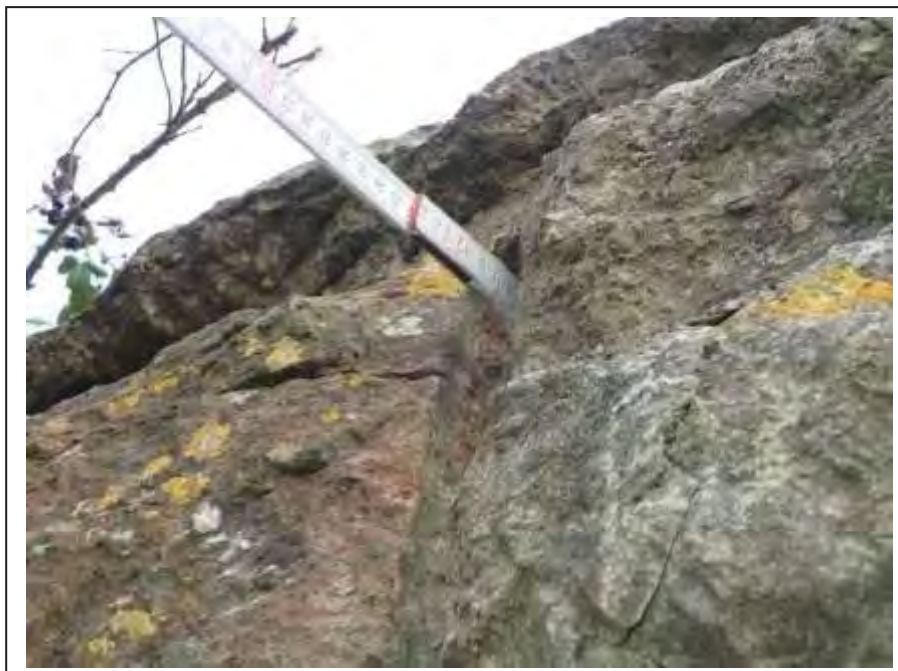
Photograph no 80: joint loss within the external face of the C/e parapet noted up to 180mm

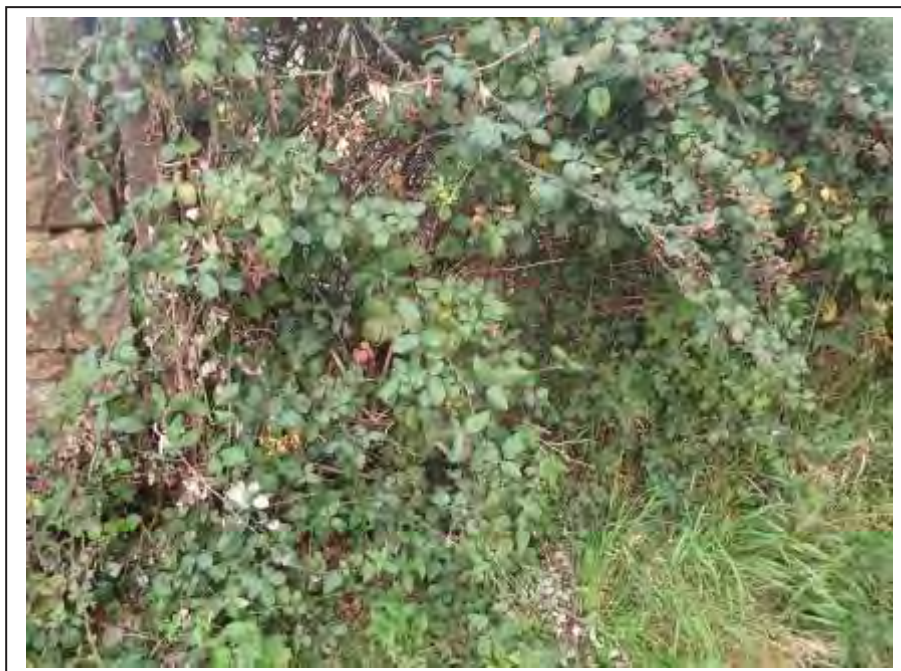
Photograph no 84: end post visible but no straining wire noted on the U/S, C/e

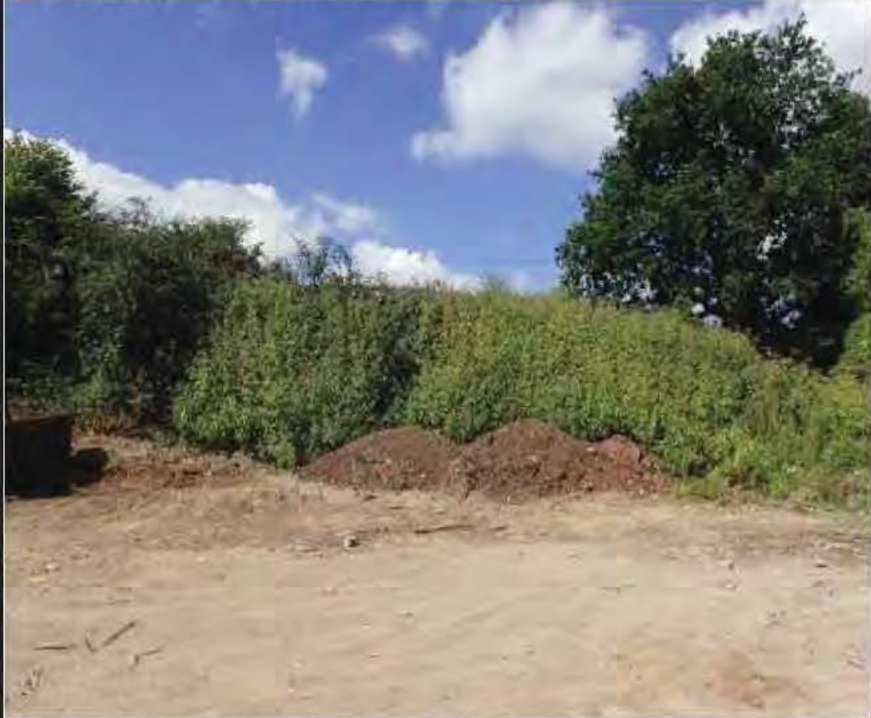
<p>Examiner comments</p> <p>There is no evidence of any repair works having been undertaken within the structure since the previous visual examination dated 27/08/15.</p> <p>A number of defects are found within the structure. All defects are considered long-standing unless noted.</p> <p>See pages 2 & 3 for details.</p>
---	---

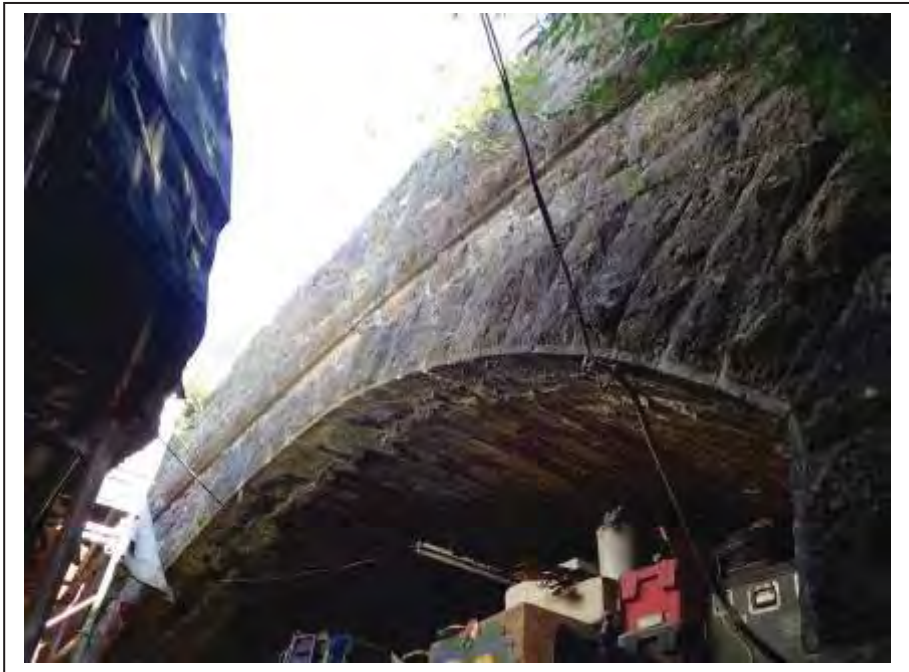
Photograph no 8: general condition of the C/e voussoirs

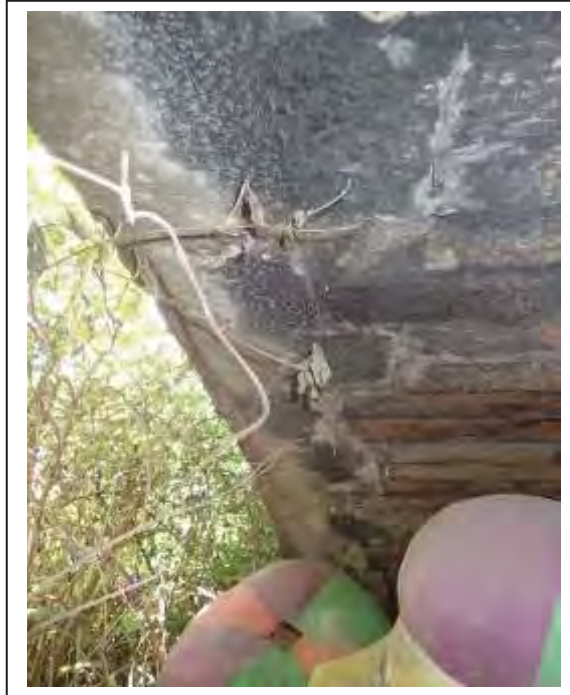
Photograph no 9: calcite deposits noted at the rear of the L/e voussoirs may cover underlying fracture.

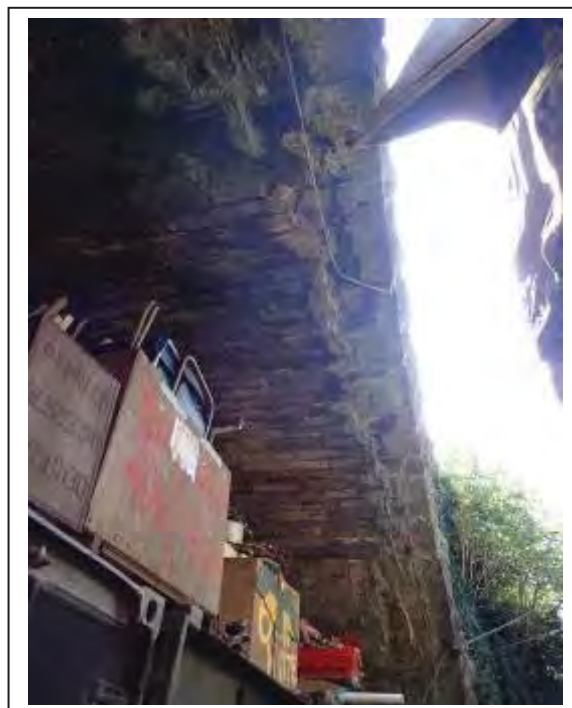
Photograph no 10: calcite deposits noted at the rear of the C/e voussoirs may cover underlying fracture.

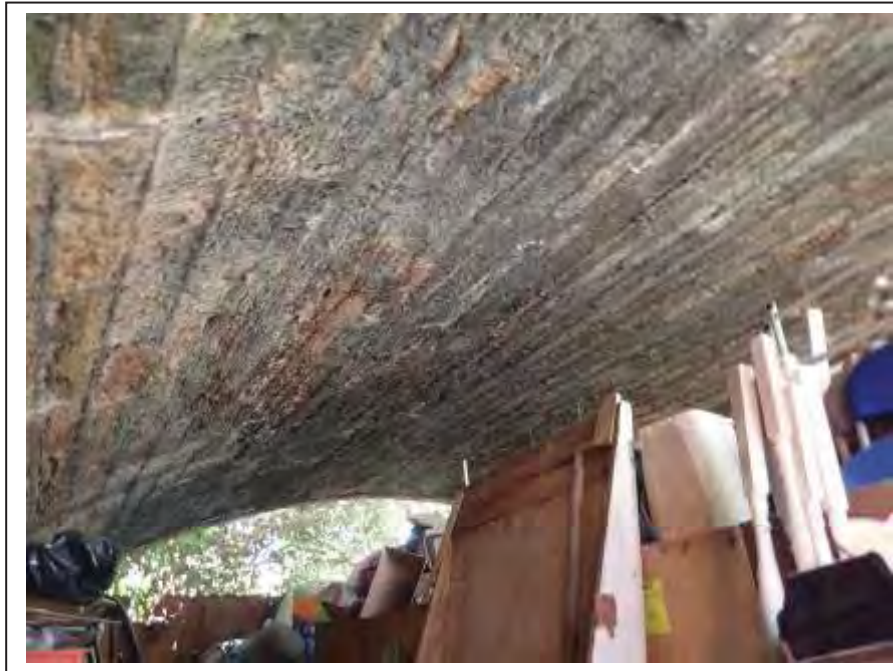
Photograph no 11: odd spalled stones noted within the soffit

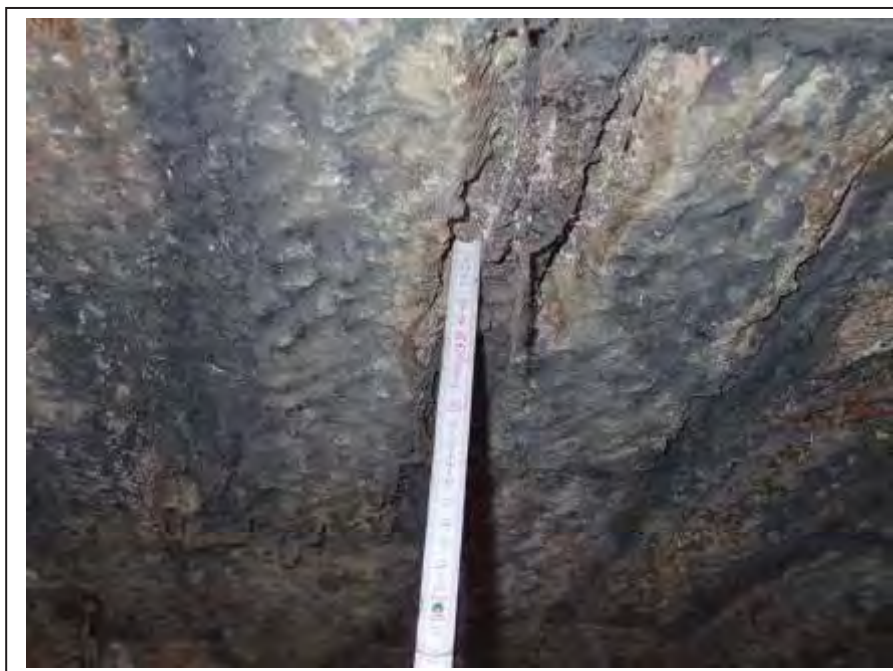
Photograph no 12: spalling at joint lines noted up to approx 50mm

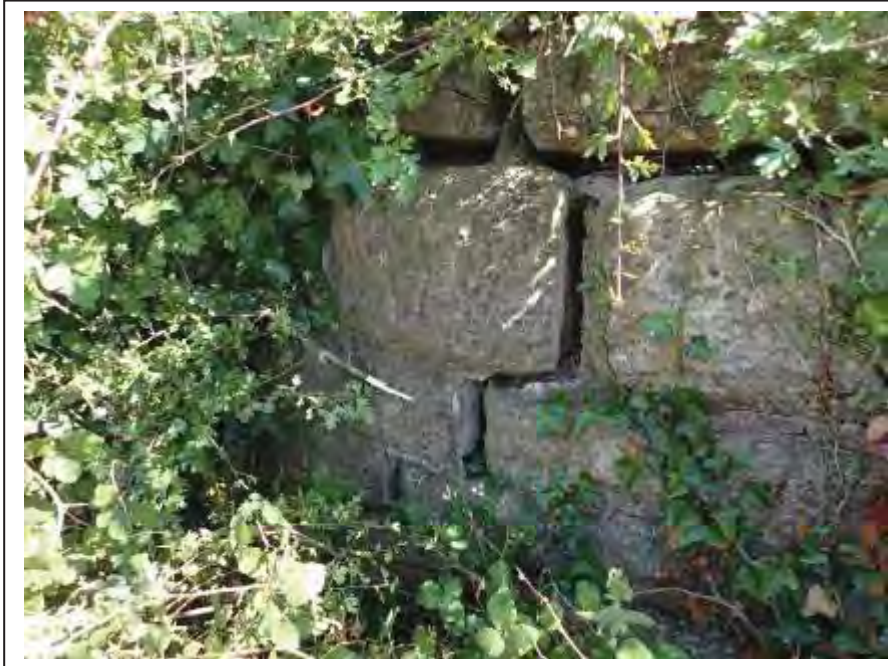
Photograph no 13: long-standing fracture and displacement noted towards the U/S quoin of the L/e parapet

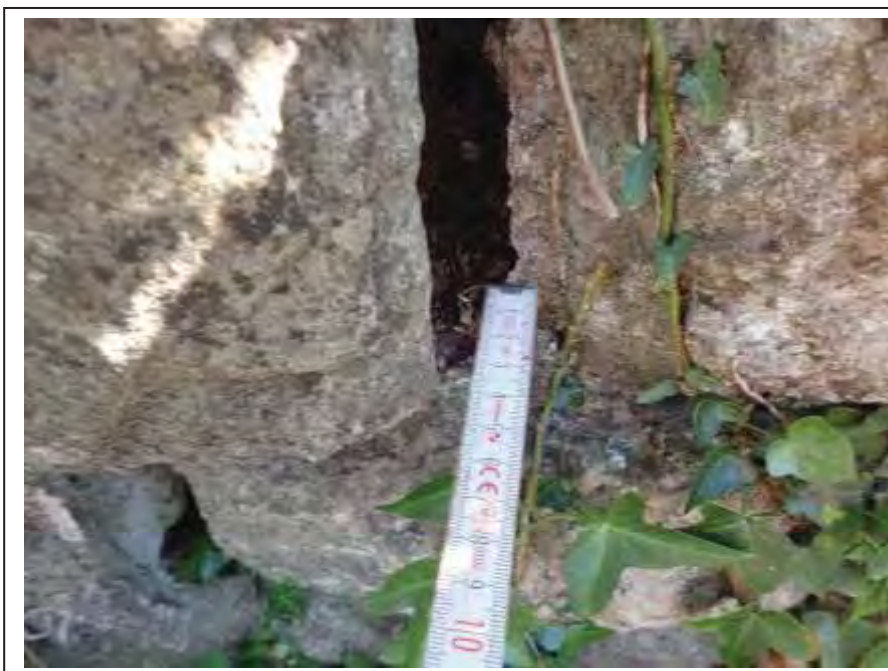
Photograph no 14: forward displacement noted up to 45mm at fracture line

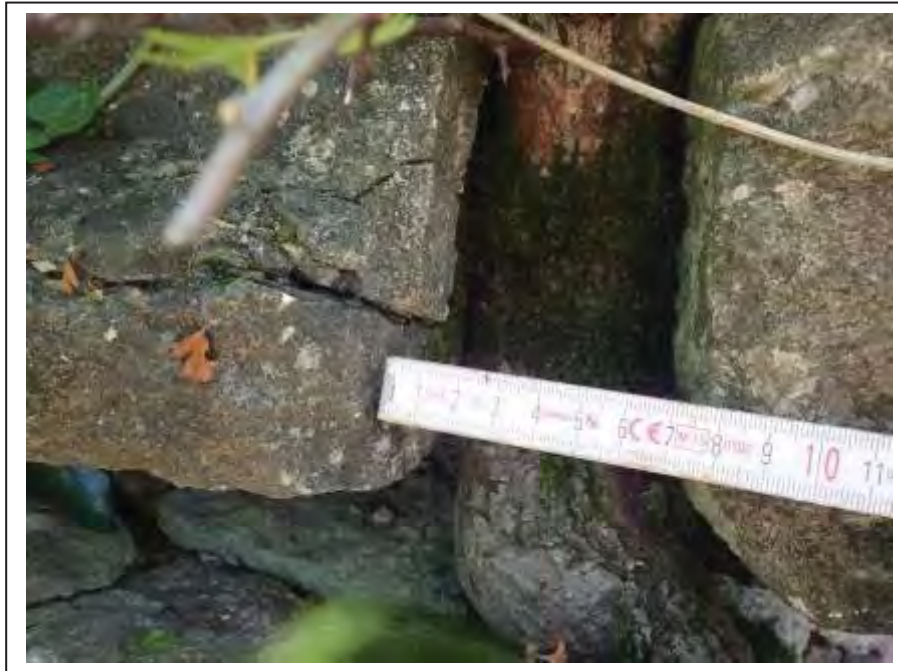
Photograph no 15: displacement at the coping noted up to 70mm

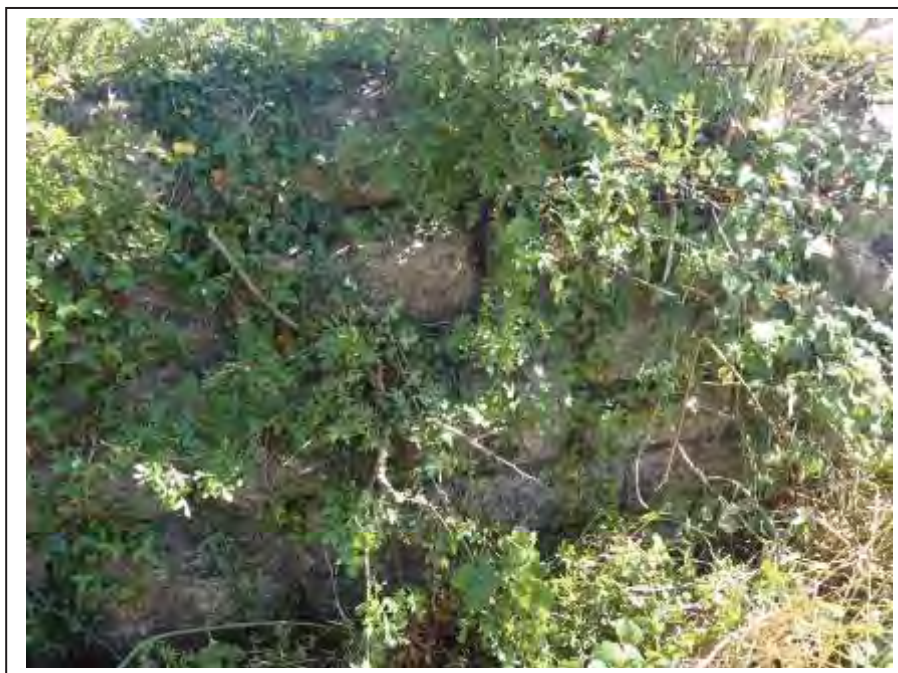
Photograph no 16: displaced copings along the L/e parapet located approx 2.7m from the U/S quoin

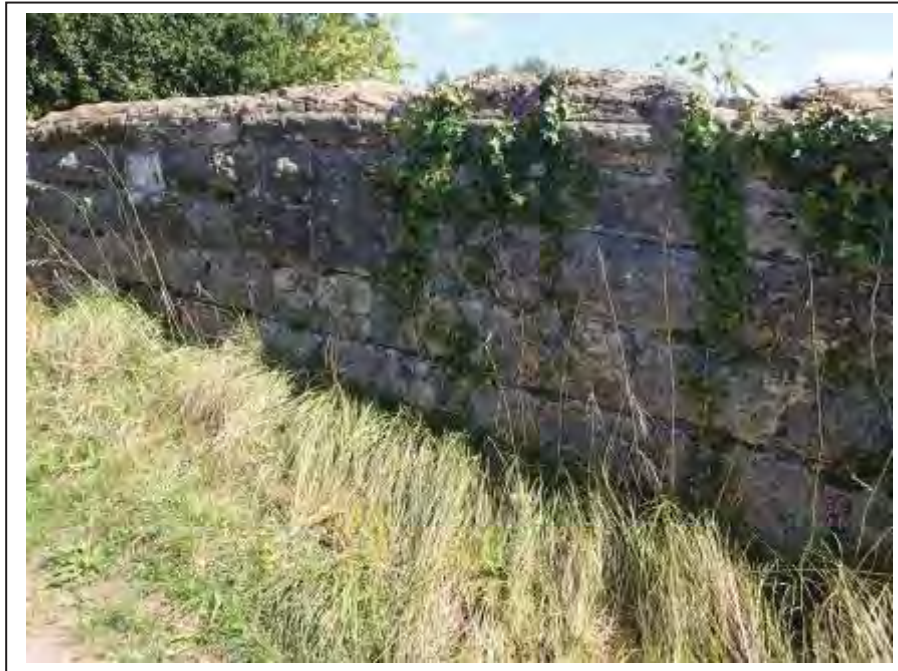
Photograph no 17: lifting and cracking mortar with associated open joints within the L/e parapet

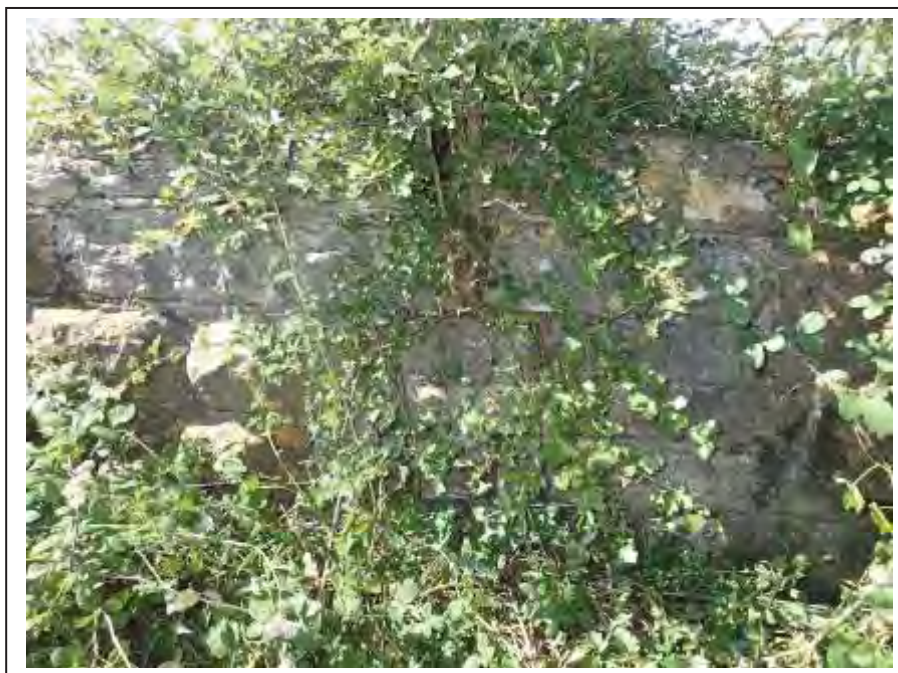
Photograph no 18: long-standing fracture noted towards the U/S quoin of the C/e parapet

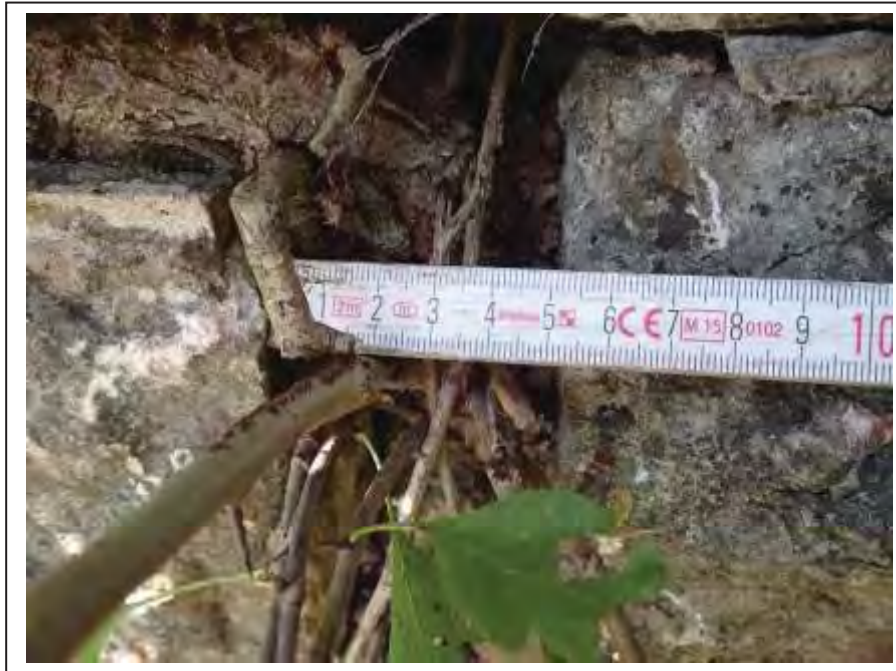
Photograph no 19: fracture open to 50mm within the C/e parapet

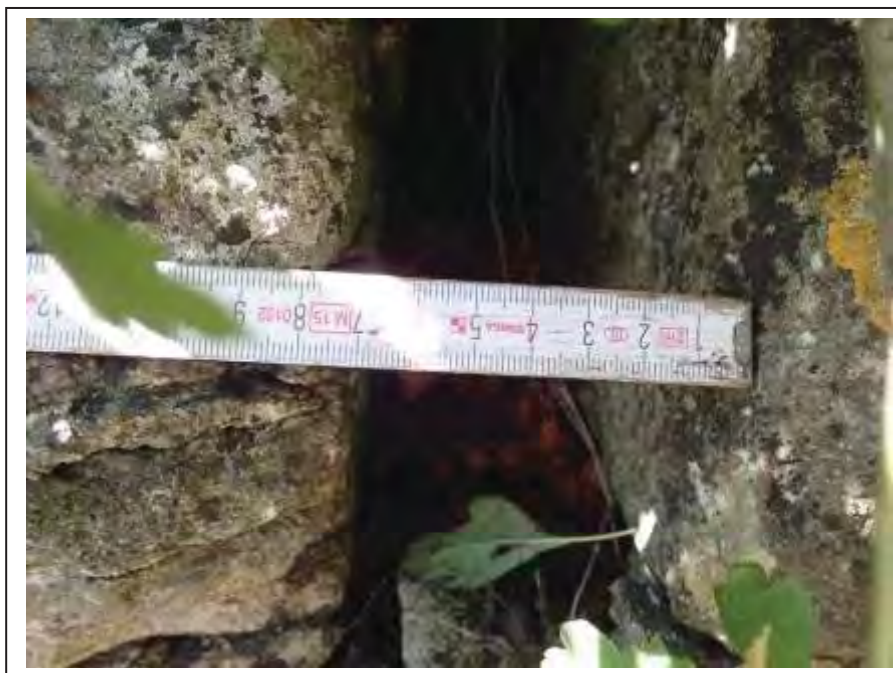
Photograph no 20: displacement at the coping perp noted to 70mm

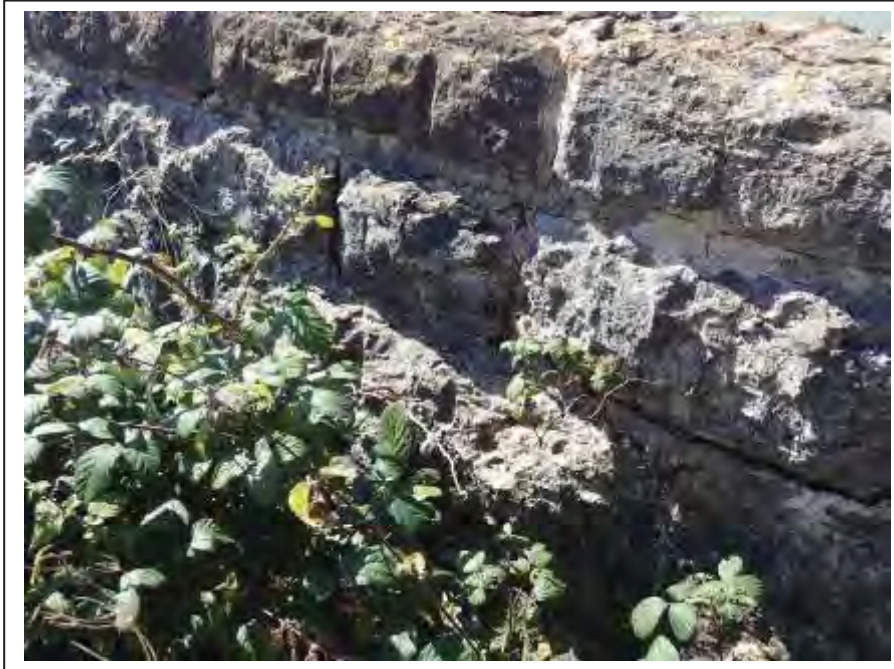
Photograph no 21: odd stones found to move under hammer within the C/e parapet

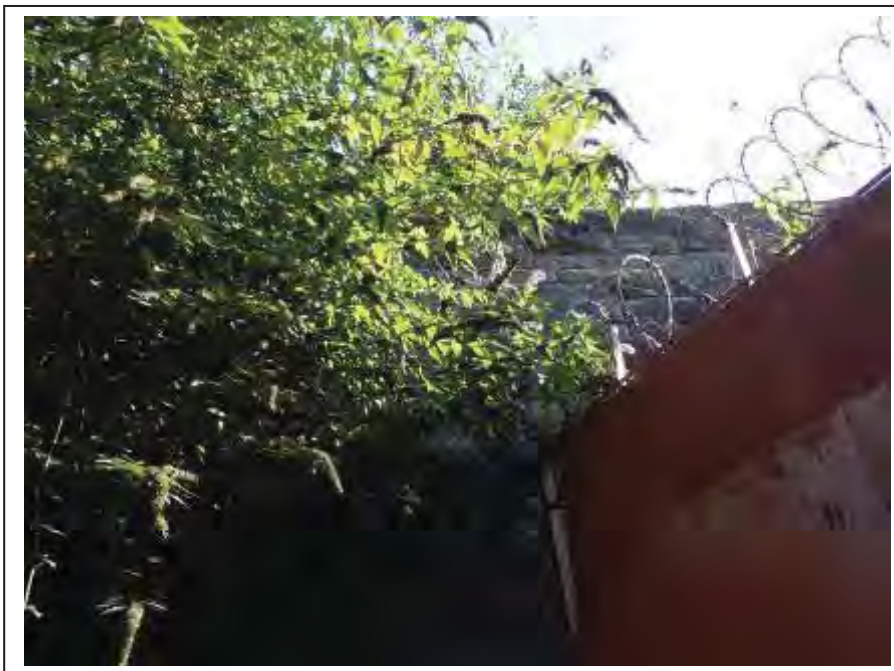
Photograph no 22: long-standing fracture within the external face of the C/e parapet obscured by vegetation

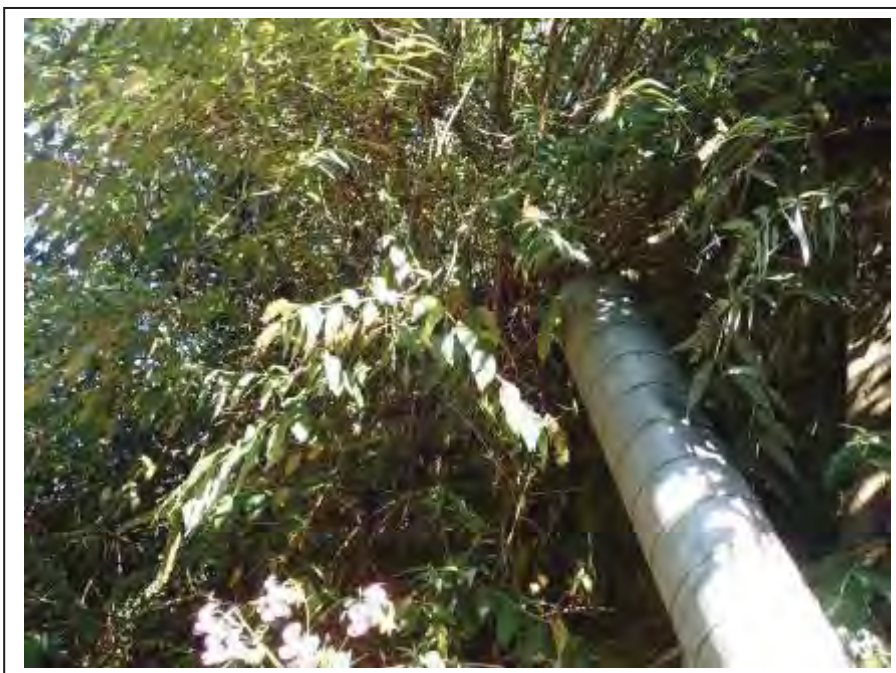
Photograph no 24: sapling growth noted within the U/S, C/e wingwall

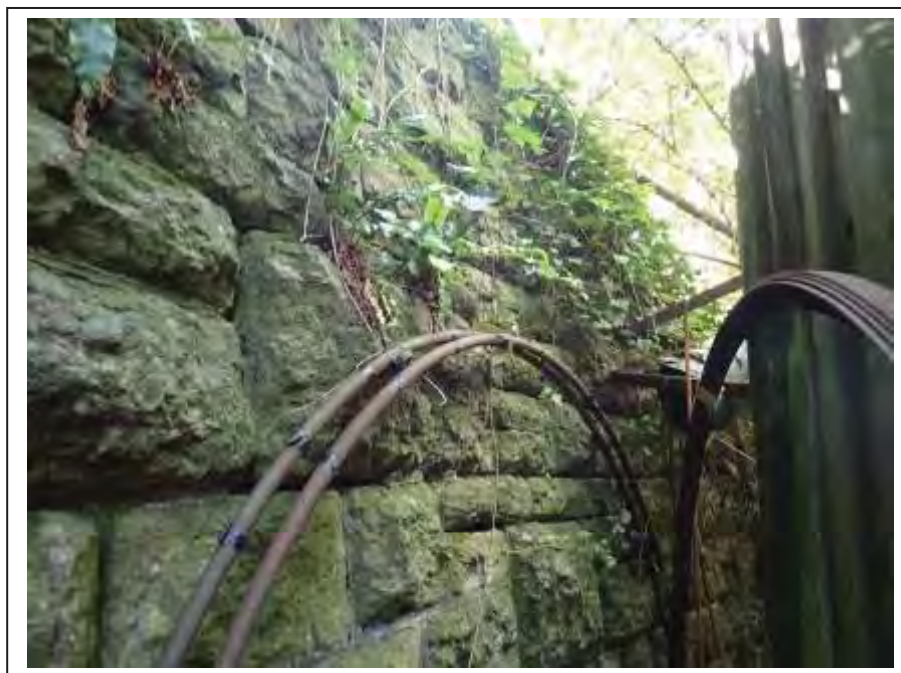
Photograph no 26: example of mortar loss noted within the D/S, C/e wingwall

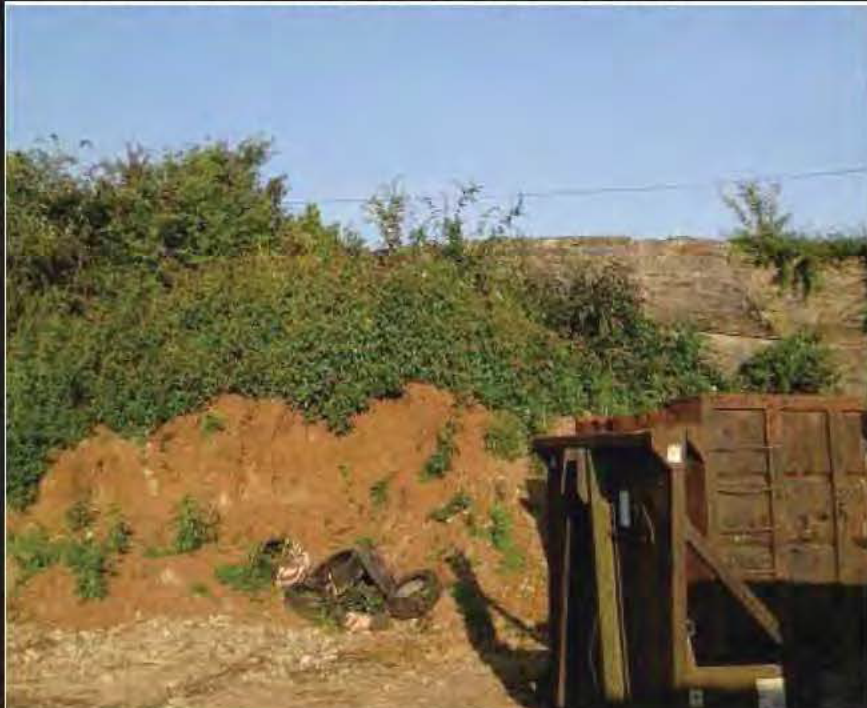
<p>There was no evidence of any repair works having been carried out within the structure since the previous visual examination dated 22/08/14.</p> <p>A number of defects are found within the structure. All defects are considered long-standing unless noted.</p> <p>See page 2 for details.</p>

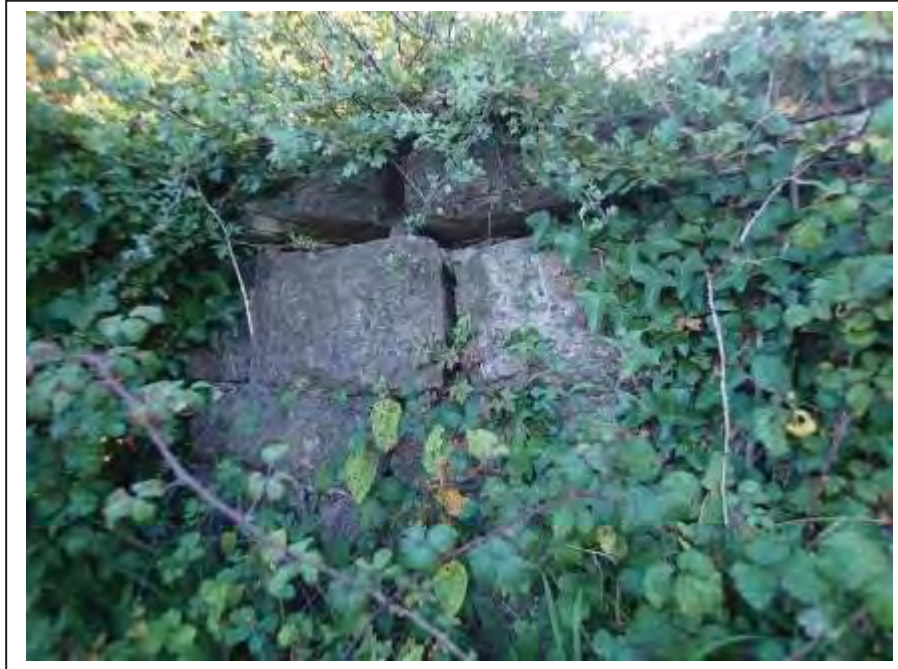
Photograph no 3: long-standing fractured and displaced stonework to internal face of the L/e parapet located towards the U/S quoin

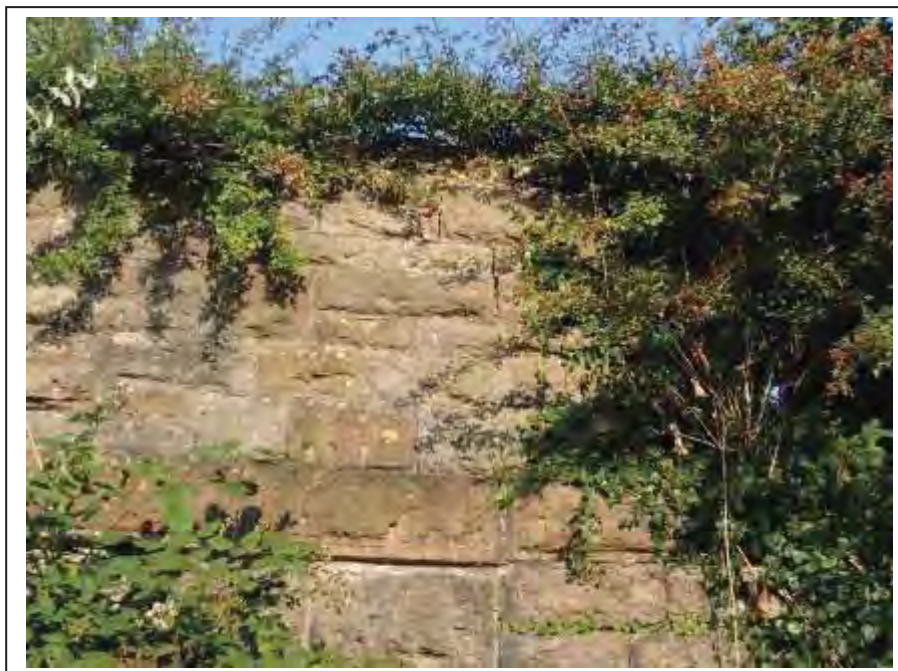
Photograph no 4: fracturing noted towards the U/S quoin of the L/e parapet within the external face

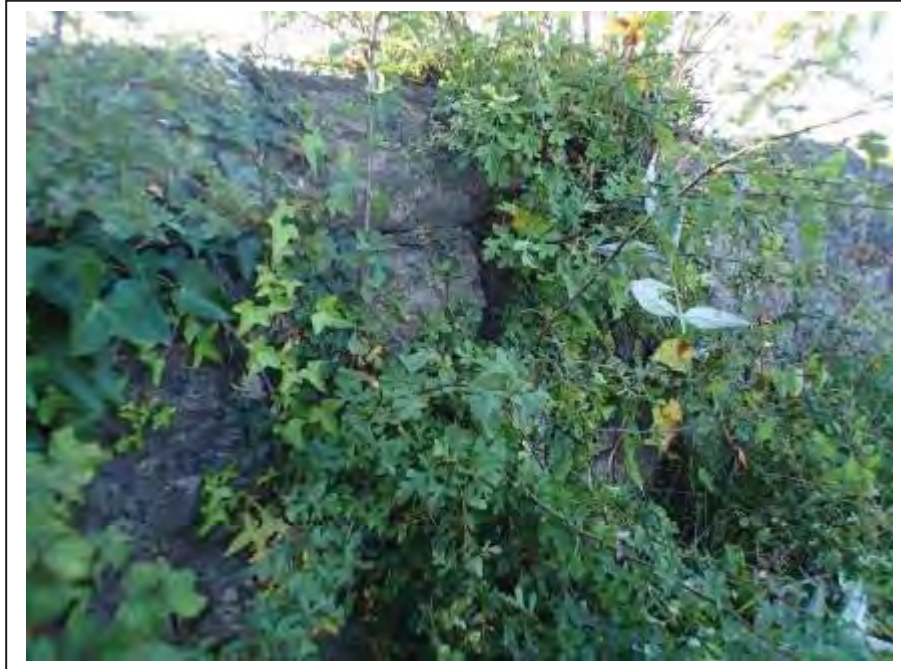
Photograph no 5: lifting copings noted along the L/e parapet due to root ingress approx 2.7m from the U/S quoin

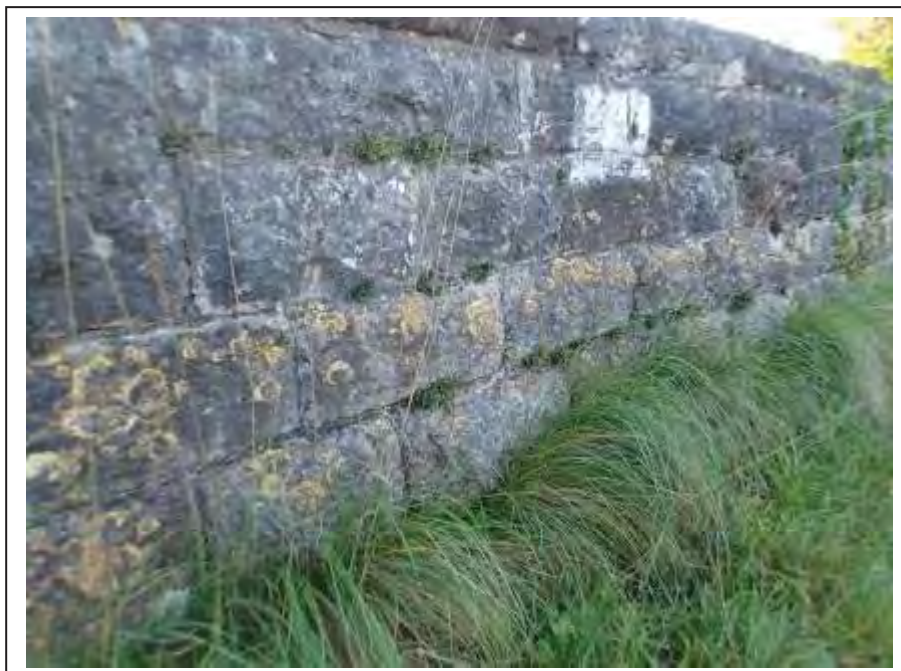
Photograph no 6: lifting and cracking mortar content with odd stones found to move on hammer within the L/e parapet

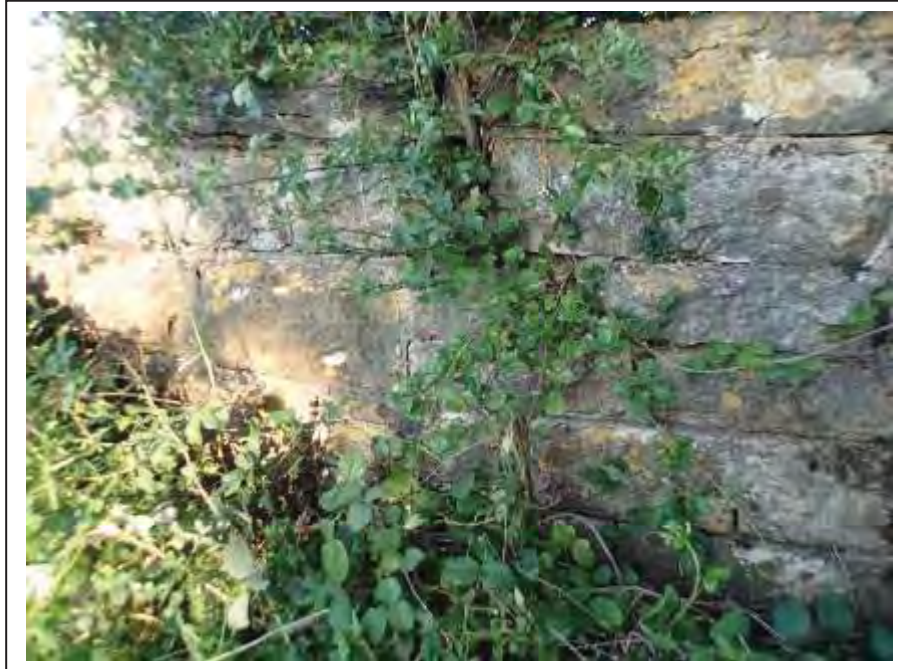
Photograph no 7: long-standing step fracture towards the U/S quoin area of the C/e parapet

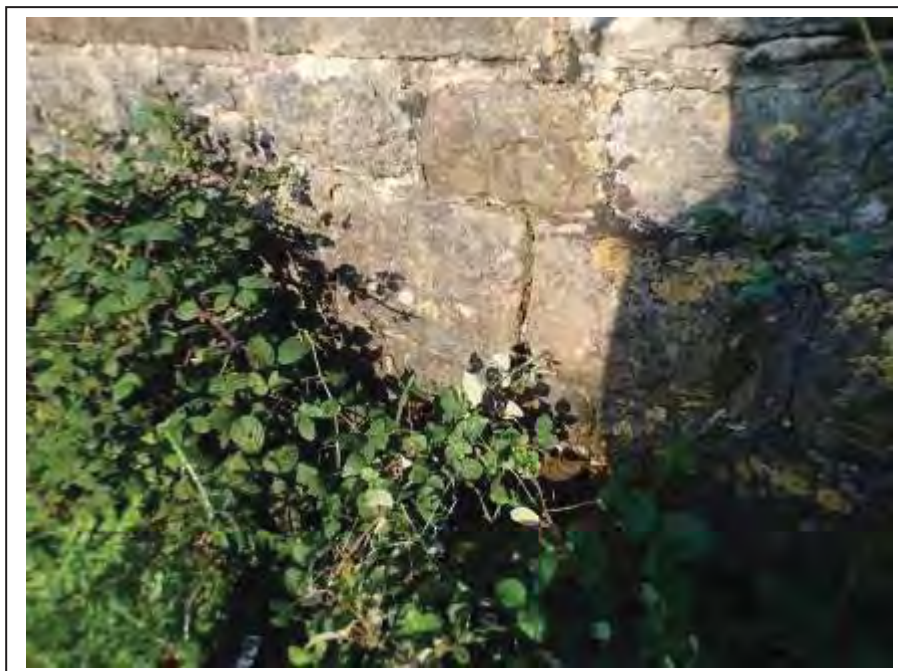
Photograph no 8: odd areas of mortar loss with odd stones found to move on hammer within the C/e parapet

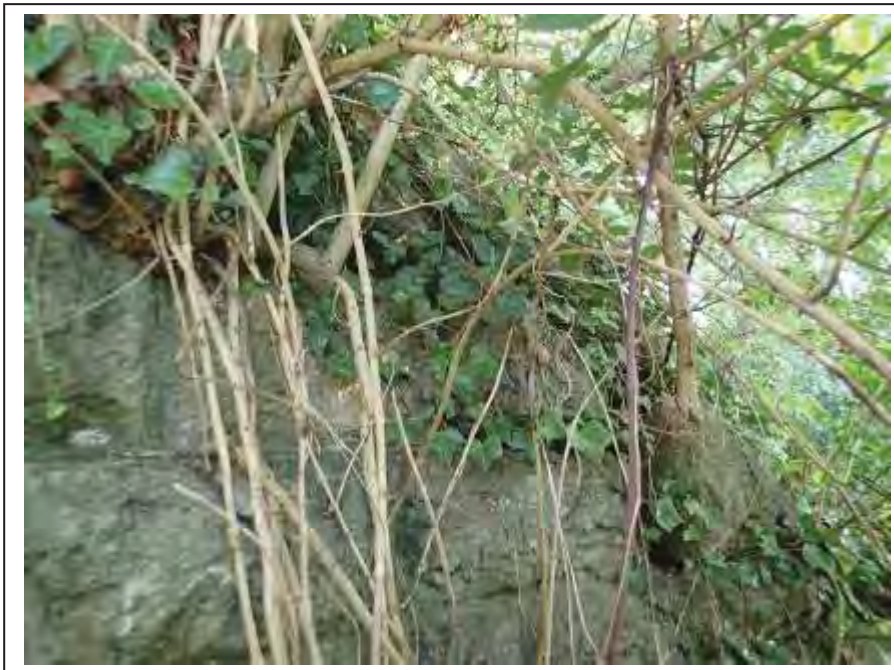
Photograph no 10: some displaced copings at cut stones noted along the U/S, L/e wingwall

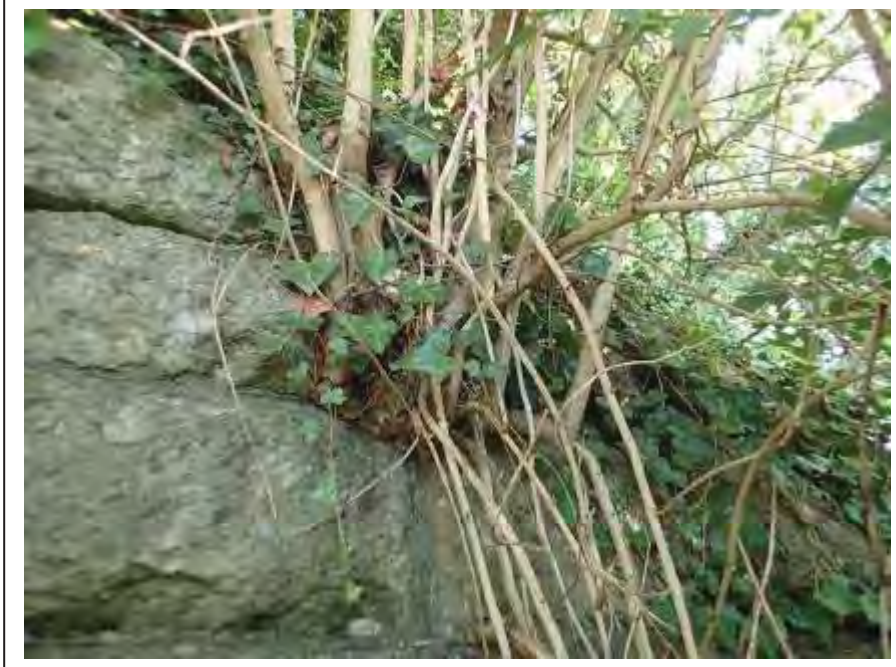
Photograph no 11: sapling growth noted within the U/S, L/e wingwall

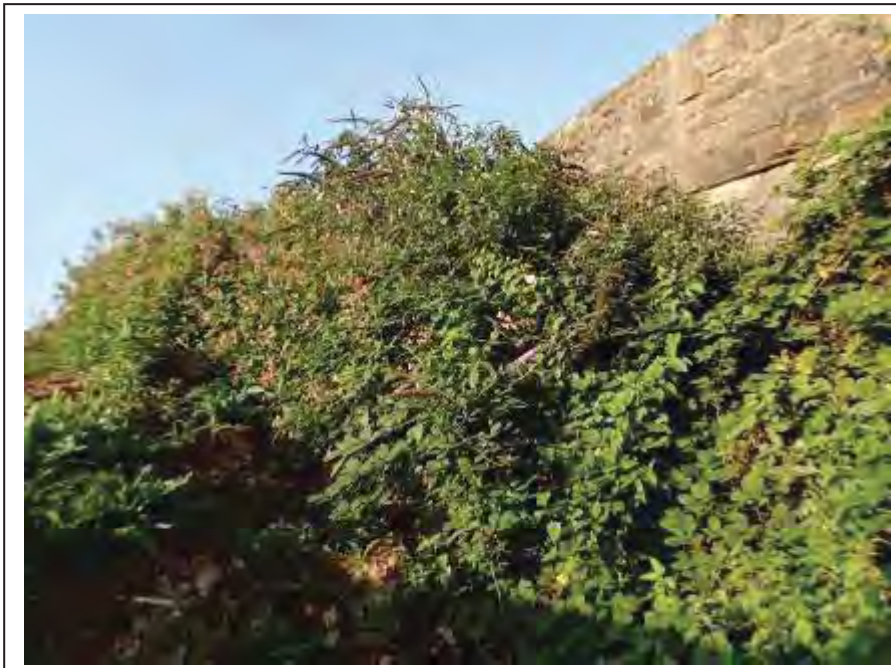
Photograph no 12: vegetation growth located in front of the L/e elevation
