Our ref: 101465
Your ref:

[REDACTED]
Historical Railways Estate
3rd Floor
37 Tanner Row
YORK
YO1 6WP
[REDACTED]

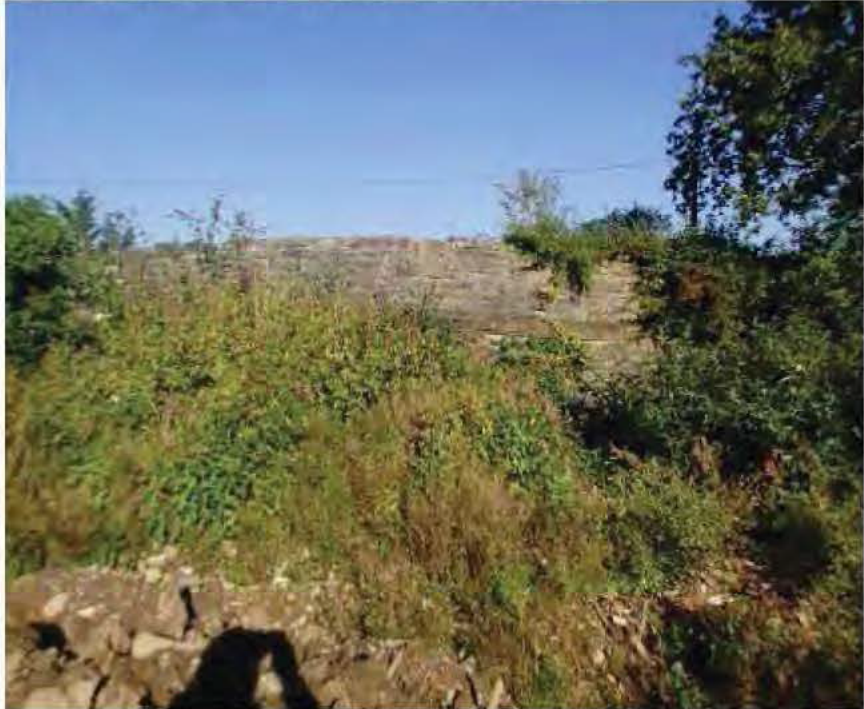
<p>There was no evidence of any repair works having been undertaken within the structure since the previous visual examination.</p> <p>A number of defects are found within the structure. All defects are considered long-standing unless noted. See page 2 for details.</p>

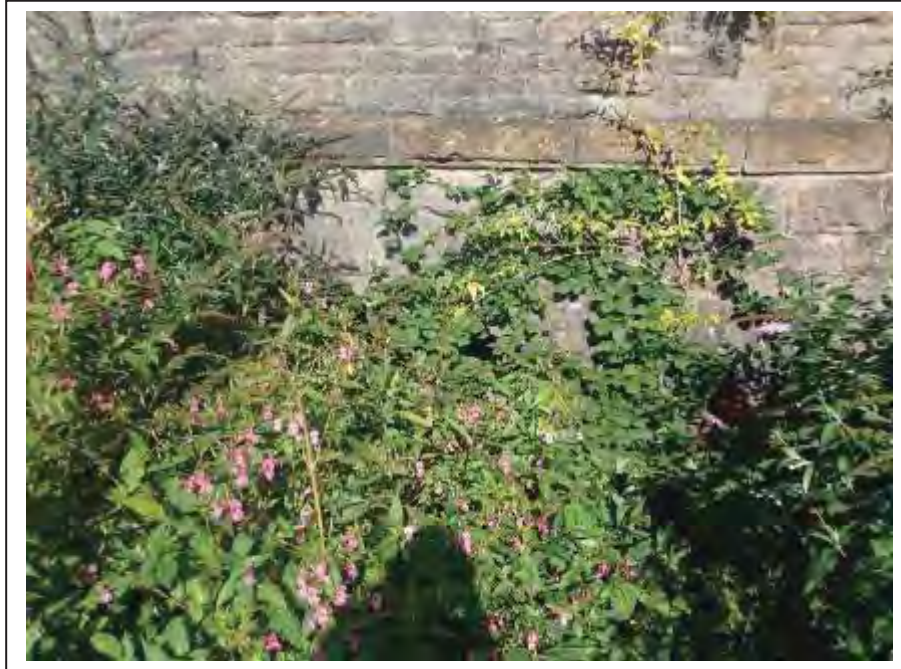
Photograph no 5: vegetation restricts full inspection of the L/e voussoirs.
 Evidence of long-standing joint loss noted at the extrados joint

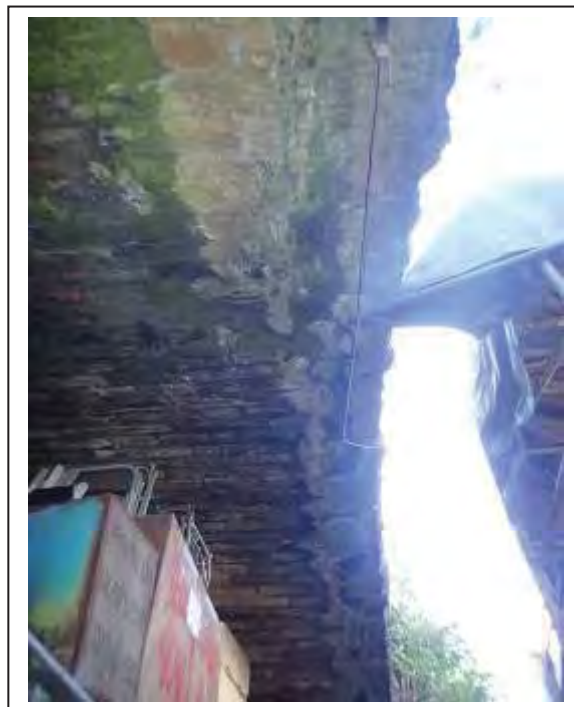
Photograph no 6: calcite deposits to the rear of the C/e voussoirs may cover an underlying fracture.

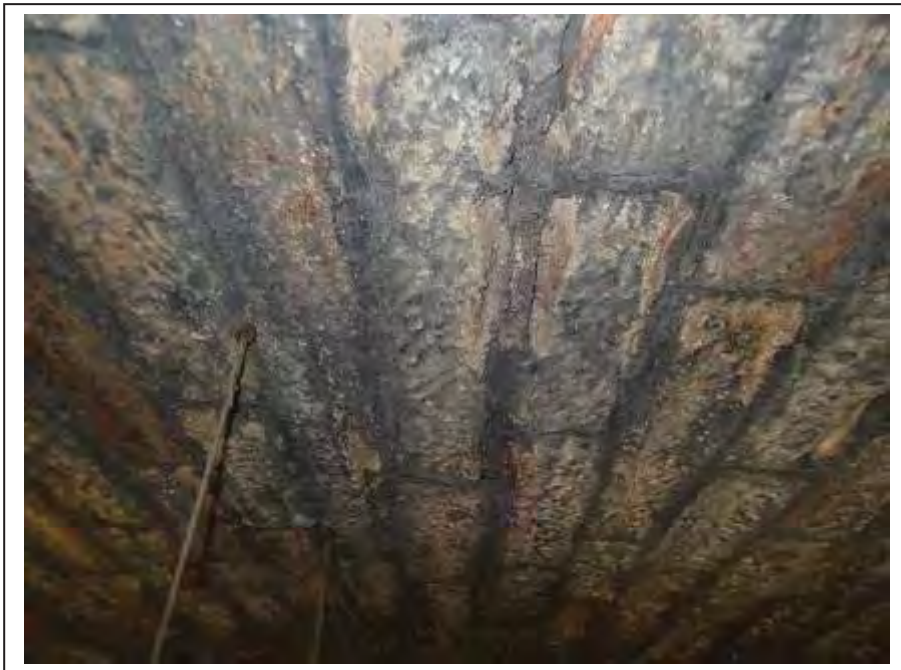
Photograph no 8: example of spalling along the joint lines within the soffit

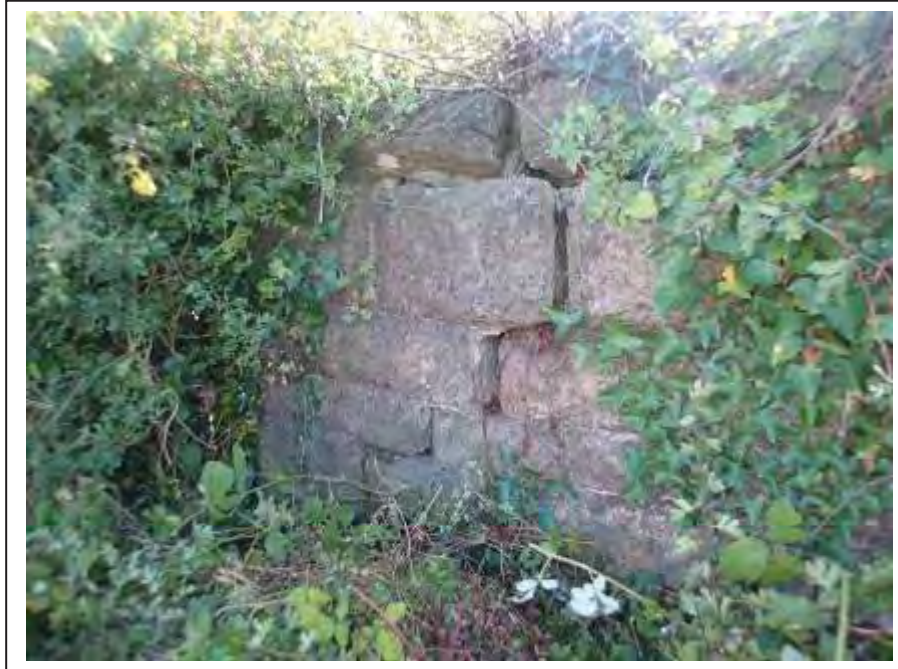
Photograph no 9: long-standing fractured and displaced stonework to internal face of the L/e parapet located towards the U/S quoin

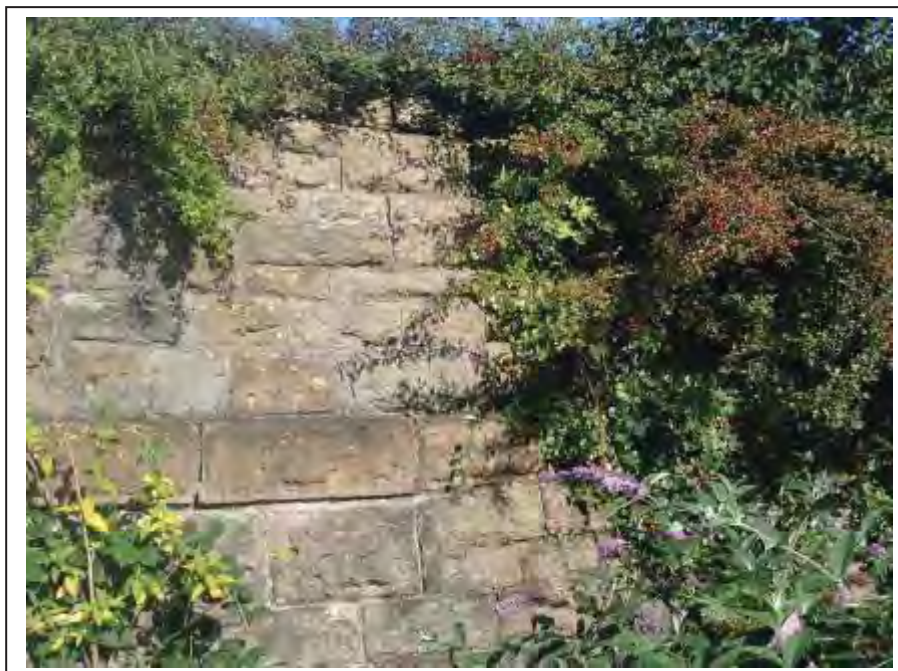
Photograph no 10: fracturing noted towards the U/S quoin of the L/e parapet within the external face

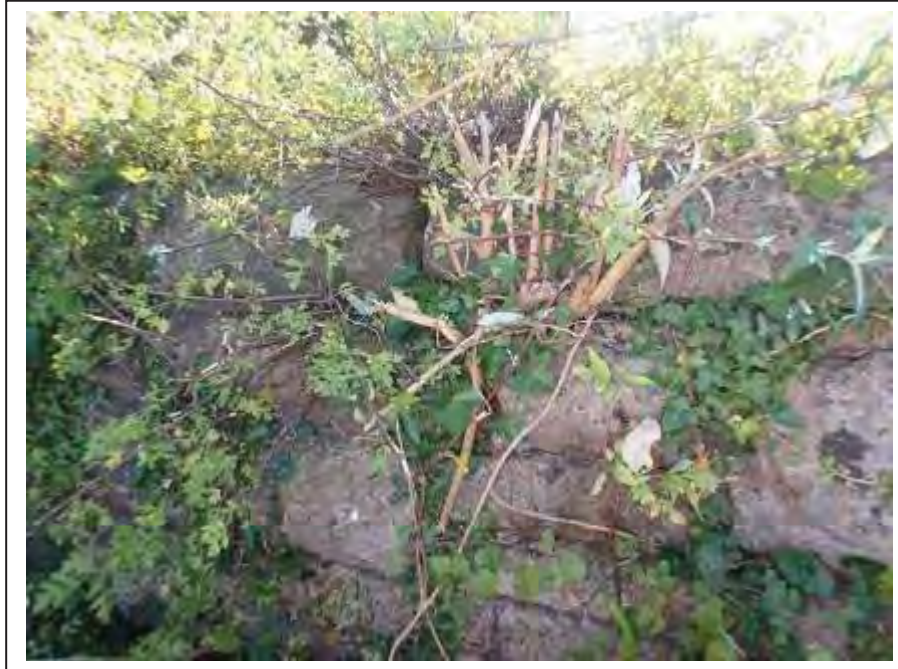
Photograph no 11: lifting copings noted along the L/e parapet due to root ingress approx 2.7m from the U/S quoin

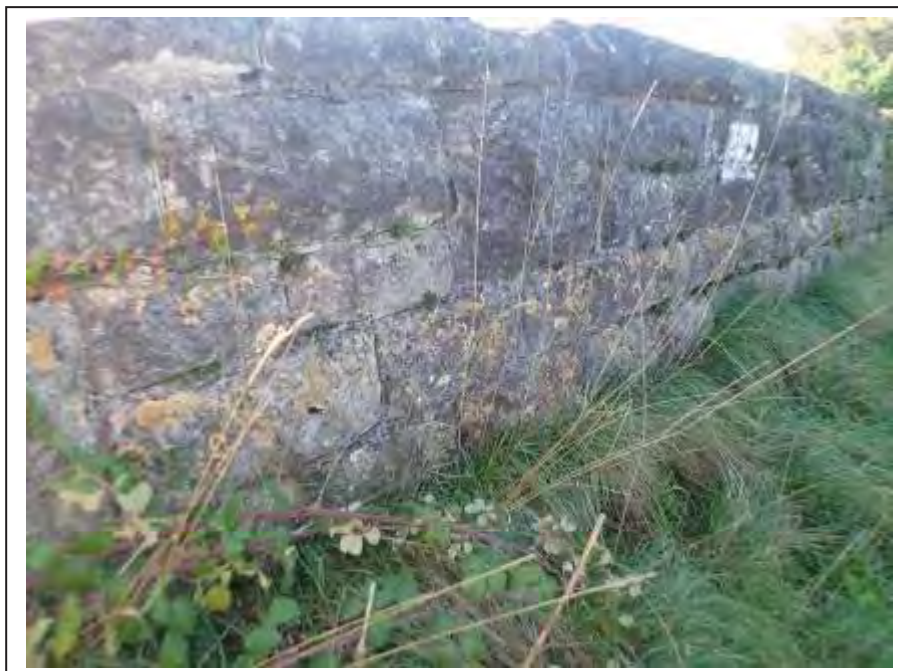
Photograph no 12: lifting and cracking mortar content with odd stones found to move on hammer within the L/e parapet

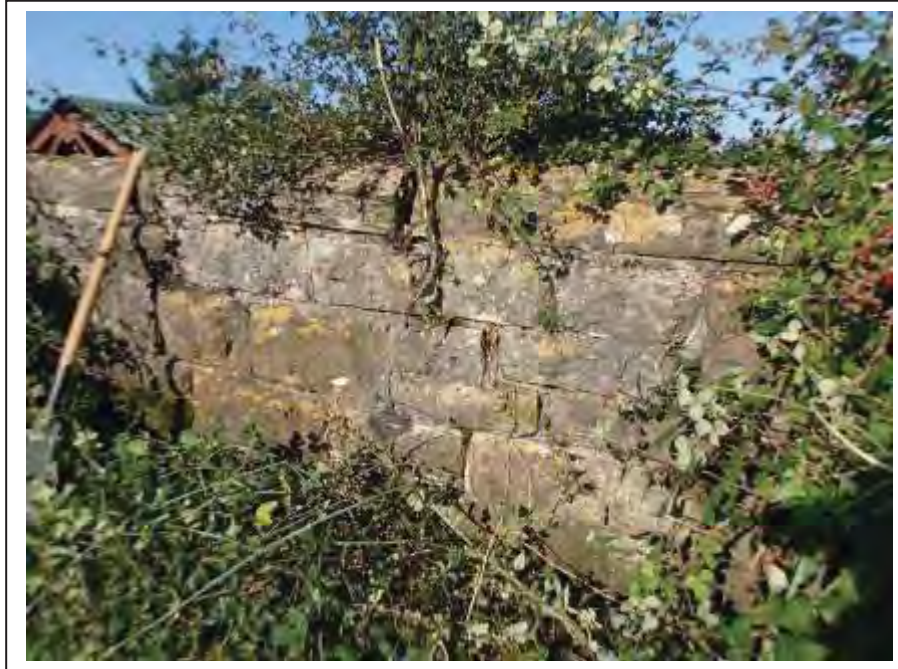
Photograph no 13: long-standing step fracture towards the U/S quoin area of the C/e parapet

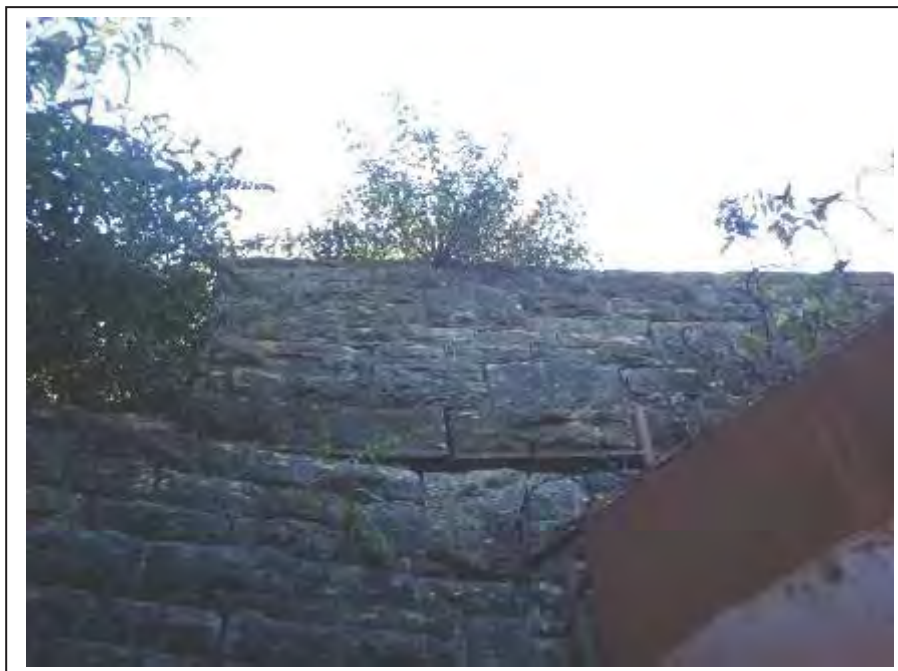
Photograph no 14: long-standing step fracture visible to the external face of the C/e parapet on the U/S
 Associated pushing stonework noted to approx 15mm

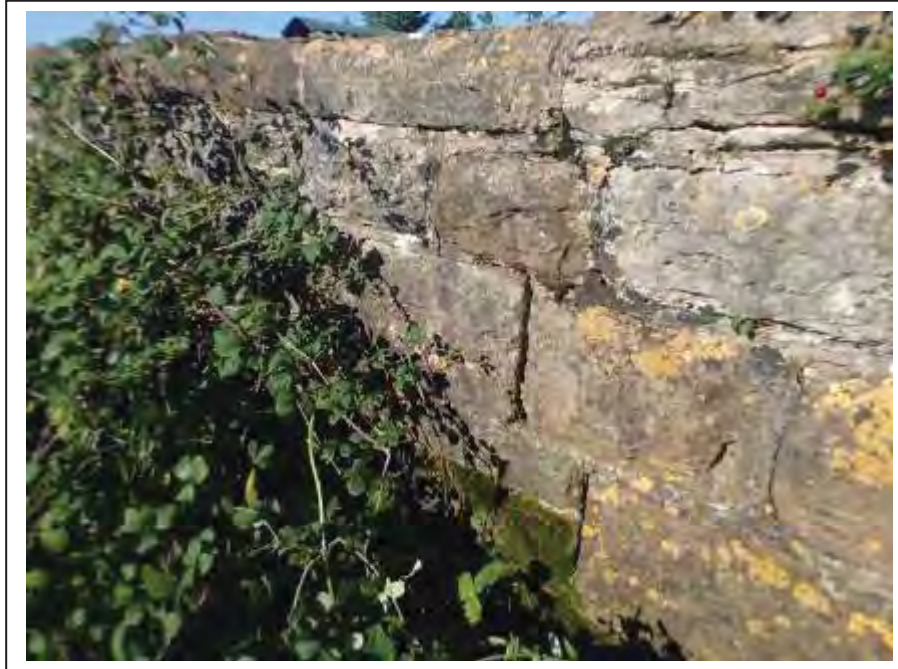
Photograph no 15: odd areas of mortar loss with odd stones found to move on hammer within the C/e parapet

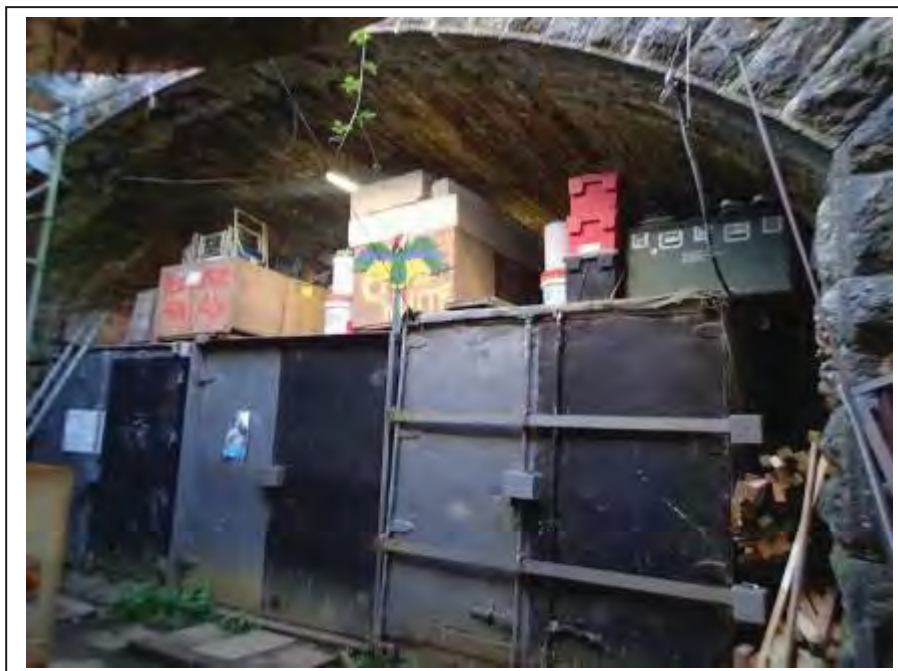
Photograph no 16: no access to the abutments
