Supporting the uptake of resilient repair during the recovery process (FD2706)

Appendix 6: Eden Bridge House Case Study

REVIEW OF DEFRA EDEN BRIDGE HOUSE PROPERTY FLOOD RESILIENCE IMPLEMENTATION

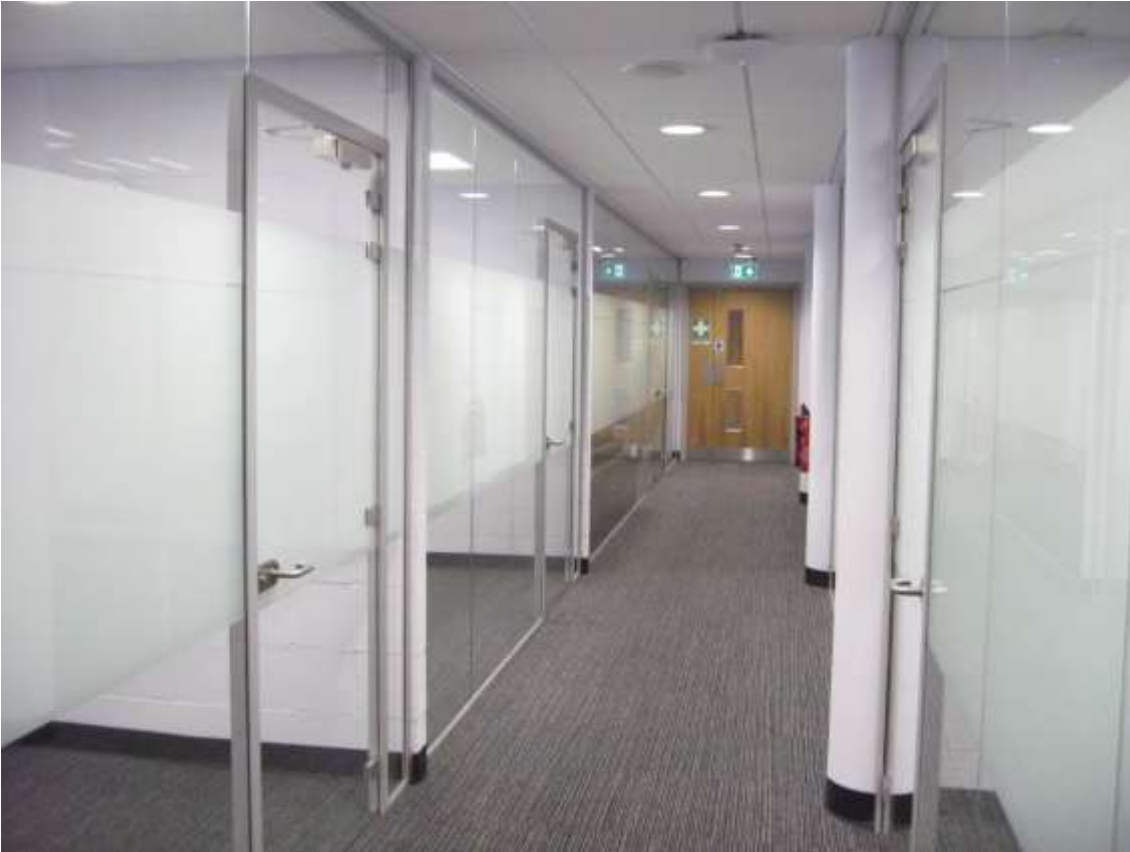
Figure 3 - Eden Bridge House – Refurbished Lower Ground Floor

The refurbishment of the lower ground floor of Eden Bridge House has created a clean and open conference and meeting room space. The openness is heightened by the use of glass panels with appropriate privacy screening rather than traditional partition walls. Some users have been critical of the space calling it ‘sterile’; there has also been disappointment at the restrictions placed on fixing noticeboards/whiteboards etc to the wall (restriction imposed as means of maintaining integrity of the Sika waterproof membrane system).

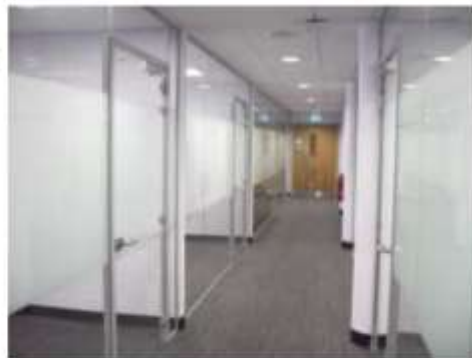
Corridor showing. Painted wall finish direct on masonry rather than plastered. replacement of partition walling with glass panel walling. 'sacrificial' carpeting.

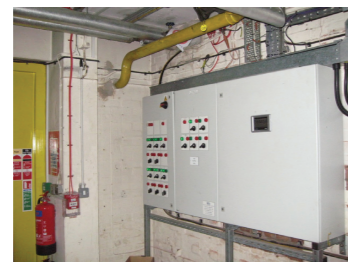
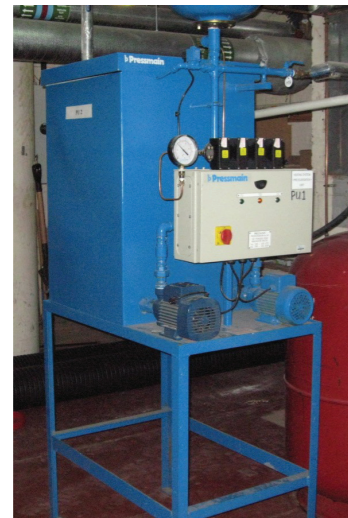
Electrical supply

Electrical panel relocated upstairs. A generator connection was also added to this panel which would enable a temporary electrical supply to be given to the building in the event that local electrical network distribution had been knocked out by the flood.

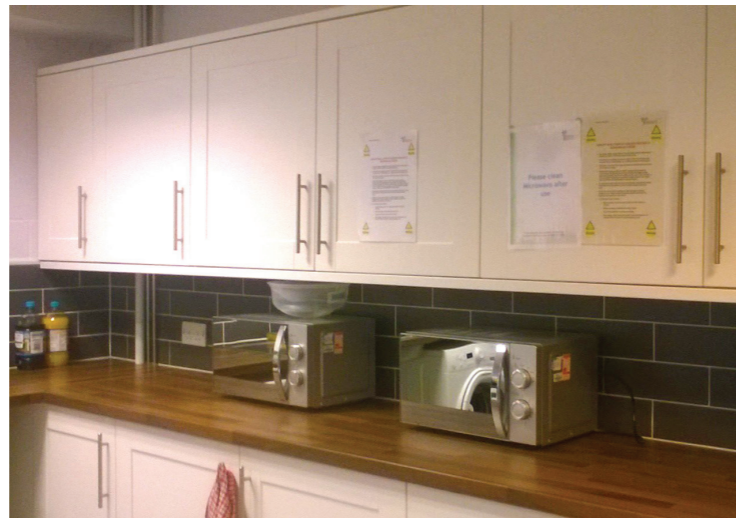
Services adaptations

Due to the high level of past flooding, it was agreed that, to be truly resilient, electrical and data systems would need to be mounted so high on the walls as to be impractical for use. Therefore it was agreed that the main infrastructure would be distributed within the ceiling in each room. Connections would then be taken from these and run to socket distribution in dado trunking around the walls, like an extension lead from the ceiling sockets. In the event of flooding, the 'extension lead' would be discarded, the trunking cleaned out and a new set of 'extension leads' replaced.

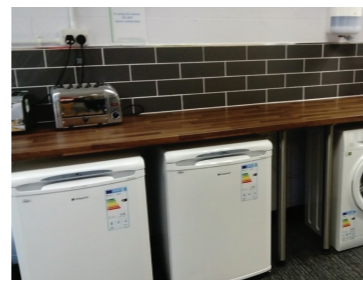
Kitchen adaptations

The canteen kitchen is made from standard chipboard. The unit sizes are off the shelf and can be replaced within a few weeks. A flood resilient option made from solid grade laminate was over 5 times more expensive.

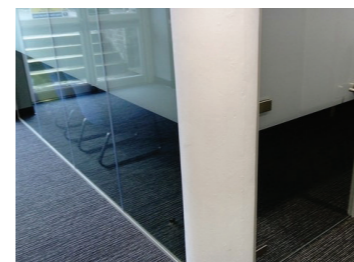
Corridor adaptations - wall membrane, finishes, doors

The wall render was chosen because it does not soak up water and harbour bacteria. As per the guidance in PAS64, after the 2015 flood over 100 swab samples were taken around the lower ground floor and the existing wall plaster was found to be harbouring bacteria in quantities that would not normally be found in an office environment. It was decided that any replacement wall coating should prevent this in the event of future flooding. The Sika render chosen can simply be washed down in the event of future flooding. It can also be repaired if damaged, has a method for retrospective penetrations to be made if required and, although expensive compared to conventional plaster, is relatively cheap given its 20yr guaranteed life and an assumption of 1 in 5 year flooding.

Timber fire doors and door frames were significantly cheaper than resilient options, due to the standard sizes used, these doors can be replaced within 6wks.

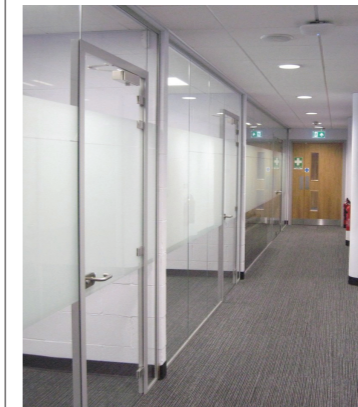
Offices relocated upstairs. Paper storage relocated upstairs. Meeting rooms and canteen space were chosen as the least disruptive to be out of use for an extended period of time. Although both these facilities being out of action would disrupt business operations, they were more easily transferable to other temporary locations than other operations.

Flood resilient furniture was reviewed, however these were all very expensive. New meeting room furniture could be procured within the 6wk drying/cleaning period. Defra was able to relocate unused furniture from other parts of the estate which gave a very cost effective solution. Where possible they used conference and meeting room furniture that can be easily dismantled and moved to safety.

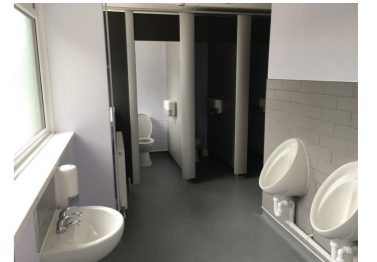
Toilet adaptations

The toilets are now resilient to flooding due to the materials used to fit them out. The walls around most of the area has been rendered with the Sika product, however due to its rough final surface, it was decided this would be unhygienic and difficult to clean in 'splash risk' areas so tiles with a waterproof adhesive and grout were used. The toilet cubicles has previously been standard chipboard units, these have been replaced with solid grade laminate. This was more expensive, however cubicle manufacturers could not guarantee a 6wks lead time on replacements. Although it was considered whether other toilets in the building could be used for an extended period if those on the lower ground floor were taken out of action by flood, it was decided that the solid grade product was worth the extra cost, particularly as it is more durable than standard chipboard and would have a longer life.

There is also a shower area on the lower ground floor, this was fitted out as a wetroom to be fully resilient.
