SERIOUS INCIDENT

Aircraft Type and Registration:	BAe ATP, SE-MAO	
No & Type of Engines:	2 Pratt and Whitney Canada PW126 turboprop engines	
Year of Manufacture:	1989 (Serial no: 2011)	
Date & Time (UTC):	22 May 2020 at 1258 hrs	
Location:	Birmingham Airport	
Type of Flight:	Commercial Air Transport (Cargo)	
Persons on Board:	Crew - 2	Passengers - None
Injuries:	Crew - None	Passengers - N/A
Nature of Damage:	None reported	
Commander's Licence:	Airline Transport Pilot's Licence	
Commander's Age:	57 years	
Commander's Flying Experience:	4,984 hours (of which 211 were on type) Last 90 days - 56 hours Last 28 days - 30 hours	
Information Source:	AAIB field investigation

Synopsis

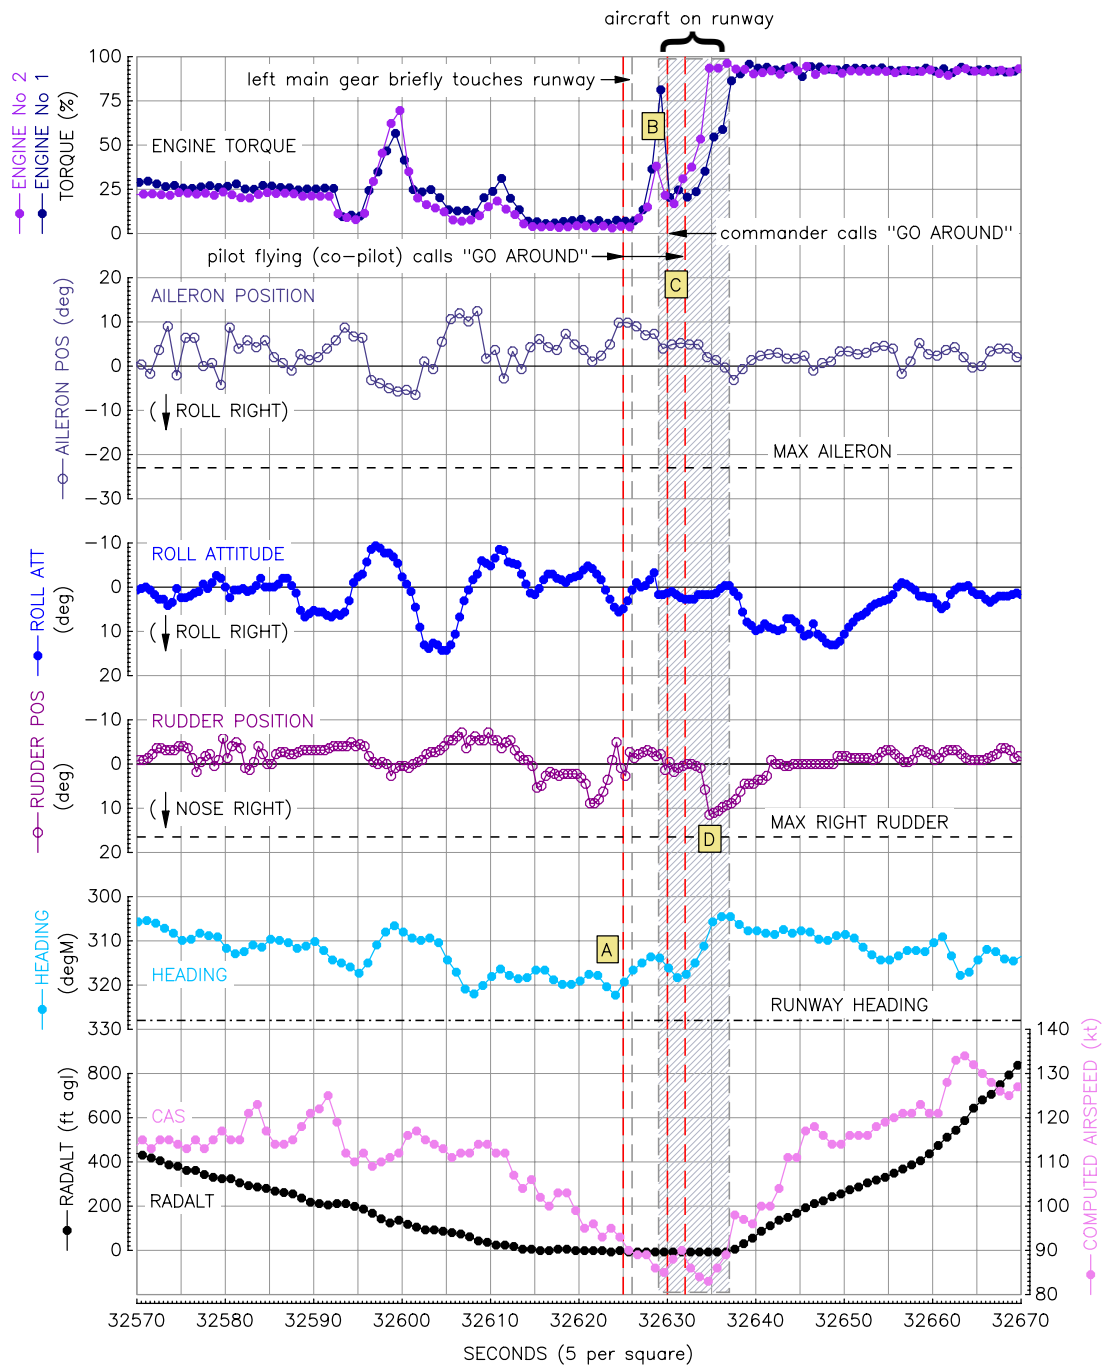
Figure 1 plots the flight data for the first approach and go-around. It starts with the aircraft on the descent passing through 400 ft agl, crabbed to the left by over 20° to the runway heading, and shows that during the approach varying amount of aileron and rudder inputs were used to keep the aircraft on the extended runway centreline. Key points from the data are labelled [A] through [D] and detailed as follows:

1. The co-pilot (PF) called "GO-AROUND" just as the aircraft was about to touch down briefly on the left main gear [A] (and Figure 2). The aircraft heading was about 8° to the left of the runway heading and increasing. The rudder deflection varied around zero and just under half left aileron was being used.
2. During the next three seconds the aircraft veered away from the runway heading while the commander was heard to say "LAND IT LAND IT LAND IT". The engine torques increased from idle to about 80% and then back to about 25% just as the aircraft touched down [B]. At touch down, the aircraft's heading was 15° left of the runway.

3. Shortly after touchdown, the commander called "GO-AROUND" which the co-pilot acknowledged [C] whilst advancing the power levers.
4. The aircraft remained on the ground for about eight seconds during which a small amount of right rudder and left aileron was initially used. The aircraft's heading responded to the right rudder before veering away to the left. About 75% of full right rudder was then applied [D]. The aircraft's heading was 24° left of the runway as the aircraft became airborne (Figure 3).

Flight data for the go-around

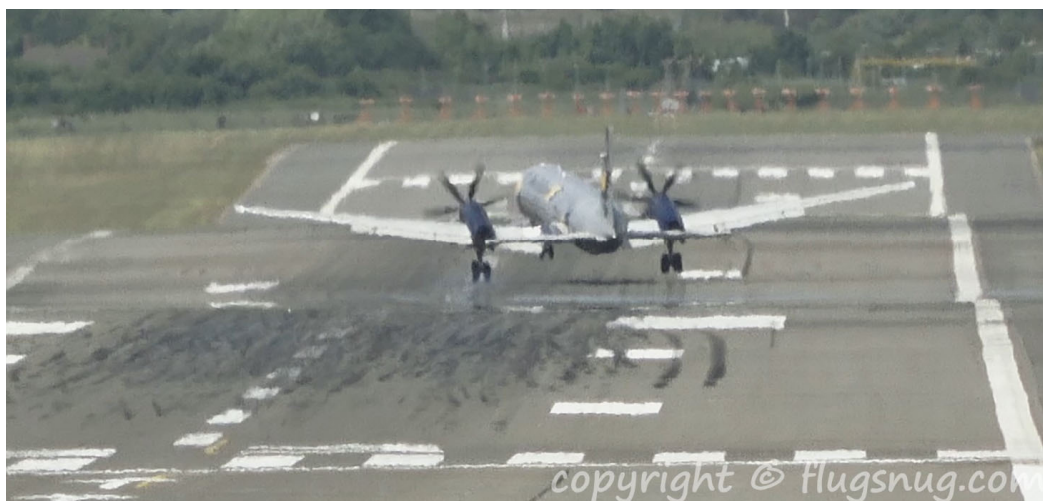
Figure 2

Image showing Point A from Figure 1 – touchdown on Runway 33

The co-pilot flared the aircraft and it briefly touched down although insufficient rudder had been applied to line the aircraft up with the runway. As a result of not pointing down the runway, the co-pilot decided to perform a go-around and called "GO-AROUND". The commander either did not hear him or did not hear him correctly and instead called for the co-pilot to land the aircraft. As a result, the co-pilot closed the thrust levers that he had begun to open, and the aircraft again touched down about 20° nose left of the runway direction. The co-pilot did not have full right rudder applied and as a result the aircraft diverged from the centre of the runway in the strong crosswind. The commander called for a go-around which the co-pilot acknowledged. Go-around power was selected, and the go-around performed as per the SOPs.

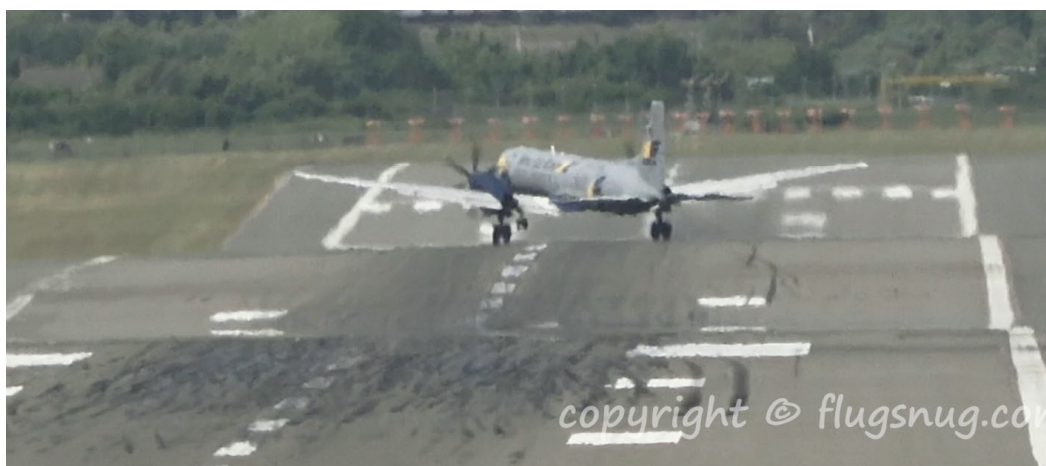
Figure 3

Image showing Point D from Figure 1 – power applied for the go-around

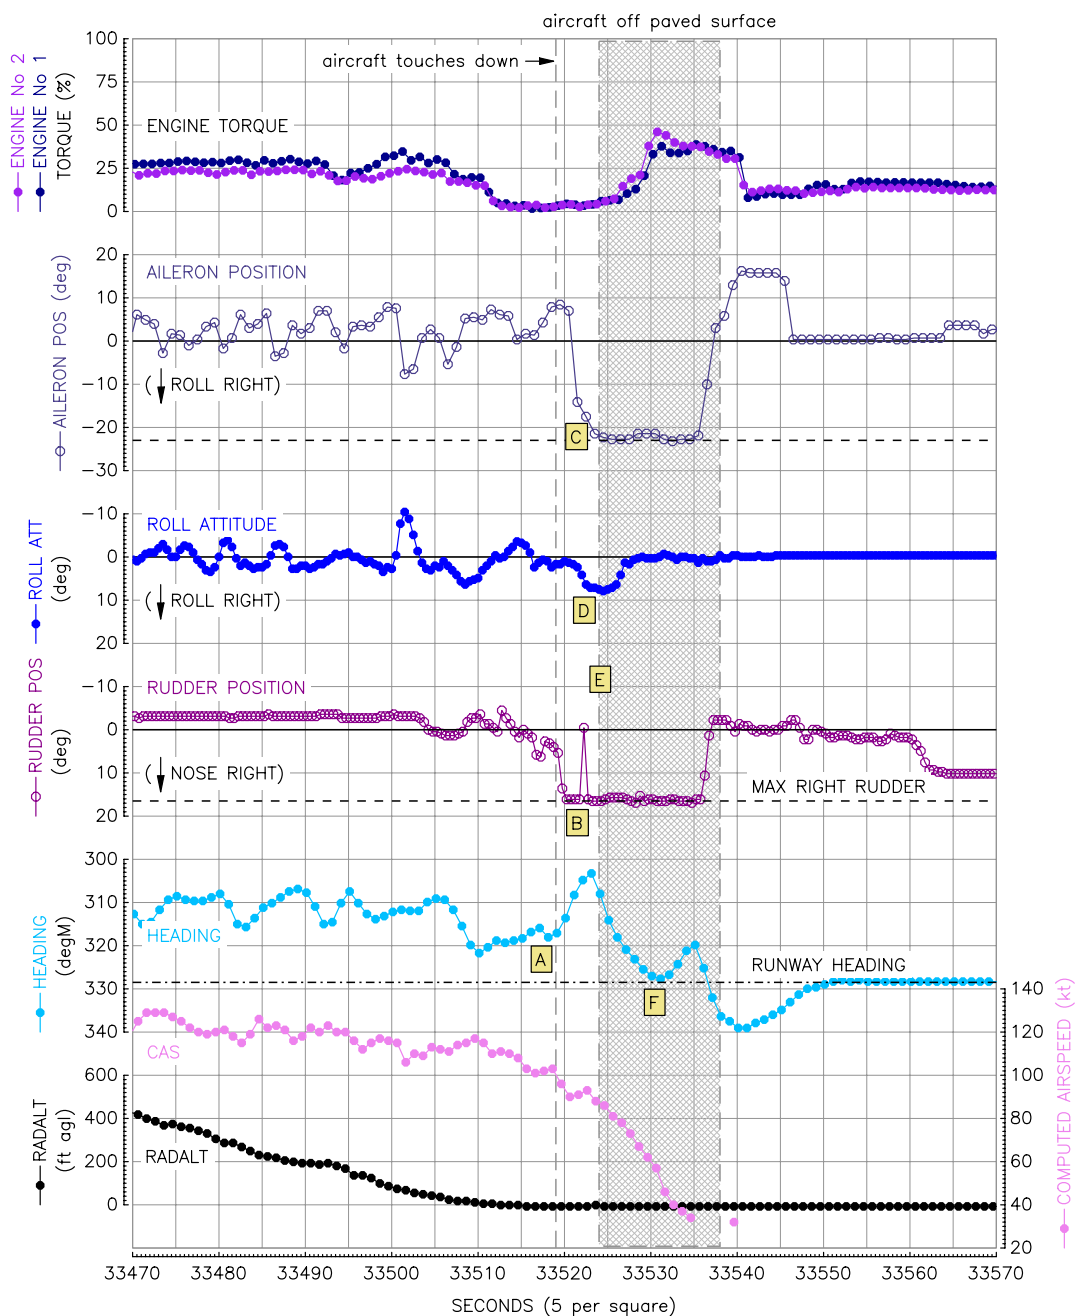
Figure 4
Flight data for the landing

Figure 4 plots the flight data for the landing. It starts with the aircraft on the descent passing through 400 ft agl, crabbed to the left by about 20° to the runway heading. A small amount of left rudder was used throughout the approach, with similar roll control to that of the first approach. During the last 15 seconds of the approach, the rudder became more active and moved to the right, reducing the crab angle to about 10° left of the runway heading. Key points from the data for the landing are labelled [A] through [F] and detailed as follows:

1. At touchdown, the aircraft heading was about 10° left of, and veering away from, the runway heading [A] (and Figure 5).
2. Full right rudder was immediately applied [B] and slowed the veering to the left, which peaked at 24° nose left.

3. Full right aileron was applied [C] causing the aircraft to bank 8° left wing up [D] and lift the left main gear off the runway (Figure 6).
4. About five seconds after touching down, the aircraft left the paved surface to the left [E] (and Figure 7) but in a right turn on the nose and right main gear.
5. Seven seconds after leaving the paved surface, the aircraft turned onto the runway heading [F], but on a parallel track to the left of the runway, before veering a little to the left again then back right, re-joining the runway another seven seconds later (Figure 8).

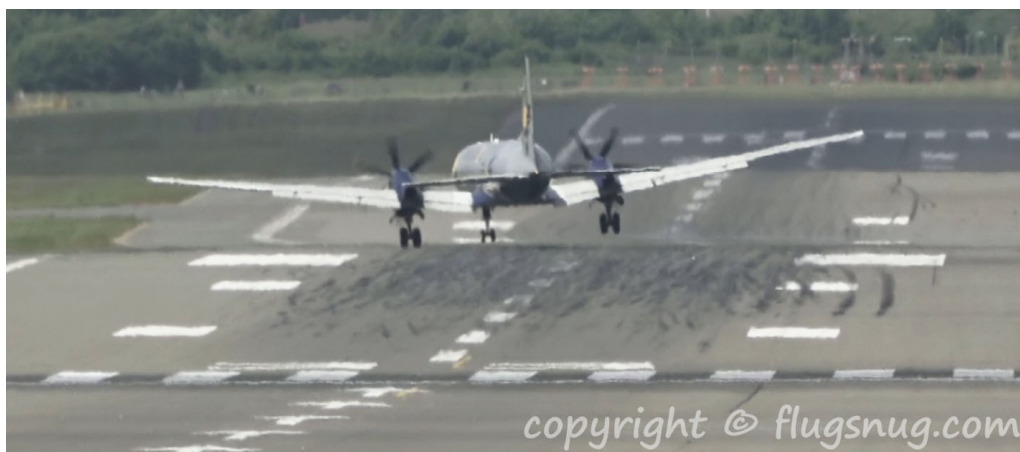
Figure 5

Image showing Point A from Figure 2 – touchdown on Runway 33

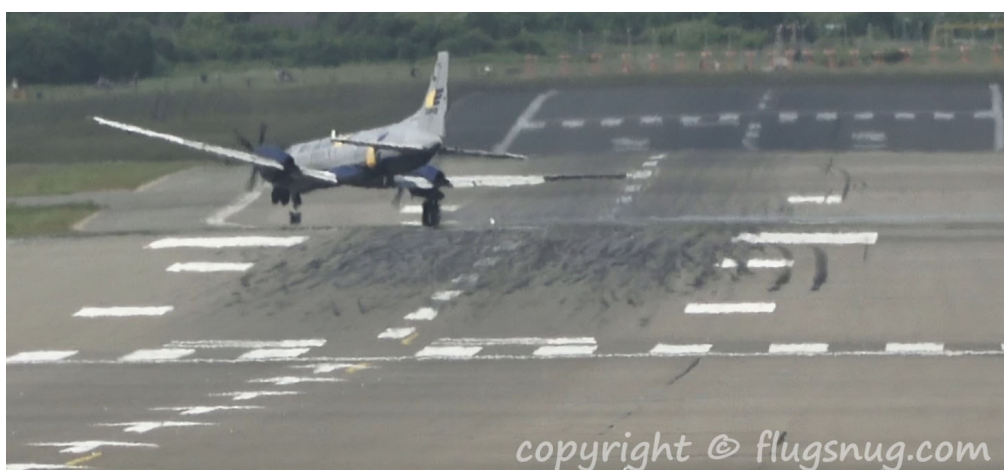
Figure 6

Image showing Point C from Figure 4 – full right aileron applied

The application of full right aileron was almost certainly the result of an inappropriate automatic process (motor programme). Moving the steering wheel right when wanting to steer a car right and moving the control wheel to place the right aileron to full deflection are the same movements. It is likely therefore that as the commander reached his maximum ability to consciously process the inputs coming in from his senses, he subconsciously reverted to a more familiar automatic process and attempted to 'steer the car'.

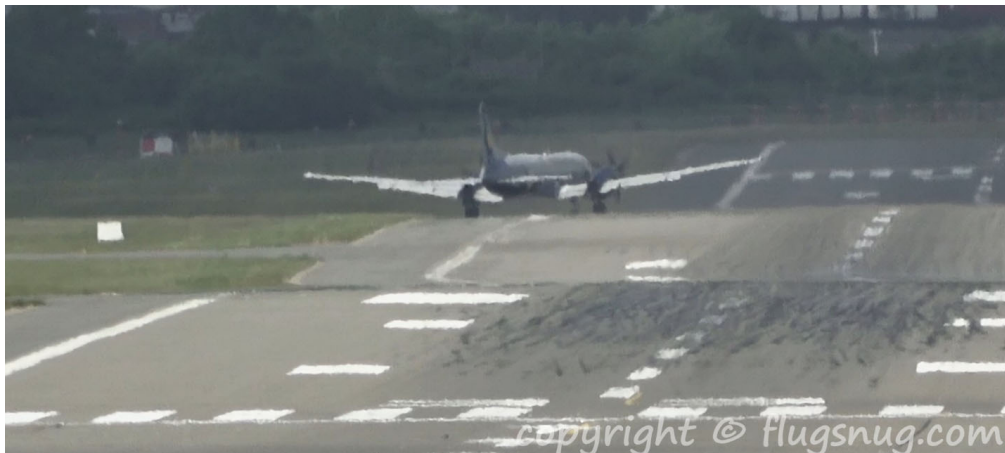
Figure 8

Image showing Point F from Figure 4 – SE-MAO returns to the paved surface

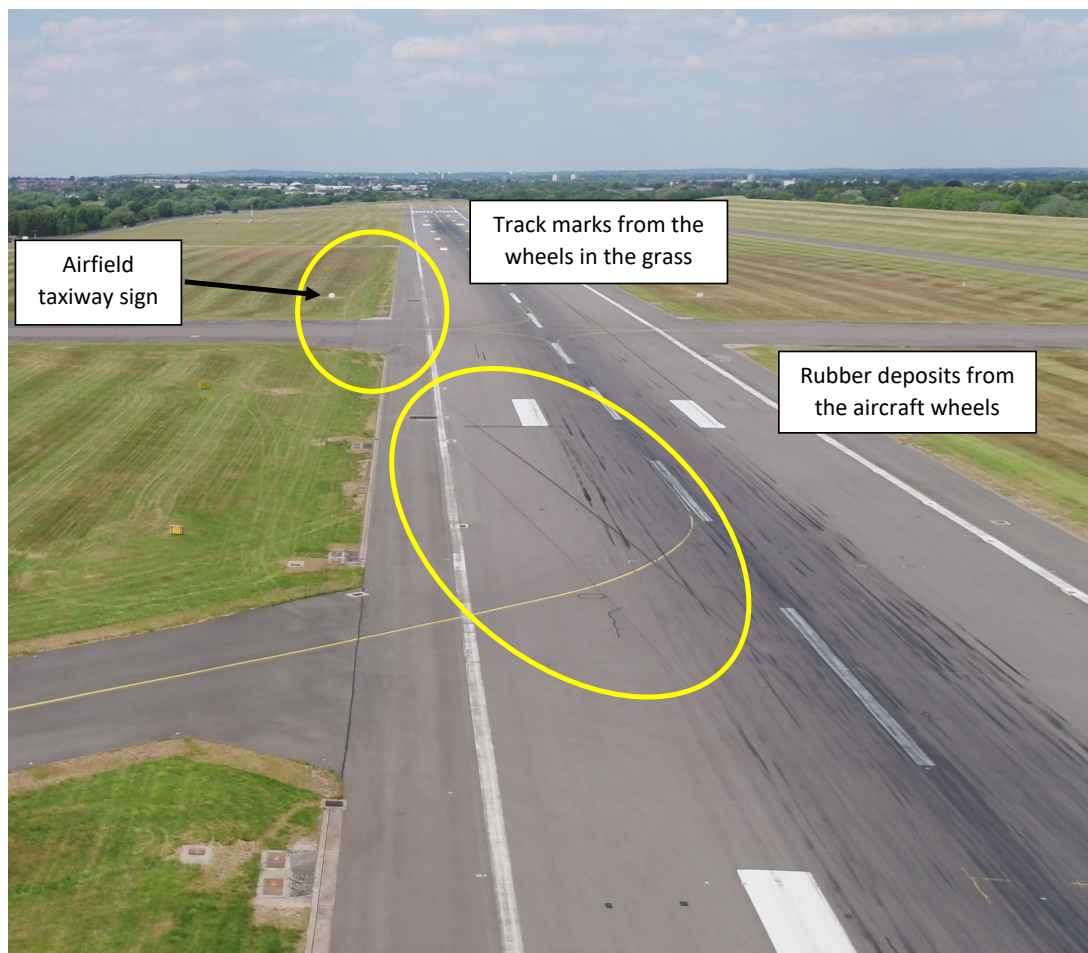
A team was deployed to survey the incident site. The nature of the terrain over which the aircraft travelled during the runway excursion was even and firm. The aircraft tyre marks on the airfield and the tracks in the grass were very clear and allowed accurate measurement. To determine the path of the excursion from the runway, GPS markers were sited at key points on the aircraft tyre tracks and an unmanned air system (UAS) used to compile an aerial survey of the section of airfield.

Using the images taken by the UAS it was possible to measure the distance from when the aircraft first left the paved runway surface until when the last wheel returned to the runway. The total distance was 450 m. Figure 11 shows the extent of the excursion, with the wheel tracks clearly visible in the grass.

UAS image of the runway and grass markings

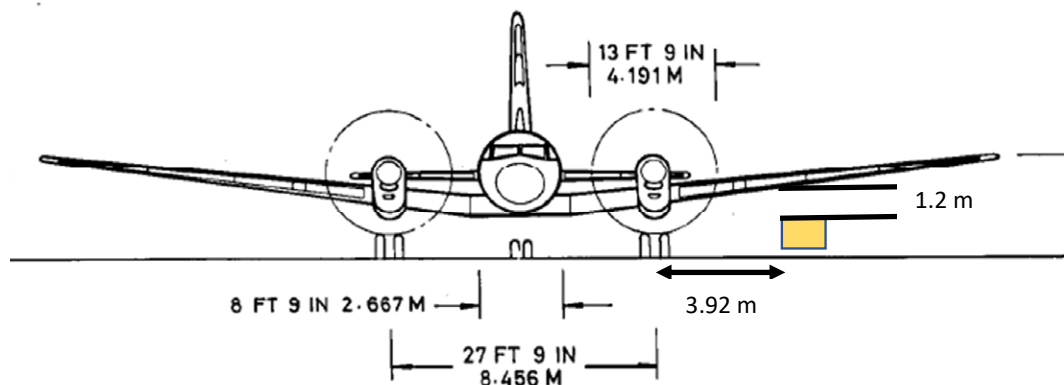
The airfield taxiway sign that passed under the left wing during the excursion was calculated to be just over 1 m below the lower surface of the wing. The sign was outside the diameter of the propeller, but it was above the lowest point of the rotational arc. Figure 12 shows the aircraft wing passing over the sign and Figure 13 shows an image of how close the sign was

to the wing. Whilst all signs on the airport are designed to be frangible, it is likely that had the propeller hit the sign some damage would have occurred to the aircraft.

Distance of SE-MAO from taxiway sign represented by the yellow box
