ACCIDENT

Aircraft Type and Registration:	Rans S6-116 Coyote II, G-BUWK	
No & Type of Engines:	1 Rotax 912-UL Piston engine	
Year of Manufacture:	1993 (Serial no: PFA 204A-12448)	
Date & Time (UTC):	4 August 2020 at 1000 hrs	
Location:	Bradley's Lawn airstrip, Cross in Hand, Heathfield, East Sussex	
Type of Flight:	Private	
Persons on Board:	Crew - 1	Passengers - None
Injuries:	Crew - 1 (Fatal)	Passengers - N/A
Nature of Damage:	Destroyed	
Commander's Licence:	Private Pilot's Licence	
Commander's Age:	65 years	
Commander's Flying Experience:	6,070 hours (of which 5,800 were on type) Last 90 days - 79 hours Last 28 days - 37 hours	
Information Source:	AAIB Field Investigation

Synopsis

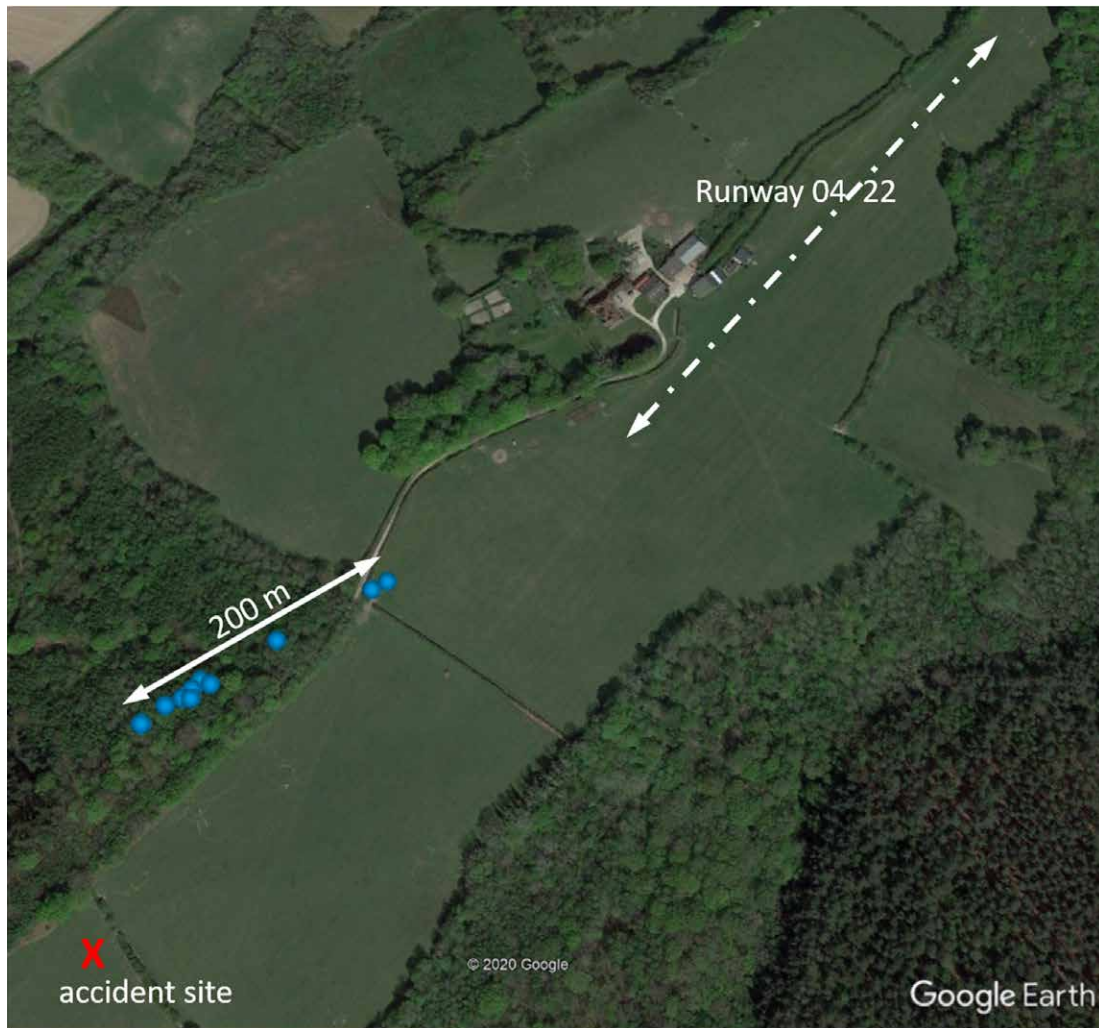
Figure 1
Partial ground track derived from ADS-B data

The accident site was in a grass field approximately 480 m south-west of the airstrip's Runway 22 threshold (Figure 1), and approximately in line with the extended runway centreline.

The aircraft was fitted with a Mode S and ADS-B³ Out transponder but was flying too low to be detected by radar. Some of the ADS-B Out broadcasts were nevertheless detected and recorded by ground stations of the Flightradar24⁴ network that were in line of sight of the aircraft. The recordings covered a period of 17 seconds starting shortly after takeoff as the aircraft flew toward the south-west corner of the airstrip and ending about 200 m further on, 130 m north of the accident site. The last 12 seconds of recorded ADS-B Out broadcasts contained the aircraft's latitude and longitude, as shown in Figure 1.

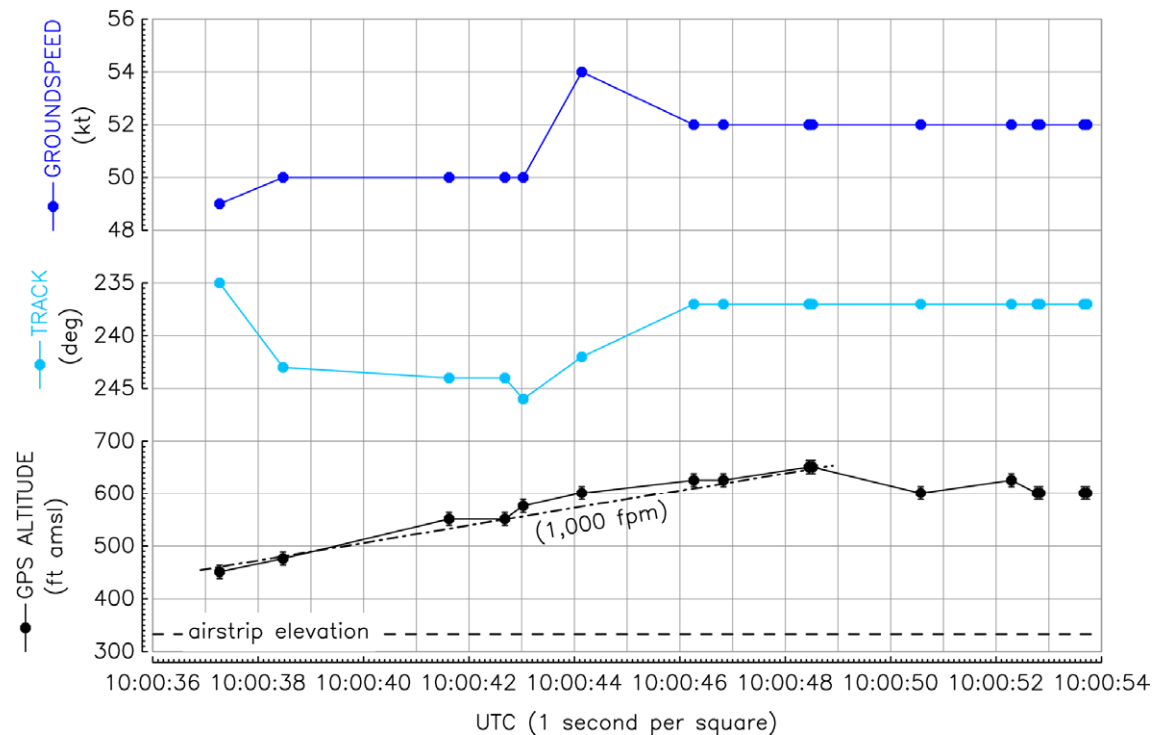
Figure 2
ADS-B Out flight data

Figure 2 plots the aircraft's GPS altitude (25-ft resolution), track and groundspeed from the ADS-B Out broadcasts. It shows that, shortly after takeoff, the aircraft turned right through about 25°, before turning left 9° on to a track of 237°, which was maintained at a groundspeed of 52 kt for the last seven seconds of recordings.

As the aircraft passed over the south-west corner of the airstrip it was about 220 ft above the airstrip elevation and climbed a further 100 ft over the next six seconds. The climb rate of the aircraft was, on average, approximately 1,000 ft/min (consistent with normal climb performance information provided by the manufacturer for this aircraft type at a mass of 544 kg). It then descended at about 1,000 ft/min to 270 ft above the airstrip elevation before the recordings stopped. The last recorded point positioned the aircraft about 200 ft above and 130 m north of the accident site.

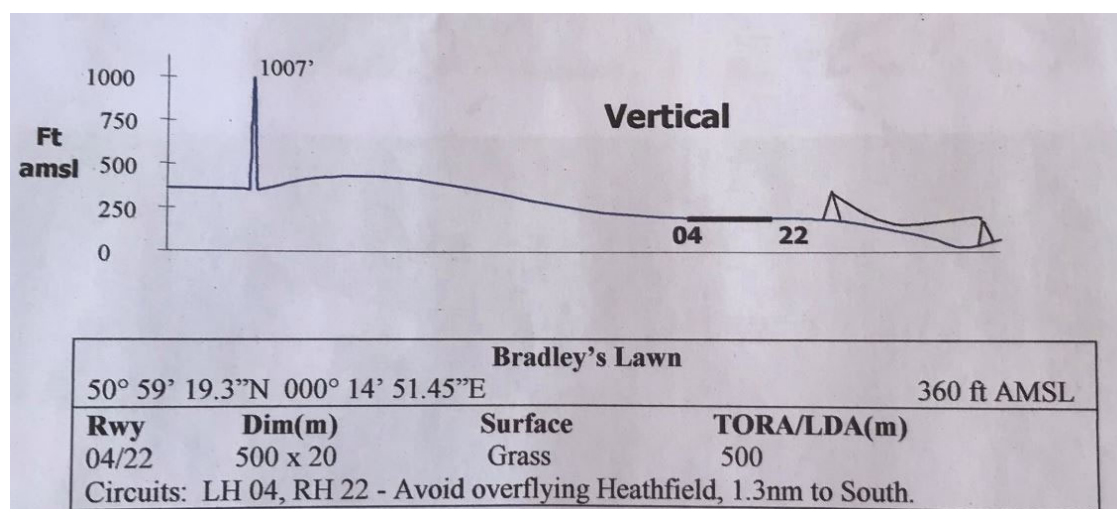
Figure 3
Bradley's Lawn airstrip

Bradley's Lawn is a grass airstrip situated on fields surrounded by high trees (Figure 3). Its runway is aligned north-east / south-west; the flight path on departure from Runway 22 is over fields with gently rising ground. A TV aerial 489 ft in height (1,007 ft amsl) is situated just under 1 nm to the southwest from the airstrip.
