Report on the investigation of
the engine failure and fire on board
the ro-ro cargo vessel

Finlandia Seaways

11 miles east of Lowestoft

16 April 2018

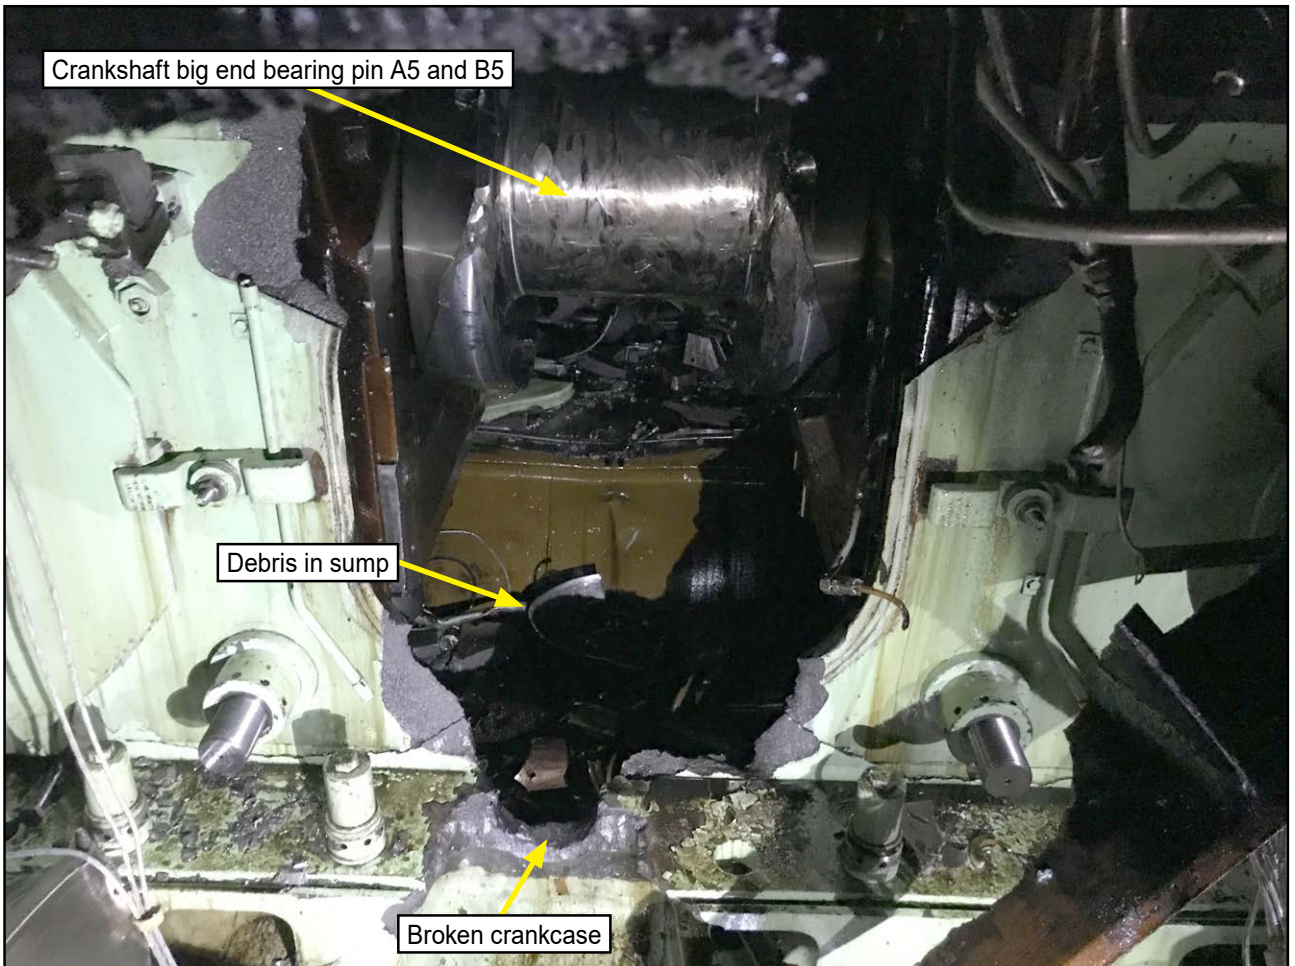
Finlandia Seaways' main engine suffered substantial structural and component damage during its failure. The engine crankcase structure was ruptured on the port and starboard sides of units five and six, with crankcase explosion relief valve doors and large sections of the crankcase casting being propelled several metres across the floorplates (**Figures 17 and 18**).

Figure 18: Starboard crankcase damage at B5

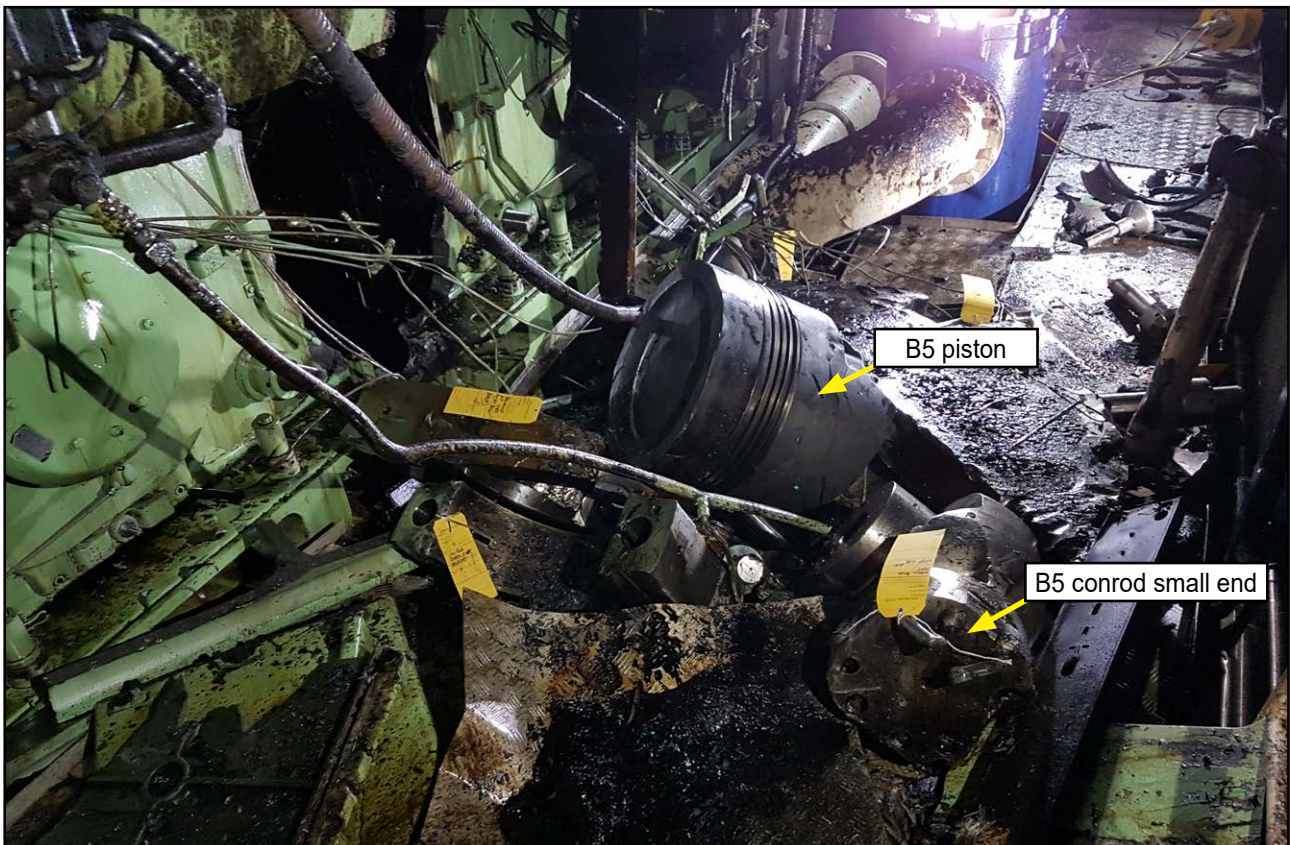
Figure 20: B5 components on starboard side deck plates

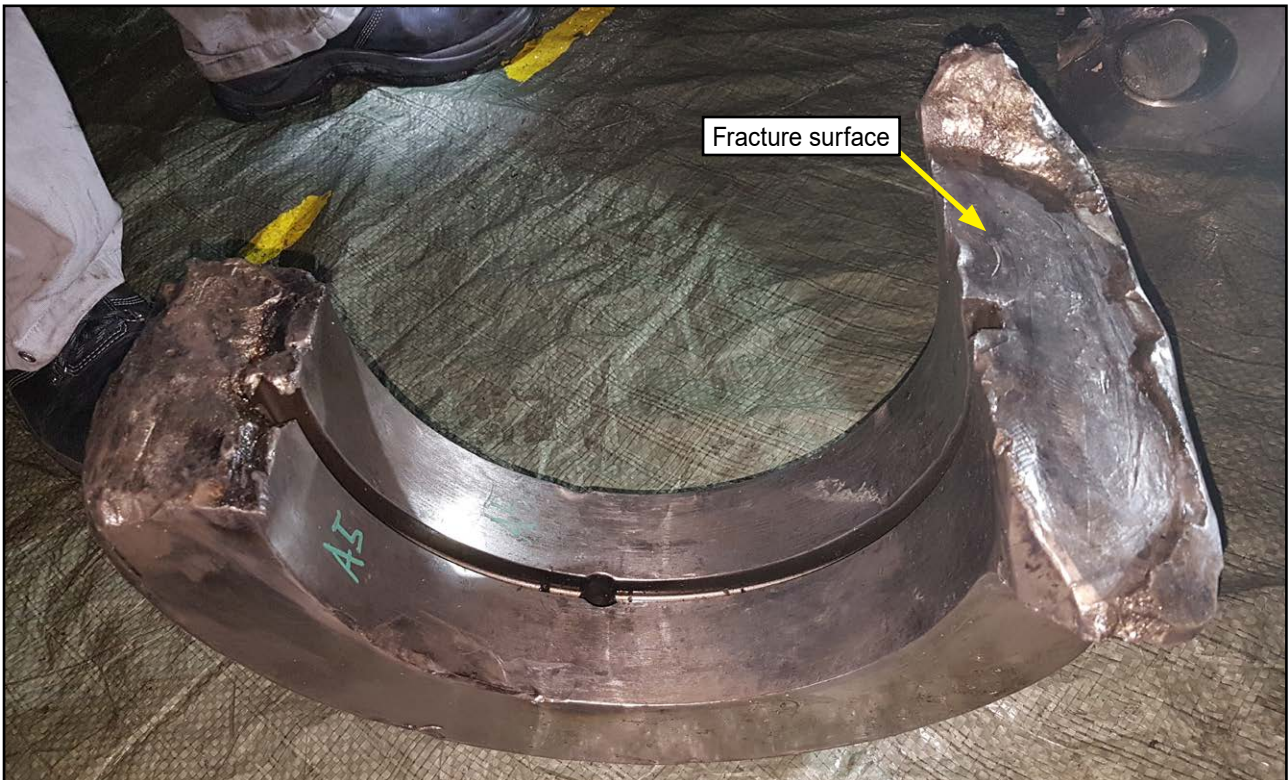
Figure 25a: A5 small end upper half

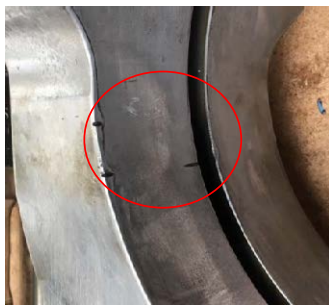
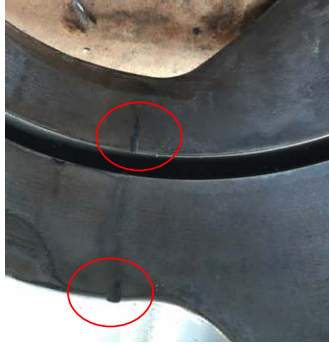
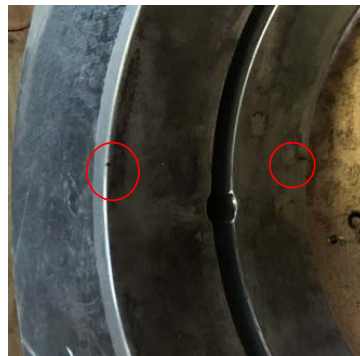
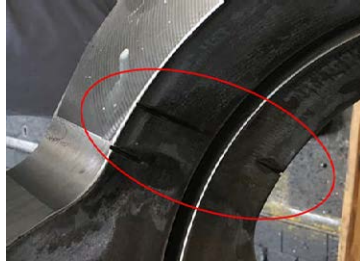
✓ **7 of 11 investigated small ends show notches!**

- ✓ Non of the small ends shows hints of fretting in the surface.
- ✓ Non of the small ends shows hints of cracks in the surface (MPI)
- Ultra sonic investigation underneath notch is in process (finalisation until 27.07.2018)
- Measurement of the bearing bore is in process (finalisation until 27.07.2018)
