Rail Accident Investigation Branch

Rail Accident Report

Freight train derailment at Eastleigh, Hampshire 28 January 2020

Report 02/2021
March 2021

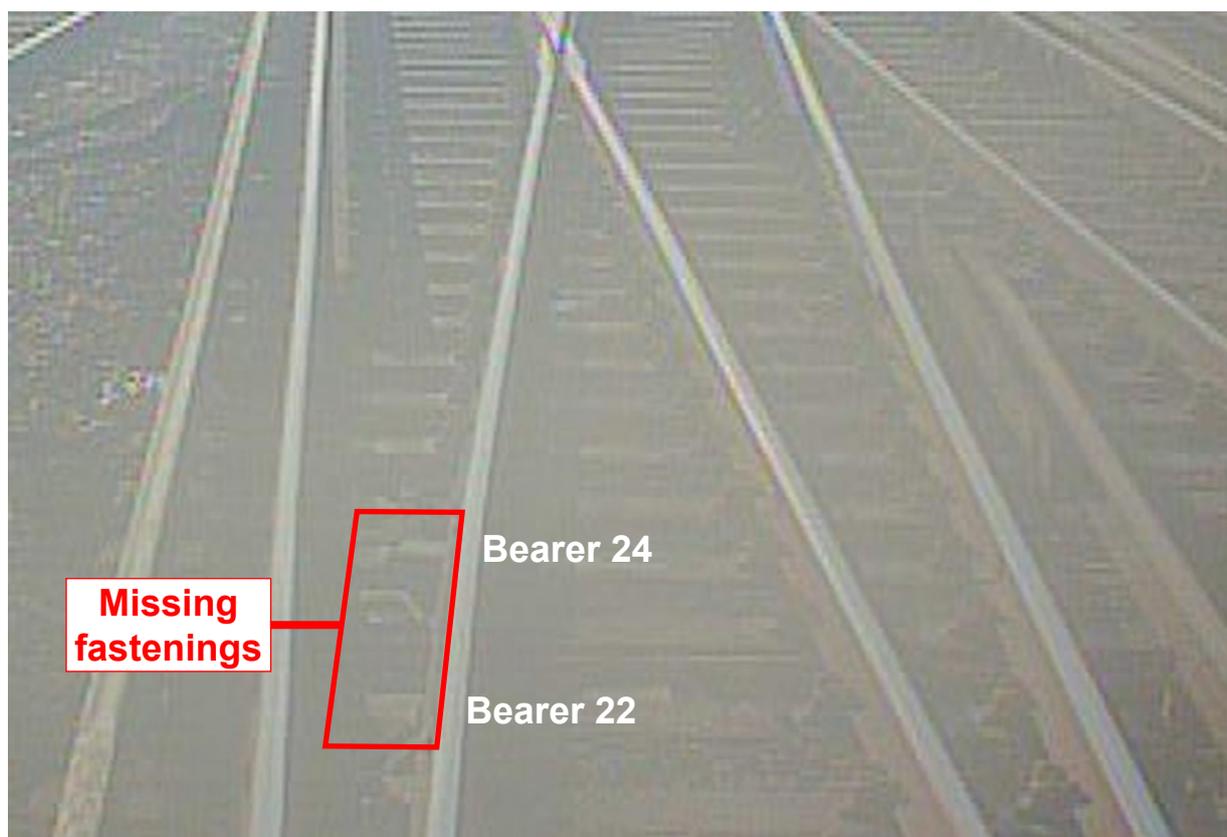
Figure 4: Forward facing CCTV from 2S27 showing three missing fastenings on bearers 22, 23 and 24 (image courtesy of South Western Railway)

- 42 Forward facing CCTV from train 2S27 confirmed that three of the nine fastenings found to have failed after the accident were missing prior to the passage of train 4O05 (paragraph 23). These were the fastenings to the left-hand side of the closure rail at bearers 22, 23 and 24 (figure 9).

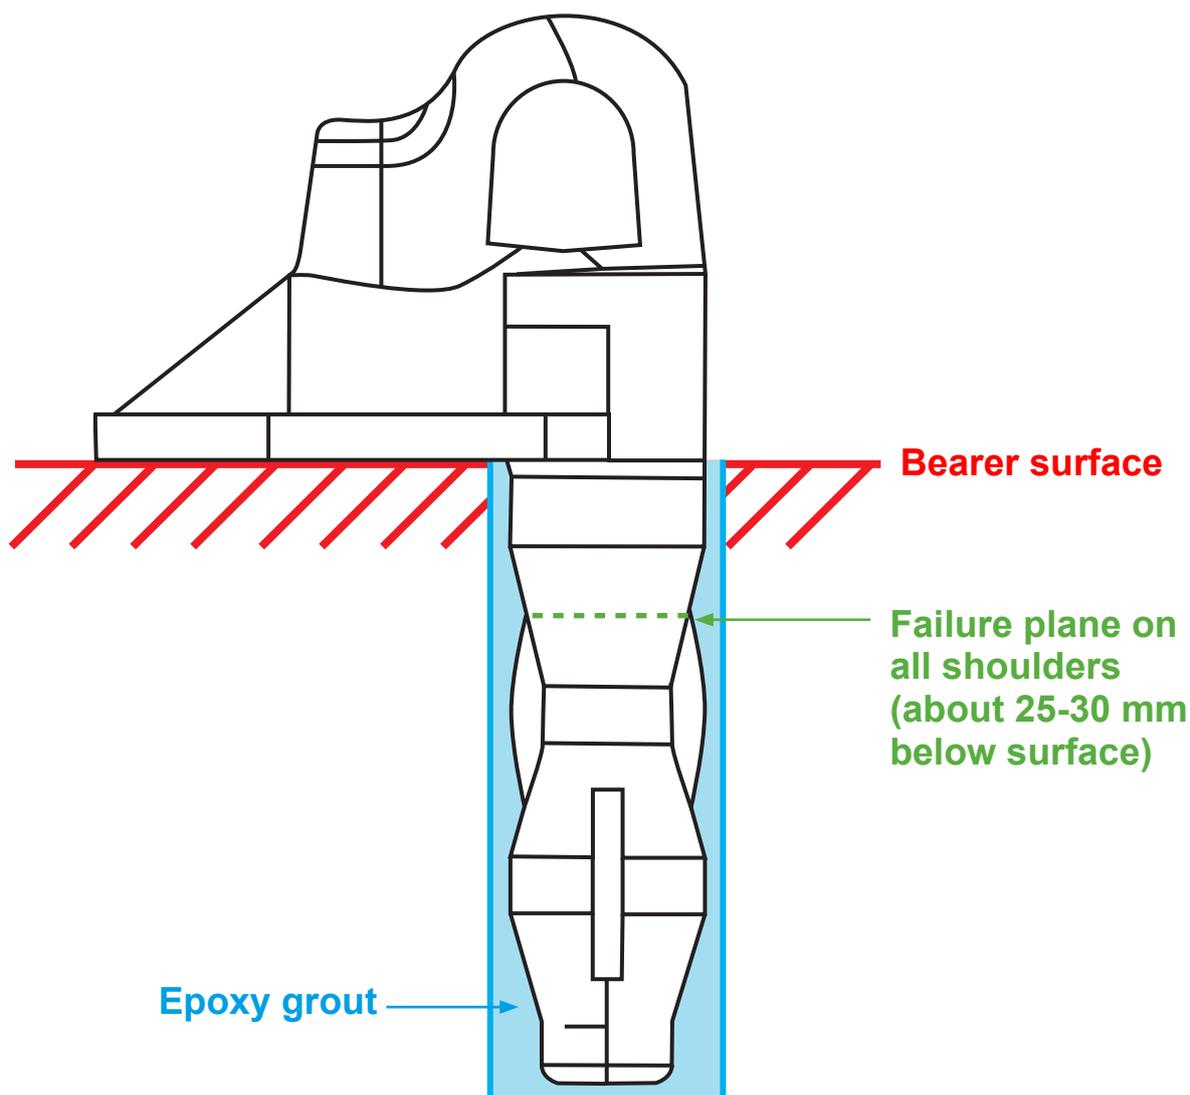
- 40 A site survey undertaken by RAIB and Network Rail following the derailment found that the left-hand closure rail of 450A points had moved laterally, widening the track gauge enough so that the locomotive's wheels were able to drop into the space between the rails and derail (paragraph 25). This survey found that a total of nine consecutive fastenings had failed along the left-hand closure rail. For comparison, module 3 of NR/L2/TRK/001 states that maintenance action must be taken where three or more consecutive fastenings are missing or ineffective.
- 41 An examination of the fastenings which failed showed that they had all done so via a fracture through the stem of their cast iron shoulders, at a point approximately 30 mm below the surface of the bearer (figures 7 and 8). This is one of the narrowest parts of the stem in the direction of the failure.

Figure 7: Profile view of a cast iron shoulder indicating the typical plane of failure in green.

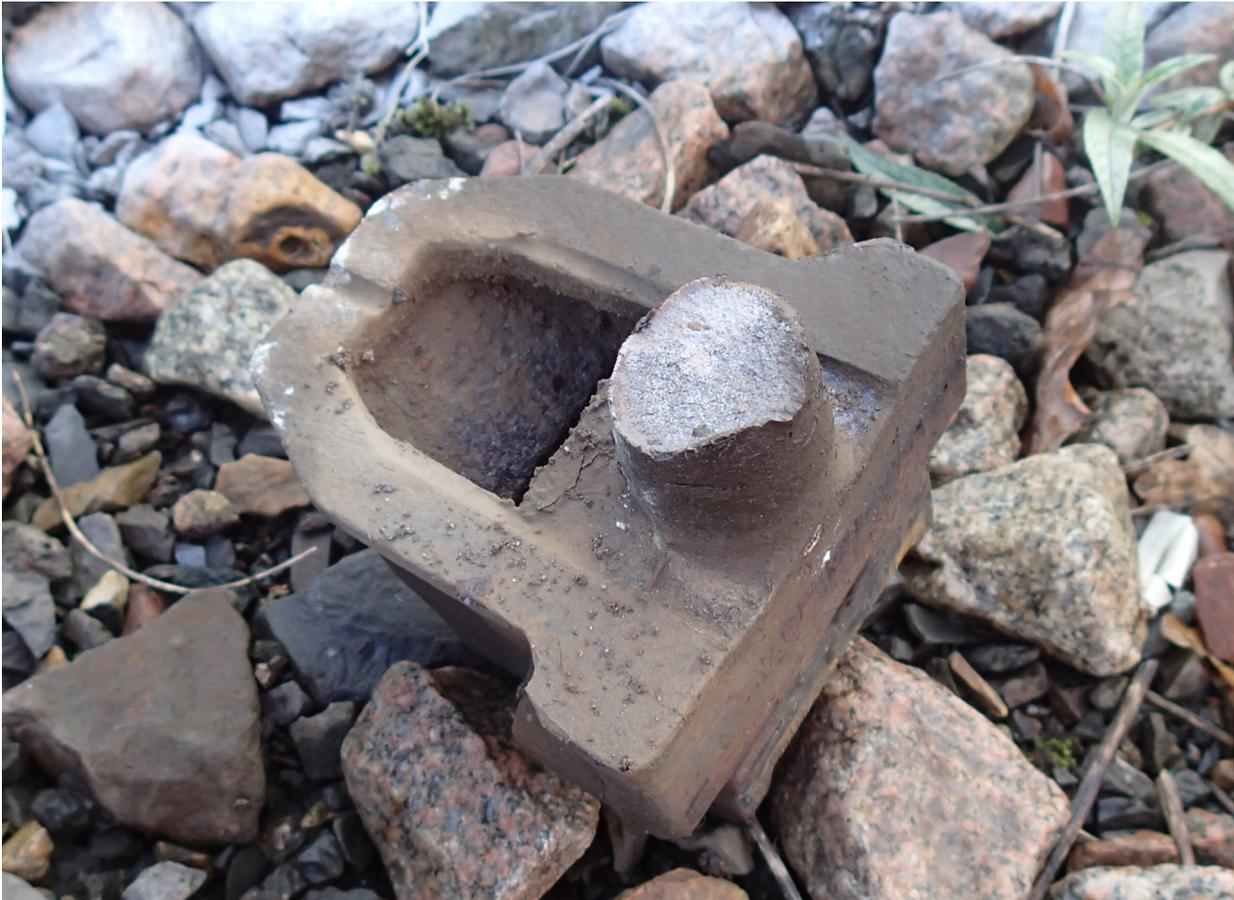
Figure 8: Photograph of one of the failed cast iron shoulders

- 44 An independent metallurgical inspection was commissioned by Network Rail on a sample of four of the fractured shoulders from 450A points, and the four found on the ground nearby. This inspection, combined with other analysis commissioned by Network Rail, showed that three of the shoulders from 450A points had failed in a fast-brittle manner (see paragraph 81), whereas the others had been subject to a fatigue failure (see paragraph 47). It is probable, given the failure mode of the surrounding shoulders, that the missing shoulder from bearer 22 was also subject to a fatigue failure (figure 9). This meant that six consecutive shoulders, from bearers 20 to 25 inclusive, were probably fractured along the left-hand closure rail prior to the derailment.
