Subject: Cracking of Goodyear G90 tyres manufactured in South Africa.

Equipment: All Wolf Land rovers.

Subject: Safety Issue on Wolf Land Rovers

Equipment Affected: All Wolf Land Rovers, TUL (HS), TUM (HS) and BFA.

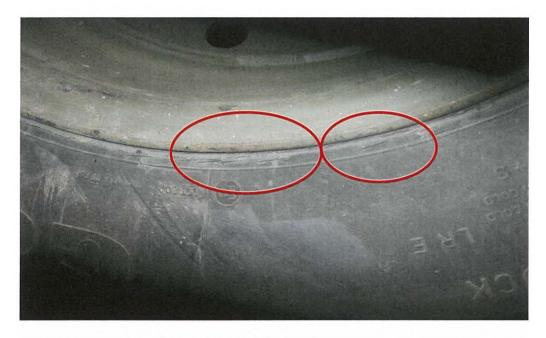
Issue: Here at land Training Fleet we hold 86 Land rovers of various types. So far since the second safety notice we have changed about 210 tyres. Now although we have been examining our tyres, as per AESP 2610-A-409-531, we have noticed that the South African tyres Goodyear G90 can have small radial cracks, As shown in the picture below

These cracks can grown over a period of time, in some cases a matter of weeks.

Of all the Michelins inspected no tyres were found to have this fault. So as you might expect good engineering practice suggest that we change the tyre.

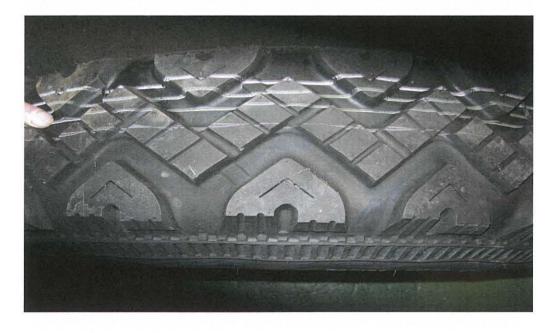
The two pictures above are to indicate that this is a brand new tyre and was fitted as a spare so nil road use. These cracks vary in width and length.
