**ACCIDENT**

| <b>Aircraft Type and Registration:</b> | Europa, G-BXTD | |
| <b>Date &amp; Time (UTC):</b> | 28 July 2020 at 1226 hrs | |
| <b>Location:</b> | Enstone Airfield, Oxfordshire | |

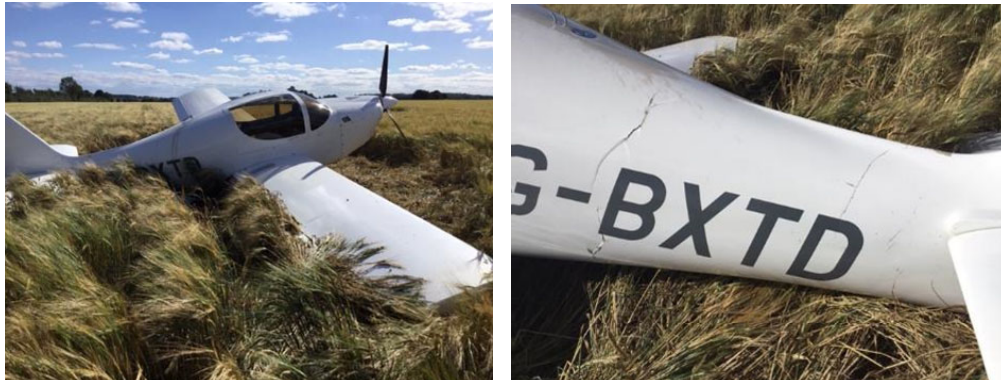
**Figure 1**

Measuring the length of the path through the crops revealed that the aircraft had travelled approximately 50 metres along the ground before stopping. The landing and subsequent turn damaged the aircraft's right undercarriage outrigger, wing, flap and aileron. Cracks were evident in the rear fuselage between the cockpit and tail (Figure 1) and the tail section below the left elevator was also cracked and the skin distorted. There was no damage to the cockpit area.

Aircraft final resting position and cracks evident in the rear fuselage section

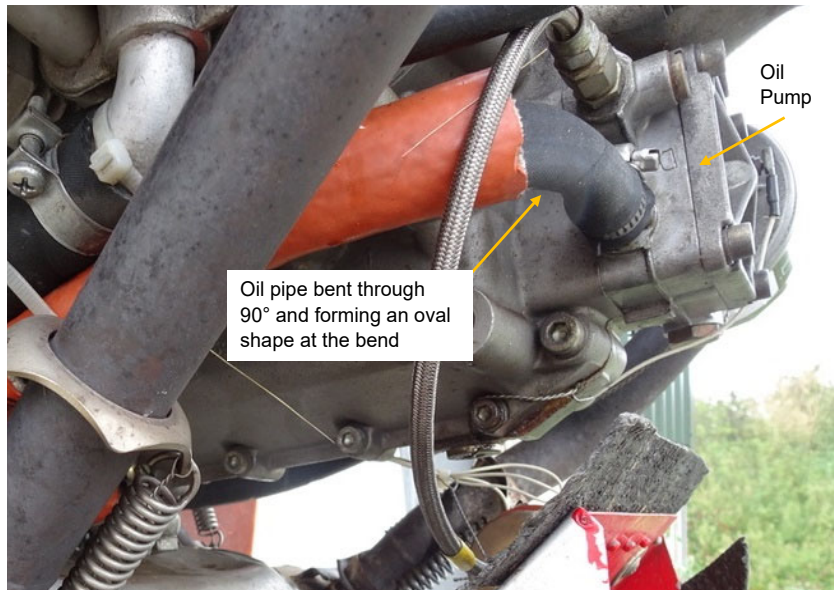
**Figure 2**

Before removing the engine, the owner noticed the cross-sectional shape of the pipe from the oil cooler had narrowed where it had been bent by 90° in order to connect it to the oil pump (Figure 2). On checking the Europa engine installation manual, the owner realised that an oil pipe with a pre-formed 90° bend was available, to avoid bending the pipe when connecting it to the pump. However, the owner also commented that later testing on a bench showed that this geometry only created an 'oval' cross-section in the pipe and did not 'kink' it. Further, the aircraft had flown with the pipe in this geometry for its Permit test flight and for a further flight as part of the owner's type conversion, with no indication of oil pressure problems at any stage.

Oil pipe showing narrowing at the bend connecting it to the pump

The sharp bend radius and distortion of the oil pipe at the connection to the oil pump would have caused oil flow to be restricted to the engine to some degree. However, the presence of oil in the crankcase, and over the working parts, shows that oil was reaching the working parts and the aircraft had flown a number of times in this condition, without adverse indications.

The cause of the engine stoppage could not be positively determined. It was found that the bend radius of the oil pipe, connected to the oil pump, narrowed its cross section, restricting oil flow into the engine to some extent. However, bench tests of this geometry, and the fact that the aircraft had flown like this a number of times, indicated that it is unlikely to have been the major factor in the engine failure.

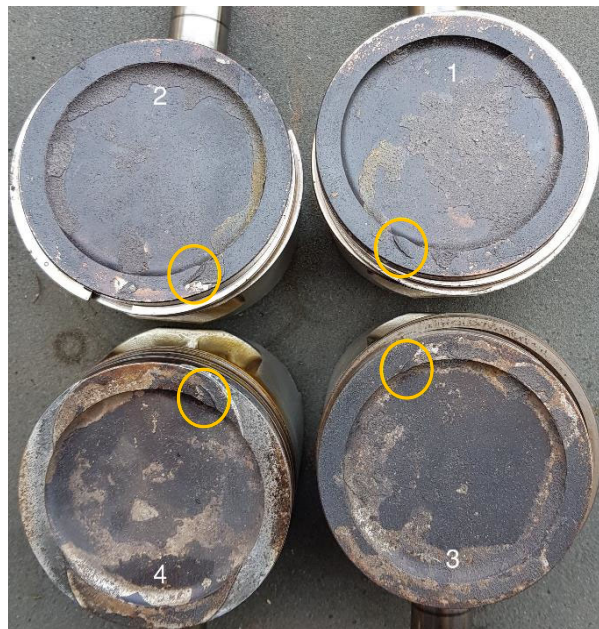
**Figure 3**

After removing the pistons from the engine, dents were found on the top surfaces (crown). The shape of the dents matched the edges of the cylinder inlet valves. None of the inlet valve stems were bent and the edges of the valves showed no signs of impact damage. The dents in the piston crowns were also coated with carbon deposits (Figure 3).

Piston crowns showing dents from impact with inlet valves

The inlet valve impact marks on the piston crowns indicate that an abnormal event, such as an engine overspeed after a propeller strike, had caused the valves and the pistons to collide at some point before the aircraft's purchase in 2019. The presence of carbon deposits in the dents also showed that the damage had occurred prior to the accident flight. Once the valves were removed and inspected, the owner determined that the valve stems were straight and there were no impact witness marks on the edge of the valve heads; the valves may have been replaced during a previous engine repair. The owner commented that he should have given more weight to the propeller strike information when deciding the depth of inspections necessary to restore the aircraft after the purchase in 2019.

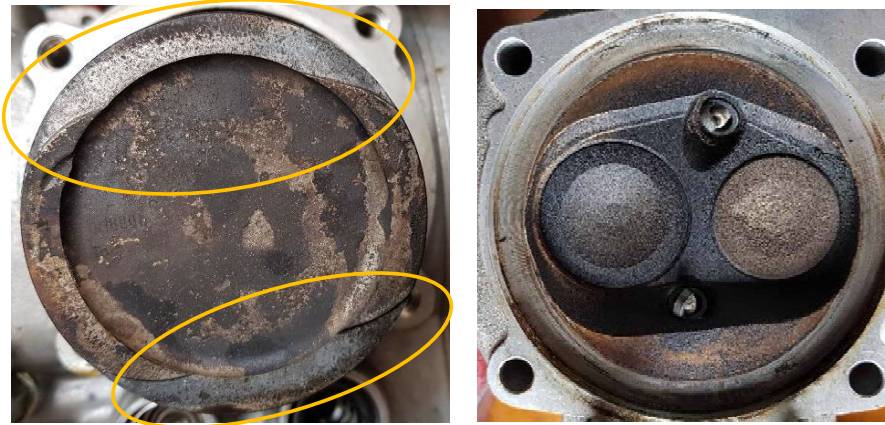
**Figure 4**

The No 4 piston had also been in contact with the cylinder head, creating cylinder head shaped dents in the crown (Figure 4).

Piston crown (left) showing dents made by the cylinder head (right)

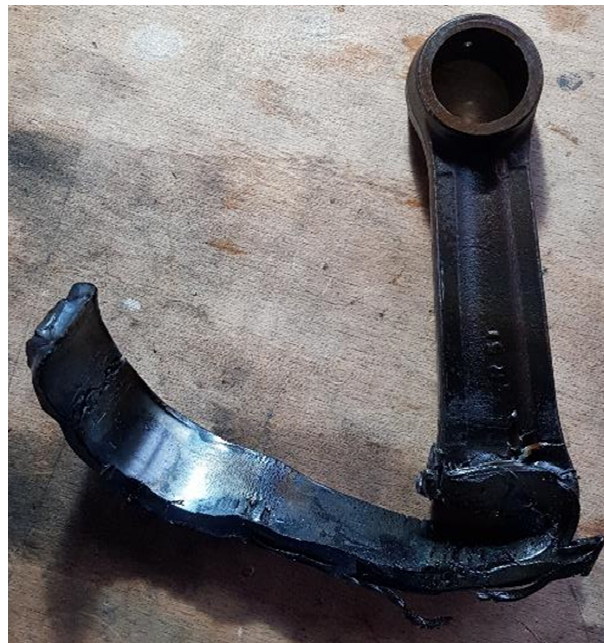
**Figure 5**

When the engine crankcase was opened, it was evident the No 4 piston connecting rod and bearing had failed at the attachment to the crankshaft (Figure 5). There were impact marks along the lower edges of the adjacent No 3 piston and cylinder.

Failed No 4 piston connecting rod

Evidence of surface pitting around the sides of the pistons showed that a corrosive environment had existed within the crankcase and 'regular running' of the engine had probably not been enough to avoid corrosion damage during the extended period in which the aircraft was not flown. Corrosion-initiated fatigue may have weakened the engine's working parts, resulting in failure of the No 4 connecting rod.

There were also indications of corrosion within the engine, probably due to an extended period in which the aircraft was not flown. There was further evidence of mechanical damage within the engine related to a previous incident, probably of a propeller strike and likely engine overspeed. The combination of these factors, the corrosion and mechanical damage, is more likely to have brought about the engine failure, through a fatigue mechanism in the No 4 connecting rod.
