ACCIDENT

Aircraft Type and Registration:	Aviad Zigolo MG12, G-CIUF	
No & Type of Engines:	1 Monster 185 piston engine	
Year of Manufacture:	2015 (Serial no: 4/2015/27)	
Date & Time (UTC):	4 November 2020 at 1140 hrs	
Location:	Near West Heath Common Quarry, West Sussex	
Type of Flight:	Private	
Persons on Board:	Crew - 1	Passengers - None
Injuries:	Crew - None	Passengers - N/A
Nature of Damage:	Damage to right mainwheel strut and fuselage tubes	
Commander's Licence:	Private Pilot's Licence	
Commander's Age:	64 years	
Commander's Flying Experience:	1,376 hours (of which 24 were on type) Last 90 days - 17 hours Last 28 days - 2 hours	
Information Source:	Aircraft Accident Report Form submitted by the pilot

Synopsis

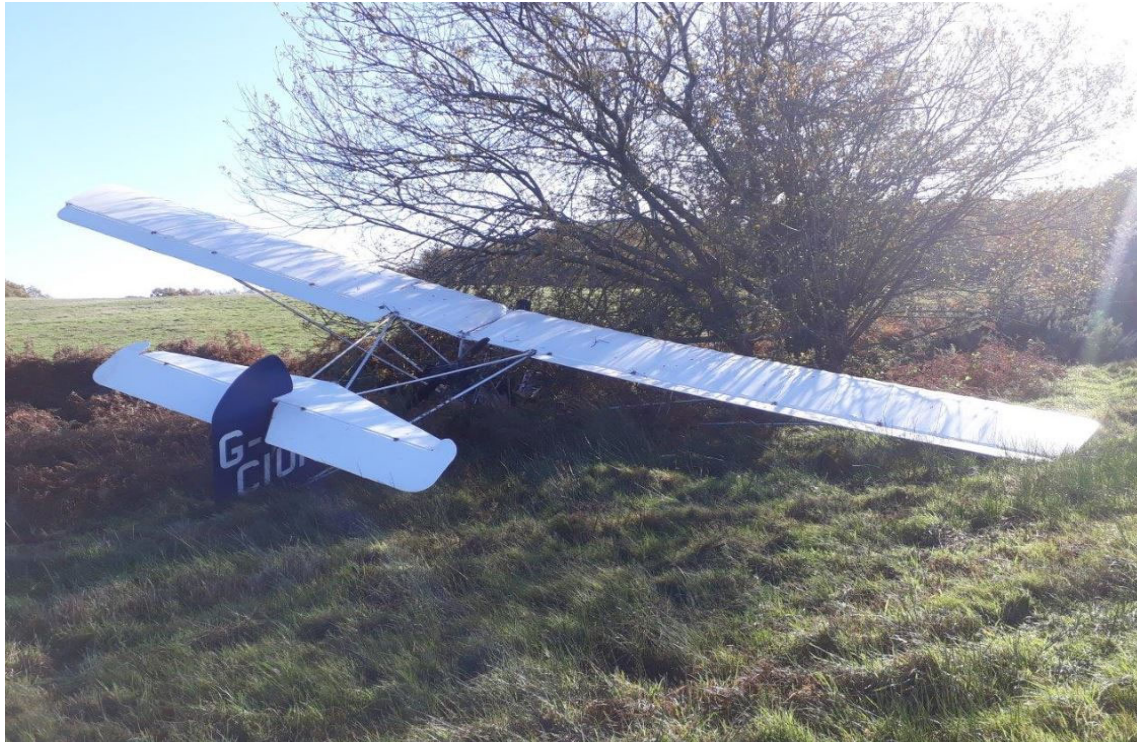
Figure 1

The pilot set up an approach to a grass field but as he descended the glide deteriorated and the aircraft undershot into a very narrow field, coming to rest against a willow bush (Figure 1). The willow bush absorbed some of the impact energy and the pilot, who was uninjured, was able to vacate the aircraft without assistance. The aircraft's right mainwheel strut and some of the fuselage tubes were damaged in the impact.

G-CIUF following the forced landing

An inspection of the aircraft by the pilot after the accident found that the engine had seized, which he considered to have been caused by the engine over-speeding after the propeller drive belt had failed. The engine-driven belt pulley showed signs of overheating, due to the belt slipping.

The forced landing occurred due to the failure of the propeller drive belt. The drive belt had not exceeded its suggested service life, but new drive belts of improved quality are now available from the aircraft kit distributor.

The Aviad Zigolo MG12 is classified by the CAA as a single seat deregulated (SSDR) type, and is therefore unregulated with respect to its airworthiness. The aircraft maintenance manual requires that the drive belt is changed at 100 hour intervals. The failed belt had accumulated 44 hours in service since installation. The pilot stated that drive belts of improved quality were now available from the aircraft kit importer.
