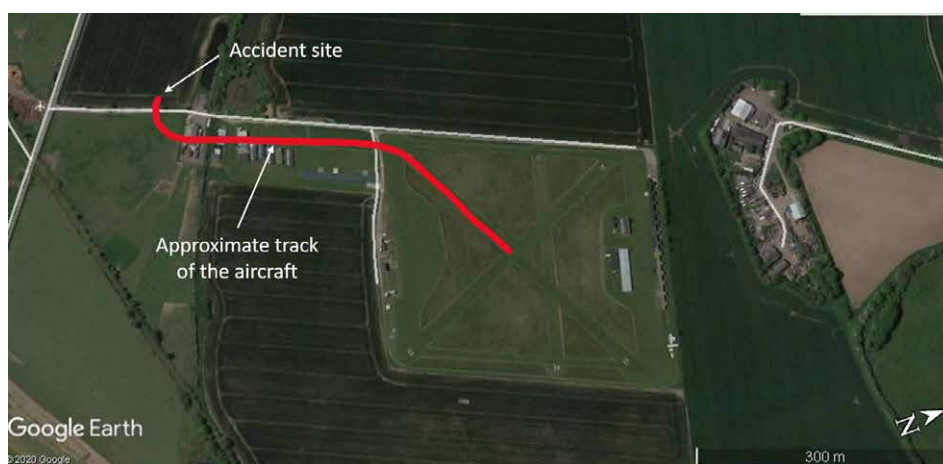
Figure 1

Approximate flight path of aircraft.

As the aircraft turned right, the intended approach path crossed a line of trees. The instructor stated: “I commenced a turn between two trees with the intention of landing between them, but the skidding of the aircraft was drawing us nearer to the tree to port. I had to increase the rate of turn to avoid the tree and we lost height rapidly.” In doing so, he applied an angle of bank (AOB) of between 45° and 60°, with a consequent significant increase in the rate of descent.

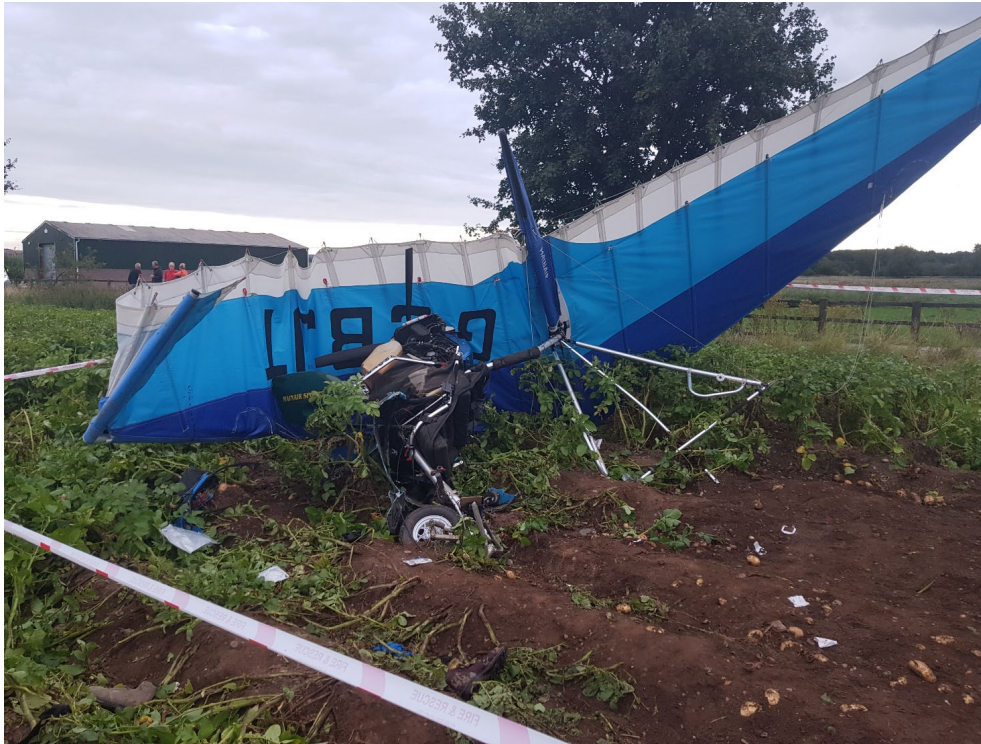
Figure 2

The aircraft came to rest pointing back towards the airfield, and the forward fuselage was badly damaged (Figure 2). The student suffered serious injuries, but the instructor suffered minor injuries and was able to extract himself from the aircraft. He asked some passers-by to call an ambulance and he remained with the student until the emergency services arrived to effect a rescue.

Aircraft after the forced landing

As a result of the increased rate of descent, the aircraft could not reach the intended touchdown point and was extensively damaged during the impact sequence. As a result of the fuselage disruption, the student suffered serious injuries and had to be rescued by the emergency services.
