ACCIDENT

Aircraft Type and Registration:	X'Air Falcon 582(2), G-CGOV	
No & Type of Engines:	1 Rotax 582/48-2V piston engine	
Year of Manufacture:	2010 (Serial no: BMAA/HB/599)	
Date & Time (UTC):	13 September 2020 at 1730 hrs	
Location:	Old Park Farm Airfield, Port Talbot	
Type of Flight:	Private	
Persons on Board:	Crew - 2	Passengers - None
Injuries:	Crew - None	Passengers - N/A
Nature of Damage:	Damage to landing gear	
Commander's Licence:	Private Pilot's Licence	
Commander's Age:	41 years	
Commander's Flying Experience:	361 hours (of which 146 were on type) Last 90 days - 1 hour 30 minutes Last 28 days - 1 hour 30 minutes	
Information Source:	Aircraft Accident Report Form submitted by the pilot

Synopsis

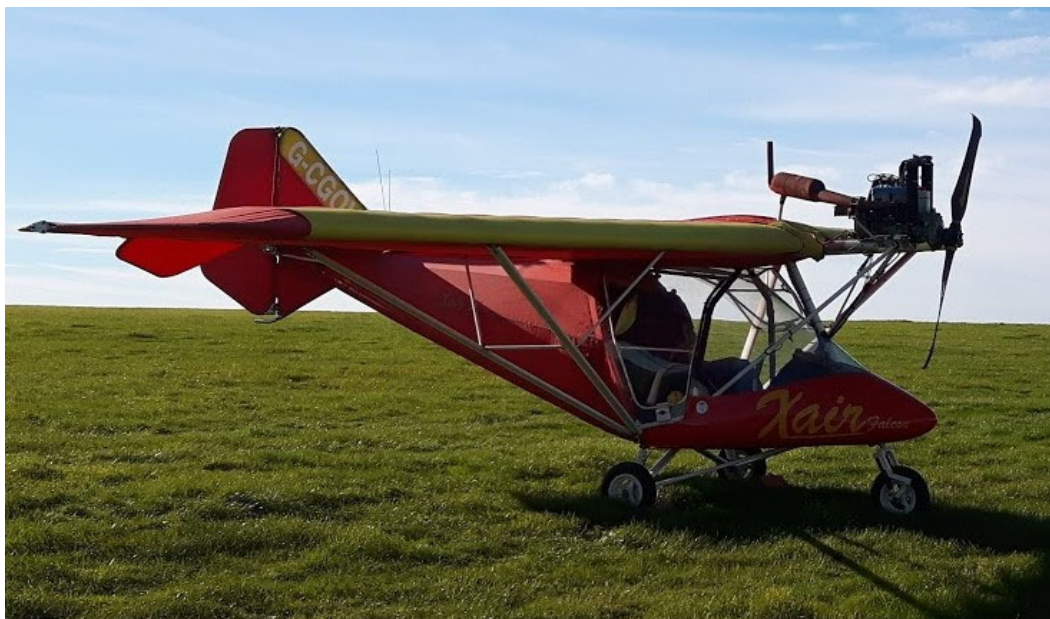
Figure 1

G-CGOV, X'Air Falcon (with permission of the owner)
