**ACCIDENT**

<b>Aircraft Type and Registration:</b>	Scheibe Super Falke SF25E, G-KDEY	
<b>No &amp; Type of Engines:</b>	1 Limbach SL 1700-EA1 piston engine	
<b>Year of Manufacture:</b>	1976 (Serial no: 4325)	
<b>Date &amp; Time (UTC):</b>	23 March 2020 at 1651 hrs	
<b>Location:</b>	Aston Down Airfield, Gloucestershire	
<b>Type of Flight:</b>	Private	
<b>Persons on Board:</b>	Crew - 1	Passengers - None
<b>Injuries:</b>	Crew - 1 (Serious)	Passengers - N/A
<b>Nature of Damage:</b>	Destroyed	
<b>Commander's Licence:</b>	Private Pilot's Licence	
<b>Commander's Age:</b>	72 years	
<b>Commander's Flying Experience:</b>	3,446 hours (of which 344 were on type) Last 90 days - 1 hour Last 28 days - 1 hour	
<b>Information Source:</b>	AAIB Field Investigation

**Synopsis**

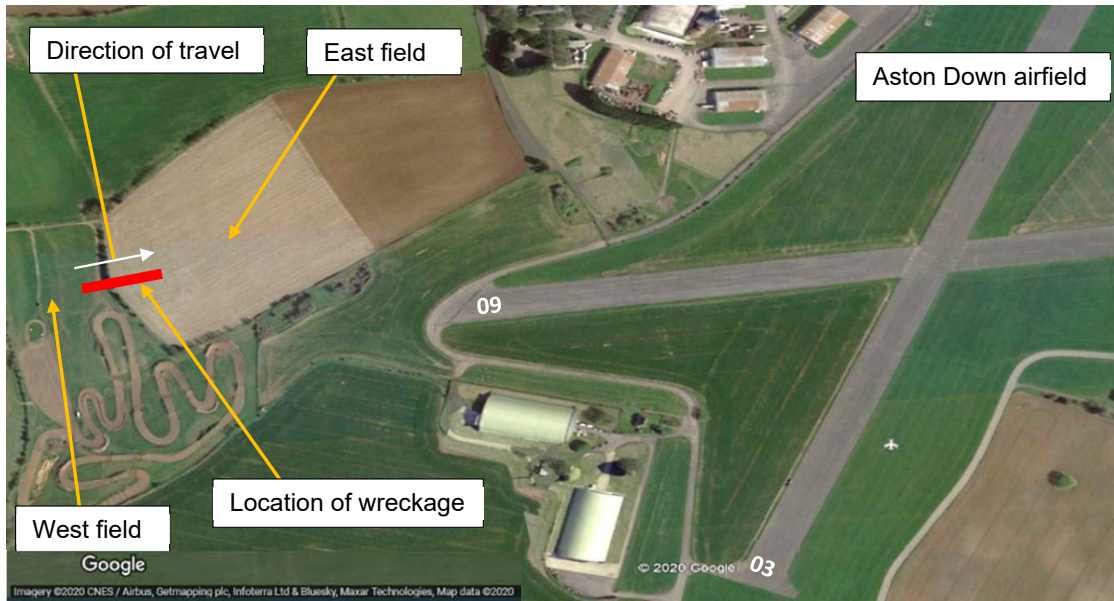
**Figure 1**

Location of the accident site on the western boundary of Aston Down airfield

The wreckage of G-KDEY stretched across two fields to the west of Aston Down airfield (Figure 1).

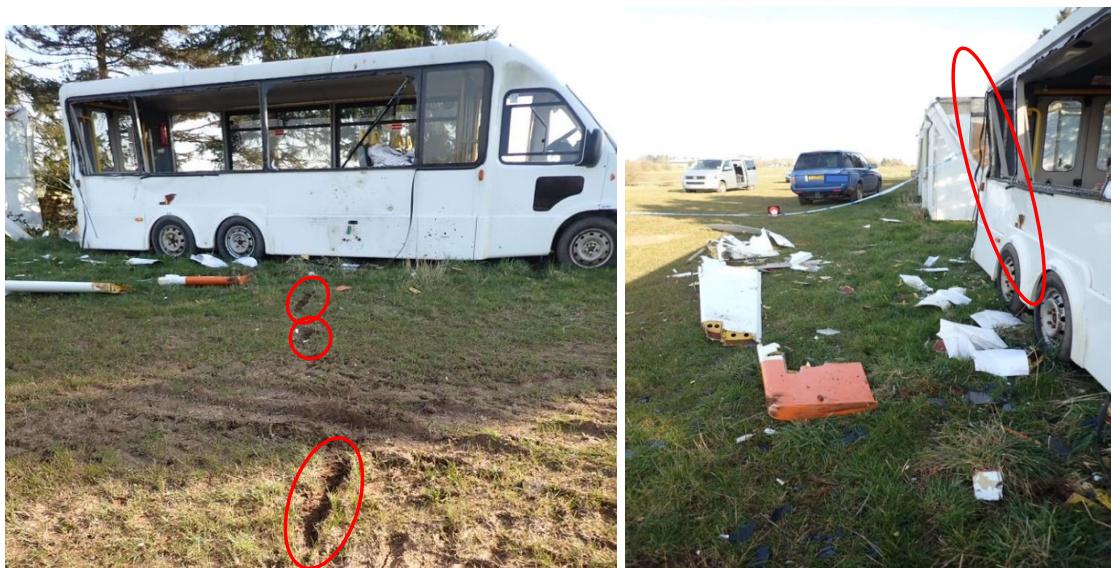
**Figure 2**

From the ground marks it was evident the aircraft was heading east towards the airfield at the time of the accident. The first impact marks were made by the right wing tip, which touched the ground three times before the leading edge of the wing hit a small bus parked along the treeline of the west field (Figure 2).

Ground impact marks, detached right wing and impact angle on the bus

On striking the bus, the wing detached and landed by the bus, while the remainder of the fuselage and left wing glanced off a flat roofed cabin located to the left of, but in line with, the vehicle.

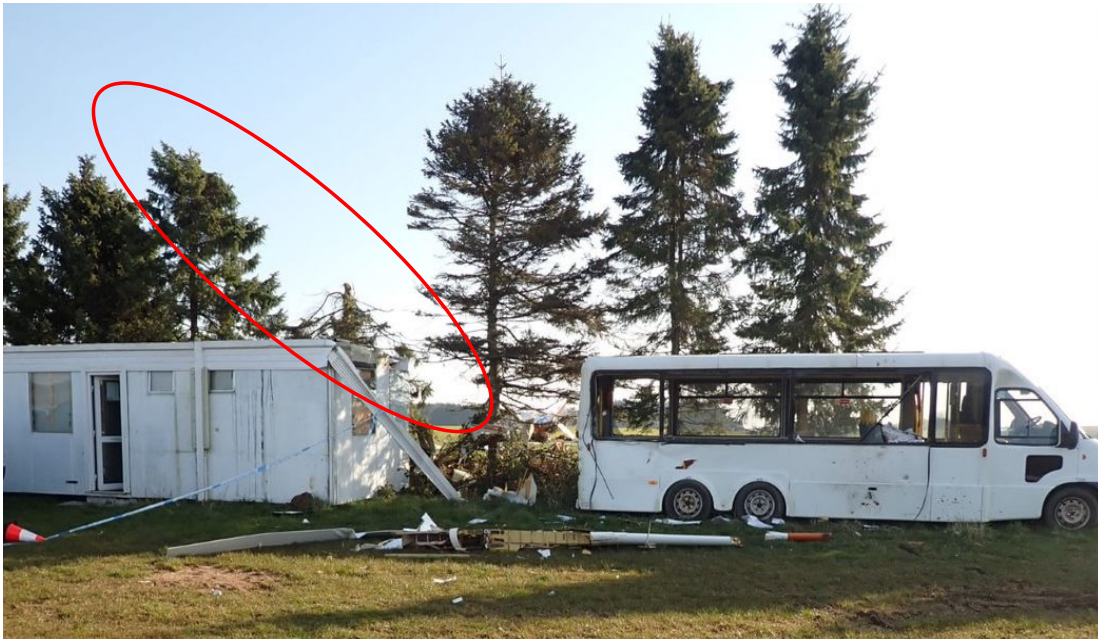
**Figure 3**

Damage to the cabin roof and the angle sliced through the tree line

The fuselage bounced off the top right side corner of the building's roof and continued into the treeline. The left wing and fuselage sliced through the trees (Figure 3) before hitting the east field at a shallow angle.

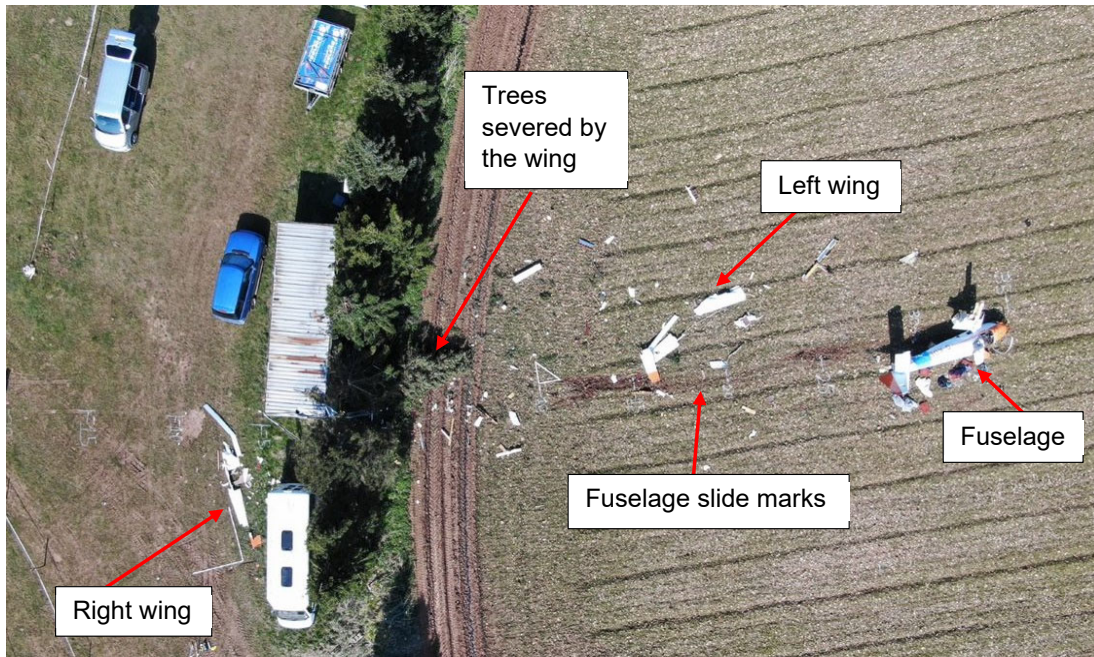
**Figure 4**

The remaining wing detached and landed to the left of the aircraft's path. The fuselage continued sliding along the ground before finally stopping in a slightly right nose down attitude pointing towards the airfield (Figure 4). One of the propeller blades broke away from the hub between hitting the trees and the ground in the east field and the remains were found under the left wing.

Overhead view of the final positions of the fuselage and wings

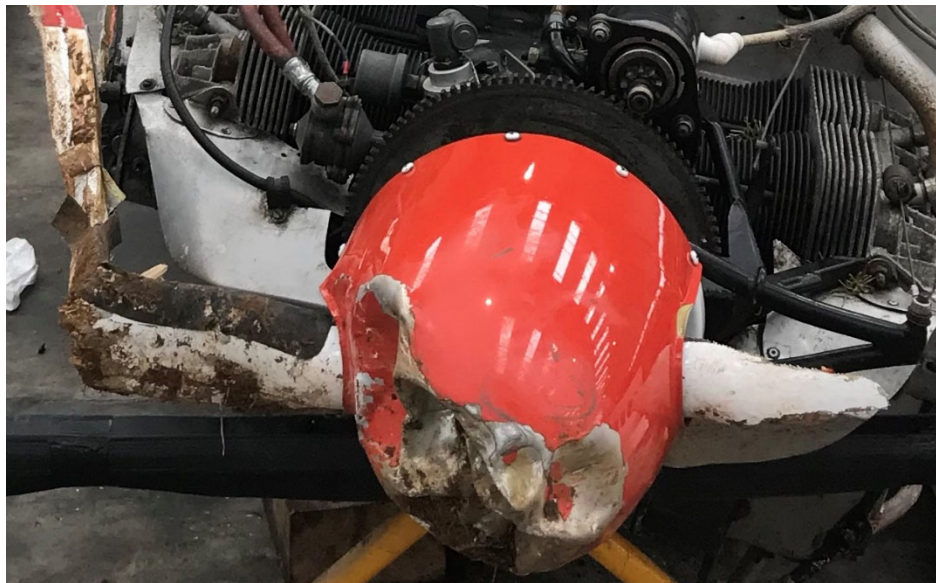
**Figure 5**

The other propeller blade bent backwards and, although some of the blade broke away, it was still attached to the hub.

The propeller's spinner had large impact dents but there were no radial score marks to indicate the propeller was rotating under power when it hit the ground (Figure 5). The tail and fuselage behind the cockpit were largely intact, with minor damage to the leading edges of the fin and left tailplane.

Remains of the propeller blades and the dented spinner

Examination of the engine, the propeller and the spinner indicated that the engine was not producing power when the aircraft struck the ground. However, the remains of branches were lodged in the engine bay and propeller from the trees that were damaged in the tree line between the east and west fields. It is likely the engine stopped when the propeller sliced through the trees, causing one blade to separate near the root and land in the east field, while the other was bent backwards but remained attached to the hub.

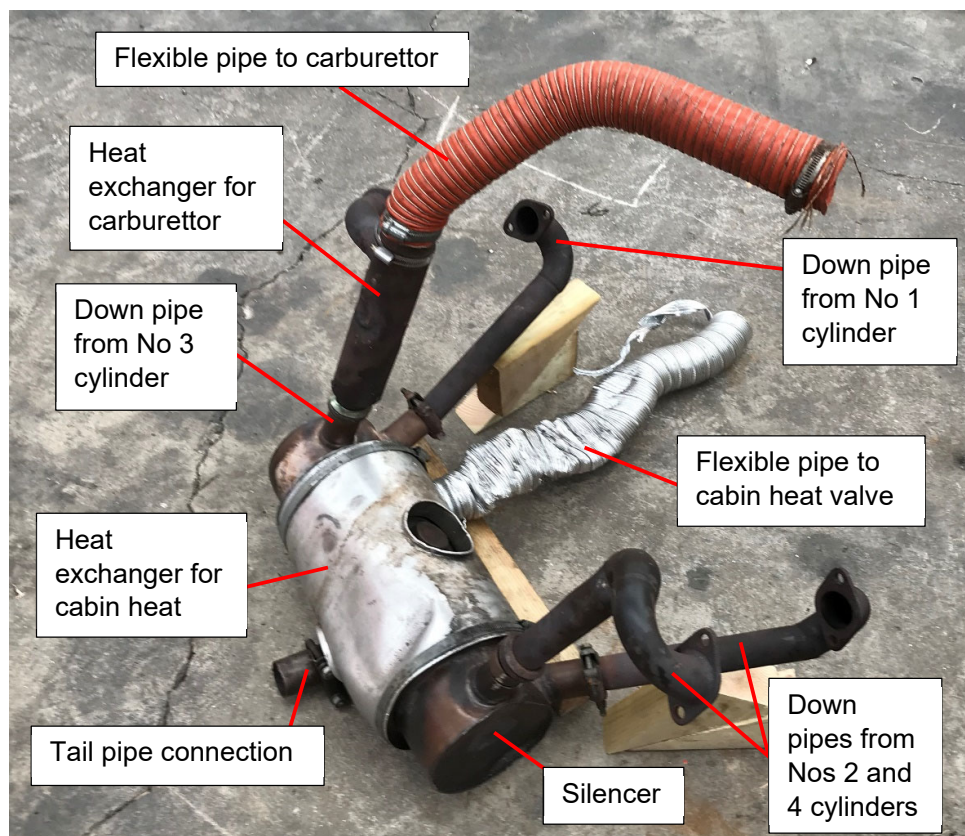
**Figure 6**  
G-KDEY exhaust system

The exhaust consists of a silencer positioned directly under the engine and connected to each of the engine's four exhaust ports by down pipes. Exhaust gasses pass from the piston combustion chambers, through the down pipes to the silencer and are vented rearwards to atmosphere underneath the aircraft by a tail pipe. To make use of the heat from the exhaust, a heat exchanger is fitted around the silencer. Atmospheric air from the front of the engine cowling passes into the heat exchanger and is warmed by the silencer (Figure 6).

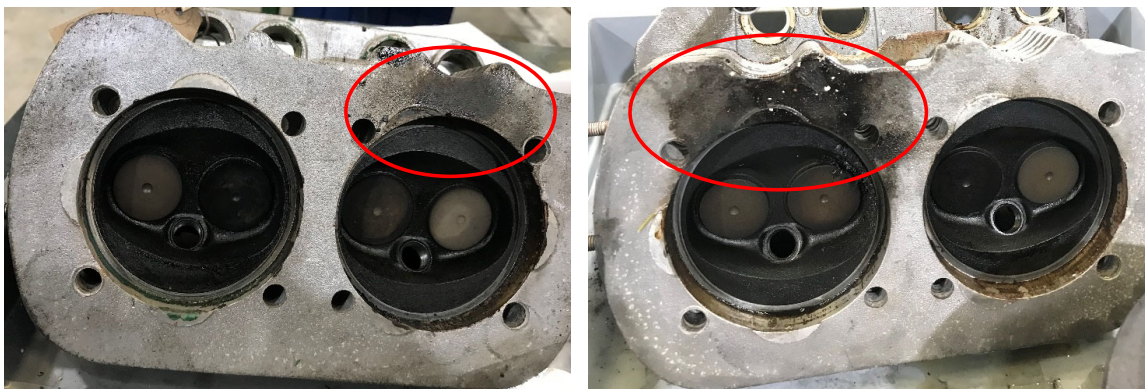
**Figure 7**

No 3 and 4 cylinder heads showing signs of staining

The engine manufacturer stated that the staining visible on the cylinder heads was condensation mixed with soot and may contain traces of fuel and oil. On engines that have been overheated, a slight deformation of the cylinders and cylinder heads occurs as operating time increases. For the Limbach 1700 engine, deformation only occurs at the cylinder head and the cylinders are made of grey cast iron. This means that during cold

start, gases can be pushed through the seal between the cylinder and head. However, when these components are heated they become tightly sealed. The components of an air-cooled motor reach the operating temperature very quickly, so the sealing process is completed during engine warm-up.

If exhaust gases were able to flow through the seal during high loads, there would have been an immediate melting of the affected parts at the site of the leak. Under partial load, the exhaust gases reach a temperature of 900°C and aluminum alloys melt at approximately 650°C. A leaking exhaust gas stream would act like a cutting torch and quickly burn through the cylinder head at the sealing surface.

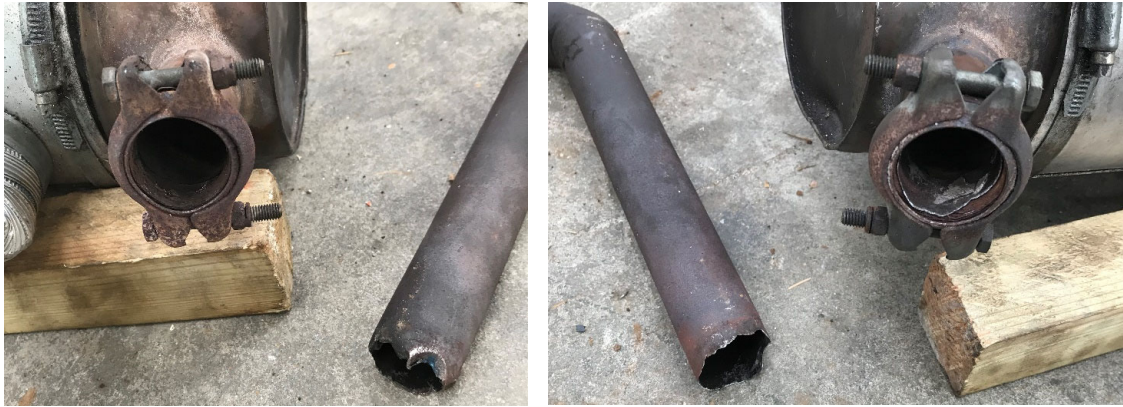
**Figure 9**

On dismantling the remaining exhaust system, the down pipes from No 1 and 2 cylinders were easily removed by hand from the silencer despite their securing clamps and sealing rings remaining in place. Visual examination revealed the ends of both pipes had corroded and fractured completely around their diameter. The detached ends of the pipes were still fitted in the silencer. The jagged edge of No 1 cylinder's down pipe had bent inwards as the pipe was pushed further into the silencer during the accident (Figure 9). The two exhaust down pipes from No 3 and 4 cylinders were removed and visually inspected but only minor surface corrosion was evident.

Forensic analysis found that although the exhaust down pipe from No 2 cylinder was corroded and the wall thickness had reduced, it had fractured during ground impact. The down pipe from No 1 cylinder was severely corroded and forensic analysis found that it had already failed some time before the accident. Both the pipe and its sealing ring showed traces of exhaust gas leakage. The evidence was very difficult to detect visually with the exhaust still fitted to the engine and in the engine bay. The signs of leakage were not easily discernable even with the system dismantled and required forensic examination to confirm that leaks had occurred.

No 1 and 2 cylinders' exhaust down pipes and silencer pipes showing failures

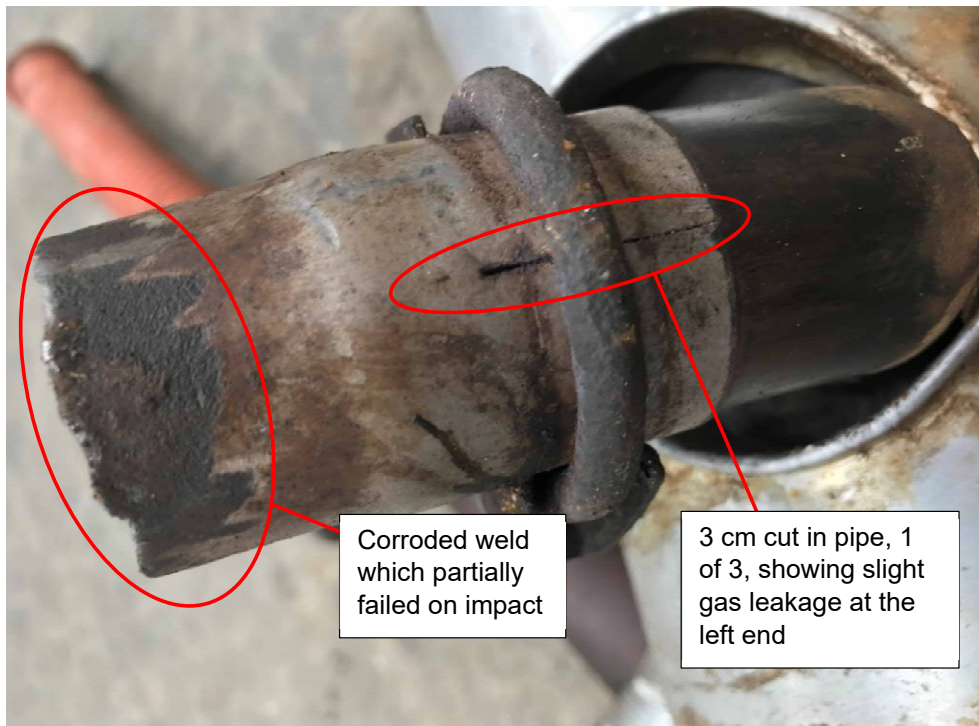
**Figure 10**

Whilst the partial failure of the exhaust tail pipe at the weld was due to ground impact, there was evidence that gas leakage had also occurred at the connection of the tail pipe to the silencer. The tail pipe had three, 3 cm cuts along the length of the pipe from the end to enable it to expand to fit over the silencer connection. A clamp was placed over the cut end of the pipe to secure it in place. As the pipe had not been fully pushed over the connection, the cuts were not completely blanketed by the silencer pipe, which allowed gas to escape when the engine was running (Figure 10). The aircraft manufacturer stated that the tail pipe fitted was not an approved design.

Partially fractured tail pipe attached to the silencer

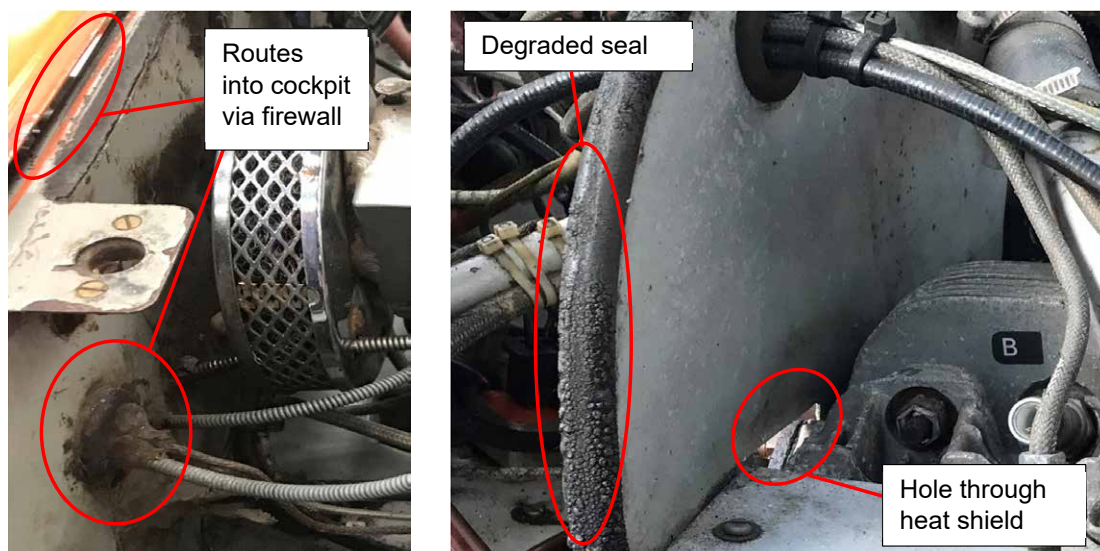
**Figure 11**

During engine removal, it was evident that the seals and grommets used in the engine firewall to protect the cockpit from engine bay gases had deteriorated and perished. It was likely that gases in the engine compartment could flow into the cockpit through the firewall (Figure 11).

Exhaust gas routes into the cockpit through bulkheads and firewalls

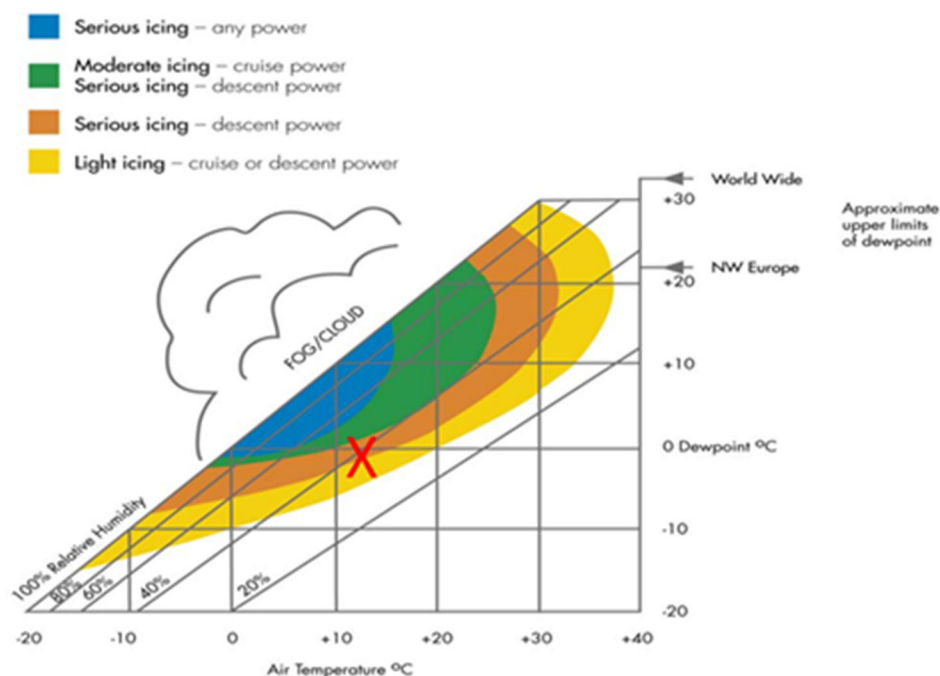
**Figure 12**  
Carburettor Icing Chart

Observations at Gloucestershire Airport, approximately 11 nm north of the accident site, at the time of the accident indicated that the wind was from 140° at 5 kt. The visibility was in excess of 10 km, the temperature was 13°C and the dew point -1°C. The atmospheric pressure was 1024 hPa. When plotted on the CAA's carburettor icing chart they indicate that there was a likelihood of serious icing with descent power (Figure 12).

Increased levels of ethanol in Mogas increases the risk of carburettor icing. Given the weather conditions on the day, partial or complete engine failure due to carburettor icing could not be ruled out.

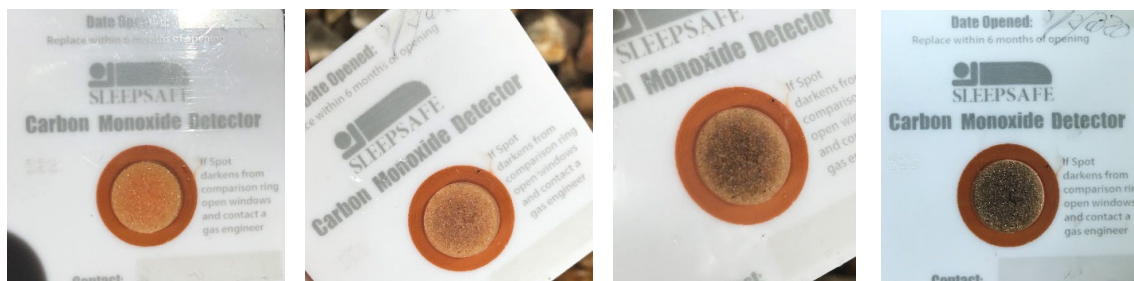
**Figure 13**

A CO spot detector was fitted to the centre of G-KDEY's instrument panel to warn the pilot if CO entered the cockpit. The detector's tan coloured spot turns black in the presence of CO. It was purchased from a non-aviation specific store in February 2020. The detector was removed and placed in front of a petrol mower exhaust to check its operation. The spot had to be held directly in the exhaust flow for 4 to 5 minutes before it started to discolour and approximately 7 minutes to turn it black (Figure 13). After an hour in fresh air, the spot reverted to its original colour.

Spot detector colour change when exposed to CO

The inspecting BGA engineer observed that following this accident he did not consider “dark spot” detectors to be an adequate means of alerting pilots to the presence of hazardous CO levels.
