ACCIDENT

Aircraft Type and Registration:	SB-5E glider, G-DEJH	
No & Type of Engines:	None	
Year of Manufacture:	1970 (Serial no: 5041A)	
Date & Time (UTC):	7 August 2019 at 1303 hrs	
Location:	Summit of Cross Fell, Pennines, Cumbria	
Type of Flight:	Private	
Persons on Board:	Crew - 1	Passengers - None
Injuries:	Crew - 1 (Serious)	Passengers - N/A
Nature of Damage:	Destroyed	
Commander's Licence:	BGA Glider Certificate with Bronze endorsement	
Commander's Age:	15 years	
Commander's Flying Experience:	69 hours (of which 2 hours were on type) Last 90 days - 21 hours Last 28 days - 9 hours	
Information Source:	AAIB Field Investigation

Synopsis

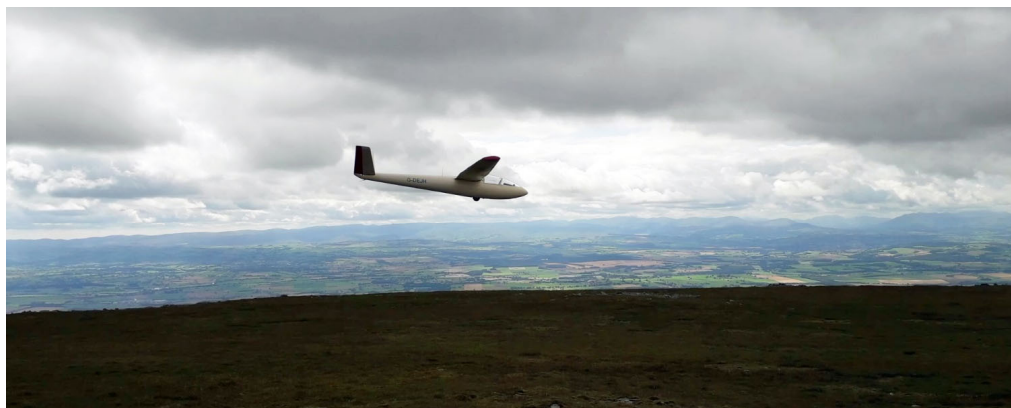
Figure 2

Still taken from video of the second pass (Image used with permission)

Analysis using specialist video software showed that shortly after the glider passed the camera position, both surfaces of the V-tail began to oscillate laterally. When viewed frame by frame the ruddervators on each side of the V-tail were seen to lag the motion of the fixed tail structure. The oscillation continued to increase in amplitude until approximately three seconds later when the whole tail section broke away from the fuselage and continued to rotate clockwise (viewed from behind) attached only by the control rods. Immediately after the structural failure, the aircraft nose and right wingtip dropped to point at the ground and the glider fell vertically until it passed below the level of the summit and hit the ground.

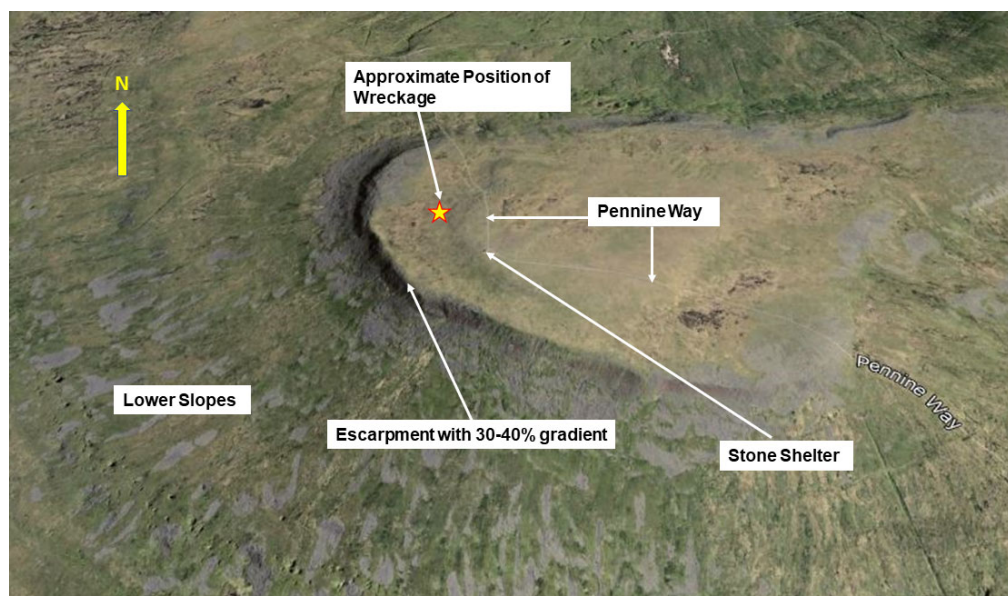
Figure 3

The plateau of Cross Fell Summit, with approximate position of wreckage (Google Earth)

The main wreckage was on an area of relatively flat ground approximately 170 m north-west of the trig point on the summit plateau of Cross Fell. This was approximately 80 m west of the Pennine Way path. The accident site was compact with the main sections of the aircraft located together. Deep impact marks were present in the ground from the nose, right wingtip and wing leading edge. However, the fuselage of the glider had largely disintegrated in the impact, and lightweight sections of plywood skin had been blown by the wind across a large area.

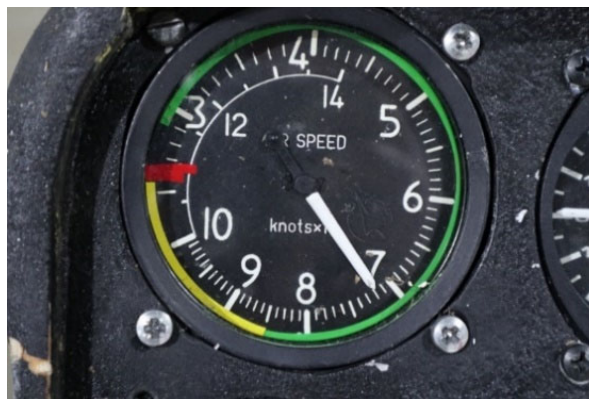
Figure 5

The ASI had been annotated with a green band around the outside of the dial, transitioning to amber at 85 kt and with a broad red line between approximately 108 kt and 110 kt (Figure 5).⁷

ASI from G-DEJH showing speed range markings

The ASI and cockpit placard had been incorrectly annotated with a Rough Air speed limit of 85 kt since at least 1992, and possibly since the glider was imported to the UK in 1981. This discrepancy had not been detected when the limitations placard in the cockpit and ASI markers were replaced at the 2016 annual maintenance check. It is, therefore, likely that the glider had operated above the actual certified Rough Air speed limit of 75 kt on previous occasions in rough air.

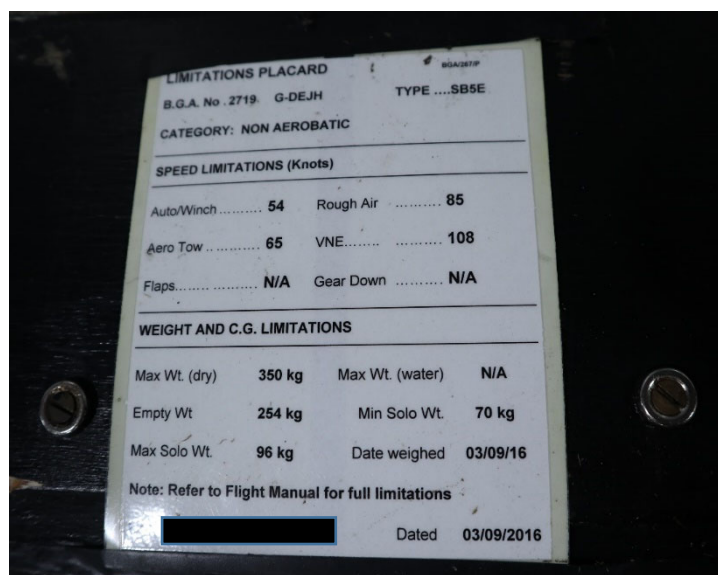
Figure 6

The limitations placard in the cockpit had a section entitled '*Speed Limitations (Knots)*' and indicated that the maximum operating speed (V_{NE}) was 108 kt and the Rough Air speed limit was 85 kt (Figure 6). The placard was dated 03/09/2016 and had been issued by a BGA Inspector.

Cockpit placard from G-DEJH

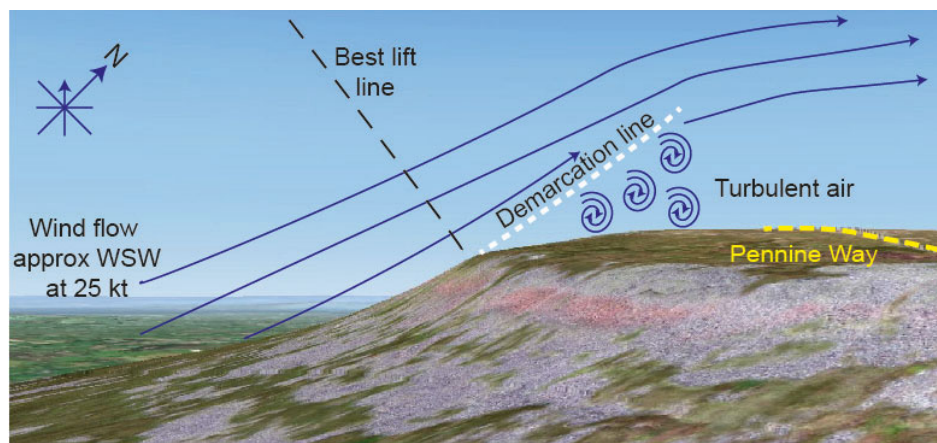
Figure 8

A view of the plateau (Figure 8) in the approximate direction that the glider was flying immediately prior to the accident, shows the wind effects that the glider likely encountered. It illustrates the area of best lift in the smoother uplifting air on the windward side of the ridge (left of the demarcation line) and the more turbulent air behind (right of the demarcation line). On the north-western edge, where the ridge curved round to the east, the turbulence would have been greater as the wind direction became less perpendicular to the ridge. The direction of the wind is also likely to have been affected as it flowed around the plateau, possibly resulting in a slightly more south-westerly flow. The plateau at the summit of Cross Fell, sitting above the main ridge, would likely have experienced stronger winds than the ambient wind at the same level.

Likely effect of the wind on the summit of Cross Fell where the accident occurred
