The collision between the commercial fishing vessel *Vertrouwen* and recreational motor cruiser *James 2* resulting in the sinking of *James 2* and loss of three lives Shoreham-by-Sea 6 August 2017

SUMMARY

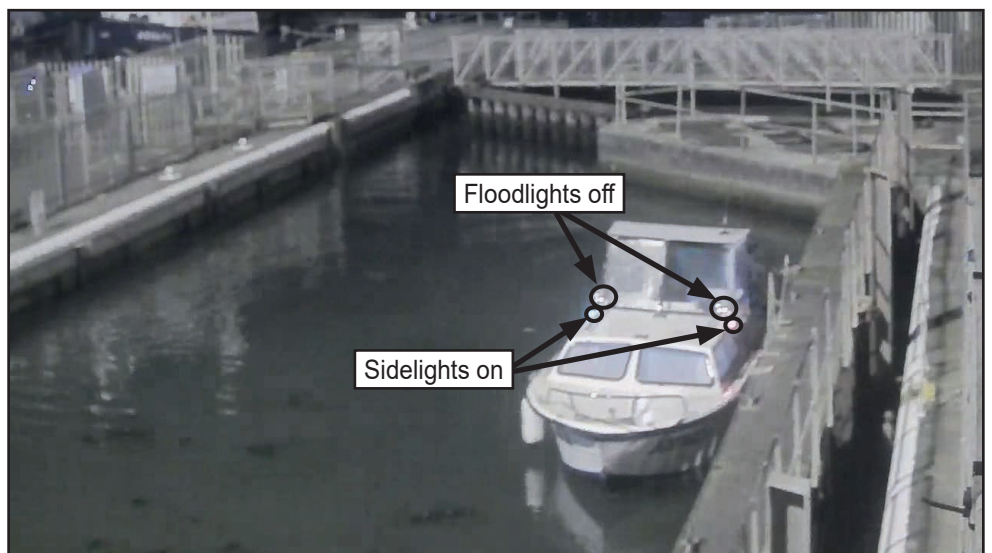
Figure 2: *James 2* in locks

James 2 had port and starboard sidelights and these were on when the boat departed Shoreham (**Figure 2**). It did not have a masthead light, sternlight or all-round white light. Mircea used *James 2*'s forward-facing spotlights to assist his manoeuvre off the pontoon in the marina and out of Riverside Yard, but they were switched off before the vessel entered the lock and left the port. Mircea and Irinel wore LED head torches on the evening of the accident, and they also had hand torches available on board.

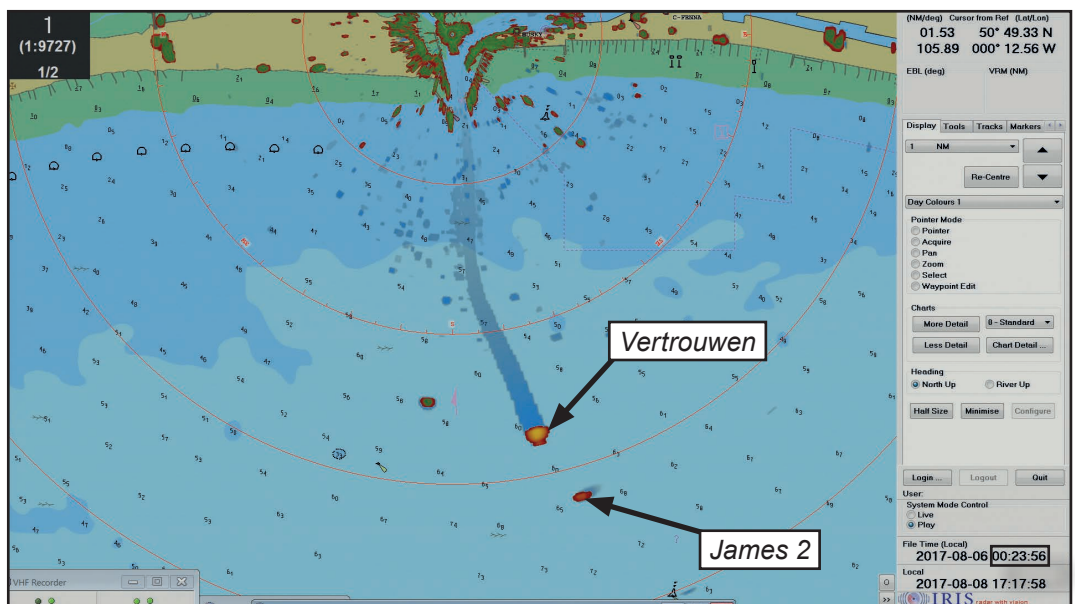
Figure 3c: *Vertrouwen* position as skipper uses his mobile phone

At 0024, *Vertrouwen's* skipper used his mobile phone to send a message on social media to a friend on board another fishing vessel; *Vertrouwen* was about a quarter of a mile from *James 2* and on a collision course with the boat (Figure 3c). The skipper then started to compile his electronic departure report.

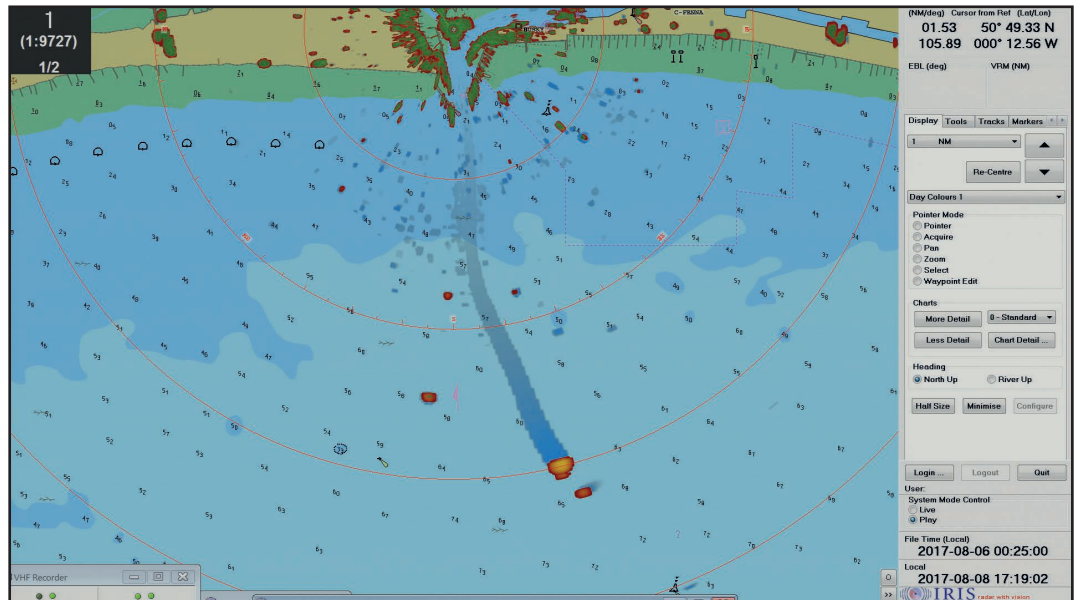
Figure 3d: *Vertrouwen* and *James 2* immediately before the collision

At 0026, *Vertrouwen* struck *James 2* on its starboard quarter with a glancing blow (**Figure 3d**) and its bow wave washed over the motor cruiser's stern. *James 2* started to sink by the

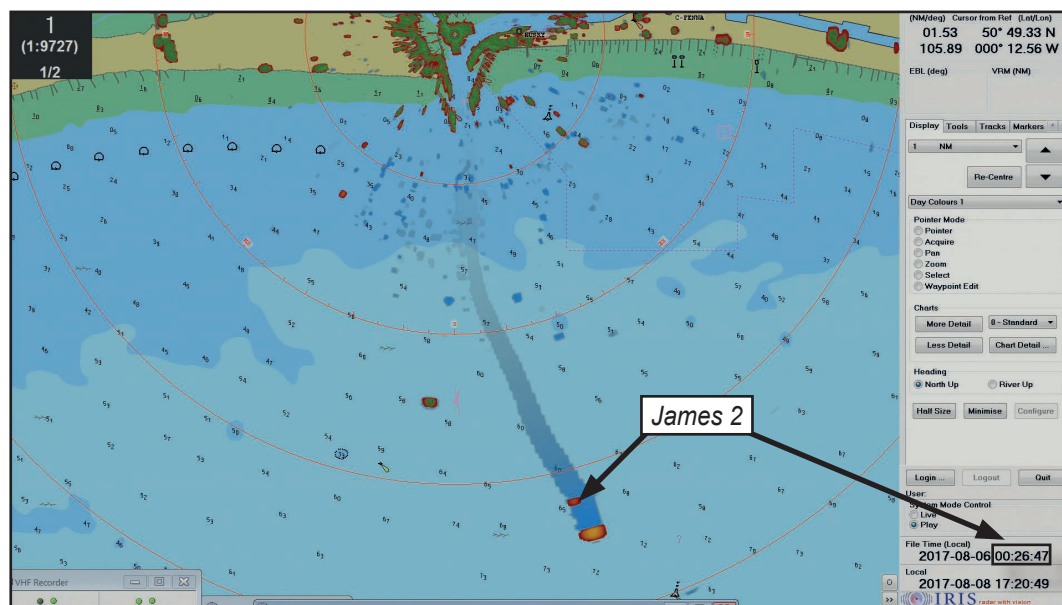
Figure 3e: *Vertrouwen* and *James 2* shortly after the collision

stern as water continued to flood over the low transom. The anglers tried frantically to bail the boat out and also gain the attention of the crew on board *Vertrouwen* by shouting and flashing their torches, but

Vertrouwen did not stop (**Figure 3e**).

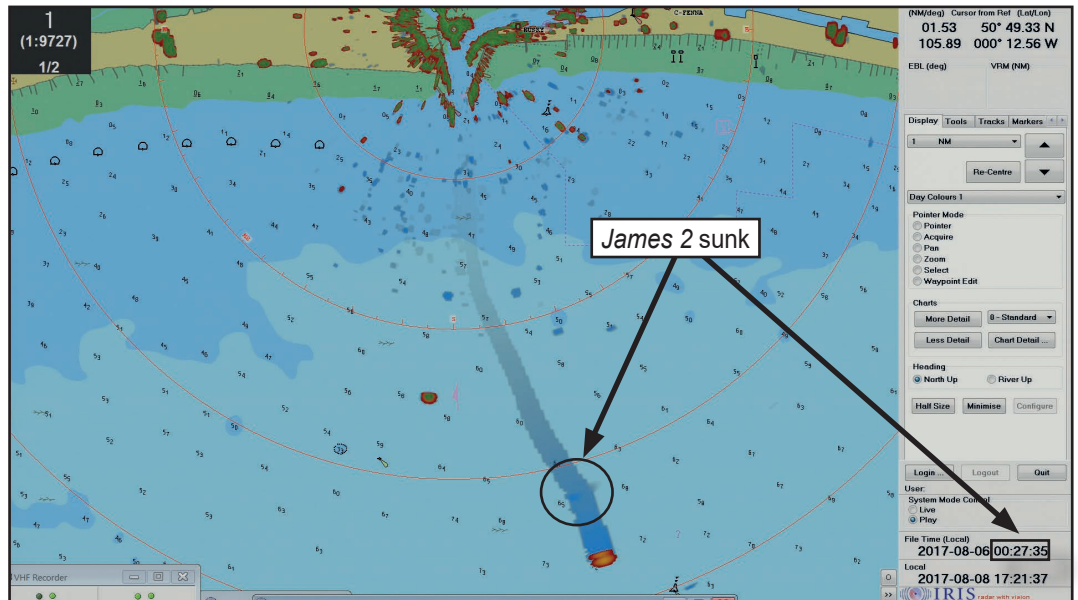
Figure 3f: *James 2* sunk position

passed his knife to the survivor, who managed to cut a second fender free as *James 2* sank less than 2 minutes after the collision (**Figure 3f**).

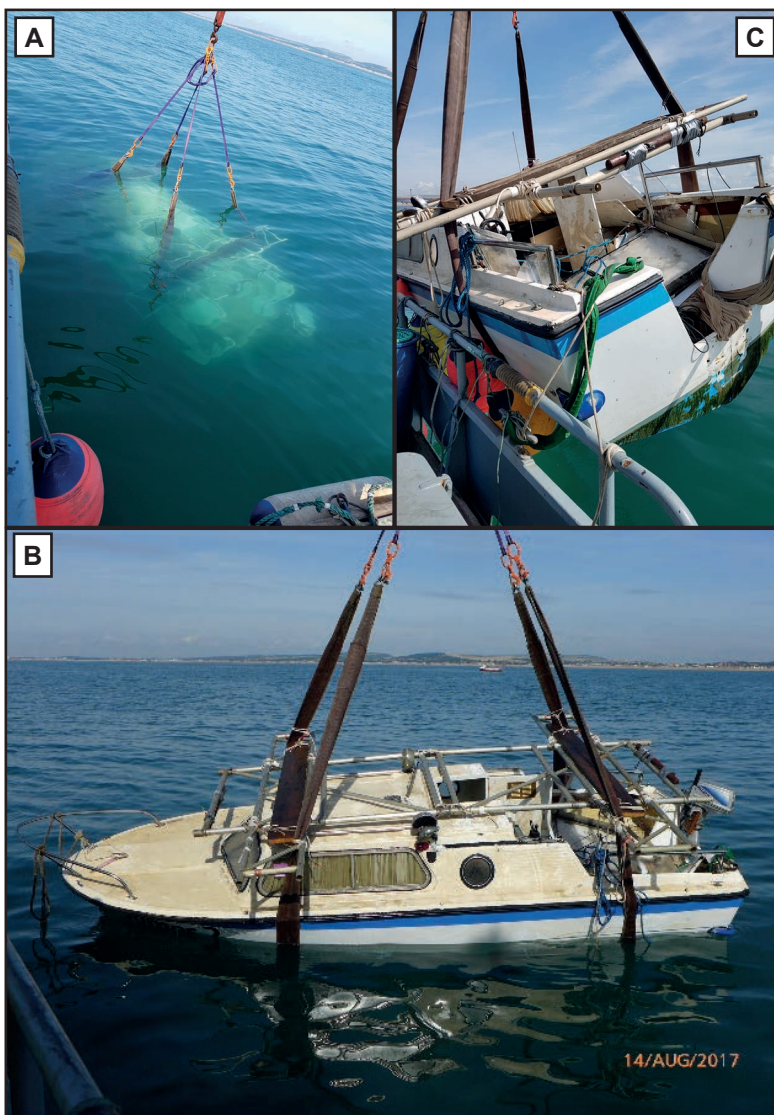
Figure 4a, b and c: *James 2* wreck recovery

The wreck of *James 2* was located using side-scan sonar 6 days after the accident. The wreck was initially surveyed on the seabed by divers and, on 14 August 2017, it was raised and landed ashore (**Figures 4a, b and c**).

Close examination of the wreck revealed that *James 2* had suffered no structural damage as a result of the collision. Some minor scuff marks were found on the starboard quarter of the hull, but these appeared to be old and similar to other scuff marks found around the hull. The inspection also identified that the engine throttle was in the neutral position and the cabin lights were switched off.

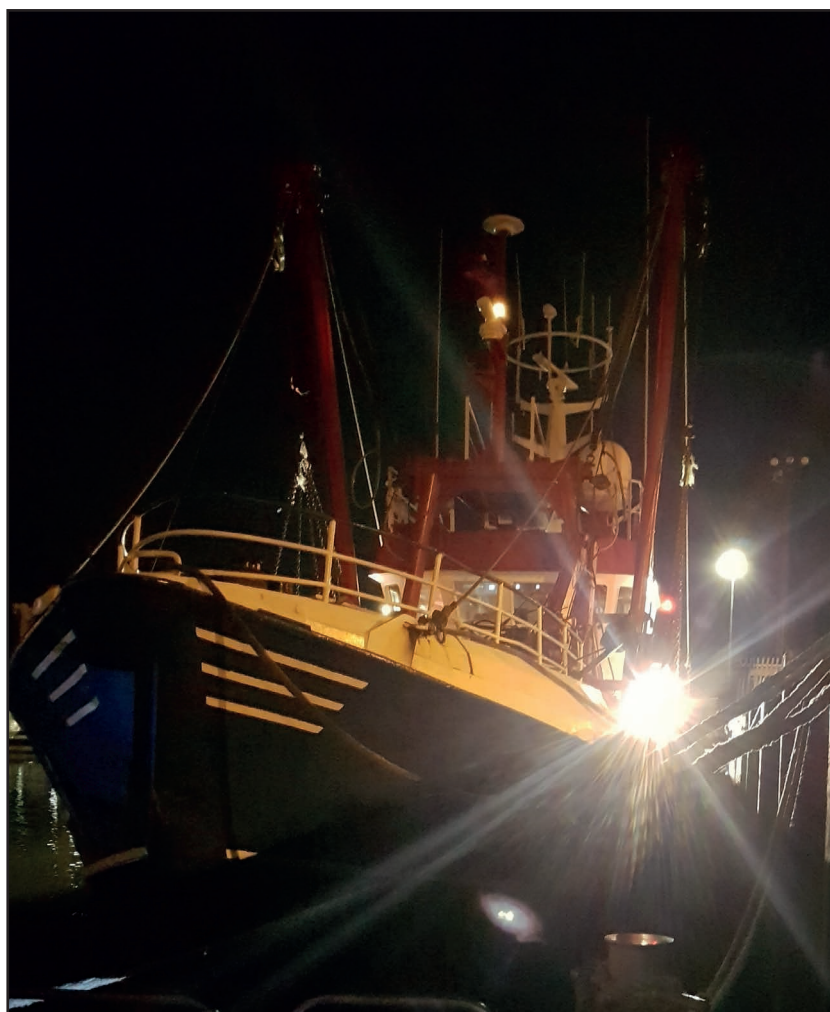
Figure 6: *Vertrouwen*'s forward facing dredge deck floodlights visible from ahead

When *Vertrouwen* departed Shoreham harbour its navigation lights were showing. *Vertrouwen* had halogen and LED floodlights for illuminating its forward and aft working decks. It also had two forward-facing halogen floodlights to illuminate the port and starboard dredge bag landing areas (**Figure 6**). The skipper usually left these on at night, and they were on when *Vertrouwen* left the harbour.

The brightness of *Vertrouwen*'s floodlights would almost certainly have created backscatter from its deck, superstructure, and equipment forward of the wheelhouse. This would have adversely affected the skipper's night vision and diminished his ability to visually identify small craft with low levels of illumination, such as *James 2*.

Vertrouwen was showing the navigation lights required by the COLREGS for a motor vessel of its size while underway. However, the brightness of its forward-facing floodlights would have made it harder to see the vessel's navigation lights from *James 2*'s deck and so determine its direction of travel.

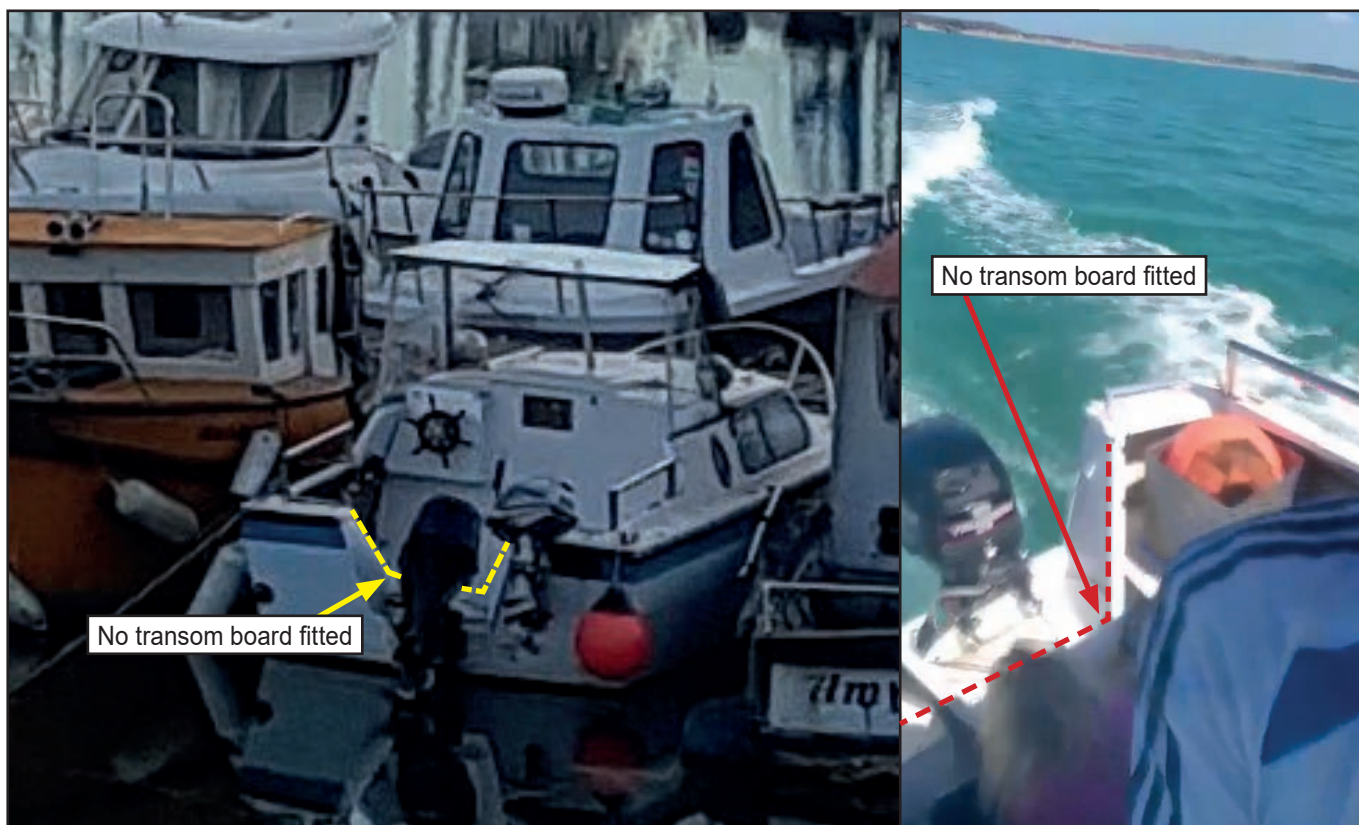
mounting the outboard motor. Inspection of the boat identified that previous owners had fitted transom boards on the inside of the cut-out to increase the boat's freeboard to about 740mm. Mircea never used transom boards (**Figures 7a and b**).

Figure 7a: *James 2* on its berth in Riverside Yard July 2017

Figure 7b: *James 2* at sea summer 2017

James 2 was undamaged by the impact of the collision. It sank because it was swamped by *Vertrouwen*'s wash and had insufficient reserve buoyancy to remain afloat in the flooded condition. The cut-out in *James 2*'s transom had reduced the boat's freeboard, and therefore its downflooding height to less than 250mm. This was inadequate for a boat of its size and design when operating at sea. Had a watertight board been fitted on the inboard side of the transom cut-out, the boat's freeboard would have been almost three times greater and the risk of it becoming swamped would have been significantly reduced. If the boat had had the reserve buoyancy through built-in flotation required of similar sized boats, built to comply with the RCD, it would not have sunk. At worst, the boat would have floated awash, providing something for the sea anglers to cling to while in the water.

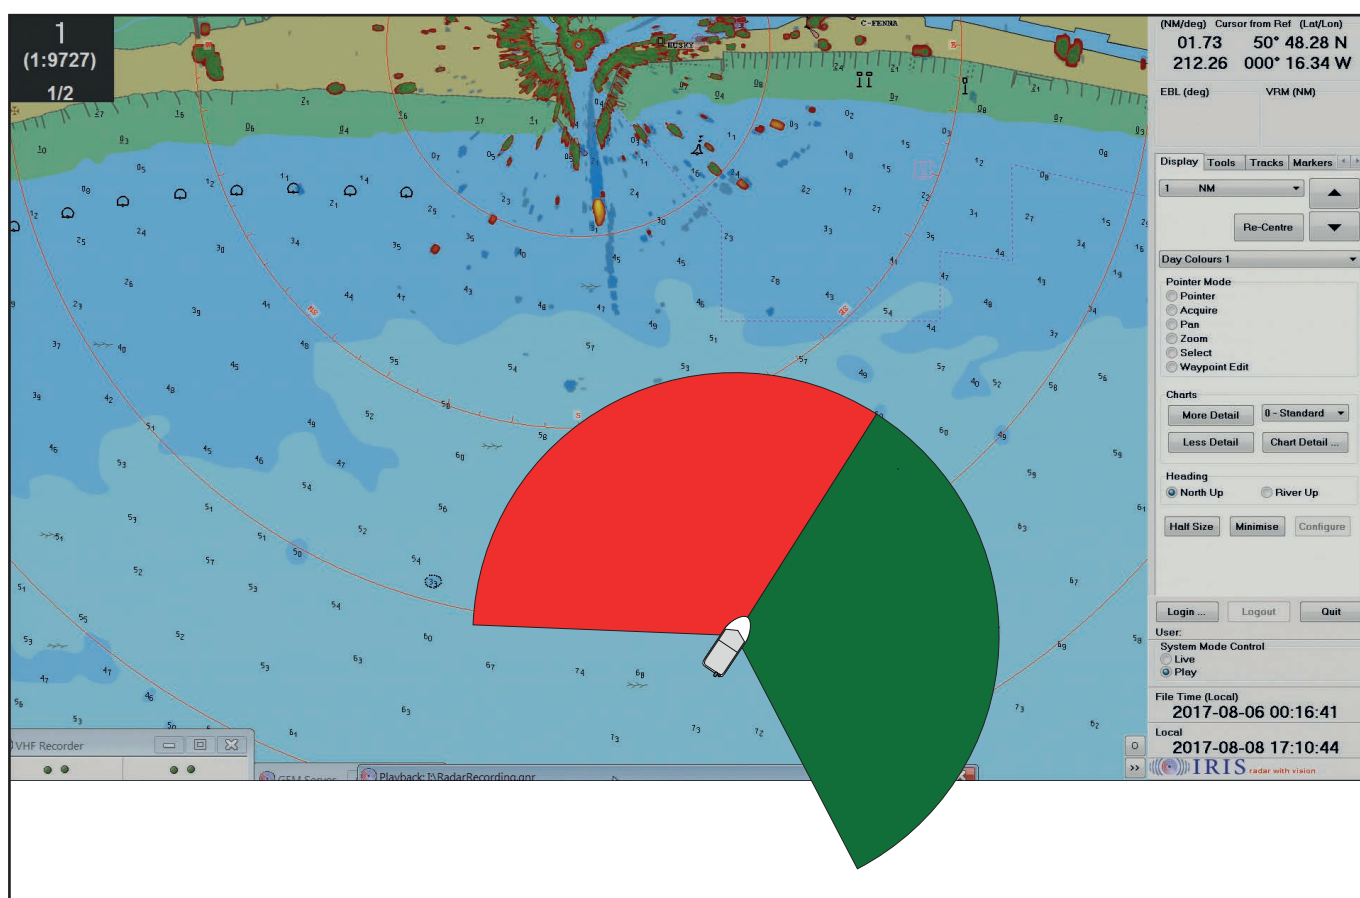
Figure 8a: Most likely orientation of the lights shown by *James 2* when it stopped to fish

James 2 was not showing all the navigation lights required for a boat of its size; it did not have either a masthead light and sternlight, or an all-round white light. If *James 2* was facing head or beam onto the approaching *Vertrouwen*, its sidelights should have been visible from *Vertrouwen*'s wheelhouse at a distance of at least 1 mile; or for at least 8 minutes prior to the collision (**Figure 8a**).

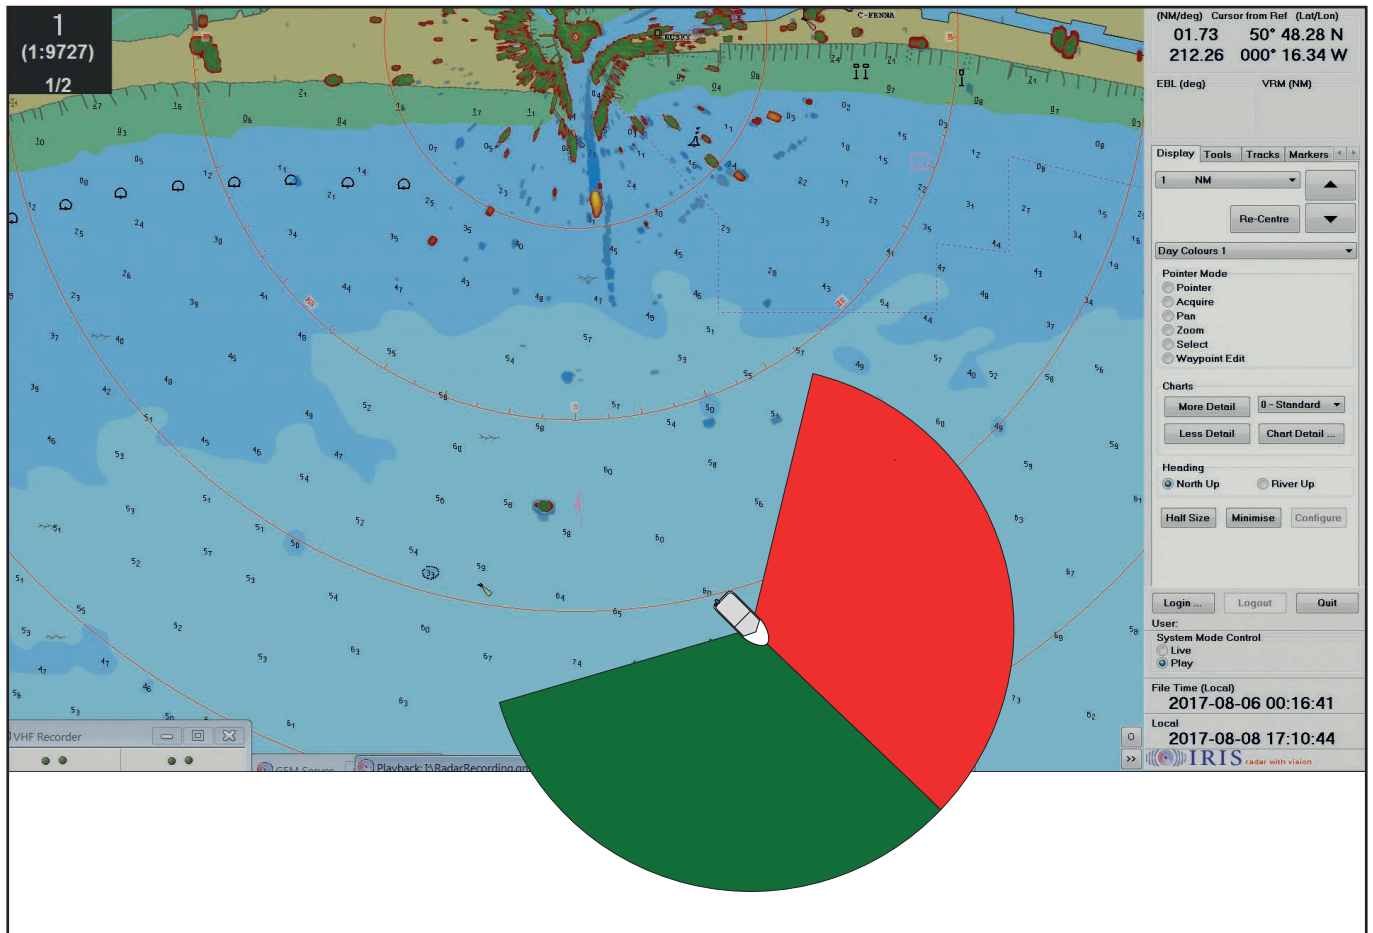
Figure 8b: Most likely orientation of the lights shown by *James 2* as *Vertrouwen* approached

The night time visibility trials conducted by the MAIB confirmed that *James 2* would have been clearly visible from the harbour breakwater if it had been showing the white navigation lights mandated in the COLREGS. The trials also showed that *James 2* would not have been visible from *Vertrouwen*'s wheelhouse until it was in very close range if the motor cruiser was drifting with its stern, or port or starboard quarters facing toward the fishing boat (**Figure 8b**).
