A14 Cambridge to Huntingdon Improvement Scheme

Bar Hill Junction

Stage 3 Road Safety Audit

Stage 3 Road Safety Audit 406395DS-TPN-ITD-117-A

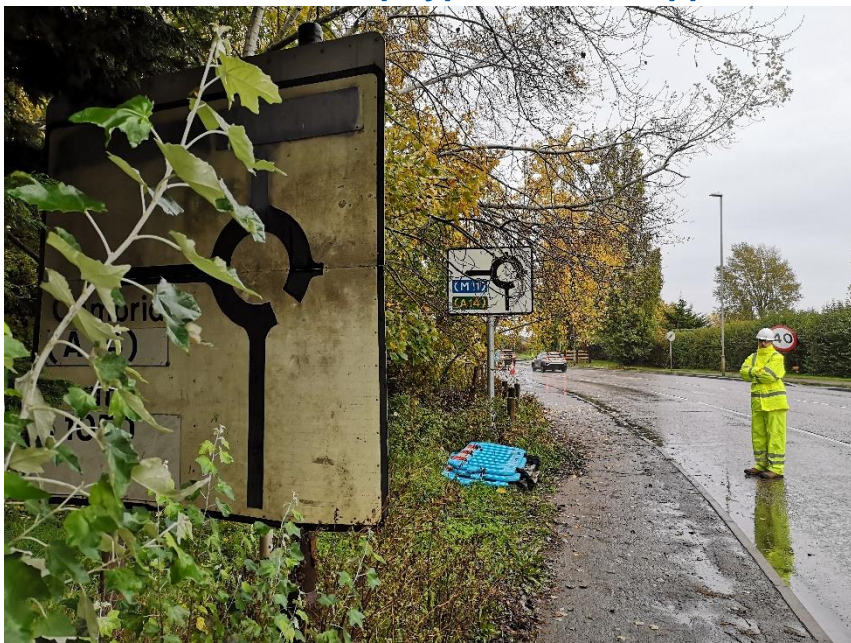
On Saxon Way, eastbound approach to the roundabout, the existing (local) map-type ADS is obscured by vegetation and the lane arrow markings on the carriageway are faded / worn.

This has the potential to increase the likelihood of shunt type / overshoot collisions at the roundabout, particularly at night or in poor weather conditions.

Photo 1: Obscured map-type ADSs on approach to roundabout

It is recommended that the existing ADS is removed, and that the vegetation is cut back, so that the new map-type ADS can be seen.

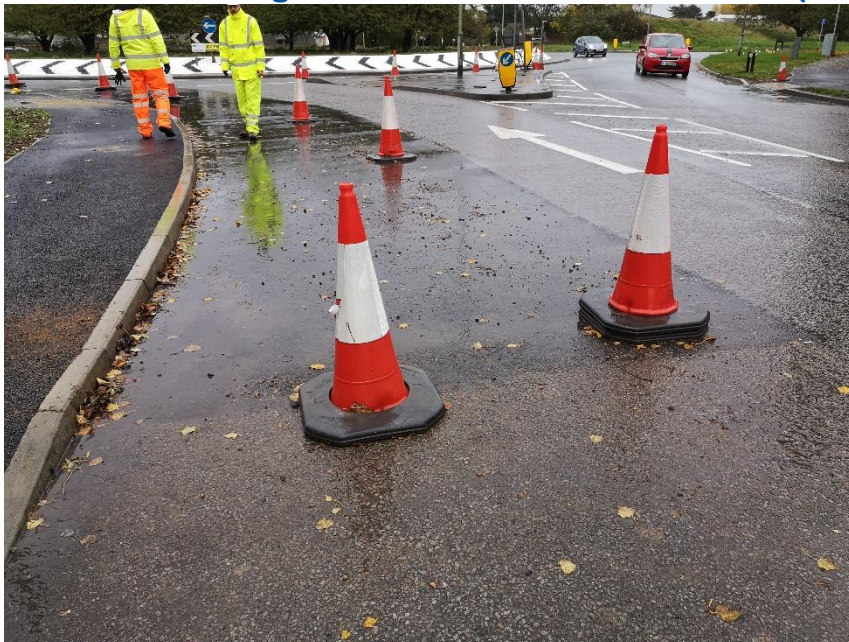
Following an inspection of the new surfacing, the Audit Team is of the opinion that there is too much binder in the surface course of Lane 1 and this may not provide the level of PSV as intended. This can result in vehicles skidding and subsequent overshoot or rear-end shunt type collisions at the roundabout.

Photo 2: Showing new surface course in Lane 1 (closed under TTM)

It is recommended that the surface course in Lane 1 is reviewed / inspected, and that adequate PSV is provided for the surface course on this approach.

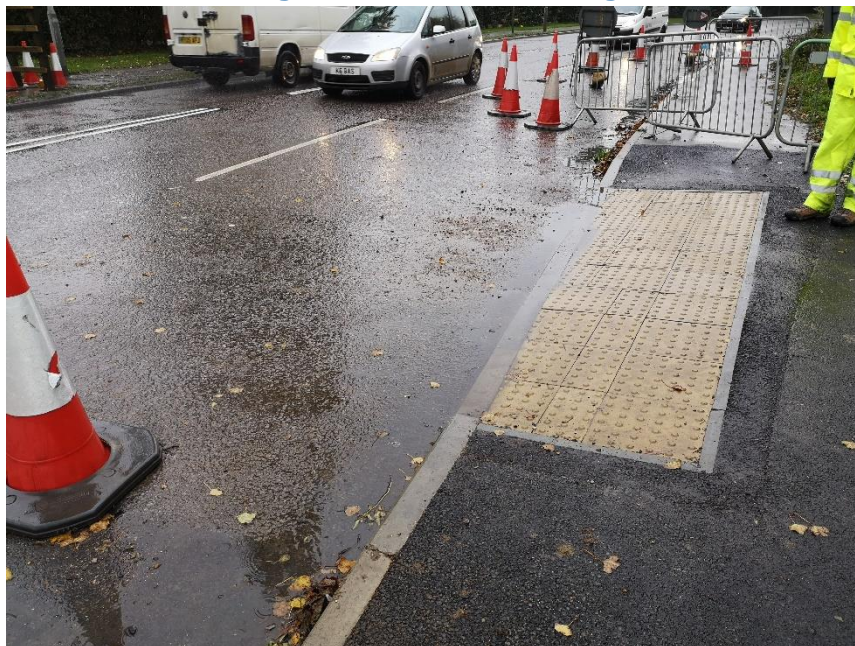
The Audit Team observed surface water that was not draining sufficiently, notably on the northern side of the NMU crossing point on Saxon Way, on the eastbound approach to Bar Hill Roundabout.

This has the potential to result in NMU injury from slips and falls, particularly if the water freezes during colder conditions. Furthermore, the ponding may cause NMUs to seek alternative (less appropriate) locations when crossing Saxon Way, increasing the risk of collisions with motor traffic.

Photo 2: Ponding in front of crossing area

It is recommended that the highway surface water drainage at this location is amended to ensure that surface water can drain sufficiently.

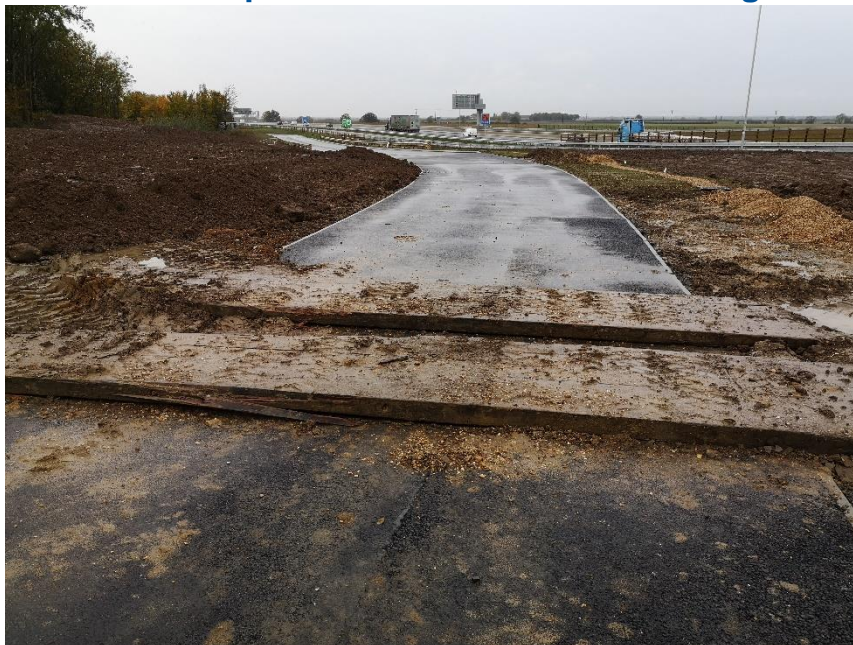
Summary: Various hazards observed within NMU route.

The new NMU route (signed as a public bridleway), on the western side of the junction, was accessible to pedestrians, cyclists and horse-riders. However, throughout the route there were a number of hazards due to ongoing / incomplete works. These included:

- Mud and detritus, presenting a slip, trip and fall hazard;
- Surface water ponding / not draining sufficiently, increasing the risk of NMU slips and falls;
- A temporary vehicle track (surface protection boards), resulting in a significant upstand and trip hazard or a rider becoming unseated.

The above risks are likely to become exacerbated during the hours of darkness, especially as there is no street lighting and no temporary traffic management in place to highlight these hazards to users.

Photo 4: Example of hazards observed throughout the new NMU route

It is recommended the route is temporarily closed to NMUs until works are completed and the hazards removed / mitigated, as soon as practicable.

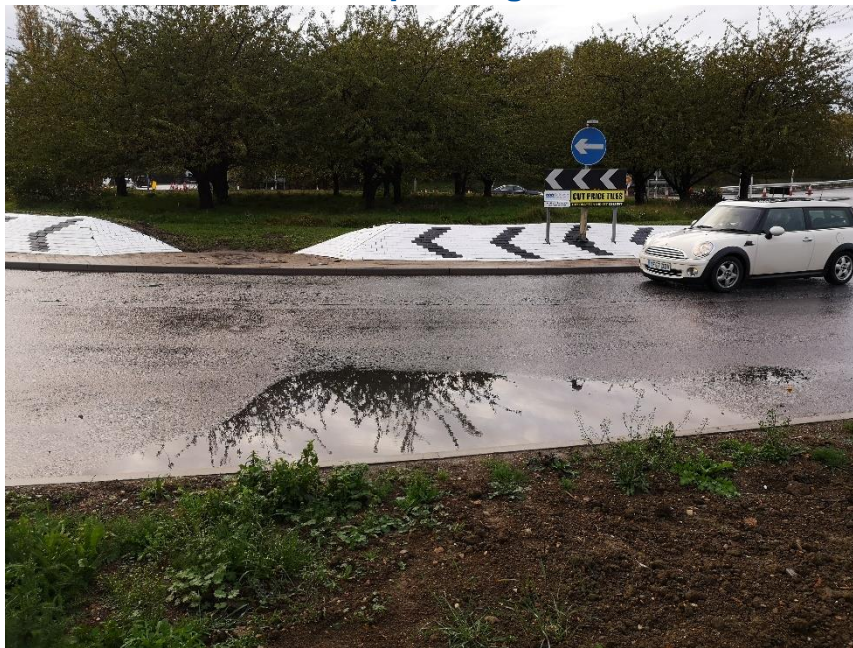
On the eastern quadrant of Bar Hill Roundabout (on the northern side of the health club access), the Audit Team observed a significant accumulation of surface water in the circulatory carriageway.

This may result in an increase of vehicles skidding and losing control as they negotiate the roundabout. The greatest risk of injury is likely to be to motorcyclists who may be more susceptible should loss of control occur at this location.

Photo 5: Surface water ponding on eastern side of roundabout

It is recommended that the highway surface water drainage at this location is amended to ensure that surface water can drain sufficiently.

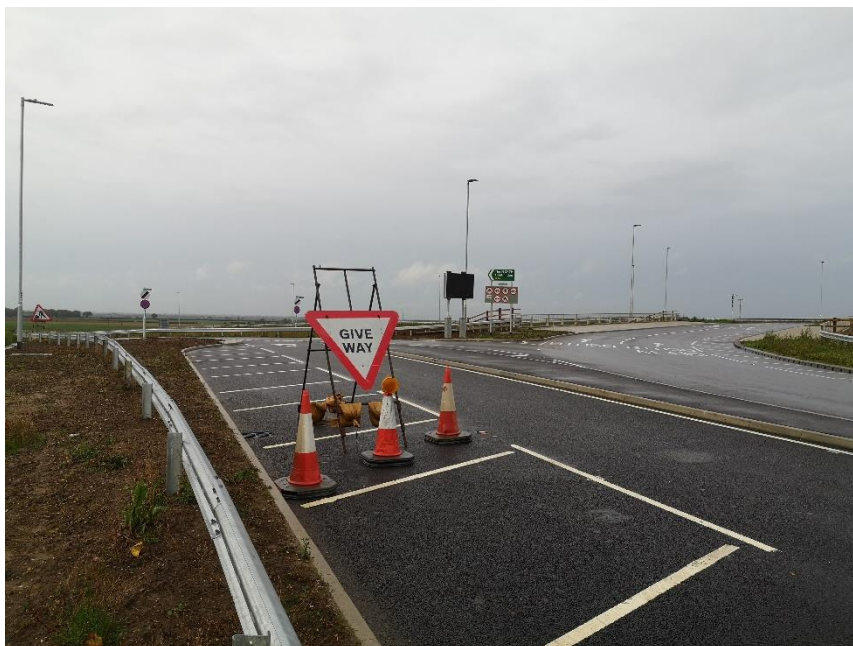
This may in turn result in shunt type collisions from close following vehicles.

Photo 6: Showing temporary give-way sign on approach to intersection

It is recommended that measures to provide motorists with additional warnings about the requirement to 'give way' are provided.

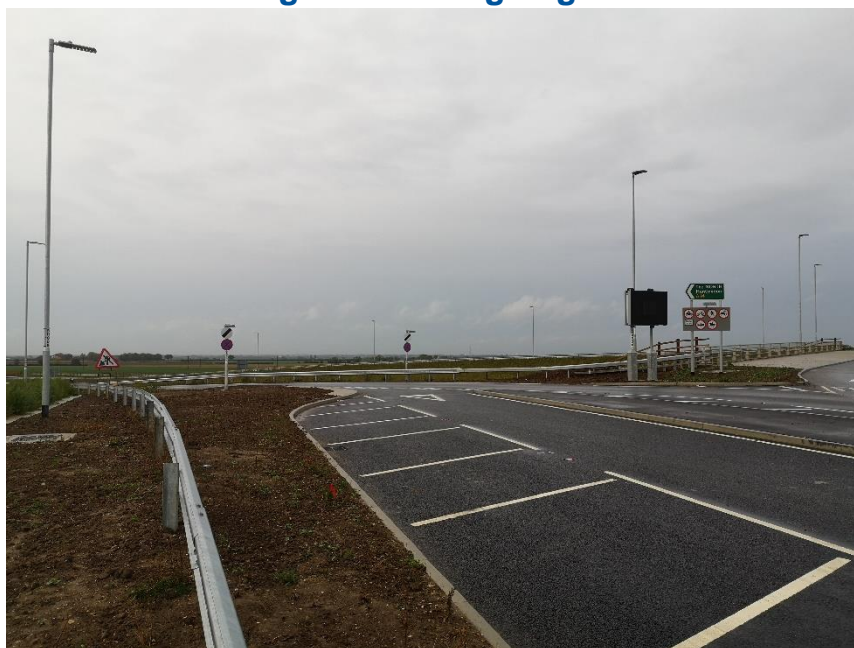
This requires the driver to come to a stop and look over their shoulder or use their mirrors to gauge a suitable gap to allow them to join the circulating traffic. It was observed that some drivers were experiencing difficulty when undertaking this manoeuvre.

There is a risk that this continued behaviour may increase the risk of rear end shunt type collisions at the give way line or has the potential for drivers to misjudge vehicles exiting the roundabout, resulting in conflicts.

Photo 7: Showing intersecting angle of SLTL with slip road

It is recommended that measures to create a larger entry / intersecting angle with the slip road are investigated.

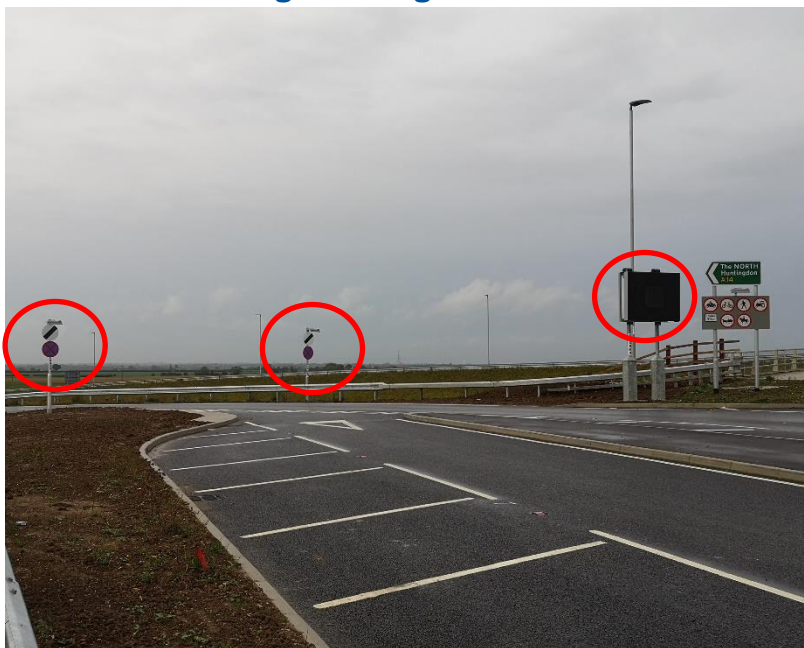
The provision of the NSL roundels for this link is considered to be contradictory to the operation of the VMSL and this may result in reduced speed limit compliance by motorists joining the A14. There is a concern that could result in an increased risk of collisions, particularly with slow / stationary traffic on the slip road.

Photo 8: Showing NSL signs and the ESS in contradiction

It is recommended that the NSL signs are removed and replaced with signs informing road users of the VMSL in operation.
