A14 Cambridge to Huntingdon Improvement Scheme

IRSA3 SWAVESEY AND LAR LINK (SWAVESEY TO BAR HILL) RESPONSE REPORT

03 August 2020

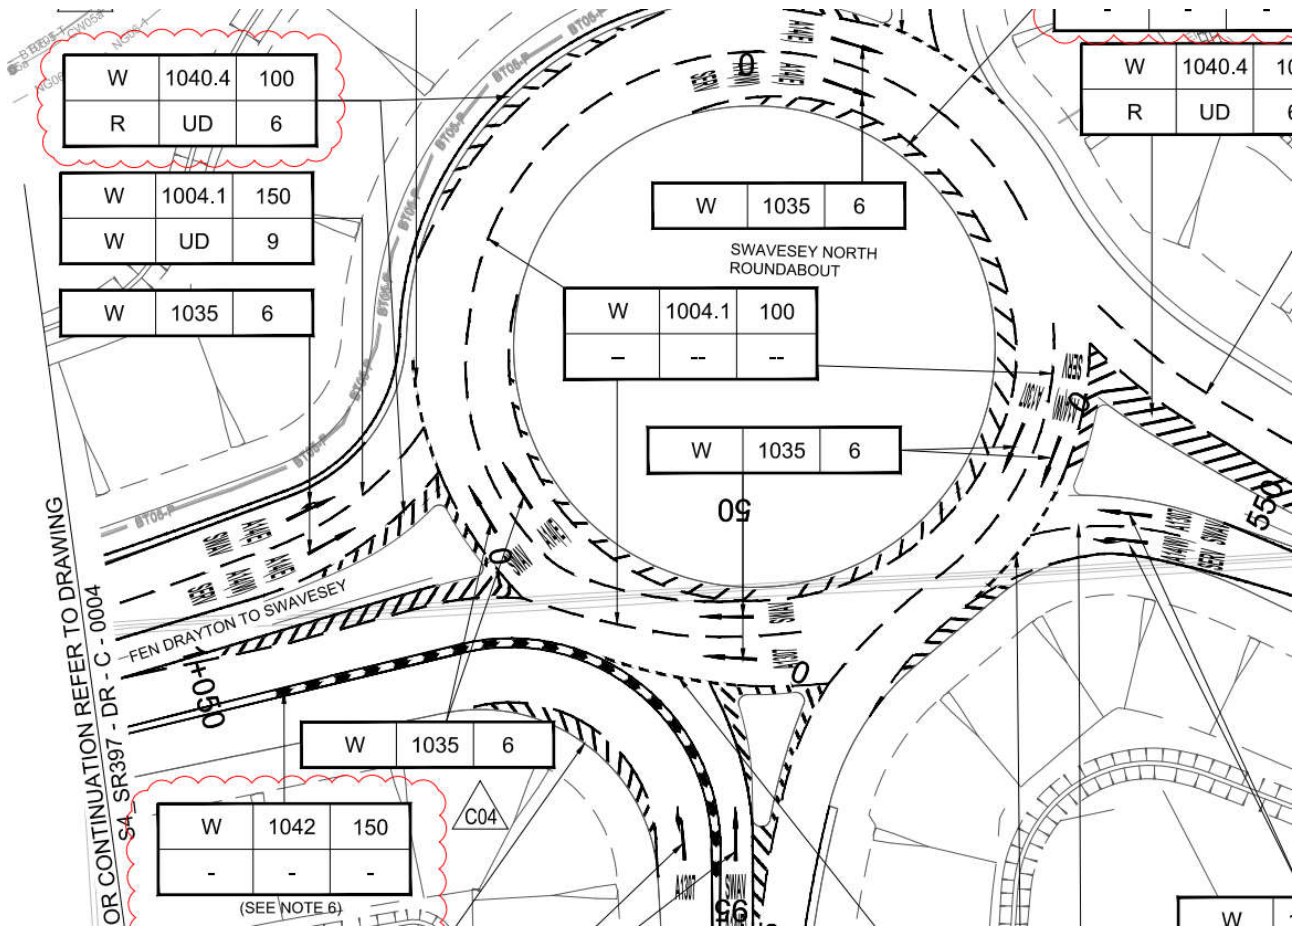
Problem 001

Location: A14 eastbound, Swavesey northern roundabout.

Summary: Lane markings on the entry arm approaches and circulatory carriageway markings may result in conflicts.

- 3.1. Vehicles turning right from the A14 Swavesey eastbound exit slip road, onto the LAR towards Swavesey and the Bucking Way roundabout would ordinarily be in Lane 2.
- 3.2. Similarly, vehicles turning right from Swavesey Link Road, west onto the A1307, would be in Lane 2 on the approach to the roundabout.
- 3.3. The Audit Team is of the opinion that the lane marking on the approaches and on the circulatory carriageway require motorists to change lanes in order to exit their intended destination.
- 3.4. This is likely to result in conflicts / side-swipe collisions on the roundabout.

- 3.6. **Agreed** – The Designer has reviewed Drg No HA528983-ACJV-HMK-S4_SR397-DR-C-0005 - C04 [refer snapshot below] and is content there is no confusion in the configuration of road marking provision

3.7. Potentially this could be an incomplete installation. Construction details should be verified against the IFC information.

- 3.5. It is recommended that the configuration of entry arm approach lanes and traffic lanes on the circulatory carriageway are reviewed and amended.

3.8. OO agree Designers Response - arrows and destination markings on the circulatory carriageway were missing at the time of audit - to be raised as DOWLS.

3.9. OO to raise DOWLS for incomplete items.

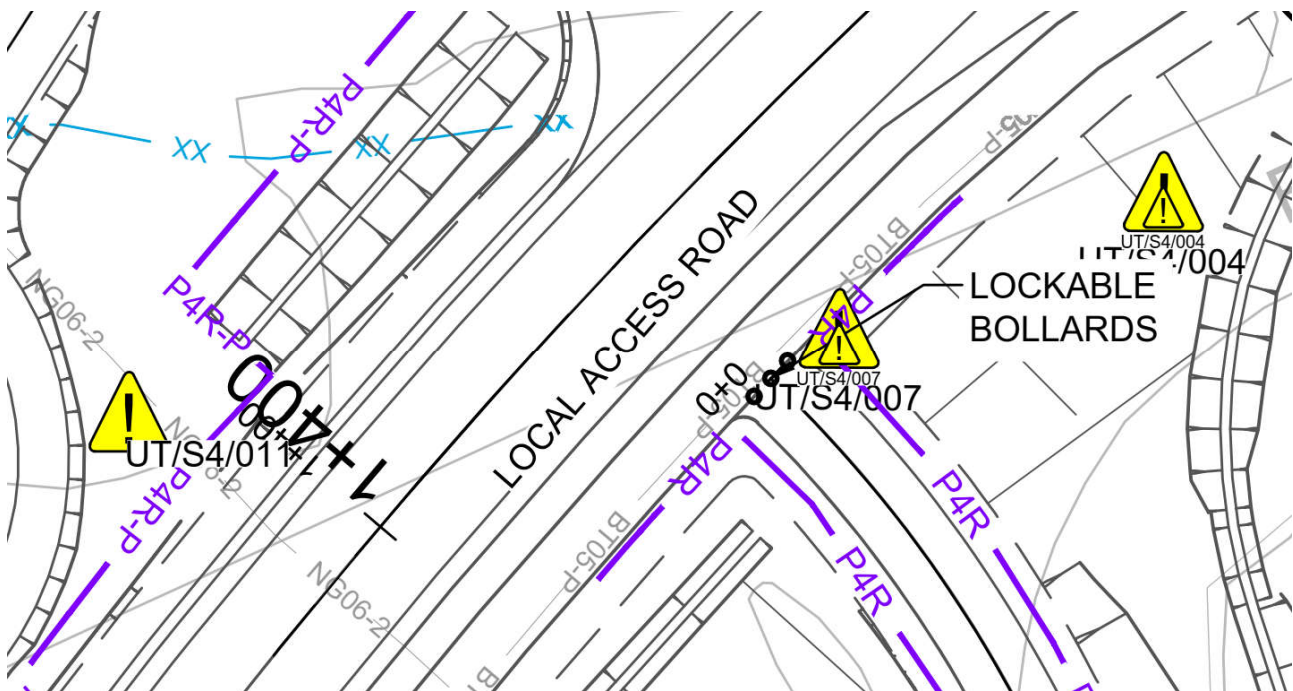
Problem 004

Location: LAR, northern side, approximate Ch.1+375

Summary: Risk of cycle conflicts with pedestrians and motor traffic.

- 3.24. The Swavesey NMU bridge has a continuation of the NMU route that descends towards the northern side of the LAR. There are no measures at the bottom of the ramp to mitigate speeds of cyclists.
- 3.25. This has the potential for cyclists to either exit rapidly onto the LAR, potentially conflicting with vehicles traversing along it, or to collide with pedestrians traversing along the NMU route on the northern side of the LAR.

- 3.27. **Agreed** – The Designer agrees that measures to control cycle speeds on the ramp should be considered and implemented where considered appropriate.
- 3.28. The Designer notes that the AIP for the associated footbridge requires provision to be made for vehicular access; Drg No HA528983-ACJV-HFE-S4_SR397-DR-C-1007-C04 shows the proposals for lockable bollards [refer snapshot below].

- 3.26. It is recommended that measures are introduced to reduce cycle speeds on the descent from the NMU overbridge.

- 3.30. Designer to determine provision of suitable measures to both manage cycle speeds AND allow vehicular access for maintenance to the footbridge.
