RE: Request for Information – RFI3321

TITLE HITCHIN HOSPITAL BEDFORD ROAD HITCHIN		(DRAFT)

Homes & Communities Agency
Site Name:	Hitchin Hospital	
Site ID:

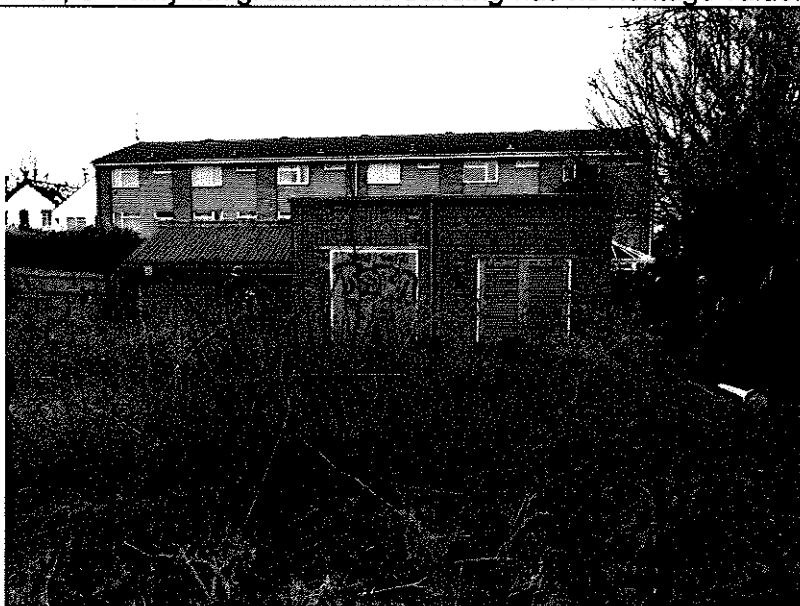
Electricity Sub-station

The electricity sub-station lies the east of the main hospital complex just to the north of a pathway. The sub-station is an L-shaped modern brick building with two rooms, one containing the generator, the other circuitry. The sub-station is located in a small square plot of land with bramble cover, on fairly flat ground. The building has no heritage value.

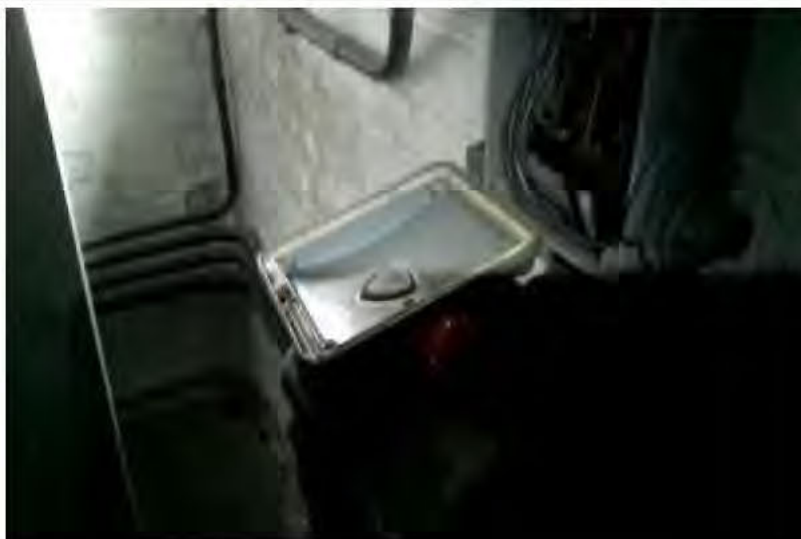
Inspection Number	3	Reference Number:	BB000225
Inspection / Sample	Sample taken	Inspection Cross Reference / Visual I.D.	N.A.D.I.S

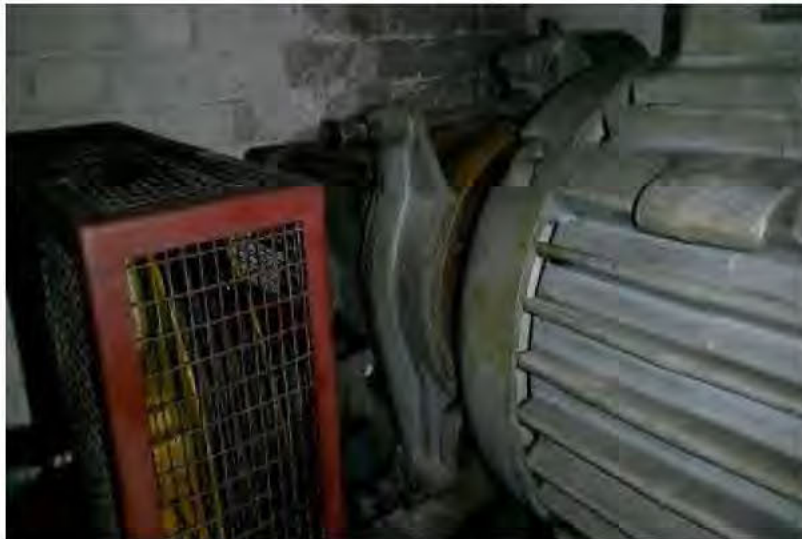
Inspection Number	4	Reference Number:	BB000226
Inspection / Sample	Sample taken	Inspection Cross Reference / Visual I.D.	Asbestos Identified

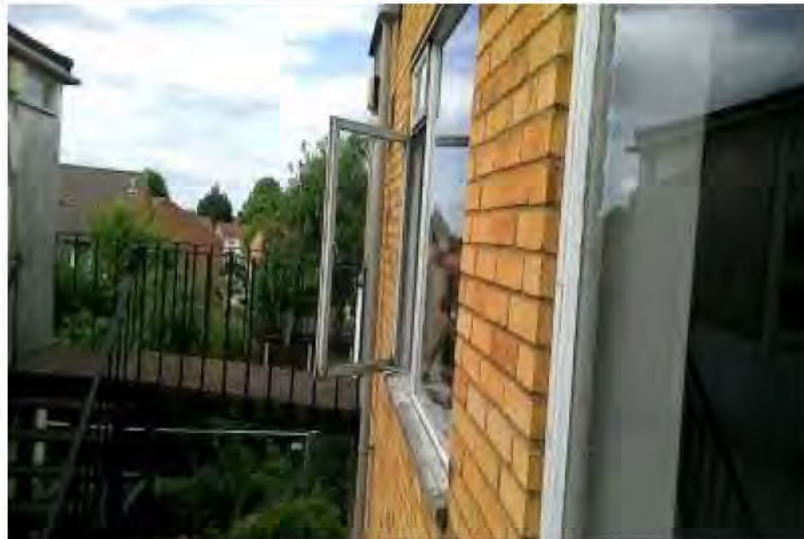
Inspection Number	12	Reference Number:	BB000234
Inspection / Sample	Sample taken	Inspection Cross Reference / Visual I.D.	N.A.D.I.S

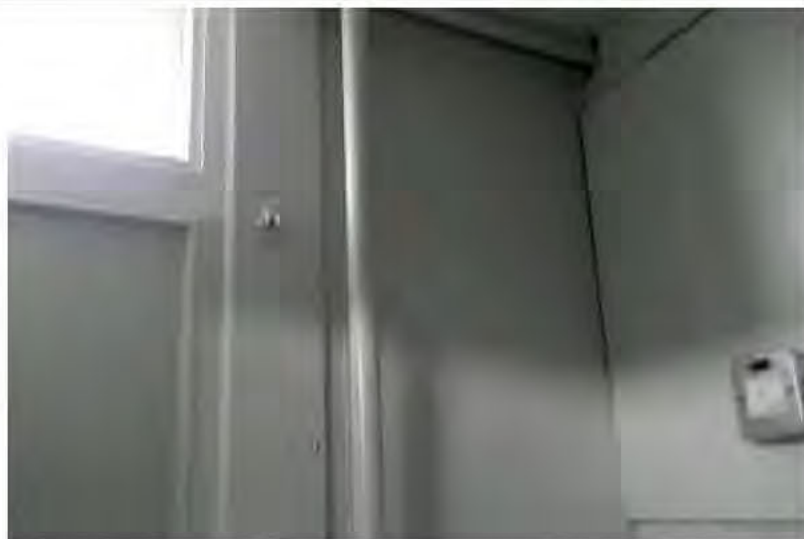
Inspection Number	14	Reference Number:	As Sample BB000235
Inspection / Sample	Visually similar to	Inspection Cross Reference / Visual I.D.	As Sample

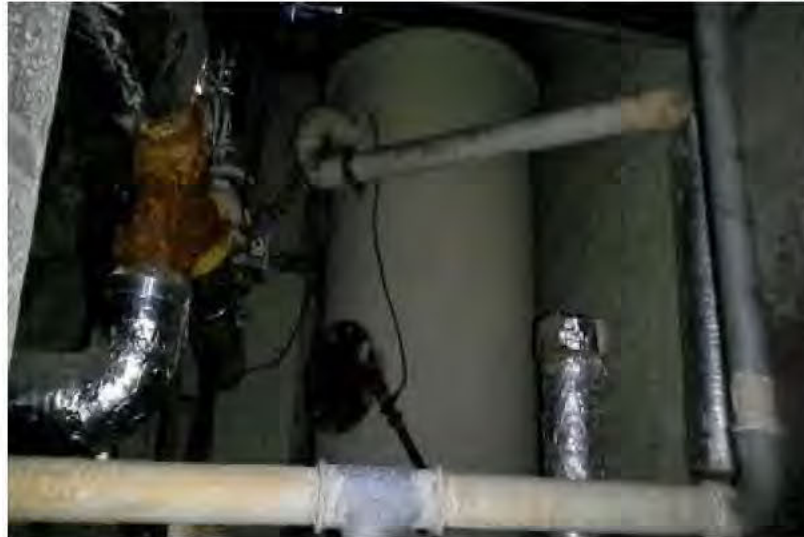
Inspection Number	24	Reference Number:	BB000243
Inspection / Sample	Sample taken	Inspection Cross Reference / Visual I.D.	Asbestos Identified

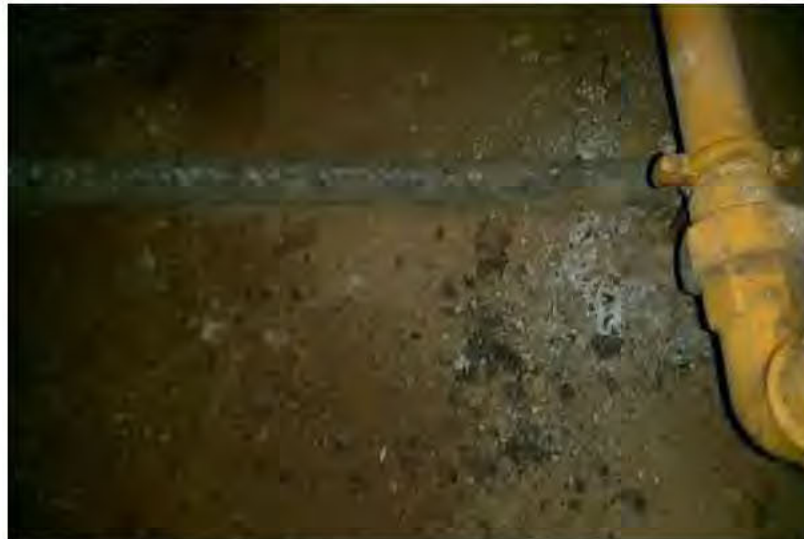
Inspection Number	28	Reference Number:	BB000247
Inspection / Sample	Sample taken	Inspection Cross Reference / Visual I.D.	Asbestos Identified

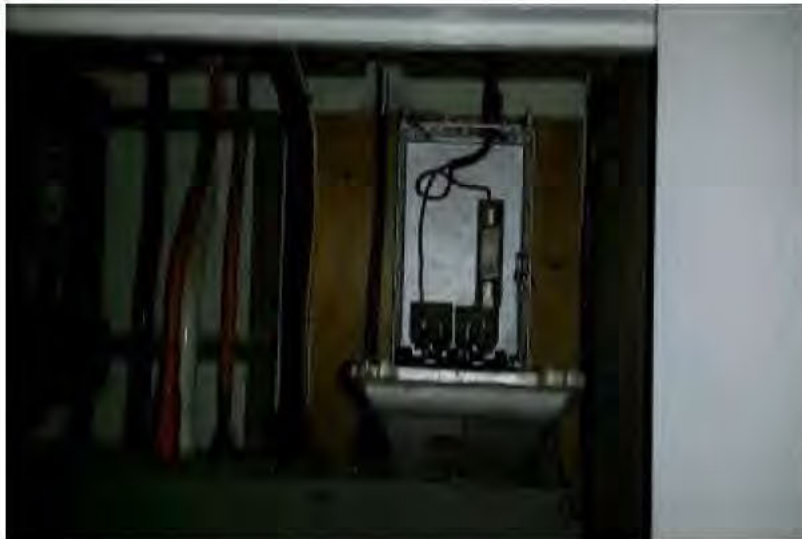
Inspection Number	34	Reference Number:	BB000250
Inspection / Sample	Sample taken	Inspection Cross Reference / Visual I.D.	Asbestos Identified

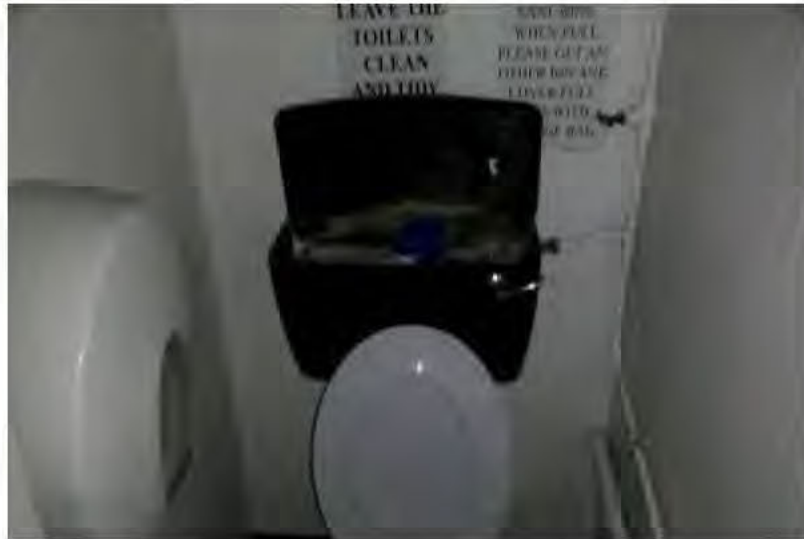
Inspection Number	48	Reference Number:	BB000255
Inspection / Sample	Sample taken	Inspection Cross Reference / Visual I.D.	Asbestos Identified

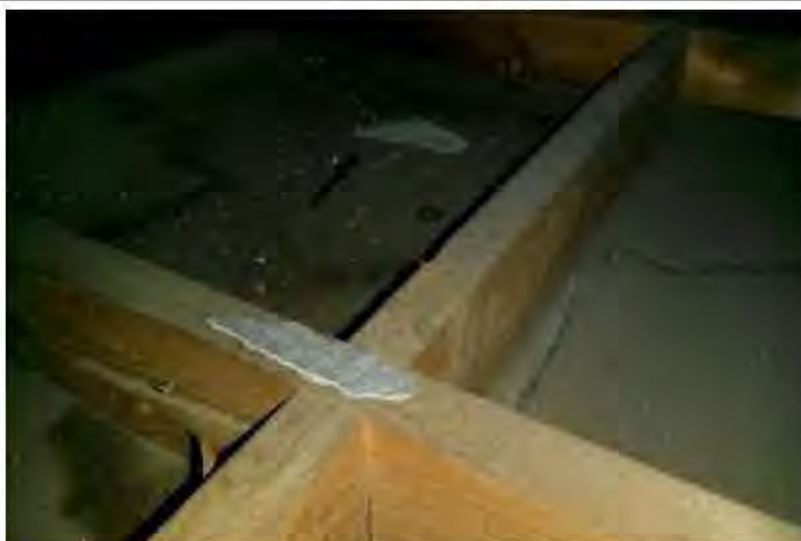
Inspection Number	66	Reference Number:	BB000259
Inspection / Sample	Sample taken	Inspection Cross Reference / Visual I.D.	Asbestos Identified

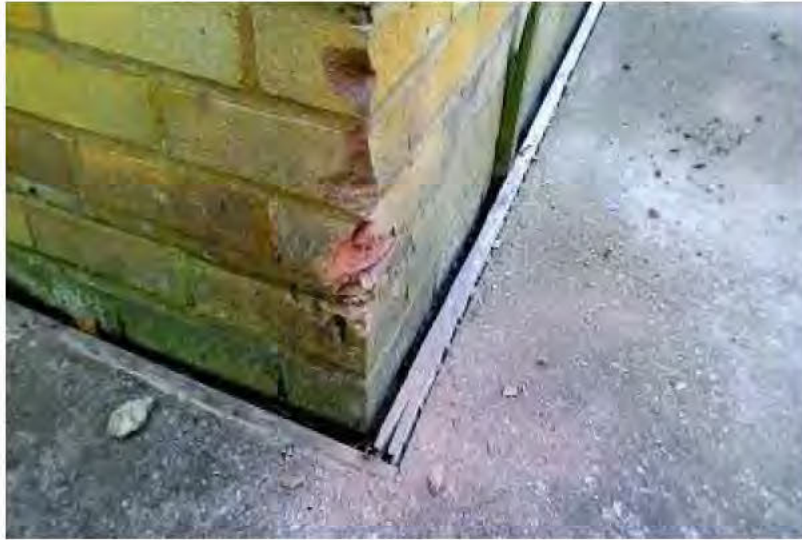
Inspection Number	77	Reference Number:	BB000260
Inspection / Sample	Sample taken	Inspection Cross Reference / Visual I.D.	Asbestos Identified

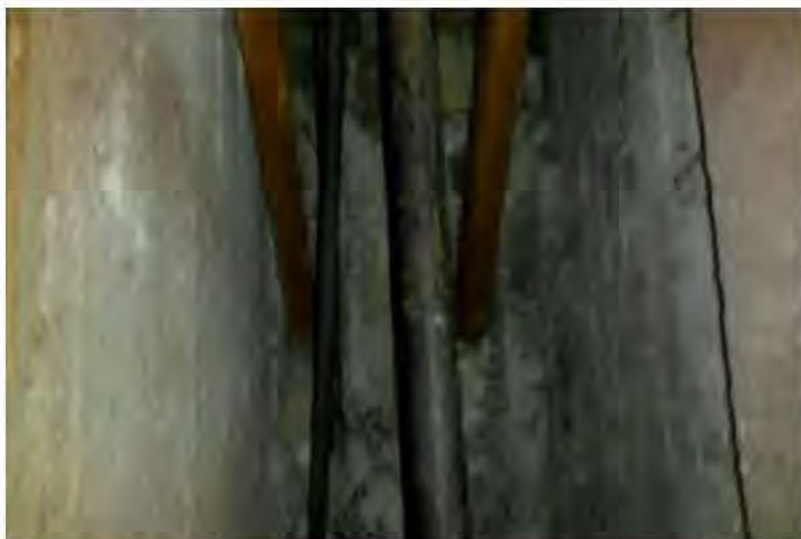
Inspection Number	90	Reference Number:	BB000267
Inspection / Sample	Sample taken	Inspection Cross Reference / Visual I.D.	Asbestos Identified

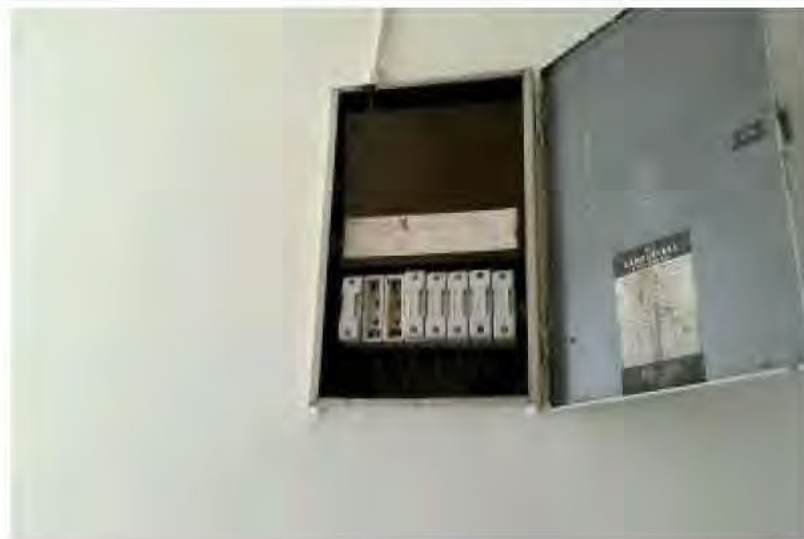
Inspection Number	136	Reference Number:	BB000286
Inspection / Sample	Sample taken	Inspection Cross Reference / Visual I.D.	Asbestos Identified

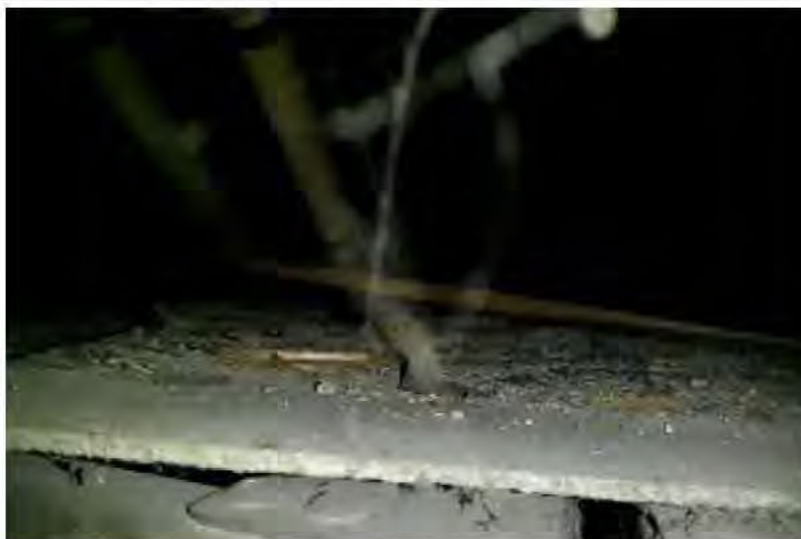
Inspection Number	142	Reference Number:	BB000290
Inspection / Sample	Sample taken	Inspection Cross Reference / Visual I.D.	Asbestos Identified

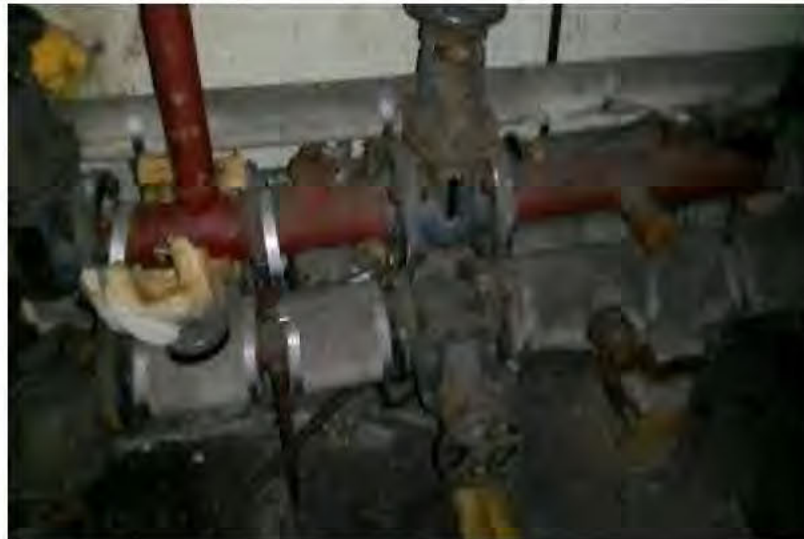
Inspection Number	159	Reference Number:	BB000297
Inspection / Sample	Sample taken	Inspection Cross Reference / Visual I.D.	Asbestos Identified

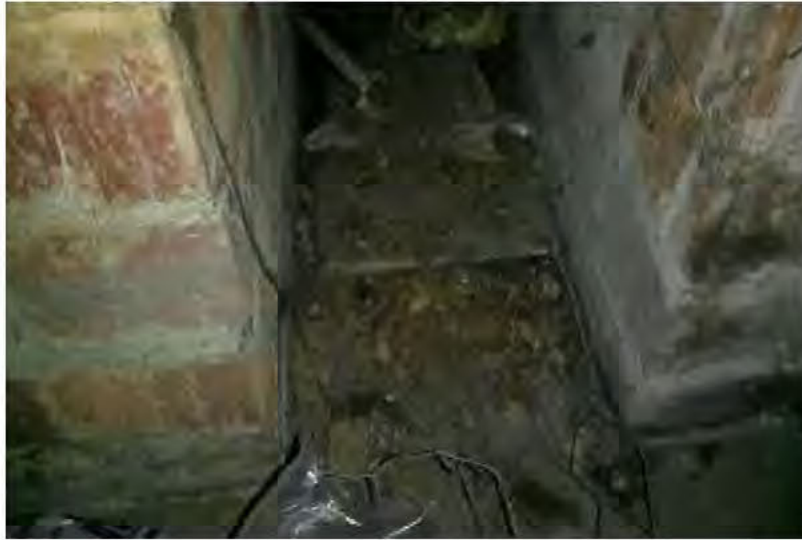
Inspection Number	163	Reference Number:	BB000301
Inspection / Sample	Sample taken	Inspection Cross Reference / Visual I.D.	Asbestos Identified
