Appendix H: WP9 – Site investigations

Prepared by BRE

BEIS Research Paper Number: 2021/017

1 Site investigations

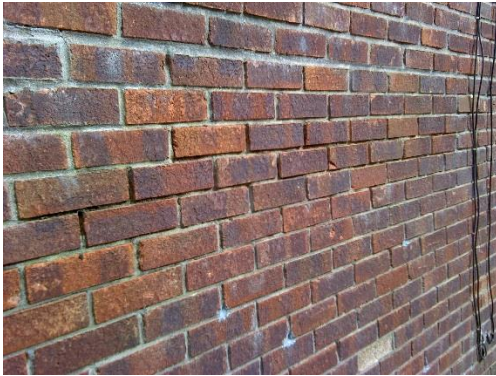
Eroded mortar

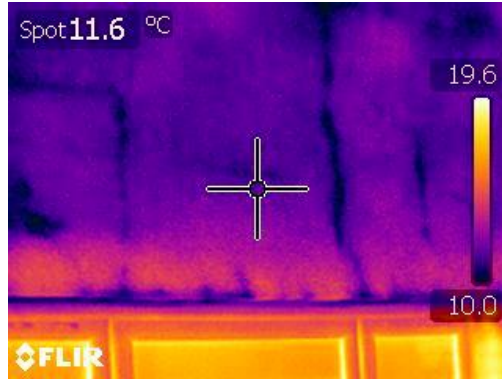
Cracking identified with IR camera

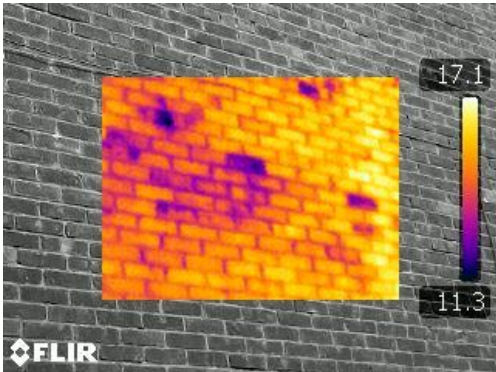
Elevated wetness in bricks caused by erosion or face damage

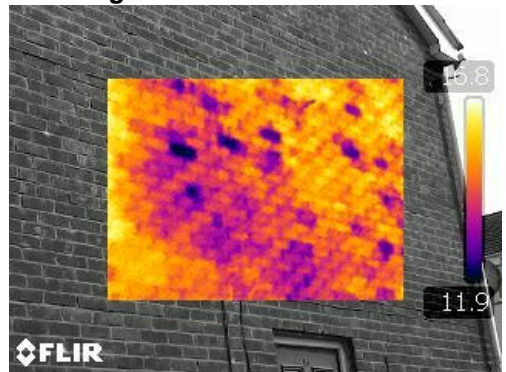
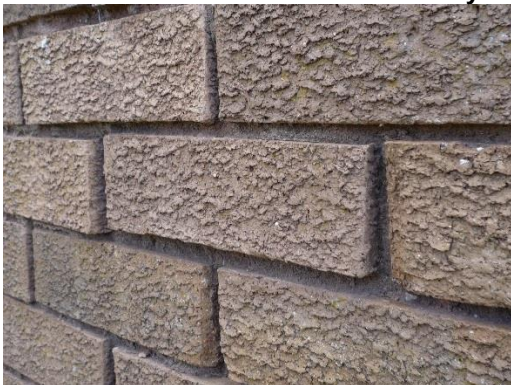
Incorrect pointing

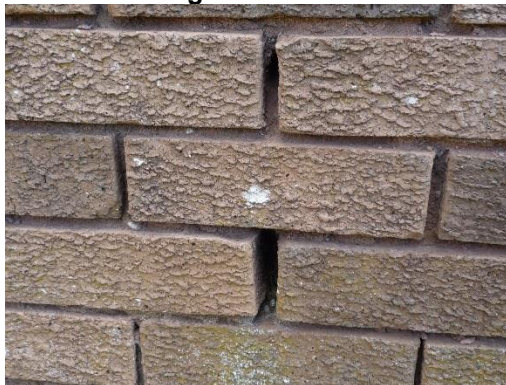
Severely eroded mortar perp end

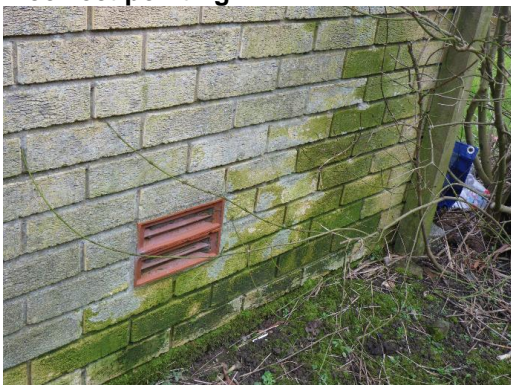
Wetness causing mossy growth

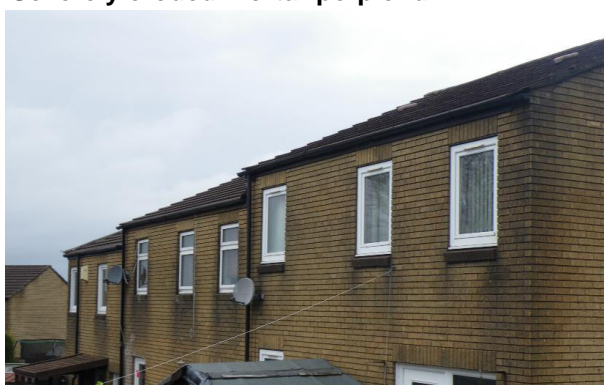
Insufficient overhang of sills and verge

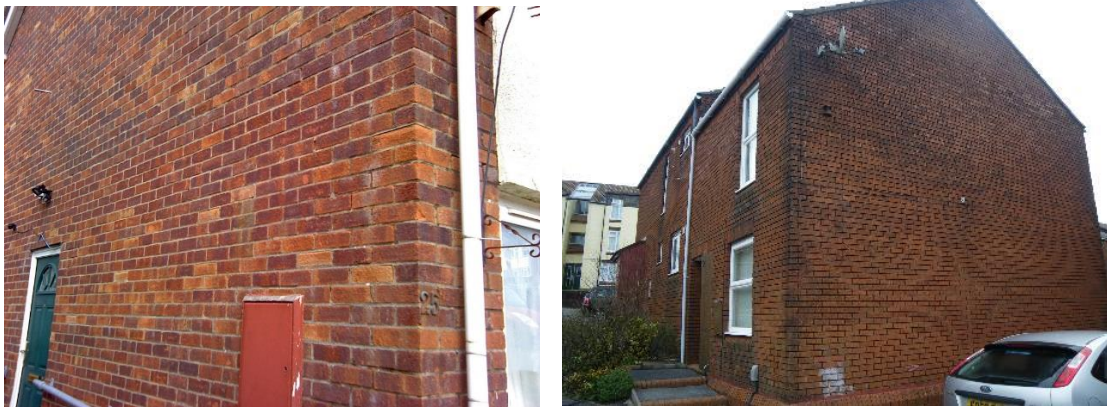
Damaged face of bricks

Visibly wet and stained brickwork
