# ***AAIB Bulletin***

***5/2021***

<b>Aircraft Type and Registration:</b>	BAe ATP, SE-MAO	
<b>No &amp; Type of Engines:</b>	2 Pratt & Whitney Canada PW126 turboprop engines	
<b>Year of Manufacture:</b>	1989 (Serial no: 2011)	
<b>Date &amp; Time (UTC):</b>	18 August 2020 at 0825 hrs	
<b>Location:</b>	After departure from Jersey Airport, Channel Islands	
<b>Type of Flight:</b>	Commercial Air Transport (Cargo)	
<b>Persons on Board:</b>	Crew - 2	Passengers - None
<b>Injuries:</b>	Crew - None	Passengers - N/A
<b>Nature of Damage:</b>	None	
<b>Commander's Licence:</b>	Airline Transport Pilot's Licence	
<b>Commander's Age:</b>	50 years	
<b>Commander's Flying Experience:</b>	14,500 hours (of which 100 were on type) Last 90 days - 60 hours Last 28 days - 30 hours	
<b>Information Source:</b>	AAIB Field investigation

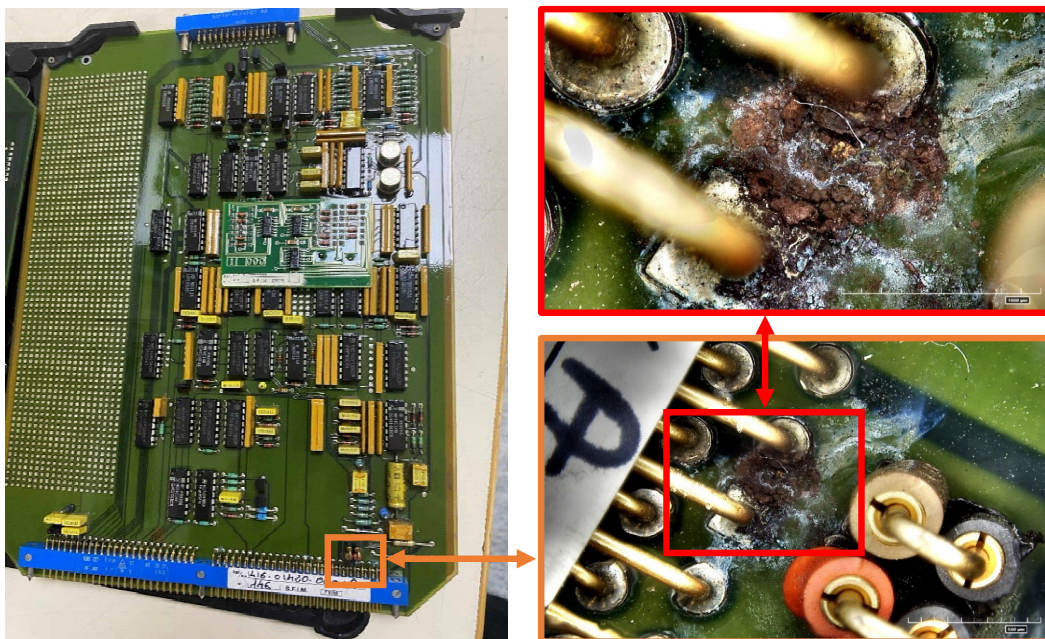
**Figure 5**

The printed circuit boards (PCBs) were removed and visual examination found localised corrosion, white translucent staining, and an accumulation of detritus on three of them. The affected PCBs were associated with the SCS logic and autopilot servo operation (Figure 5).

Corrosion, white staining and debris on one of the PCBs

The manufacturer responsible for the autopilot design reviewed photographs of the PCBs and stated that, in their opinion, the corrosion was probably caused by trapped flux, possibly left after a previous repair. They noted an area adjacent to one corrosion site where there was a visible difference in the conformal coating, Figure 6. The repair records from 2001 were no longer available so the detail of the work carried out is unknown.

When the PCBs were removed there was evidence of localised corrosion on the boards that control the autopilot servo and SCS logic. The overhaul agency and aircraft manufacturer advised that corrosion was not a known issue, and the manufacturer responsible for the design advised that it was probably caused by residual flux under the conformal coating, possibly from a previous repair. There is no requirement to check the internal condition of a computer that passes the automated test, so under the normal maintenance regime, the computer from SE-MAO would have been categorised as no fault found and recertified as airworthy.

Whilst the corrosion in the computer was worthy of note, there was no evidence to link it to this serious incident. The Type Certificate holder concluded that, with respect to the autopilot computer, the existing maintenance programme was appropriate to maintain continued airworthiness of the ATP fleet.

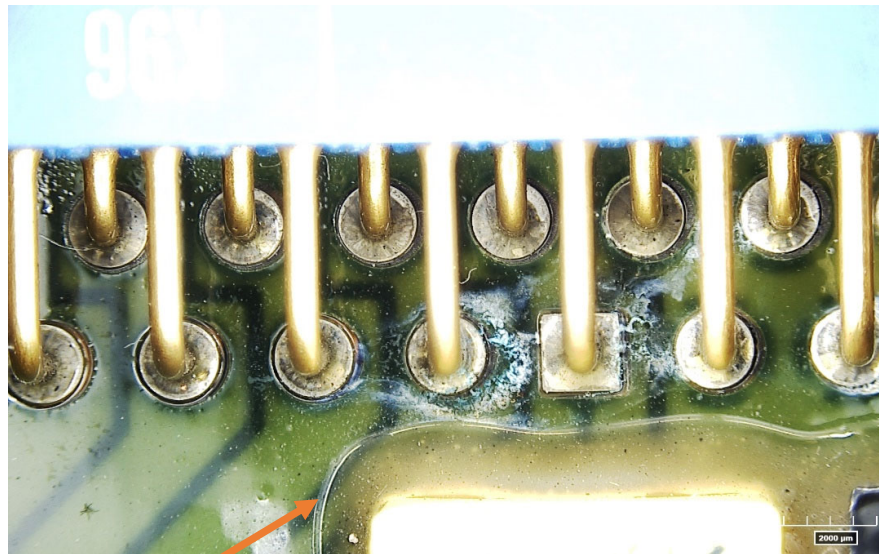
**Figure 6**

Discontinuity in the conformal coating

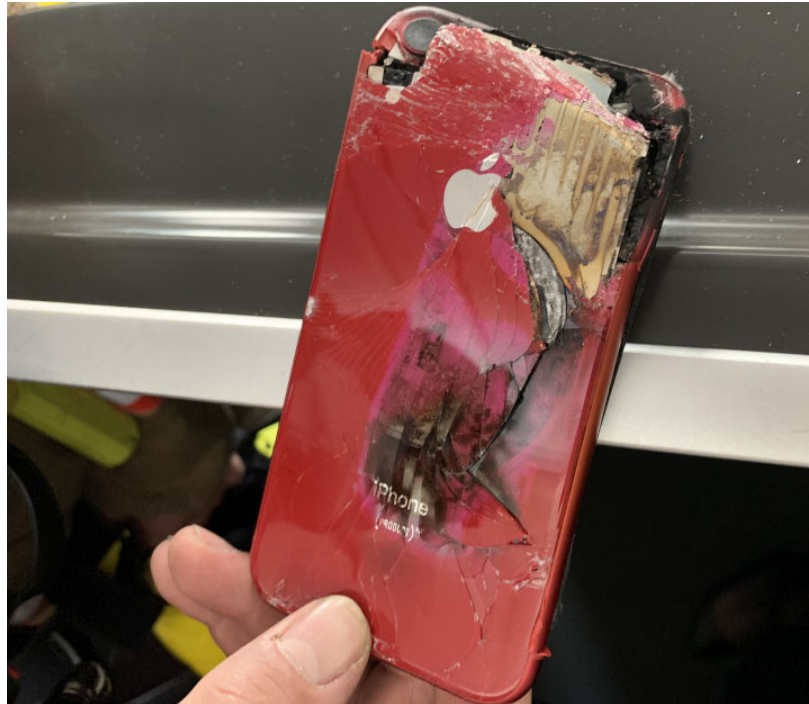
The aircraft was approaching the top of descent when the cabin crew saw smoke emanating from a passenger seat. It was discovered that a mobile phone had fallen down the side of the seat and had been crushed in the seat mechanism. The cabin crew extinguished the fire and the aircraft continued to its destination. There was no damage to the aircraft.

After landing the fire service boarded the aircraft and removed the device from the seat (Figure 1). There was no damage to the aircraft.

**Figure 1**  
Mobile phone retrieved by the fire service after landing

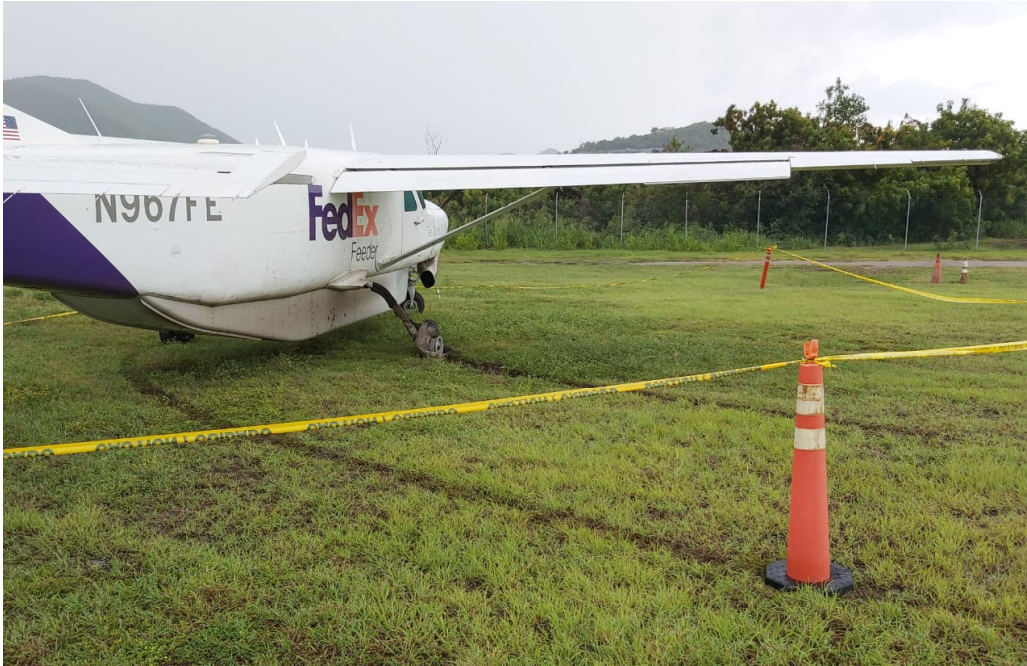
**Figure 3**

N967FE after the incident

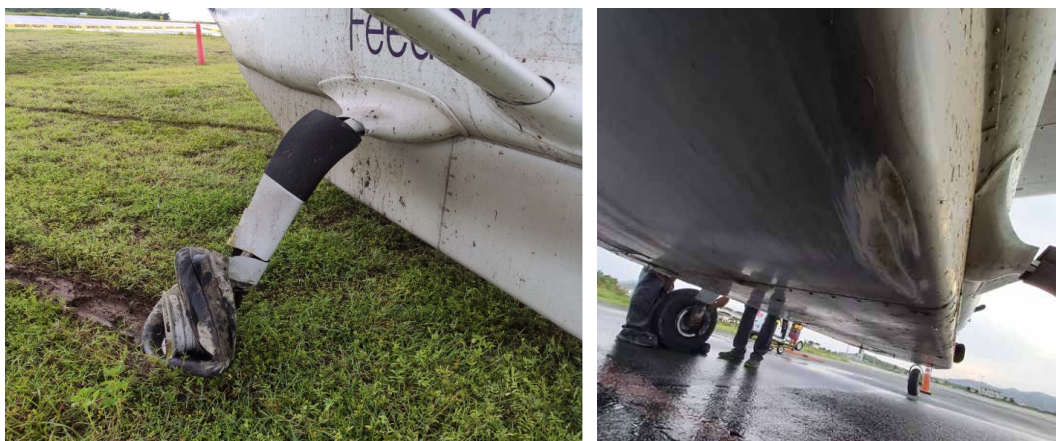
**Figure 4**

Damage to right wheel assembly and under-fuselage baggage pod

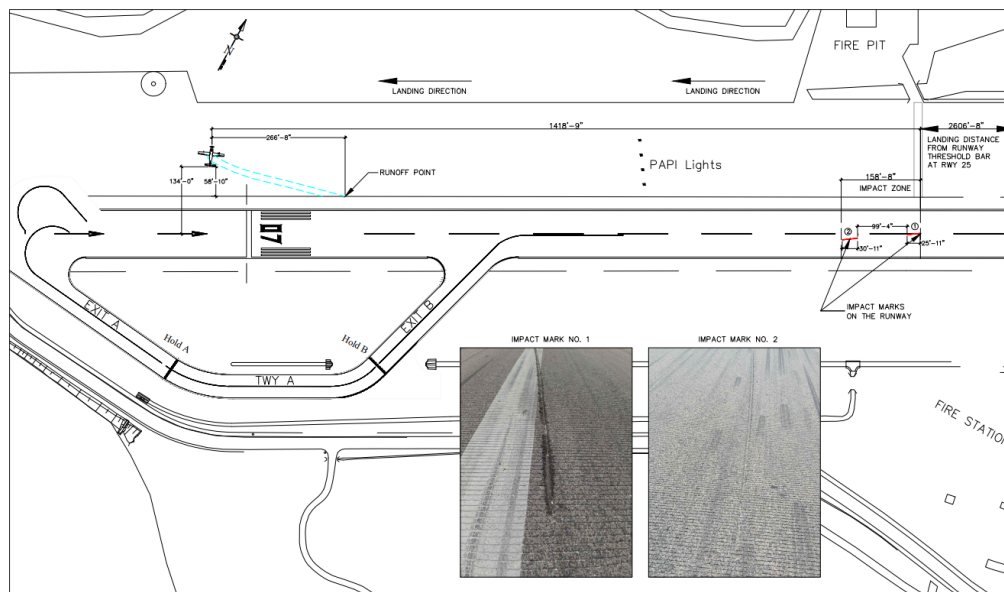
**Figure 5**

Aerodrome map showing initial impact marks and final position

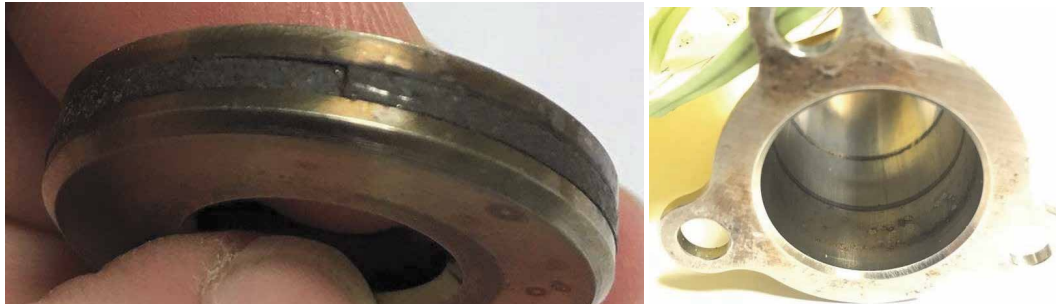
**Figure 2**

Corrosion found on piston and sleeve inner bore  
(Images used with permission of the operator)

The corroded components were replaced, and the valves operated normally during the subsequent ground runs with no oil smells or haze in the cabin.

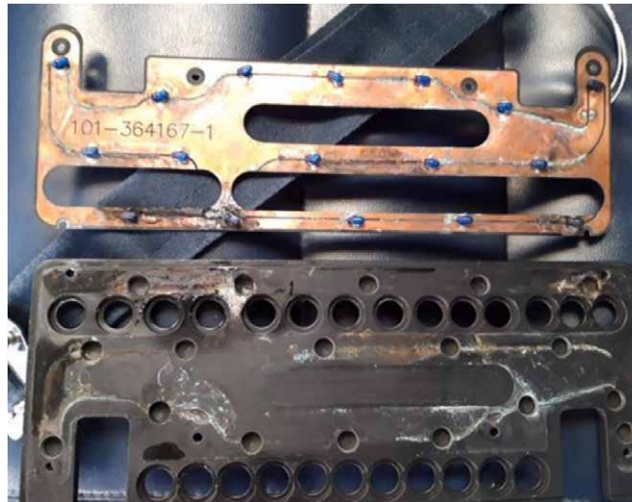
**Figure 1**

The operator found evidence of moisture ingress in the commander's CB panel and there was overheat and burning damage on the back-lighting circuit board (Figure 1).

CB panel showing evidence of moisture ingress and overheating

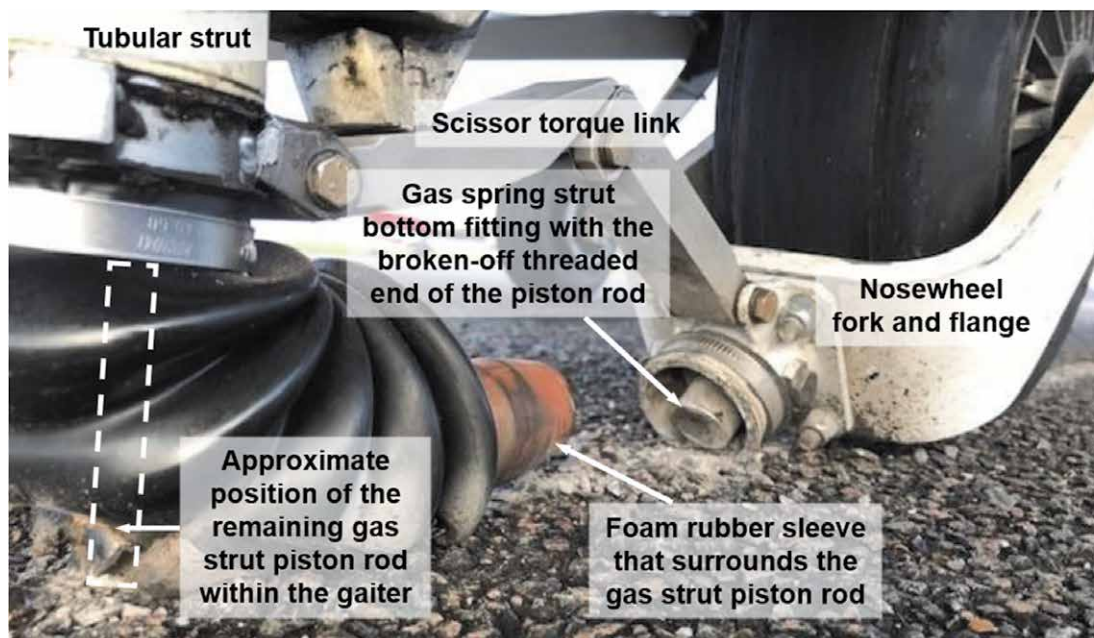
**Figure 1**

For the landing, the instructor prolonged the flare as much as possible to minimise the nose landing gear contact with the paved runway surface. During the landing rollout, the aircraft derotated onto the upper half of the nose landing gear, with the nosewheel assembly dragging behind, still attached by the scissor torque link (Figure 1), allowing the propeller blades to contact the ground.

Nose landing gear assembly after landing

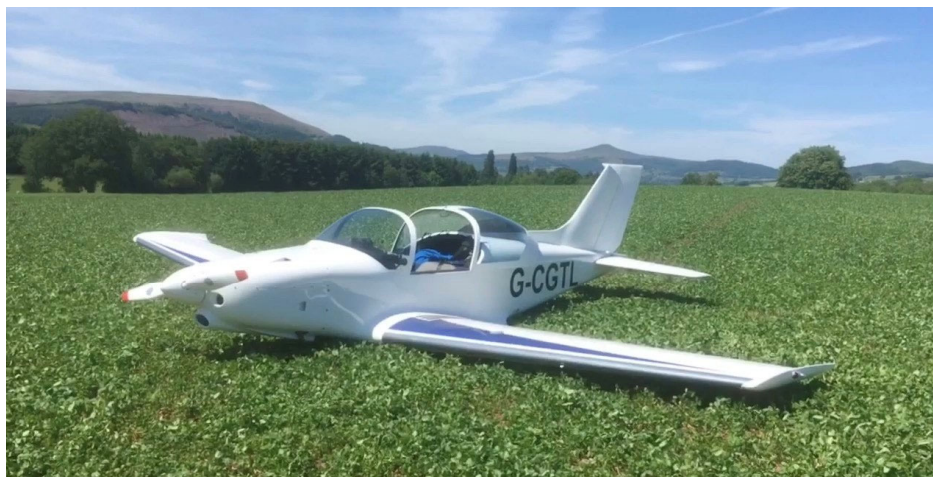
**Figure 1**  
G-CGTL after landing

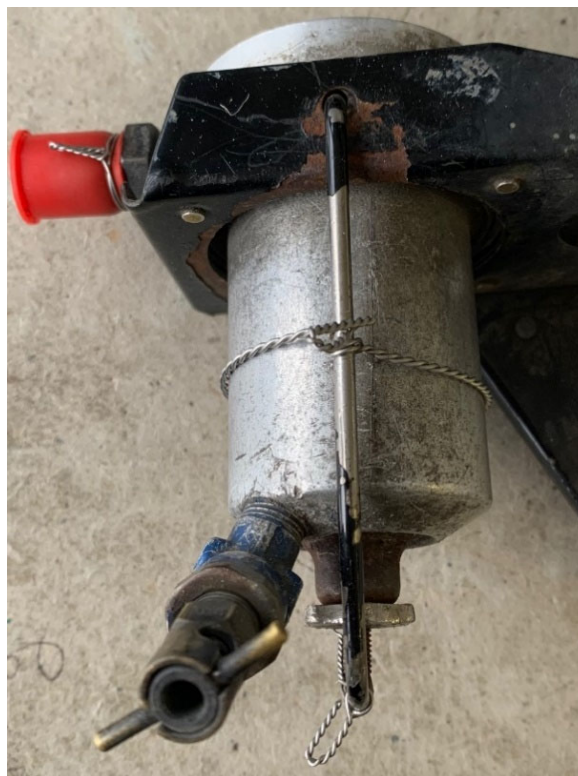
**Figure 4**

G-BZDA would have been equipped with a non-lockable gascolator drain as standard when built, but when inspected after the accident it was found to have a lockable version (Figure 4). The investigation was not able to identify how, when or why the original drain had been replaced with the wrong variant.

Gascolator and drain removed from G-BZDA after the accident

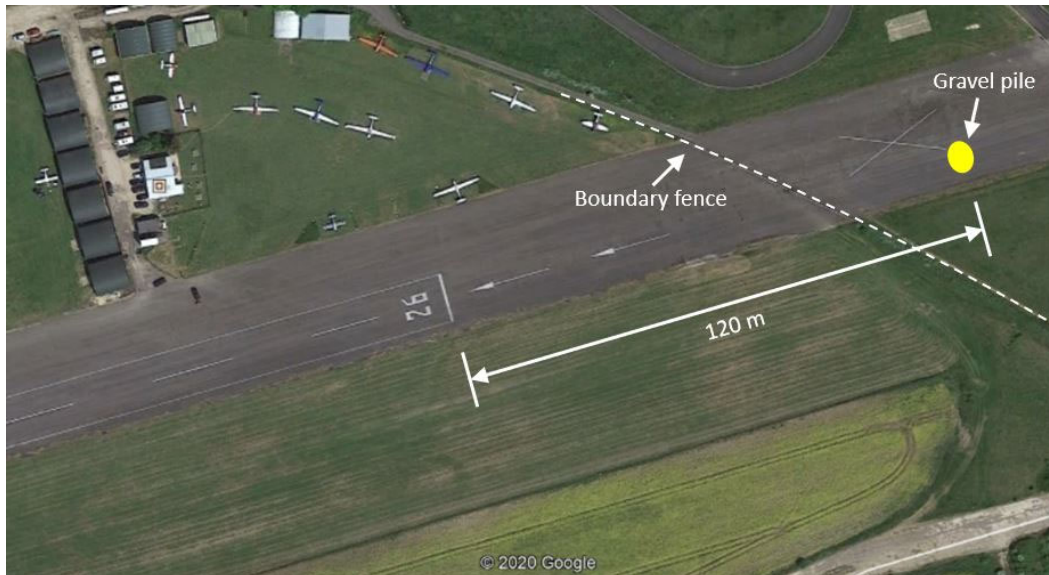
**Figure 1**

The aircraft's left main landing gear tyre struck the top of a 3.5 m tall light-coloured pile of gravel that was being stored on a disused section of the airfield, outside the airfield boundary fence. The gravel pile was on the runway extended centreline, approximately 120 m from the runway threshold (Figure 1).

Gravel pile and Runway 26 threshold

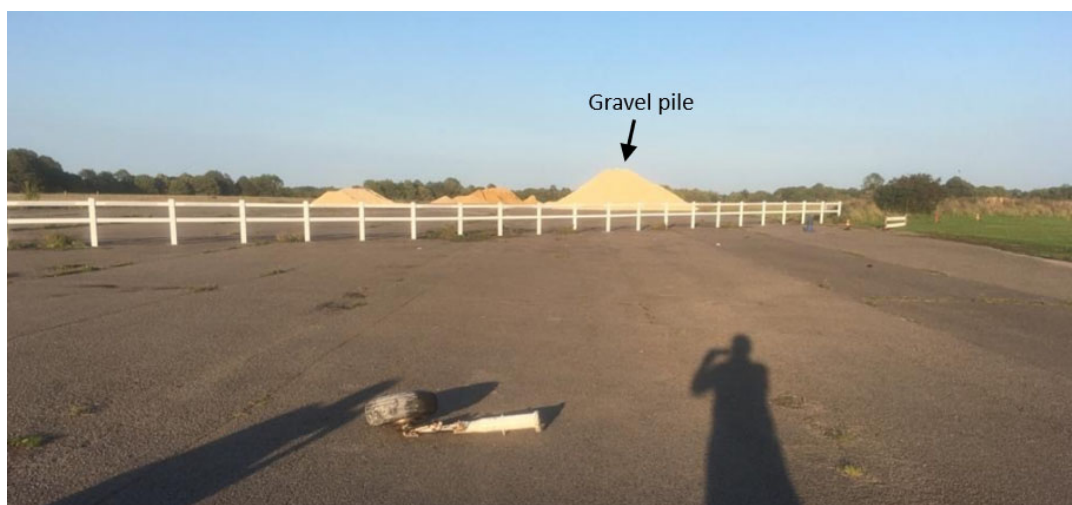
**Figure 2**

The impact caused the left landing gear leg to detach from the aircraft (Figure 2). The instructor made a radio call to the pilot, informing him that he had lost his left landing gear leg and that he should go around. The aircraft was observed to briefly touch down on the right main landing gear before the pilot applied power and the aircraft climbed away.

Gravel pile and detached landing gear leg

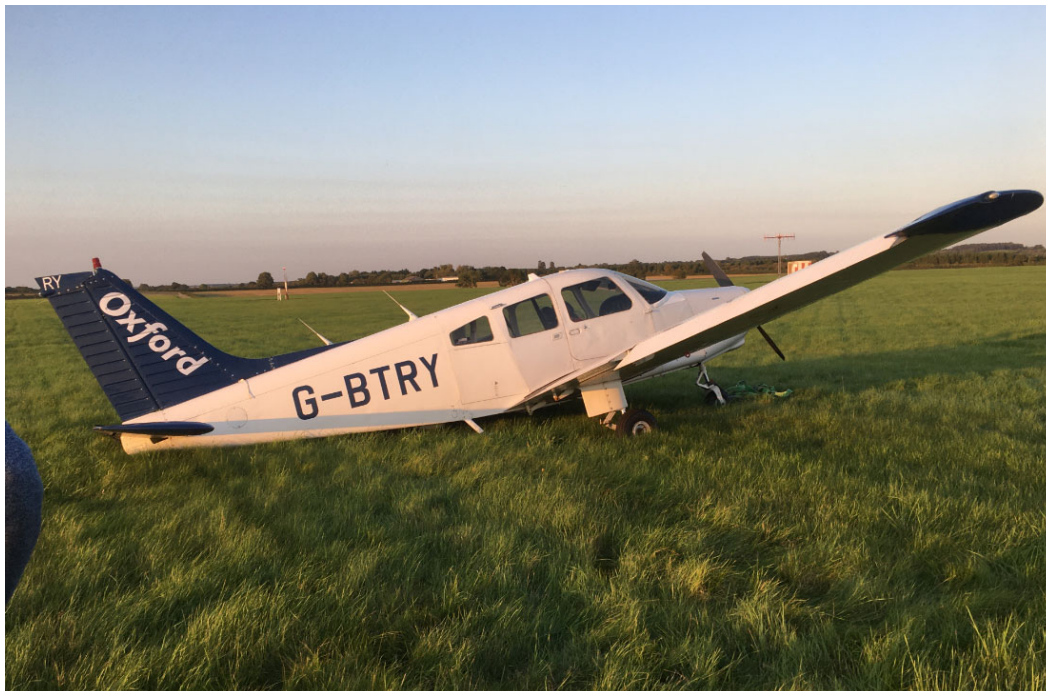
**Figure 3**

G-BTRY after landing at Oxford Airport

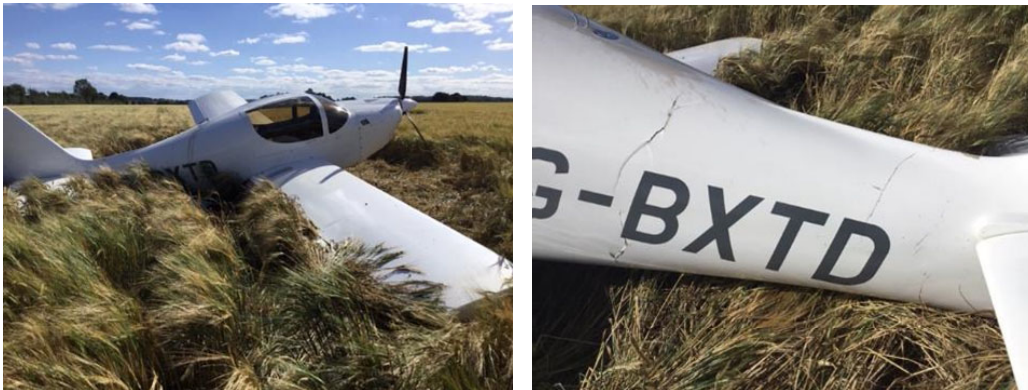
**Figure 1**

Measuring the length of the path through the crops revealed that the aircraft had travelled approximately 50 metres along the ground before stopping. The landing and subsequent turn damaged the aircraft's right undercarriage outrigger, wing, flap and aileron. Cracks were evident in the rear fuselage between the cockpit and tail (Figure 1) and the tail section below the left elevator was also cracked and the skin distorted. There was no damage to the cockpit area.

Aircraft final resting position and cracks evident in the rear fuselage section

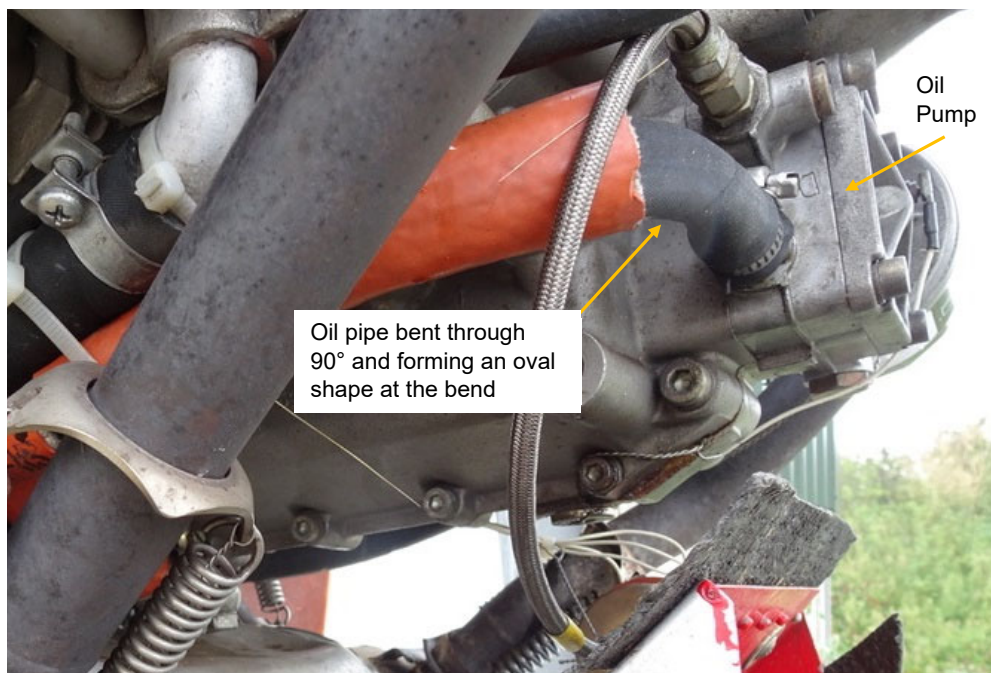
**Figure 2**

Before removing the engine, the owner noticed the cross-sectional shape of the pipe from the oil cooler had narrowed where it had been bent by 90° in order to connect it to the oil pump (Figure 2). On checking the Europa engine installation manual, the owner realised that an oil pipe with a pre-formed 90° bend was available, to avoid bending the pipe when connecting it to the pump. However, the owner also commented that later testing on a bench showed that this geometry only created an 'oval' cross-section in the pipe and did not 'kink' it. Further, the aircraft had flown with the pipe in this geometry for its Permit test flight and for a further flight as part of the owner's type conversion, with no indication of oil pressure problems at any stage.

Oil pipe showing narrowing at the bend connecting it to the pump

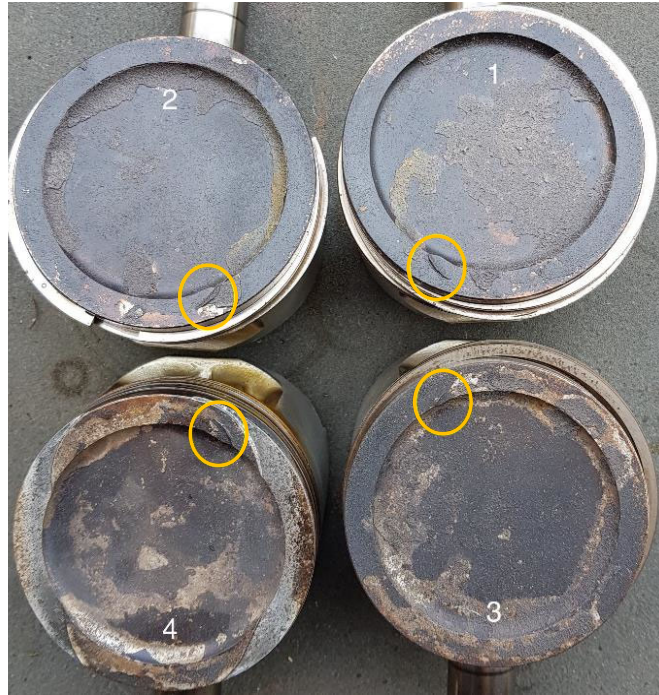
**Figure 3**

After removing the pistons from the engine, dents were found on the top surfaces (crown). The shape of the dents matched the edges of the cylinder inlet valves. None of the inlet valve stems were bent and the edges of the valves showed no signs of impact damage. The dents in the piston crowns were also coated with carbon deposits (Figure 3).

Piston crowns showing dents from impact with inlet valves

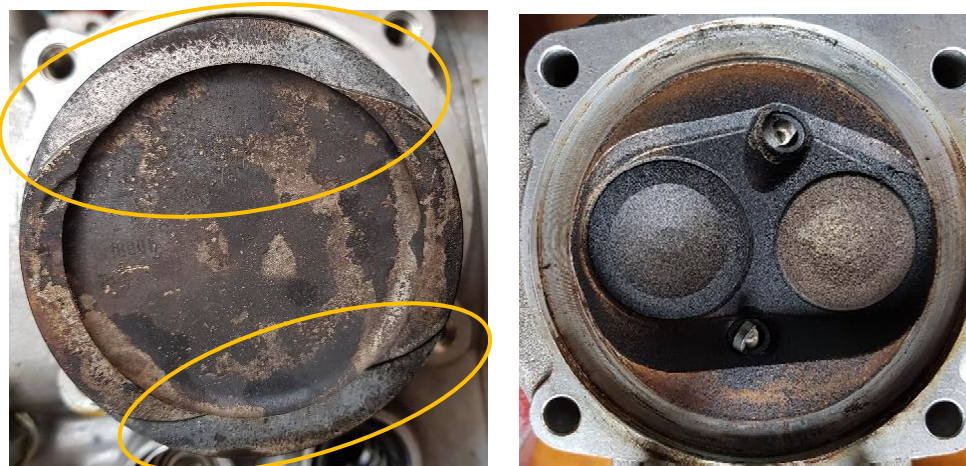
**Figure 4**

The No 4 piston had also been in contact with the cylinder head, creating cylinder head shaped dents in the crown (Figure 4).

Piston crown (left) showing dents made by the cylinder head (right)

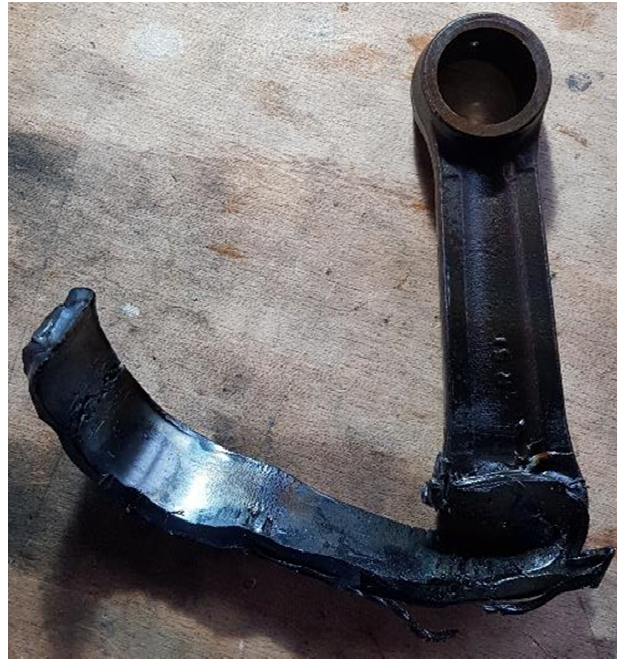
**Figure 5**

When the engine crankcase was opened, it was evident the No 4 piston connecting rod and bearing had failed at the attachment to the crankshaft (Figure 5). There were impact marks along the lower edges of the adjacent No 3 piston and cylinder.

Failed No 4 piston connecting rod
