## ACCIDENT

<b>Aircraft Type and Registration:</b>	Piper PA-28-161 Warrior II, G-BTRY	
<b>No &amp; Type of Engines:</b>	1 Lycoming O-320-D3G piston engine	
<b>Year of Manufacture:</b>	1981 (Serial no: 28-8116190)	
<b>Date &amp; Time (UTC):</b>	13 September 2020 at 1655 hrs	
<b>Location:</b>	Enstone Airfield, Oxfordshire	
<b>Type of Flight:</b>	Private	
<b>Persons on Board:</b>	Crew - 1	Passengers - 1
<b>Injuries:</b>	Crew - None	Passengers - None
<b>Nature of Damage:</b>	Damage to left main landing gear, left wing and tailplane	
<b>Commander's Licence:</b>	Private Pilot's Licence	
<b>Commander's Age:</b>	73 years	
<b>Commander's Flying Experience:</b>	18,400 hours (of which 1,415 were on type) Last 90 days - 112 hours Last 28 days - 38 hours	
<b>Information Source:</b>	Aircraft Accident Report Form submitted by the pilot

## Synopsis

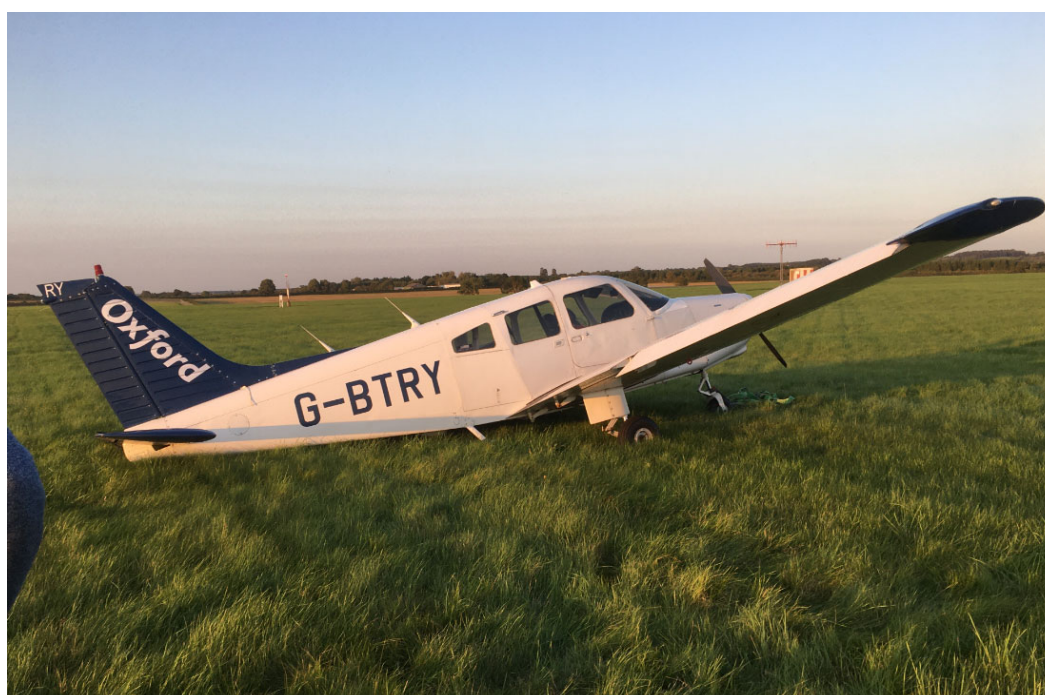
**Figure 3**

Having appraised the situation, and discussed his options with the instructor by radio, the pilot decided to divert to Oxford Airport as it had better rescue and firefighting equipment than Enstone. The instructor called Oxford Airport ATC by phone to brief them on the situation and to expect G-BTRY to arrive shortly. The pilot contacted Oxford Airport by radio and landed on Runway 19. Shortly after touchdown the aircraft left the runway's paved surface to the left, coming to rest on the grass (Figure 3). The damage to the aircraft was limited to the left wing and the tailplane, and neither the pilot nor his passenger were injured.

G-BTRY after landing at Oxford Airport
