INCIDENT

Aircraft Type and Registration:	Piper PA-28-161, G-BZDA	
No & Type of Engines:	1 Lycoming O-320-D3G piston engine	
Year of Manufacture:	2000 (Serial no: 2842087)	
Date & Time (UTC):	13 September 2020 at 1742 hrs	
Location:	White Waltham, Berkshire	
Type of Flight:	Training	
Persons on Board:	Crew - 2	Passengers - None
Injuries:	Crew - None	Passengers - N/A
Nature of Damage:	Landing gear collapsed. Bent propeller blade and left wing root skin creased	
Commander's Licence:	Private Pilot's Licence with Flying Instructor rating	
Commander's Age:	60 years	
Commander's Flying Experience:	1,008 hours (of which 574 were on type) Last 90 days - 71 hours Last 28 days - 35 hours	
Information Source:	Aircraft Accident Report Form submitted by the pilot and enquiries by the AAIB

Synopsis

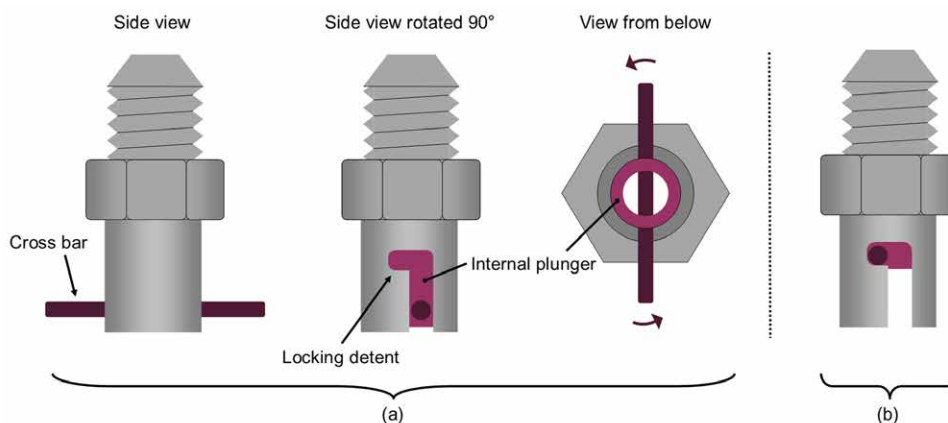
Figure 1

Lockable drain valve (a) closed (b) locked open (schematic)

With the drain valve in the open position fuel can leak from, and air can be drawn into, the gascolator leading to the risk of engine fuel starvation at high power settings, especially in climb attitudes.

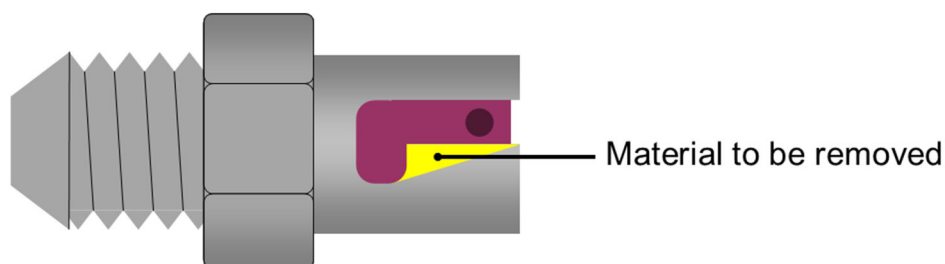
Figure 2

The AAIB investigated a gascolator drain-related accident involving a PA-28, G-BPBM, in December 1988¹. The accident report referenced a service bulletin² issued in 1975 by the CAA's Chief Service Engineer (CSE) recommending removal of the locking feature on drain valves fitted to gascolators. This was to be achieved by filing away a portion of the valve body, thereby removing the detent, so that it could remain open only if actively held in that position (Figure 2).

Drain valve with material to be removed indicated in yellow

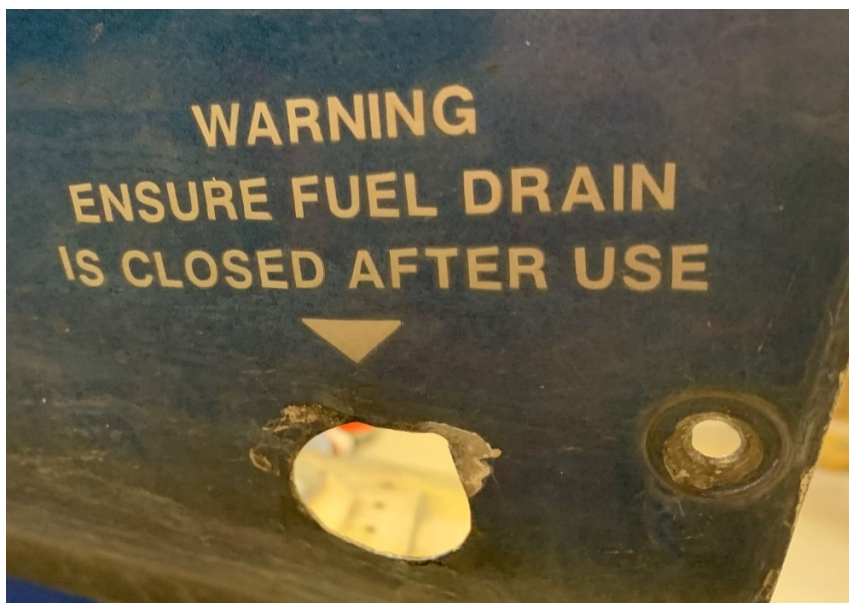
Figure 3

A subsequent accident, involving G-BHFL in November 1989³, appeared to have been caused by the same lockable gascolator drain problem. Since the drain locking feature was still present on G-BHFL, the AAIB reiterated its previous recommendation to modify such valves. In 1990 the CAA issued Emergency Airworthiness Directive (EAD) 001-02-90 which required affected aircraft to be placarded, alerting pilots to check the fuel drain was closed after use (Figure 3). G-BZDA was placarded in accordance with the EAD.

Placard wording introduced by EAD 001-02-90

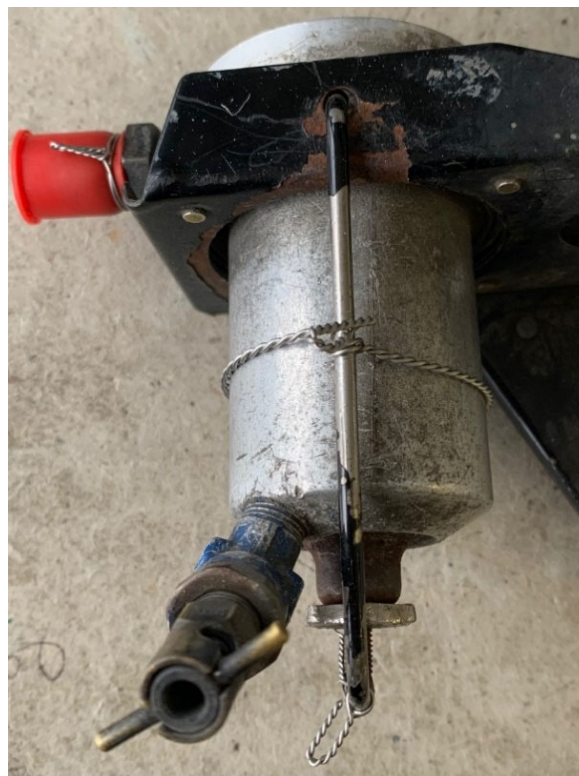
Figure 4

G-BZDA would have been equipped with a non-lockable gascolator drain as standard when built, but when inspected after the accident it was found to have a lockable version (Figure 4). The investigation was not able to identify how, when or why the original drain had been replaced with the wrong variant.

Gascolator and drain removed from G-BZDA after the accident

This accident resulted from the aircraft's gascolator drain valve being inadvertently locked open after a fuel sample had been taken. The open drain caused partial fuel starvation leading to a loss of power when the aircraft was climbing shortly after takeoff.

As a result of this accident, and after consultation with the AAIB, the UK CAA released Safety Notice SN-2021/005¹⁰ reminding owners and operators of this potential hazard for aircraft fitted with lockable gascolator drains and recommending replacement with '*suitable, non-locking alternatives*.' The Safety Notice was later amended to further recommend that aircraft are checked at the next scheduled maintenance point, and where a non-lockable gascolator drain valve is fitted, any associated placard is removed to minimise the potential for confusion.

Safety Notice SN-2021/005 was released, highlighting to owners, operators and pilots, the risks associated with lockable gascolator drains and recommending replacement with '*suitable, non-locking alternatives.*' This was later amended to include a recommendation that aircraft be checked for appropriate placarding at the next scheduled maintenance event.
