SERIOUS INCIDENT

Aircraft Type and Registration:	Pioneer 300, G-CGTL	
No & Type of Engines:	1 Rotax 912ULS engine	
Year of Manufacture:	2012 (Serial no: LAA 330-15038)	
Date & Time (UTC):	25 May 2020 at 1400 hrs	
Location:	Near Abergavenny Airfield, Gwent	
Type of Flight:	Private	
Persons on Board:	Crew - 1	Passengers - None
Injuries:	Crew - None	Passengers - N/A
Nature of Damage:	Damage to propeller and lower fuselage	
Commander's Licence:	National Private Pilot's Licence	
Commander's Age:	53 years	
Commander's Flying Experience:	1,306 hours (of which 4 were on type) Last 90 days - 10 hours Last 28 days - 0 hours	
Information Source:	Aircraft Accident Report Form submitted by the pilot and additional enquiries by the AAIB

Synopsis

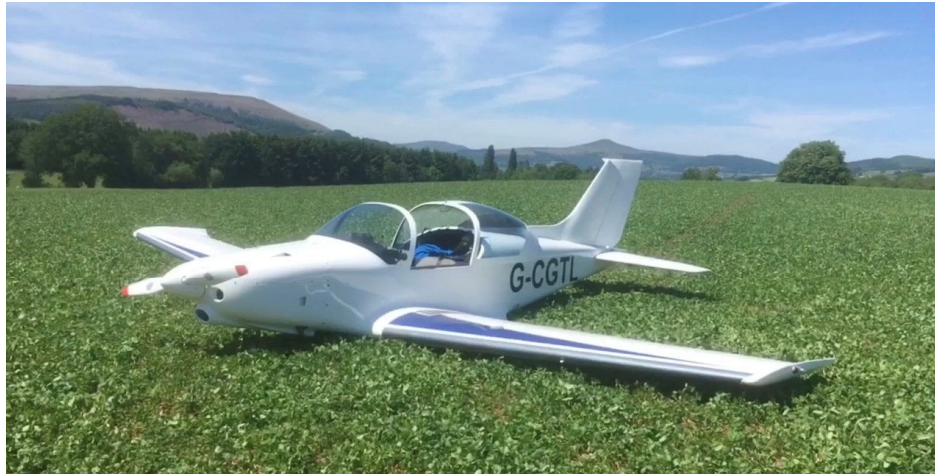
Realising he would not make it back to the airfield, the pilot turned the aircraft into wind, lowered the landing gear selector switch and chose a field in which to land. However, the three landing gear indication lights did not illuminate and he noted that the landing gear circuit breaker had tripped. He reset the circuit breaker and reselected the landing gear DOWN but the circuit breaker tripped again. The aircraft was at approximately 300 ft agl and there was insufficient time to lower the landing gear manually. At 75 ft agl he switched the engine off and conducted a successful wheels-up landing in a field approximately 1.6 miles south of the airfield (Figure 1). The pilot was uninjured and exited the aircraft without assistance.

Figure 1
G-CGTL after landing

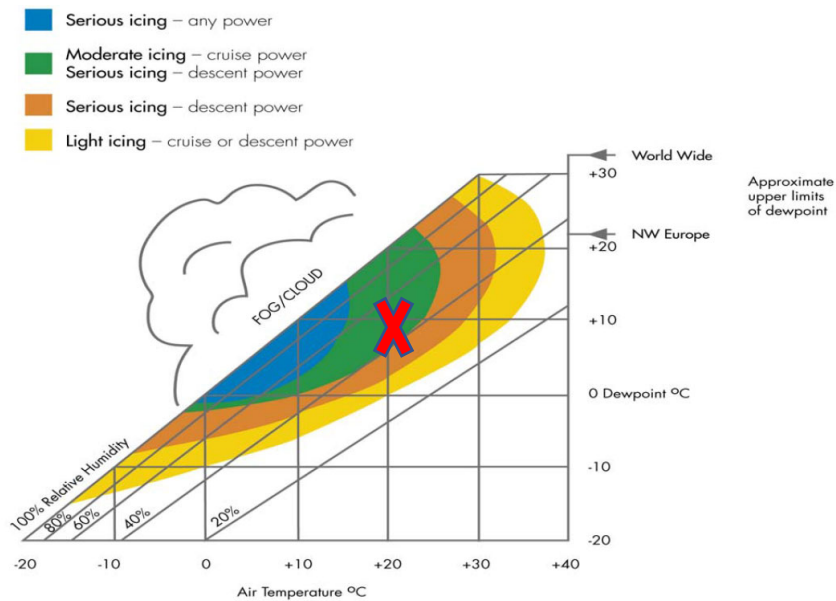
Cardiff Airport, approximately 31 miles south-west of Abergavenny Airfield, was reporting good weather conditions at the time of the flight with no cloud, visibility in excess of 10 km and a wind of between 6 and 8 kt from the south-west. The temperature was 21°C with a dewpoint of 8°C. When plotted on the Civil Aviation Authority (CAA) carburettor icing chart (Figure 2) they indicate that there was a likelihood of moderate icing at cruise power and serious icing at descent power.

Figure 2
Carburettor icing chart

The weather conditions on the day created a likelihood of moderate carburettor icing at cruise power. The pilot recalled that he maintained the initial climb power setting while attempting to establish the reason for the electrical warning, reducing the likelihood that carburettor icing could have contributed to the loss of engine power.
