**ACCIDENT**

| <b>Aircraft Type and Registration:</b> | Grob G115A, G-GPSX | |
| <b>Date &amp; Time (UTC):</b> | 7 December 2020 at 1420 hrs | |
| <b>Location:</b> | Nottingham City Airport, Nottinghamshire | |

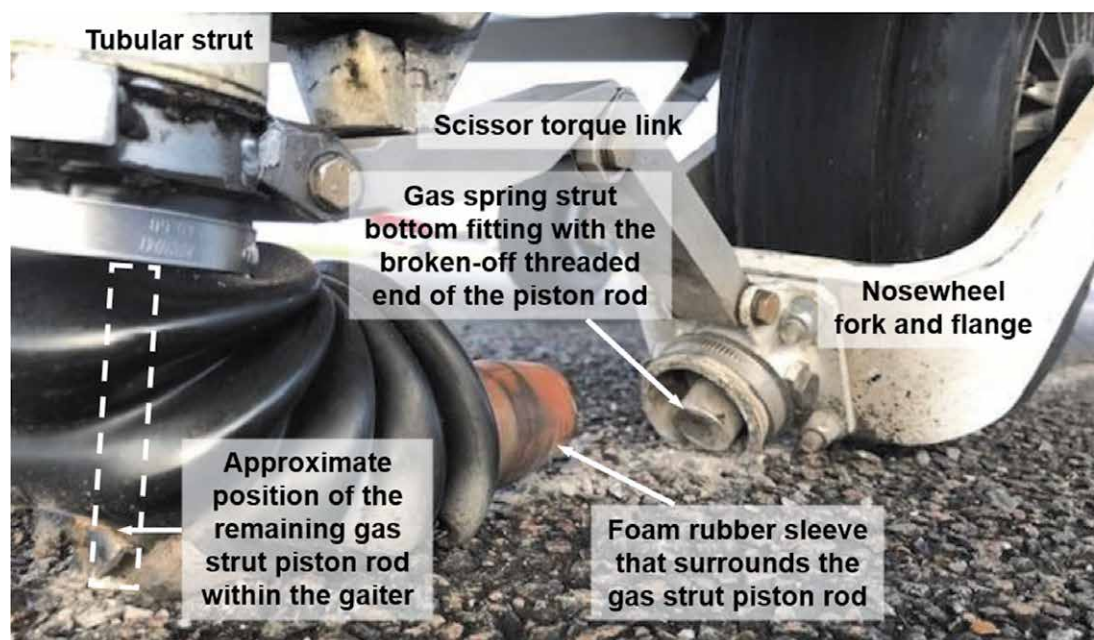
**Figure 1**

For the landing, the instructor prolonged the flare as much as possible to minimise the nose landing gear contact with the paved runway surface. During the landing rollout, the aircraft derotated onto the upper half of the nose landing gear, with the nosewheel assembly dragging behind, still attached by the scissor torque link (Figure 1), allowing the propeller blades to contact the ground.

Nose landing gear assembly after landing

The bottom fitting from G-GPSX can be seen in Figure 1 which shows that the gas strut piston rod fractured at the start of the threaded section. The sliding tube fell from the aircraft at some point during the last circuit, when the nosewheel assembly would have been swaying from the scissor torque link. The sliding tube was not recovered nor were any fragments of it found trapped between the bottom fitting and bolt in the flange.

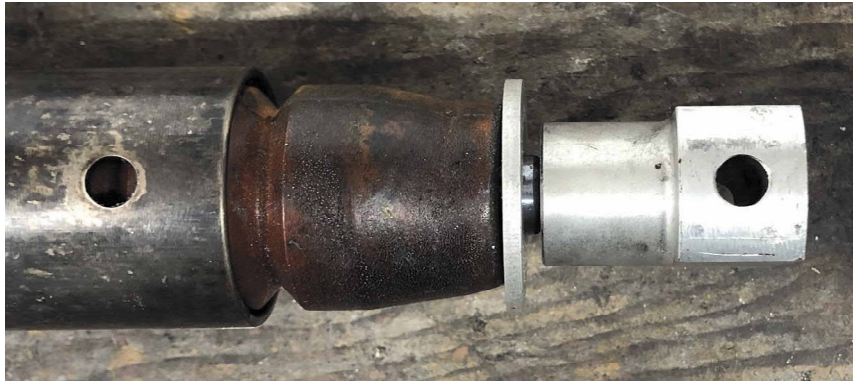
**Figure 2**

Example sliding tube, gas strut piston rod sleeve and bottom fitting with piston rod just visible as it enters the bottom fitting

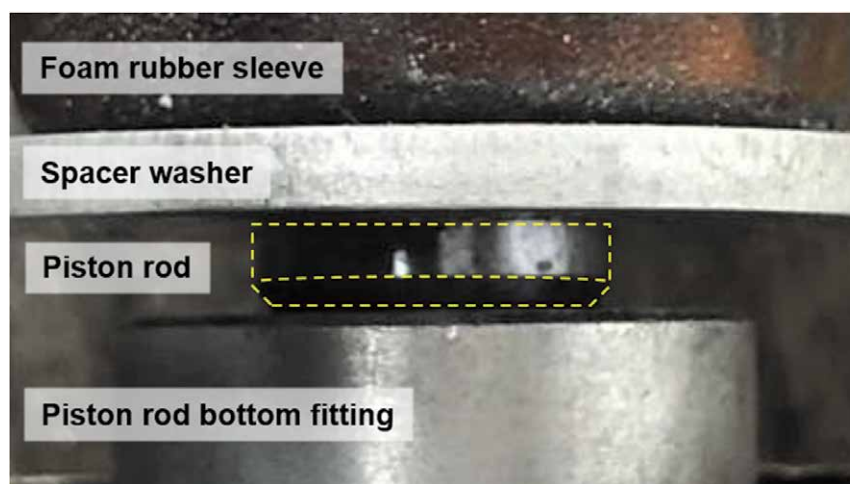
**Figure 3**

The gas strut piston rod is chamfered to the diameter of the thread root at the start of the threaded section (Figure 3).

Close-up showing piston rod chamfer at start of threaded portion of the piston rod inside the bottom fitting (the visible part of the piston rod is highlighted)
