ACCIDENT

Aircraft Type and Registration:	Grob G115A, G-GPSX
No & Type of Engines:	1 Lycoming O-235-H2C piston engine
Year of Manufacture:	1988 (Serial no: 8040)
Date & Time (UTC):	7 December 2020 at 1420 hrs
Location:	Nottingham City Airport, Nottinghamshire
Type of Flight:	Training
Persons on Board:	Crew - 2 Passengers - None
Injuries:	Crew - None Passengers - N/A
Nature of Damage:	Collapsed nosewheel, bent propeller
Commander's Licence:	Commercial Pilot's Licence
Commander's Age:	41 years
Commander's Flying Experience:	410 hours (of which 360 were on type) Last 90 days - 130 hours Last 28 days - 5 hours
Information Source:	Aircraft Accident Report Form submitted by the pilot and additional AAIB enquiries

Synopsis

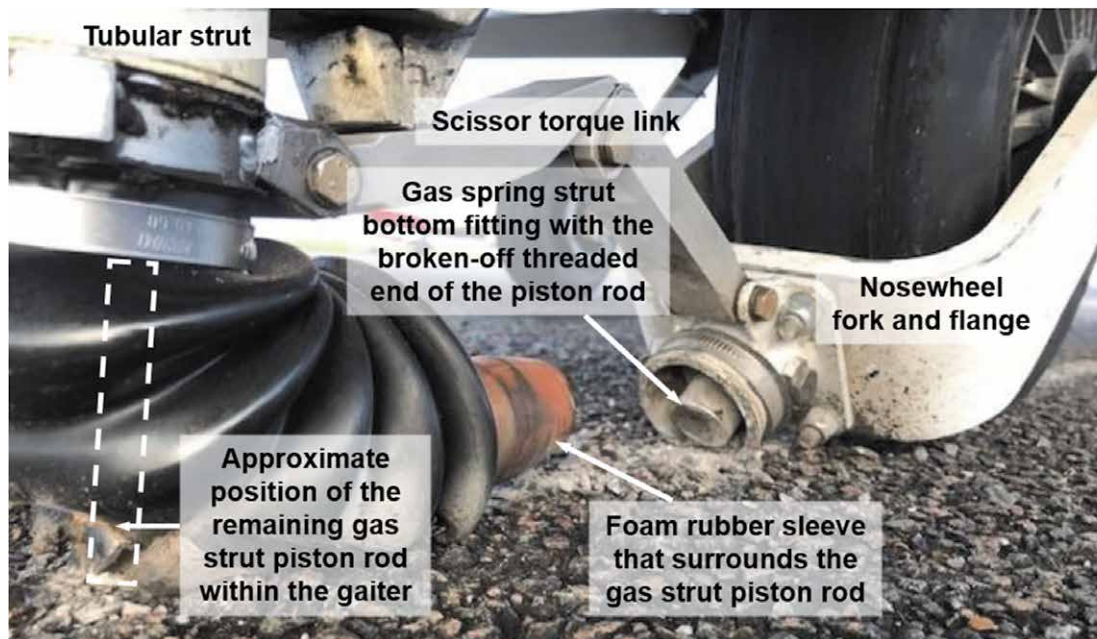
For the landing, the instructor prolonged the flare as much as possible to minimise the nose landing gear contact with the paved runway surface. During the landing rollout, the aircraft derotated onto the upper half of the nose landing gear, with the nosewheel assembly dragging behind, still attached by the scissor torque link (Figure 1), allowing the propeller blades to contact the ground.

Nose landing gear assembly after landing

The bottom fitting from G-GPSX can be seen in Figure 1 which shows that the gas strut piston rod fractured at the start of the threaded section. The sliding tube fell from the aircraft at some point during the last circuit, when the nosewheel assembly would have been swaying from the scissor torque link. The sliding tube was not recovered nor were any fragments of it found trapped between the bottom fitting and bolt in the flange.

The nose landing gear gas strut piston rod failed under overload during a touch-and-go landing. Previous similar occurrences on other aircraft occurred within days following maintenance on the nose landing gear. However, this aircraft had accumulated about 1,000 flight hours since the last maintenance on the nose landing gear, which would indicate that the maintenance carried out was not a factor in this event. It was not possible to establish the cause of the piston rod failure.

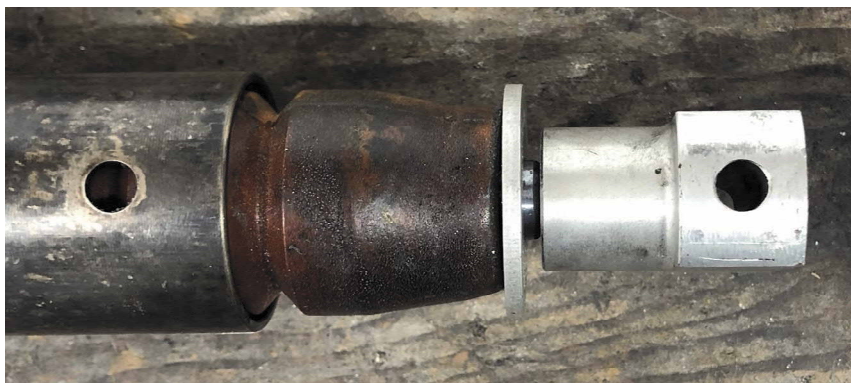
Figure 2

Example sliding tube, gas strut piston rod sleeve and bottom fitting with piston rod just visible as it enters the bottom fitting

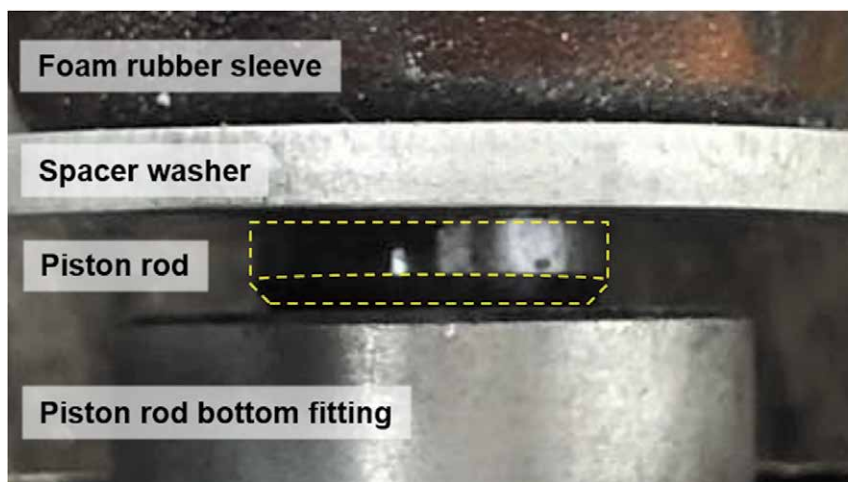
Figure 3

The gas strut piston rod is chamfered to the diameter of the thread root at the start of the threaded section (Figure 3).

Close-up showing piston rod chamfer at start of threaded portion of the piston rod inside the bottom fitting (the visible part of the piston rod is highlighted)
