Overspeed through an emergency speed restriction near Beattock, Dumfries and Galloway, 20 December 2020

Summary of the incident

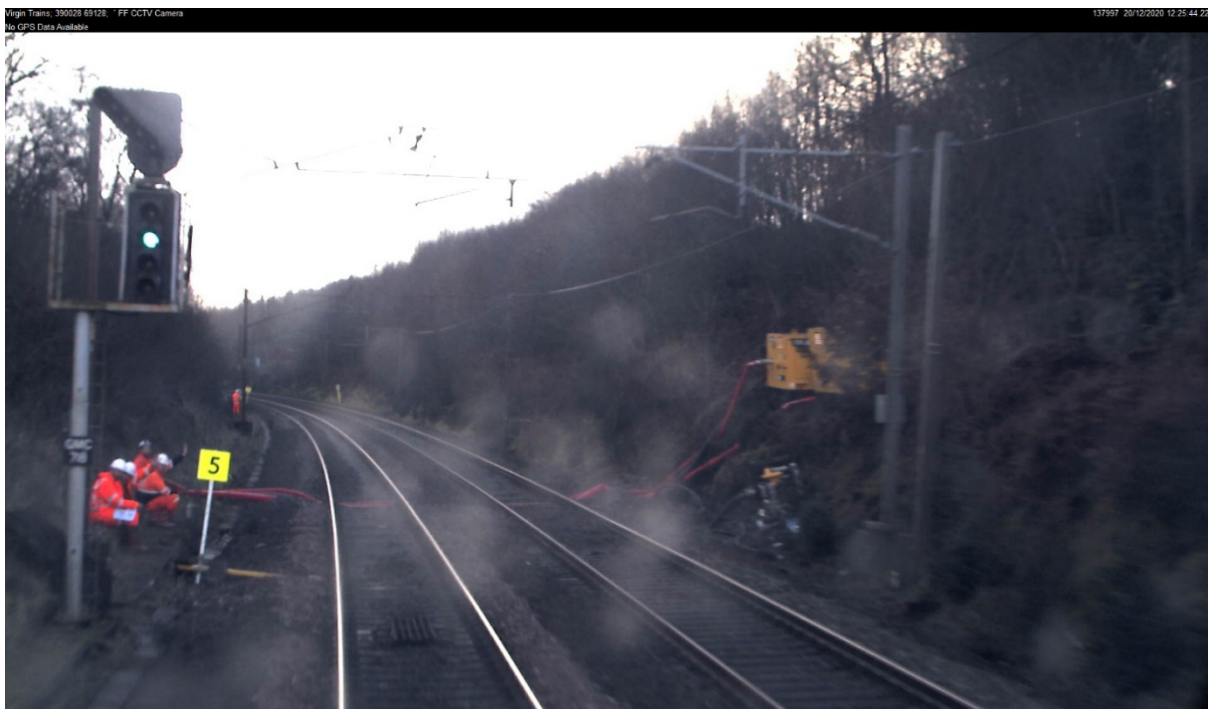
When reporting the incident to the signaller, the driver of train 1M12 stated that the distance between the warning board for the ESR and the speed indicator, showing the start of the ESR, was too short. The signaller asked the driver of the next train to check the speed restriction signage, and they subsequently reported back that it was all in place and they were able to slow down in time to comply with the ESR. Subsequent investigations by Network Rail established that the distance between the ESR's warning board and the start of the ESR was too short for trains that could approach the ESR at 125 mph (201 km/h).

Forward-facing CCTV image from train 1M12 showing the speed indicator at the start of the ESR

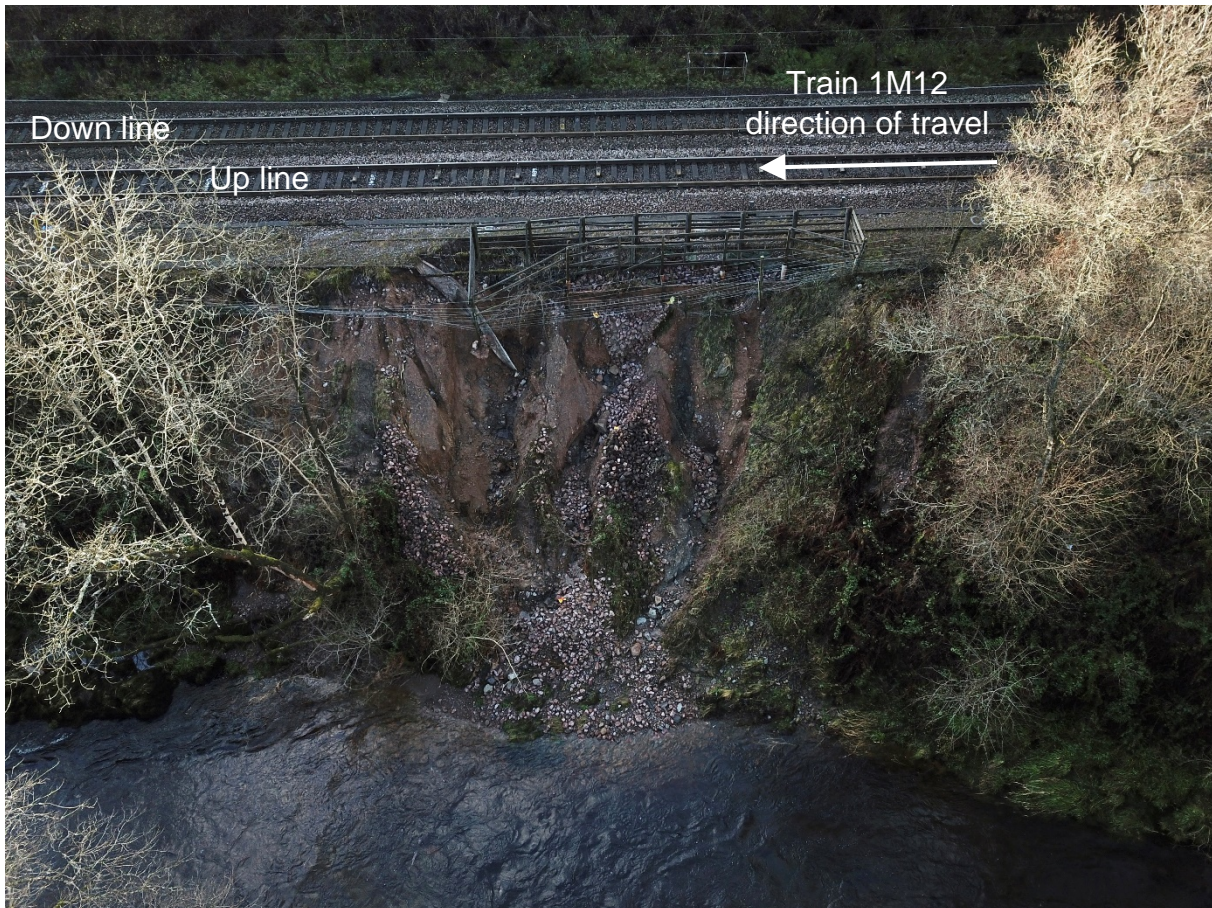
Maintenance staff subsequently found that the culvert was blocked and that the flow of water down the track had caused the embankment on the east side of the line to fail over a length of about 15 metres, at 40 miles 1400 yards. A previous failure had occurred in the same place in December 2013. After this earlier failure, Network Rail had fitted monitoring equipment to the track running alongside the top of this section of embankment. However, it did not receive any alarms from this monitoring equipment as the track had not been affected by this latest embankment failure.

The section of embankment that was washed away by the flood water

On 19 December, Network Rail arranged for contract staff to go to the site and throughout the day these staff used pumps to remove flood water and began to unblock the culvert. They also removed debris that had washed onto the track. Specialist staff attended and assessed the state of the embankment. They agreed that the West Coast main line could be reopened at this location subject to an ESR of 20 mph (32 km/h) on the down line and an ESR of 5 mph (8 km/h) on the up line. Both speed restrictions were 190 yards (174 metres) long, covering the length of the embankment failure and extending either side of it.

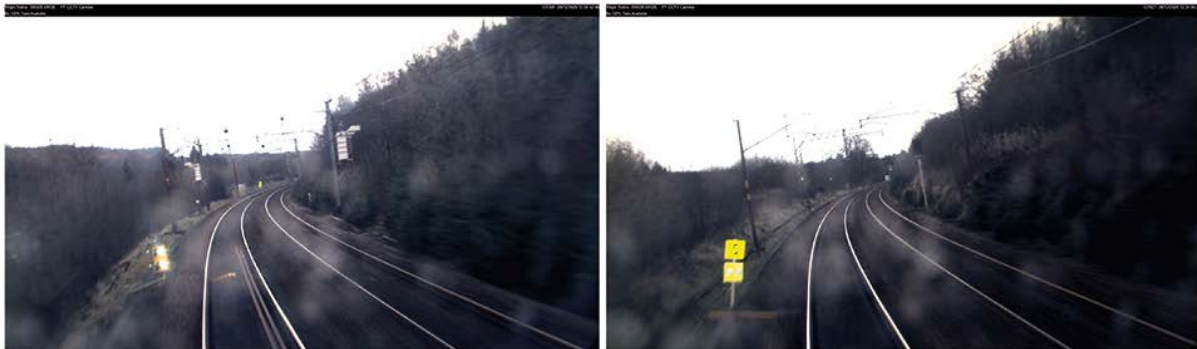
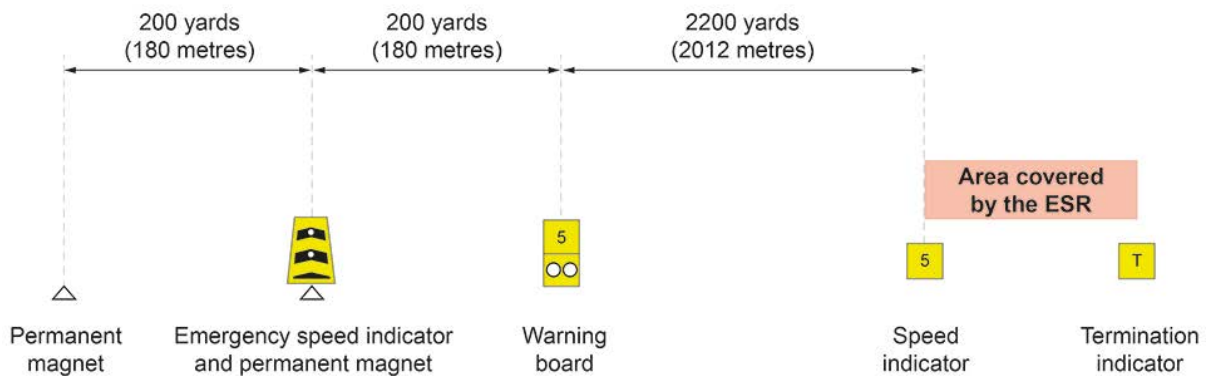
The layout of the trackside equipment for the ESR with forward-facing CCTV images from train 1M12 showing the emergency speed indicator (top left) and warning board (top right) (images courtesy of Avanti West Coast)

The distance between the warning board and the speed indicator for a speed restriction, the braking distance, should be based on the highest permissible speed that any train can approach. It should also account for the effect of the prevailing gradient on braking performance. The gradient approaching the ESR on the up line averaged about 1 in 90, falling in train 1M12's direction of travel. This falling gradient would have the effect of increasing a train's braking distance for a given brake demand by a driver (including a full-service brake application).

Tables in Appendix X of Railway Group Standard GK/RT0075 Issue 5 'Requirements for Minimum Signalling Braking and Deceleration Distances', define the minimum braking distances required for speed restrictions such as ESRs. These tables cover a range of initial approach speeds and gradients, and distances are based on a train demanding a full-service brake application. There is no table in the appendix for a 5 mph (8 km/h) speed restriction but the table for a 10 mph (16 km/h) speed restriction shows that, for an initial speed of 125 mph (201 km/h) and on a falling gradient of 1 in 100, the minimum braking distance for a full-service brake application should be 2737 yards (2503 metres). This distance increases to 3100 yards (2835 metres) for a falling gradient of 1 in 67. The steepest falling gradient at Beattock on the approach to the ESR was 1 in 81, so interpolating between the values in GK/RT0075 gives a minimum braking distance of 2945 yards (2693 metres). Forward-facing CCTV and data recorded by train 1M12 showed, however, that the braking distance for the ESR on the up line was only about 2200 yards (2012 metres). This is 745 yards (681 metres) less than the required minimum braking distance. Analysis by RAIB suggests that when train 1M12 made its step 4 brake application, its speed would have been down to 5 mph (8 km/h) before the speed indicator had the correct braking distance been available.

A person who is competent to design speed restrictions will normally determine what the appropriate braking distance should be, and will produce a design of where trackside equipment should be placed. However, at weekends or at night, as in this case, there is often no one available with the required competence to do this. The Network Rail track maintenance team therefore followed its custom and practice and implemented the ESR using a default braking distance of 1.25 miles, which is 2200 yards (2012 metres). GK/RT0075 shows that for a 10 mph (16 km/h) speed restriction, this braking distance would have been sufficient for initial approach speeds of between 100 and 125 mph (161 and 201 km/h), but only on level track.

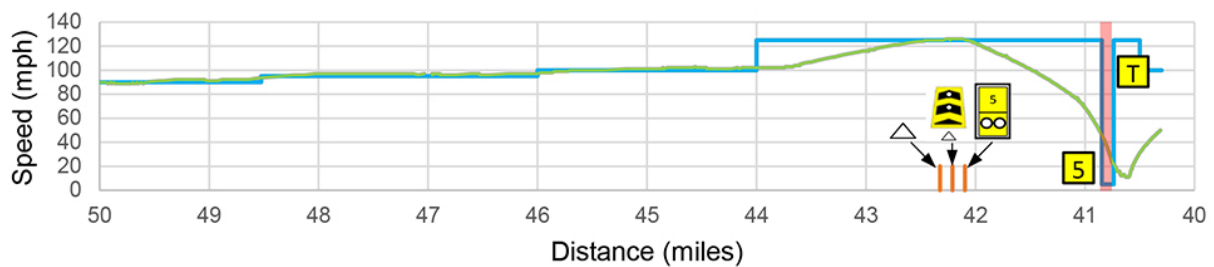
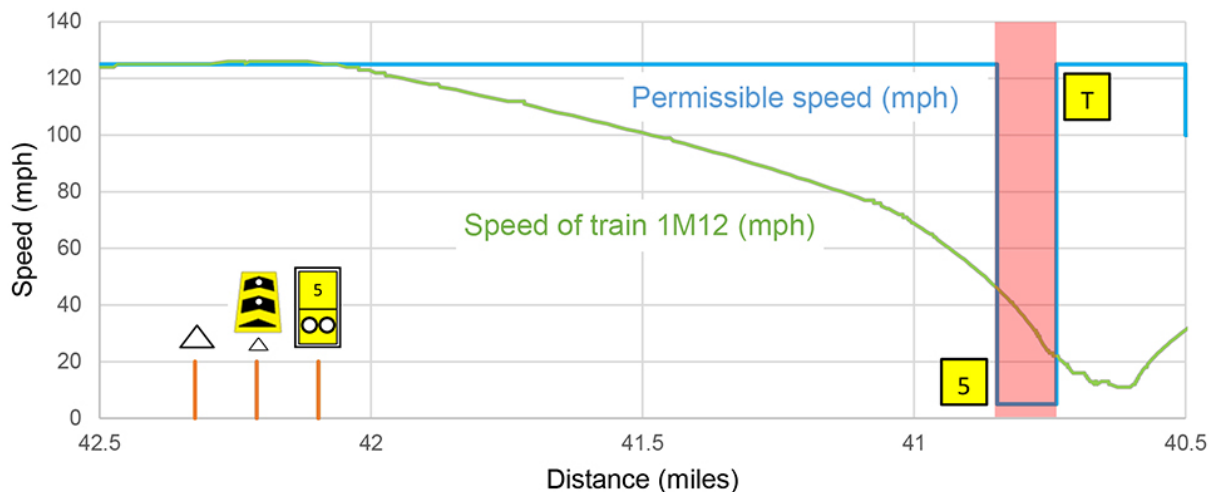
The speed of train 1M12 in relation to the positions of permissible speed changes and the ESR equipment over distances of ten miles (top) and two miles (bottom)

As train 1M12 approached the warning equipment for the ESR on the up line, it was travelling at 124 mph (200 km/h), just under the maximum permissible speed. The driver was aware of the ESR, as information about it had been given to him when he signed on for duty that morning. Upon seeing the emergency speed indicator for the ESR, the driver stopped applying traction power and allowed the train to coast. About eight seconds later, when the train was between the emergency speed indicator and the warning board, he began to apply the train's brakes. He made a step 4 brake application (where step 1 is the lightest possible brake application and step 6 the full-service brake application), about one second before the train passed the warning board. The driver expected that this level of brake application would be sufficient to slow the train down before it passed the speed indicator at the start of the ESR.

The train began to slow in response to the step 4 brake application. Based on the position of the warning board, the driver thought the start of the ESR would be close to the sidings at Beattock, but he then saw that the speed indicator was much closer than this, while the train was still travelling at 75 mph (121 km/h). He therefore made a step 6 full-service brake application. Despite this, train 1M12 was still travelling at 45 mph (72 km/h) when it passed the speed indicator and entered the area covered by the 5 mph (8 km/h) ESR, about 14 seconds later.
