INCIDENT

Aircraft Type and Registration:	Airbus Helicopters EC175B, G-EMEB
No & Type of Engines:	2 Pratt & Whitney Canada PT6C-67E turboshaft engines
Year of Manufacture:	2017 (Serial no: 5030)
Date & Time (UTC):	23 September 2020 at 1000 hrs
Location:	Aberdeen Airport
Type of Flight:	No intention of flight
Persons on Board:	Crew - 2 Passengers - None
Injuries:	Crew - None Passengers - N/A
Nature of Damage:	Bearing failure within the left accessory gearbox
Commander's Licence:	Airline Transport Pilot's Licence
Commander's Age:	37 years
Commander's Flying Experience:	5,180 hours (of which 1,325 were on type) Last 90 days - 112 hours Last 28 days - 30 hours
Information Source:	AAIB Field Investigation

Synopsis

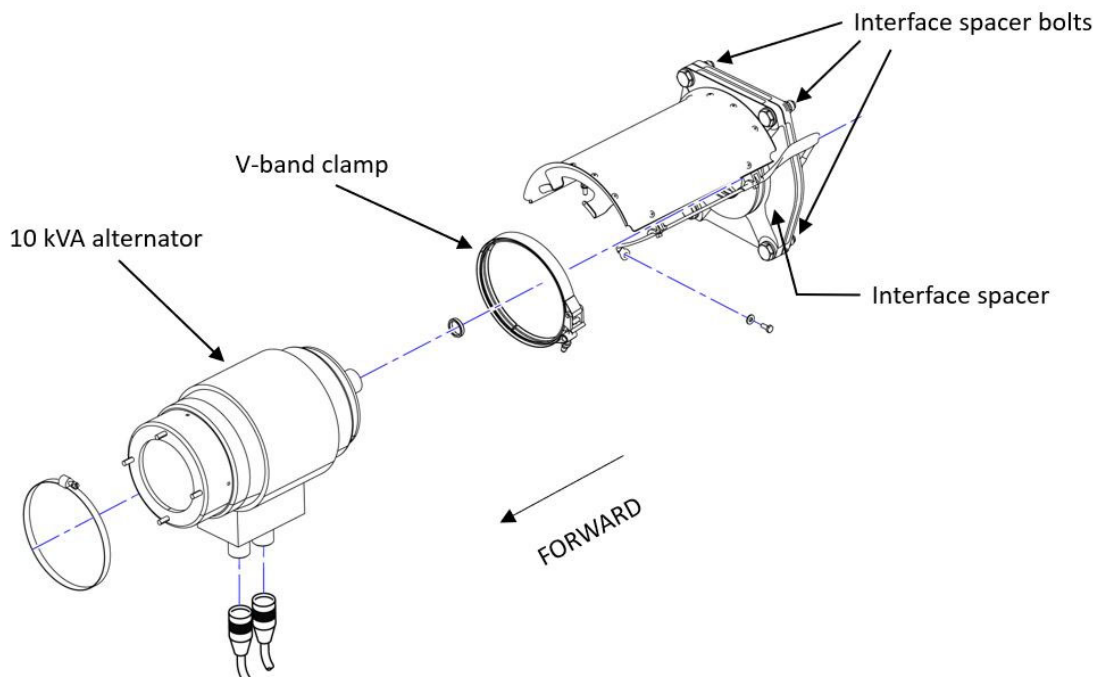
Figure 1

The exchange of the MGB accessory equipment took place in the operator's maintenance hangar with both MGBs mounted in transport stands, which provided good access for the work carried out. A Part-66 B1 licenced aircraft engineer (LAE), who was type-rated on the EC175, removed the alternator from the old LAGB, together with its V-band clamp and interface spacer as an assembly, by unfastening the four bolts that attach the interface spacer to the LAGB (Figure 1).

10 kVA alternator, V-band clamp and interface spacer (image used with permission of Airbus Helicopters)

The AMM instructions for the installation of the alternator to the LAGB require the interface spacer to be installed first⁴, before the alternator is fitted to the interface spacer by attaching it with the V-band clamp⁵. The LAE, however, installed the alternator, V-band clamp and interface spacer as an assembly to the LAGB, by attaching it with four bolts that fasten the interface spacer to the LAGB. He applied a small quantity of grease to the splines of the alternator drive shaft, as required by the AMM, before the alternator was installed.

The method of attaching the alternator to the LAGB used by the operator's LAE meant that the compression of the grease and air within the shaft link cavity was up to four times greater than would have been the case if the method specified in the AMM had been followed.

In response to this incident the manufacturer released Safety Information Notice (SIN) 3599-S-63, alerting EC175 operators to the potential hazard of excessive grease within the alternator shaft link cavity. The manufacturer has also revised the content of AMM tasks 24-21-00, 4-1 (Removal/Installation – Left Alternator 10 kVA) and 24-21-00, 4-2 (Removal/Installation – Blank or Left Alternator 10 kVA Equipment on LAGB), requiring that any excess grease is removed from the shaft link cavity prior to installation of the alternator on the LAGB. The SIN also highlighted the need to follow the published AMM procedure when installing the alternator, by attaching it using the V-band clamp.

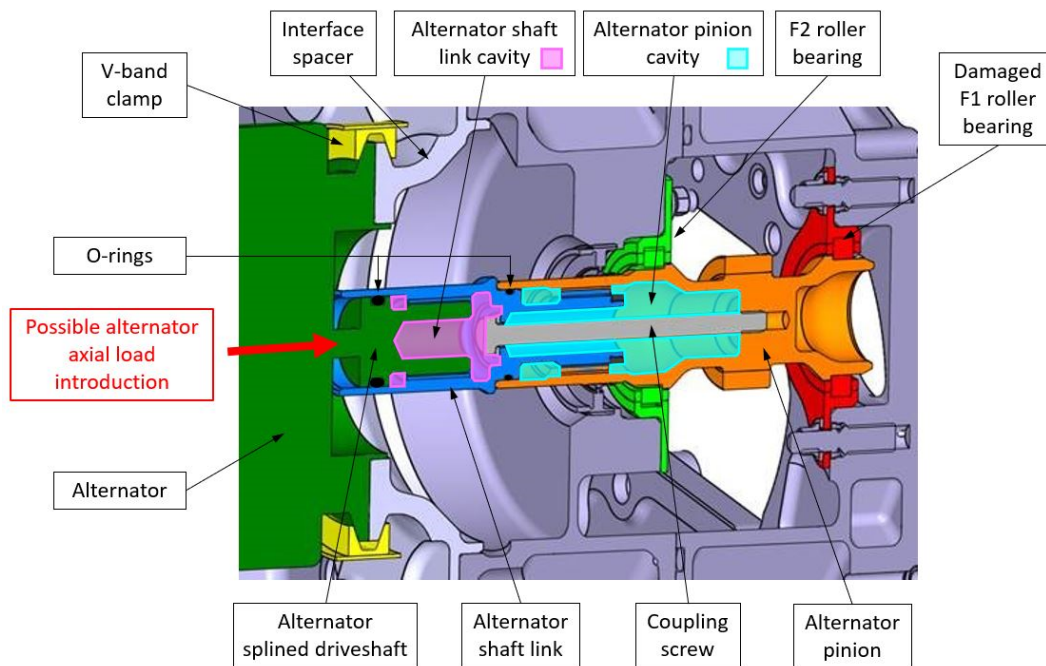
Figure 2

The new LAGB had a cover plate fitted over the alternator mounting location, which required removal in accordance with aircraft maintenance manual (AMM) task 24-21-00, 4-2, prior to installation of the alternator. Step G.6.b of this AMM task required the alternator pinion cavity to be filled with grease³ 'until it overflows', before an oil-lubricated O-ring was installed in the groove of the alternator shaft link (Figure 2). The alternator shaft link was then inserted into the alternator pinion and secured with a screw and washer. There was no AMM instruction to clean any excess grease from the alternator shaft link after it had been installed.

LAGB alternator drive (image used with permission of Airbus Helicopters)

The alternator is driven by an alternator pinion and an alternator shaft link (Figure 2) which has an internally-splined cavity that engages with the external splines on the alternator driveshaft. The alternator shaft link has a splined connection with the alternator pinion and is secured to it by a screw and washer. The alternator driveshaft has an oil-lubricated O-ring that is an interference fit within the end bore of the alternator shaft link. This O-ring seals the alternator shaft link internal cavity when the components are assembled.

The volume of grease displaced from the alternator pinion cavity, due to insertion of the alternator shaft link and screw, is approximately 70% greater than the volume available within the shaft link cavity once the alternator is mounted on the LAGB (shaded green in Figure 2).

Testing conducted by the manufacturer showed that an excessive quantity of grease within the alternator shaft link cavity can create a significant compressive axial load on the alternator pinion when the alternator is clamped to the LAGB. This is due to compression of the excess grease and air within the sealed shaft link cavity acting as a hydraulic piston. This loading case was unintended and had not been anticipated when the LAGB components and associated AMM maintenance procedures were developed.

The manufacturer has amended the content of the AMM to ensure that any excess grease is removed from the alternator shaft link cavity and has communicated this information by issuing a Safety Information Notice to EC175 operators.

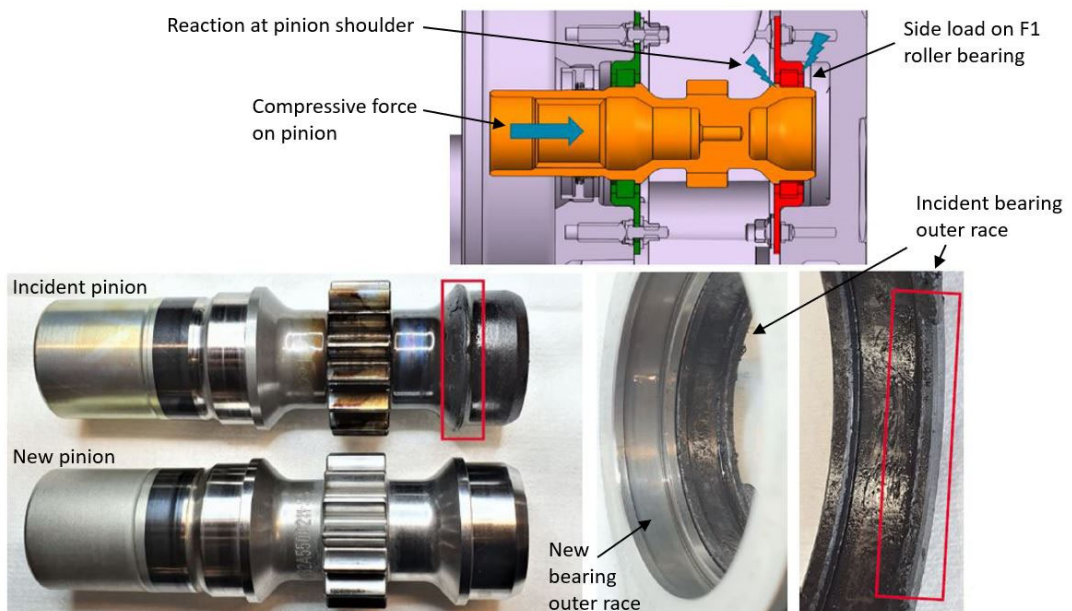
Figure 5

The end of the alternator pinion that is supported by the F1 bearing was also heat-distressed and the pinion shoulder, at the point of engagement with the F1 bearing, showed evidence of creep and wear (Figure 5). The nature of this damage was consistent with the pinion running in the overheated F1 bearing whilst subject to a compressive axial load.

Damaged alternator pinion (image used with permission of Airbus Helicopters)
