## ACCIDENT

<b>Aircraft Type and Registration:</b>	Replica Royal Aircraft Factory BE2c, G-AWYI
<b>No &amp; Type of Engines:</b>	1 De Havilland Gipsy Major Mk 10-1 piston engine
<b>Year of Manufacture:</b>	1969 (Serial no:1)
<b>Date &amp; Time (UTC):</b>	2 September 2020 at 1038 hrs
<b>Location:</b>	Sywell Aerodrome, Northamptonshire
<b>Type of Flight:</b>	Private
<b>Persons on Board:</b>	Crew - 1                      Passengers - None
<b>Injuries:</b>	Crew - 1 (Serious)      Passengers - N/A
<b>Nature of Damage:</b>	Severe damage to entire airframe
<b>Commander's Licence:</b>	Private Pilot's Licence
<b>Commander's Age:</b>	57 years
<b>Commander's Flying Experience:</b>	1,747 hours (of which 287 were on type) Last 90 days - 18 hours Last 28 days - 14 hours
<b>Information Source:</b>	Field Investigation

## Synopsis

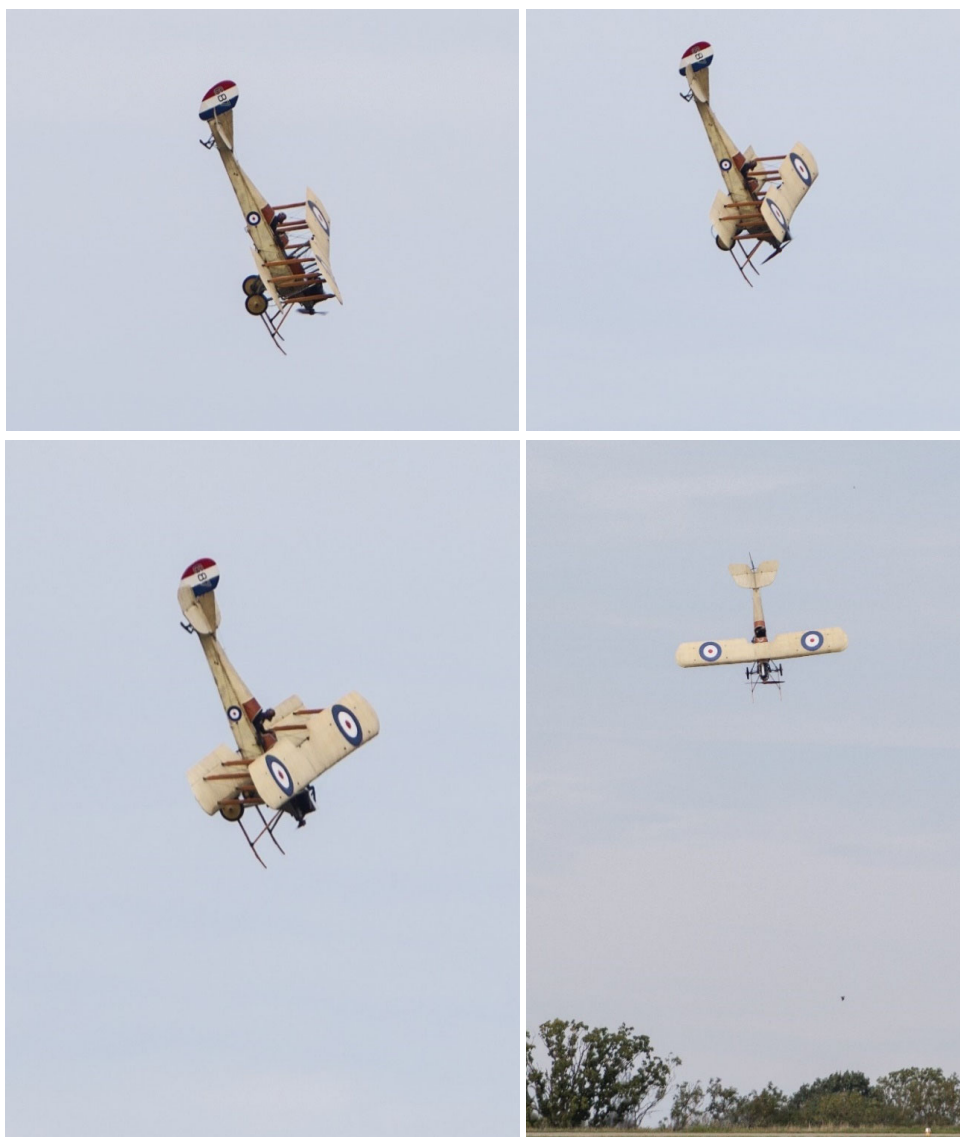
**Figure 1**

The control surface positions can be seen in the sequence of images in Figure 1. The ailerons appear to be neutral. The elevators appear to be trailing edge up suggesting the pilot was applying some aft control input. The rudder trailing edge was to the right (of the aircraft’s longitudinal axis) suggesting the pilot was applying some right rudder. It was not determined exactly how much elevator or rudder was applied but neither appeared to be at full deflection.

Four images of G-AWYI in the right descending turn showing control surface deflections (Used with permission and under copyright of the photographer)

Photographs taken during the second part of the spin show the rudder was displaced into the turn and elevator was displaced up. These inputs are the opposite of those required to recover from the spin. However, at this stage the aircraft was very close to the ground. The time from the wing dropping again to the ground was approximately 5 seconds. It is unlikely that the pilot had time to process what was happening and to make the correct inputs. As the aircraft was approaching the ground it would be instinctive to pitch up. It is possible that the in-to-turn rudder was just where the rudder was after he initially tried to centre the rudder and he did not have time to make any further changes.

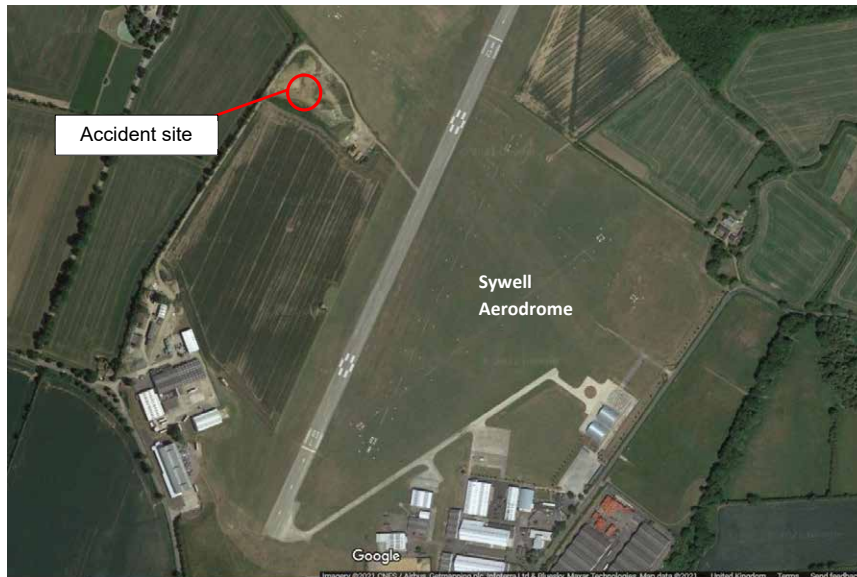
**Figure 3**

The wreckage of G-AWYI was located in a field inside the western boundary of the aerodrome (Figure 3). The ground was soft and contained several large mounds of waste earth and rubble from recent building work which restricted emergency vehicle access to the injured pilot and the aircraft.

Accident site at Sywell Aerodrome

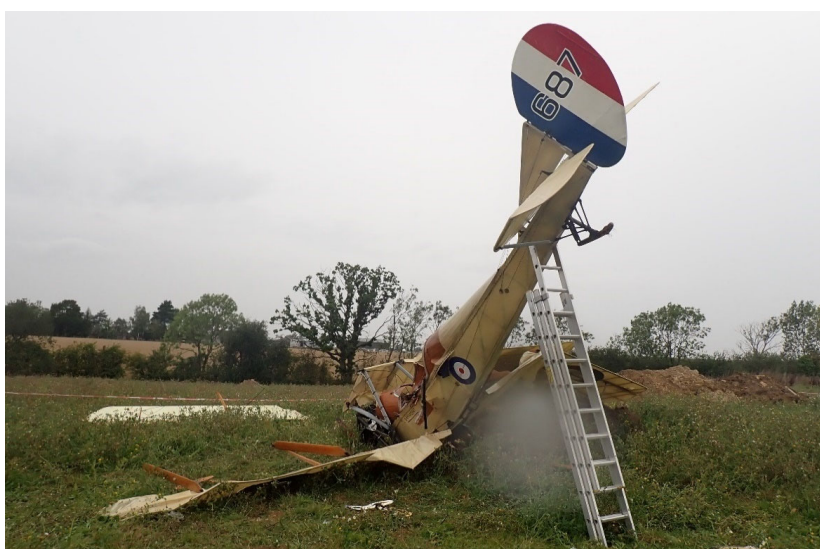
**Figure 4**

There were no ground marks to indicate the aircraft had slid or bounced on impact. The front section of the aircraft and the engine were embedded in the ground at a steep nose-down attitude (Figure 4). One blade of the fixed pitch, wooden propeller had snapped off and fragmented. The remaining blade had cracked radially around the root but was still attached to the hub. The aircraft's wooden skids were embedded in the soft earth and the landing gear was severely disrupted and partially detached from the fuselage. Due to the steep angle of impact, the aircraft's rear fuselage and tail remained high in the air and leaning to the left. The airframe structure around the rear cockpit and aft of the cockpit floor was bent and deformed by the force of the impact (Figure 5).

G-AWYI at the accident site

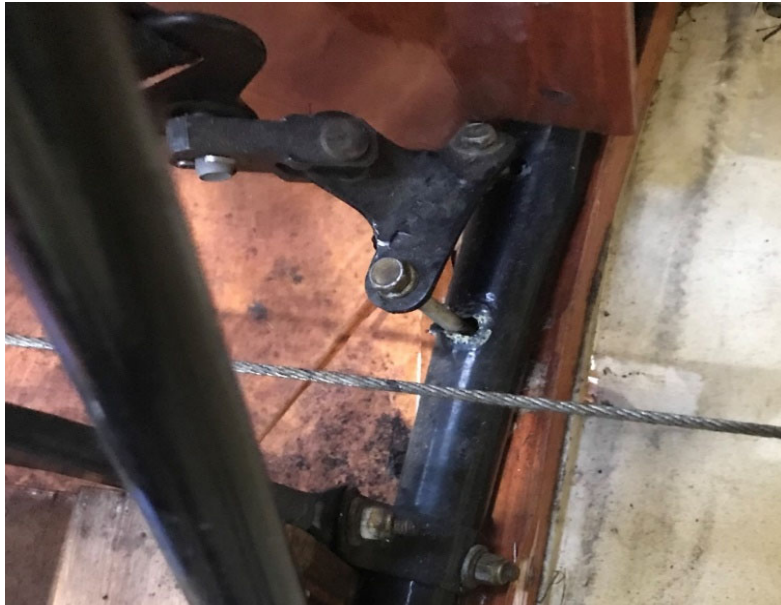
**Figure 12**

In the rear cockpit, the control column was wedged forward under the horizontal metal frame of the instrument panel. The lower right seat harness anchor bracket bolts had been pulled out of the airframe structure (Figure 12).

Rear seat lower right harness anchor bracket bolts pulled out of frame

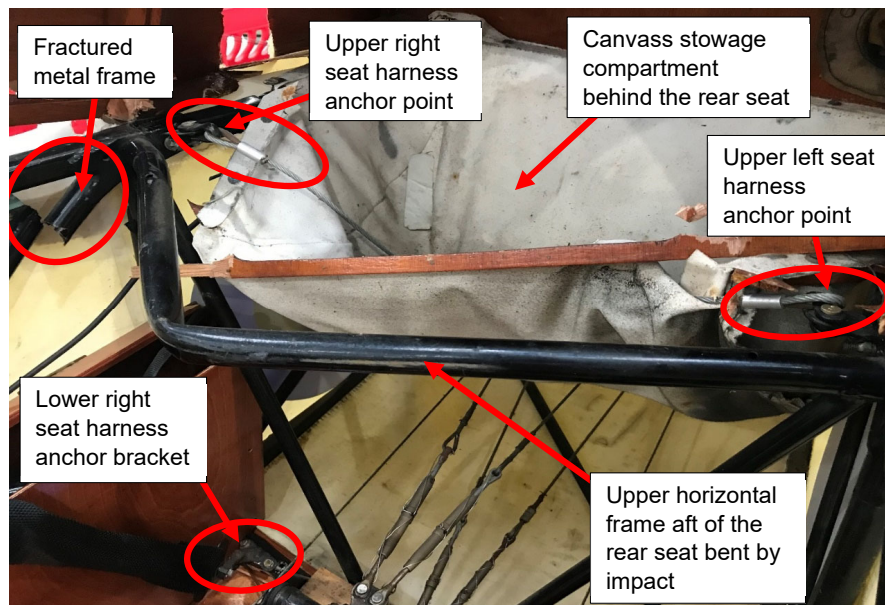
**Figure 13**

The upper, horizontal metal cockpit frame aft of the rear pilot's seat had bent (Figure 13) and the seat's mounting points were deformed.

Airframe damage behind the rear cockpit seat – view looking aft and to the left

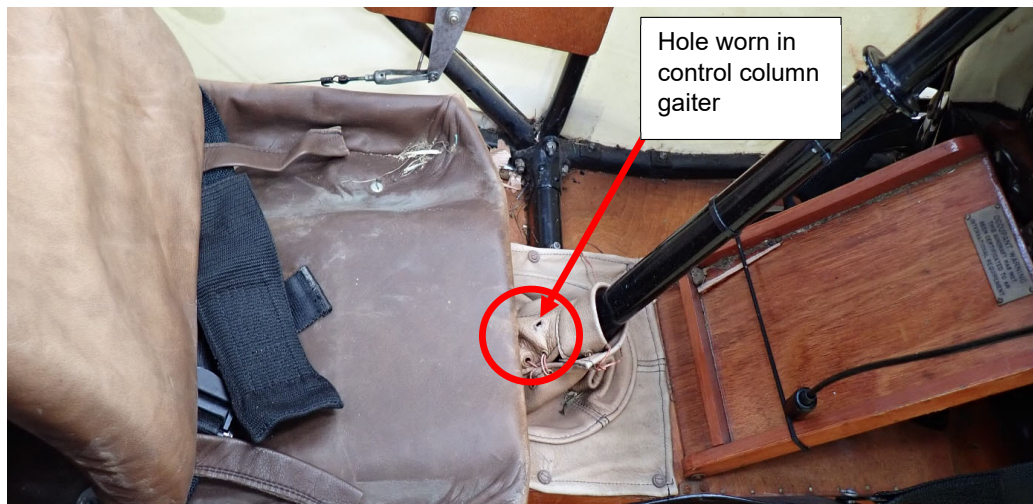
**Figure 14**

The position of the rear seat, after the accident, restricted rearward movement of the control column. A hole was found in the control column's leather gaiter where it had been worn away by contact between the control column and the seat (Figure 14).

Hole in the control column gaiter
