ACCIDENT

| Aircraft Type and Registration: | Schleicher ASH 25 E, G-CFST | |

Synopsis

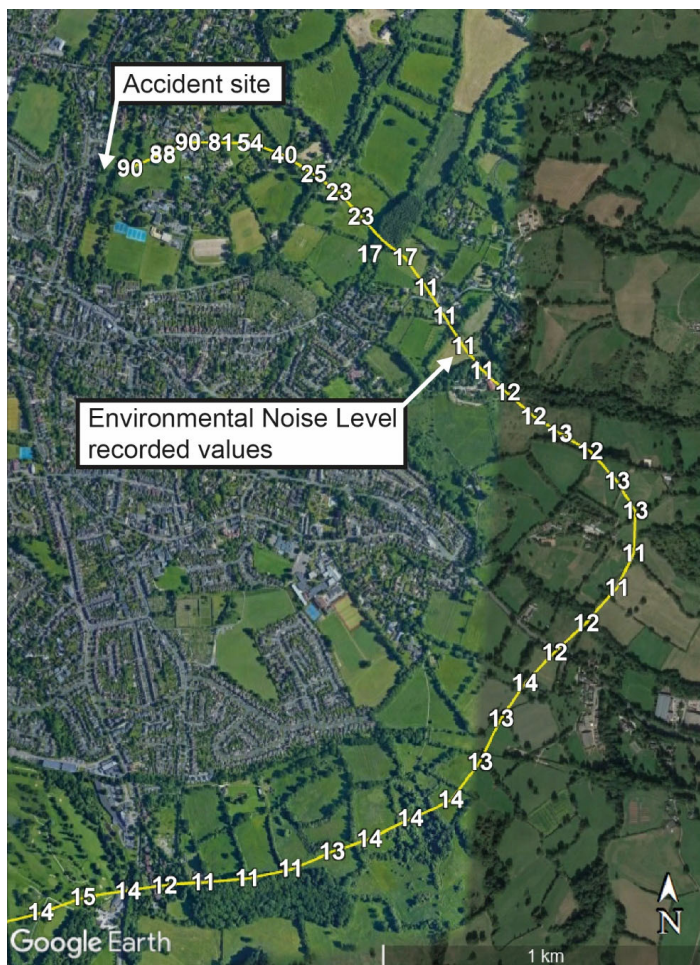
Figure 7 shows the ENL value increasing relative to the final flight path. It is likely that the increased values recorded at the end of the accident flight are associated with the deployment of the engine, but it is not known if it reflects an attempt to start the engine, or is just an increase in aerodynamic noise.

ENL values at the end of the flight

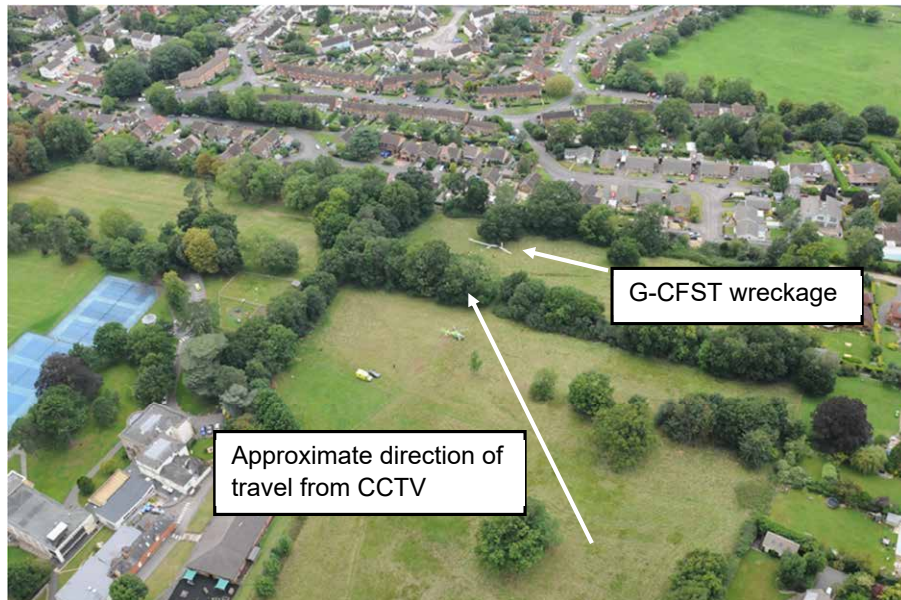
Figure 11
Accident site

The accident site was in a narrow sloping field on the edge of Cheltenham, within the grounds of a school. It was bordered to the north and west by residential areas and to the south and east by school grounds (Figure 11).

The wreckage of the glider was situated below the canopy of a large oak tree. Several large branches had broken and fallen on top of the wreckage, indicating that the glider had struck this tree. It was also apparent that the tops of some of the trees which formed the boundary with the adjacent field had been trimmed (Figure 12). Damage to the leading edge and lower surface of the outer right wing was consistent with it having struck the tops of these trees. This was subsequently confirmed by CCTV recordings.

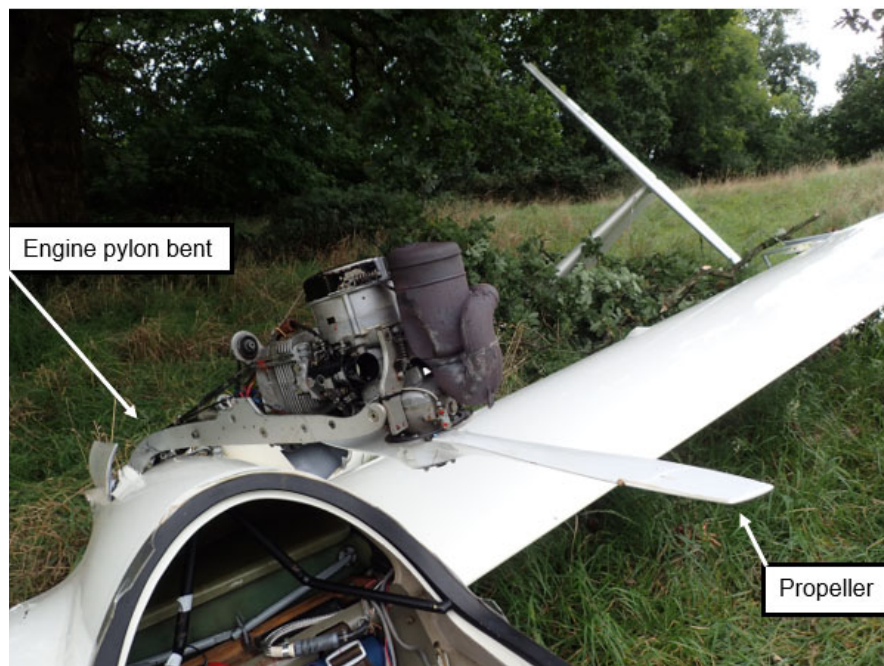
Figure 13

The engine was deployed but the engine pylon had bent forward approximately 90° from its normal deployed orientation, such that the engine was lying parallel to the top of the glider above the rear cockpit (Figure 13). The landing gear was retracted. The tail boom had fractured just behind the engine bay and the left outer wing had separated at the wing joint, leaving a section of broken spar protruding from the inner wing. The control rods for the airbrake, aileron and flap were bent rearwards and had exited through the trailing edge wing structure at the location of the wing break. The left airbrake was extended.

G-CFST wreckage showing position of engine

The engine was free from external damage but the damage sustained by the extension actuator and pylon was consistent with it being in the extended position when the ground

impact occurred. The propeller was intact and largely undamaged with the exception of two small cracks in the hub and a small nick on the trailing edge of one blade. There was no evidence of rotational scoring which might be expected if the propeller was rotating at impact.

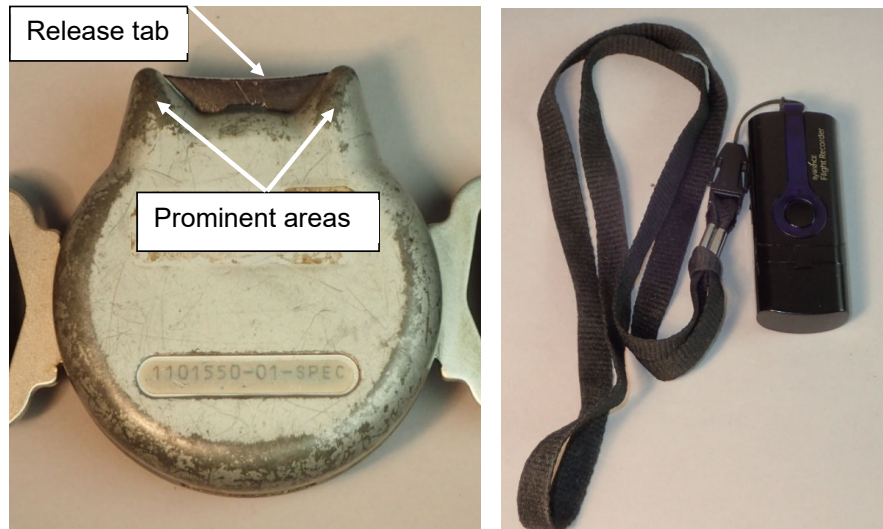
Figure 17

The pilot had been wearing a USB logger device on a lanyard around his neck. Because it was obscured by clothing, the logger’s position with respect to the QRF was not observed at the accident site. Prominent areas on the back face of the QRF are intended to guard against forward release of the tab (Figure 17). The shape of the logger was such that it could fit in the recess behind the release tab. Post-accident simulations showed that the reclined seating position in the ASH 25 E and length of the lanyard meant that the logger could rest in proximity to the QRF. There were many variables such as exact seating position and height of the wearer and the logger was easily dislodged with movement if positioned behind the QRF. It was therefore considered unlikely that the logger could have interfered with the release tab on the QRF, but the possibility could not be ruled out.

Seat harness QRF showing rear face (left) and USB logger (right)

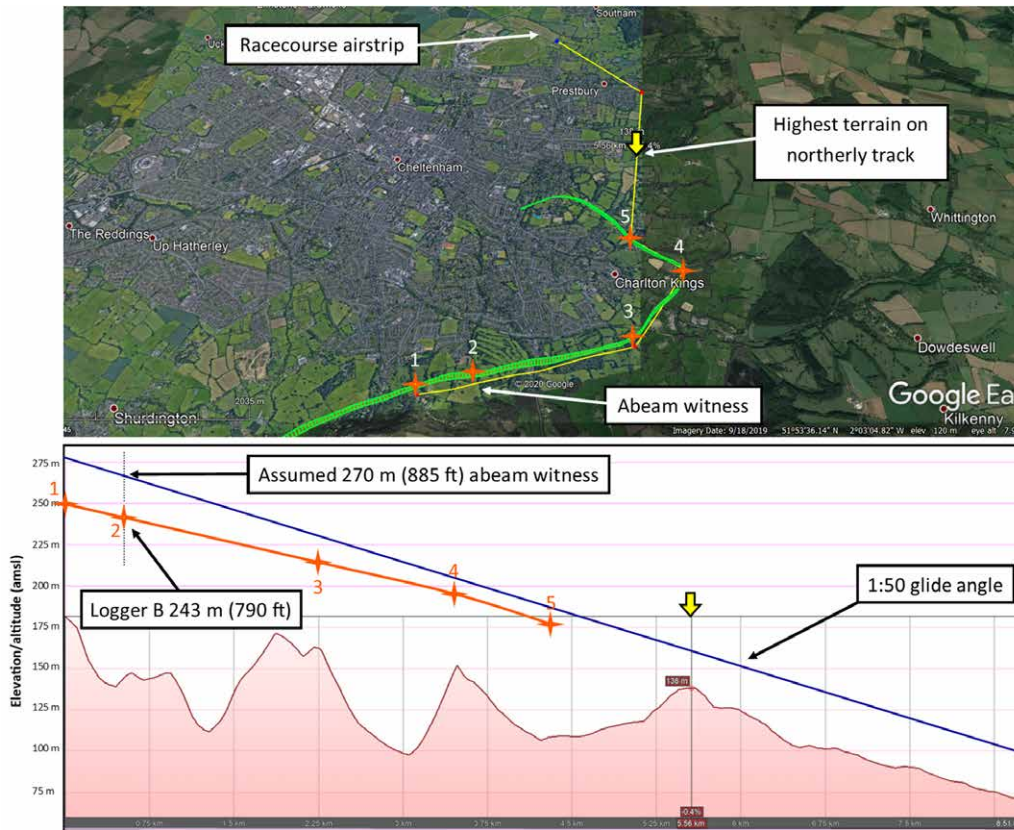
Figure 18

From Point 5 on the graphic, while the racecourse airstrip was theoretically in range, the pilot had no contingency height in reserve. Heading north from Point 5 would have looked daunting, requiring descent from approximately 230 ft agl towards hostile²⁸ rising ground. Terrain clearance at the highest ground elevation on track would likely have been less than 100 ft. From that point, with the terrain gradient approximating close to 1:50, and without factoring in trees and buildings en route, unless it found additional lift, the glider would have been at ultra-low-level for the remainder of the flight (Figure 19).

Glide angle and terrain elevation profile comparison (Image ©2020 Google)

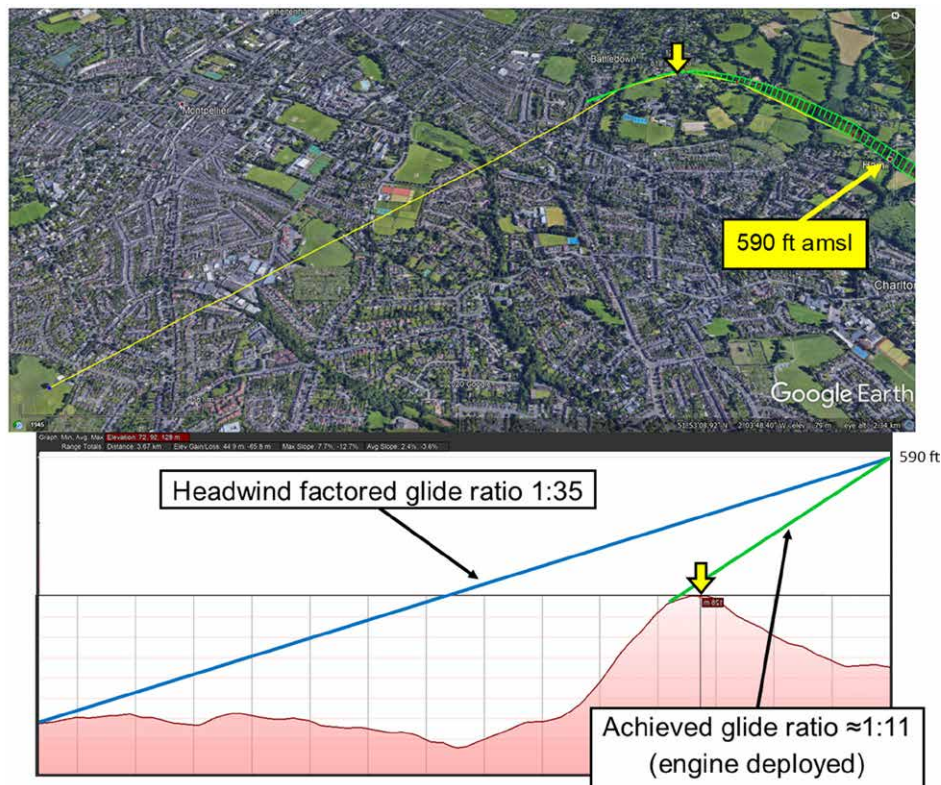
Figure 20

A comparative analysis for escaping to the south-west is at Figure 20. Assuming a 1:50 glide ratio with engine stowed, at 50 kt airspeed and compensating for a 15 kt headwind²⁹, the glider would theoretically have achieved a 1:35 glide angle over the ground. Starting from an altitude of 590 ft and following the yellow track line on Figure 20, a 1:35 descent profile appears insufficient to clear the built-up area of Cheltenham. While the glider may have been unable to reach open ground beyond the town, it could have reached the playing fields in the middle of the built-up area. Although reachable, none of the playing fields were long enough in which to safely land an ASH 25 E.

Comparison of notional 1:35 glide angle vs terrain profile across Cheltenham
(Image ©2020 Google)
