AIRCRAFT ACCIDENT REPORT 1/2021

Report on the serious incident to
Airbus A321-211, G-POWN
at London Gatwick Airport
on 26 February 2020

Air Accidents Investigation Branch

Published 4 May 2021

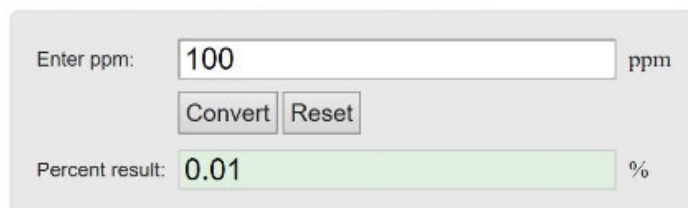
Figure 8

On 27 January 2020, it was time for the biocide treatment to be performed on YL-LCQ and Base Engineer 2 was assigned to the task. He was still unsure about the term ppm. He looked for information in the AMM abbreviation list and could not find it, so he searched the internet. He found an internet calculator that offered a ppm to percentage conversion. Base Engineer 2 explained that he mistook the number 0.01 for a factor that he could multiply by fuel quantity to get the required Kathon quantity (Figure 8).

When asked what 'by volume' meant in the biocide procedure, Base Engineer 2 stated it meant that if one of the quantities was in kilos, you must calculate the other quantity in kilos.

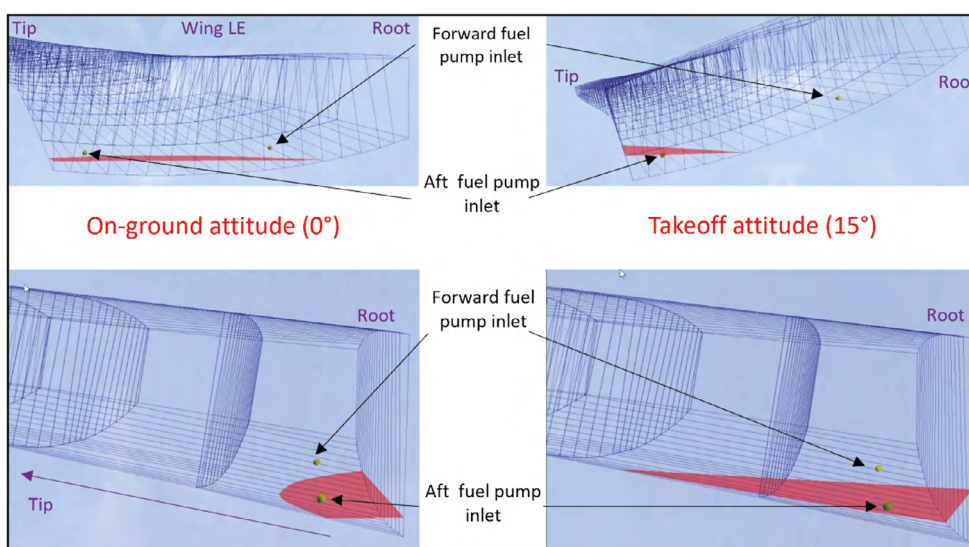
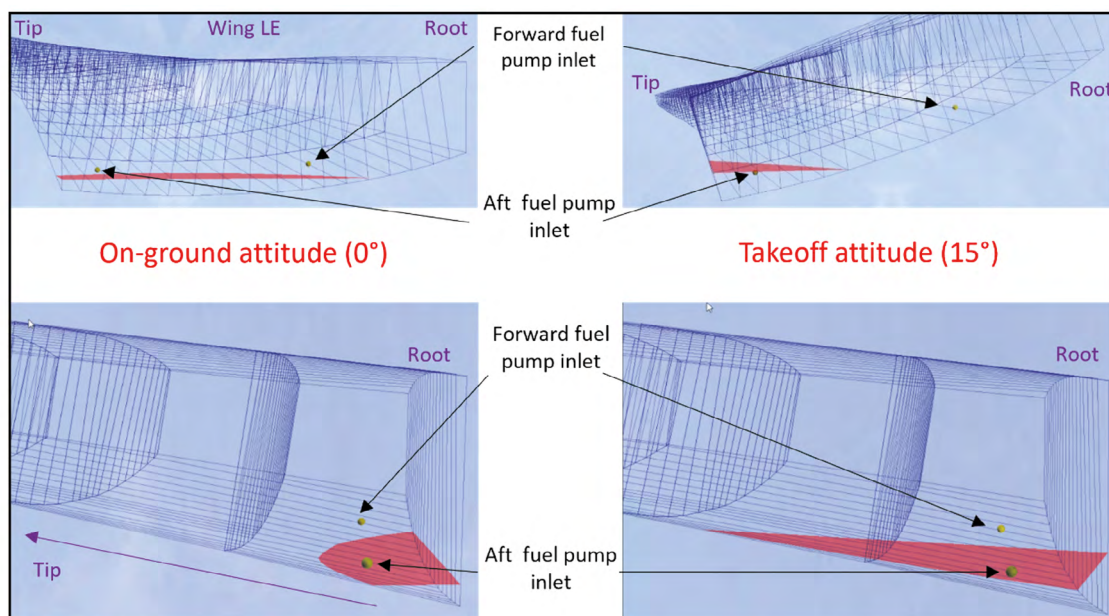
Figure 9

An assessment was made subsequently by the aircraft manufacturer which determined that the process used by the Base AMO would not have mixed the Kathon and fuel effectively. Fuel and Kathon must be agitated to mix effectively, but because they were added to the fuel tank at different locations (refuel coupling and overwing refuel aperture) no direct impingement occurred. As there was no other mechanism available to mix the two fluids, the amount of mixing would have been minimal. The assessment assumed a worse case of no mixing and, as shown in Figure 9, the level of 30 kg of Kathon at the lowest point of the tank was simulated (red surface in Figure 9). This level was then compared to the fuel pump inlet positions in the on-ground and takeoff attitude cases.

View of the left wing fuel tank at the root showing the fuel pump inlet positions in relation to approximately 30 kg of Kathon (shown in red) (images courtesy of Airbus)

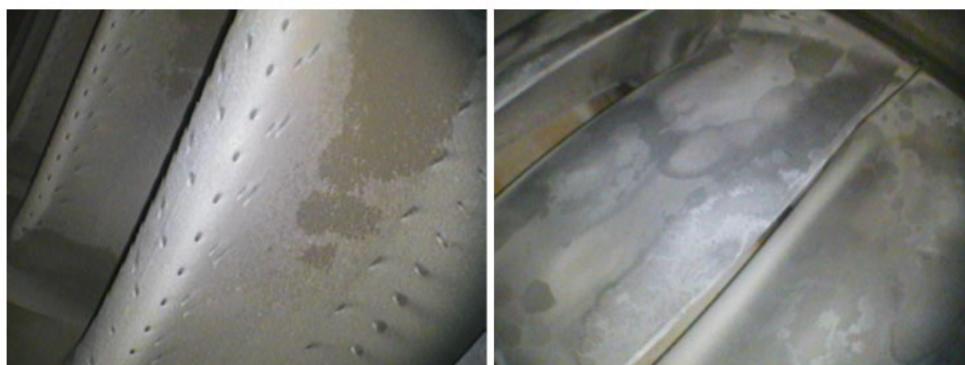
Figure 25

The aircraft's engines were subjected to an initial borescope visual examination on the day after the incident flight. Both engines exhibited similar findings. There was no significant damage evident to the fan, LP compressor or HP compressor, and any minor defects that were observed were stated to be within AMM damage limits. However, the combustion chambers, and the HPT and LPT blades were coated in a thin layer of white material that was observed on the turbine blades' convex surfaces (Figure 25). The HPT nozzle guide vanes were also coated in the white material. As the engines were not disassembled, it was not possible to obtain a sample of the white material.

White material deposits on No 2 engine combustion chamber and HPT blades observed during initial borescope inspection (No 1 engine similar)

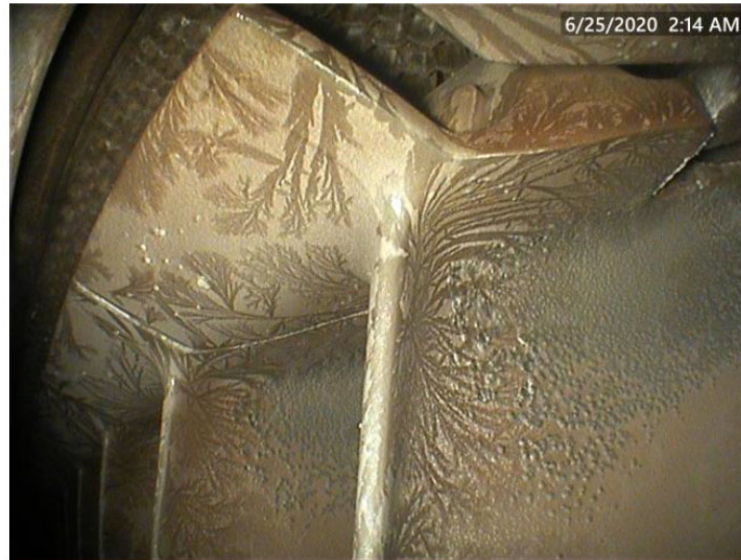
Figure 26

intervening four-month period, been dissolved into water that had condensed onto the internal engine surfaces. The white material had then reformed into the dendritic crystalline pattern as the water subsequently evaporated.

Dendritic crystalline surface deposit on engine No 2 LPT

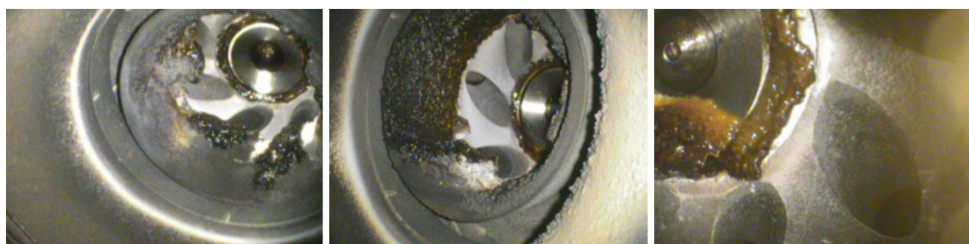
Figure 27

Both borescope inspections revealed that significant deposits of a brown material were present on all the combustion chamber swirl cups, adjacent to the fuel spray nozzles, in both engines (Figures 27 and 28).

Brown material deposits in No 2 engine combustion chamber swirl cups observed during initial borescope inspection

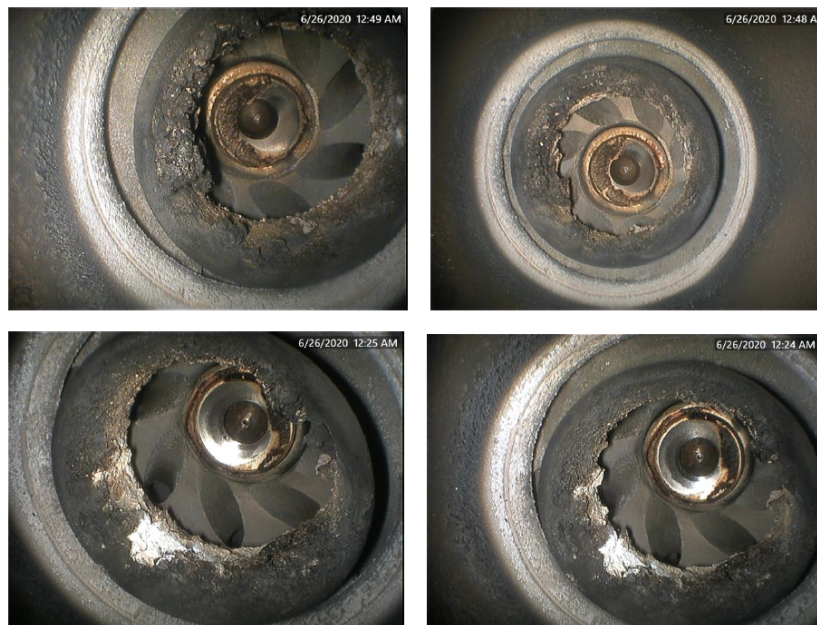
Figure 28

Brown/black material deposits in No 1 engine combustion chamber swirl cups observed during second borescope inspection

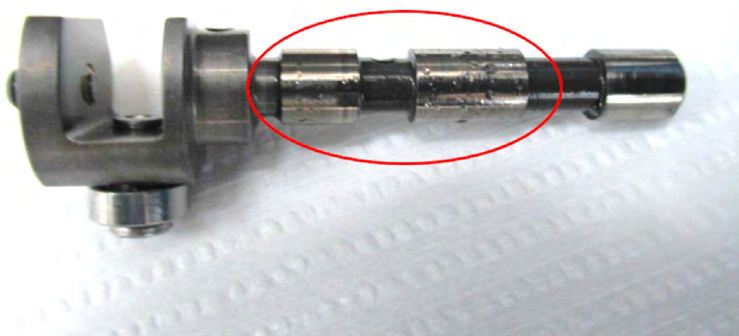
Figure 29

The HMU drive did not readily rotate when checked, and no torque check was attempted in order to prevent further damage to the unit. The unit was disassembled, and a few areas of a viscous, gelatinous substance were observed within (Figure 29).

Gelatinous residue (circled in red) on VBV pilot valve
(courtesy Woodward)

The colour of this residue varied between clear to very light yellow. Increased friction above what was considered normal was noted between almost all moving parts. The Delta P valve was seized and its drive pin was observed to be fractured (Figure 30).

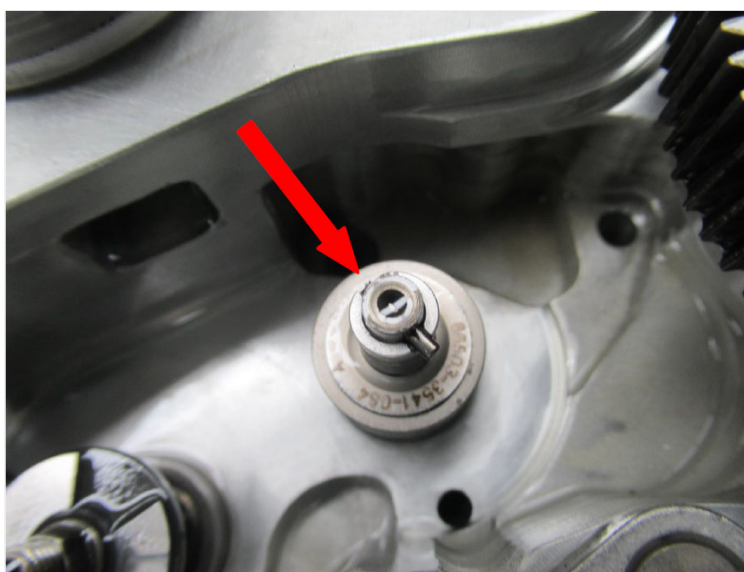
Figure 30

Fractured Delta P valve drive pin
(courtesy Woodward)

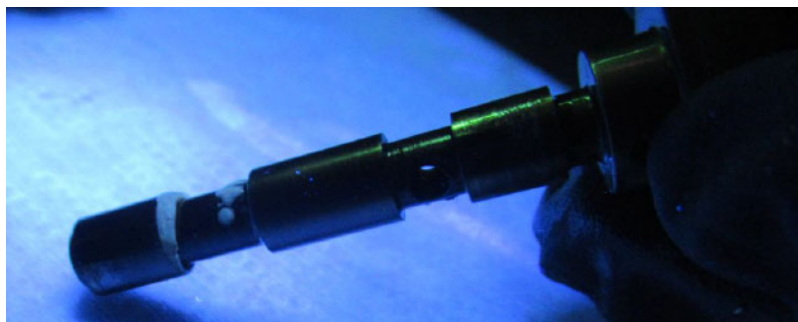
Figure 31

VBV pilot valve first-stage deposits under ultraviolet light
(courtesy Woodward)

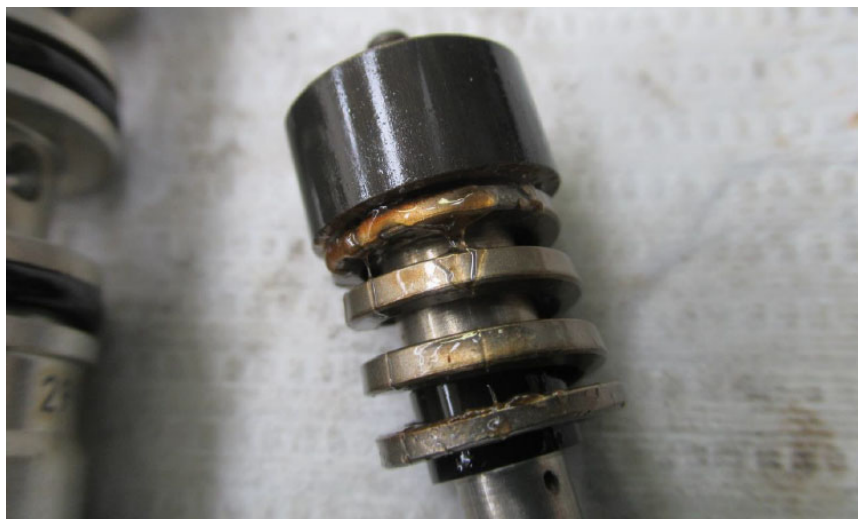
Figure 32

Brown, sticky deposits on low-pressure turbine case control turbine clearance valve (courtesy Woodward)

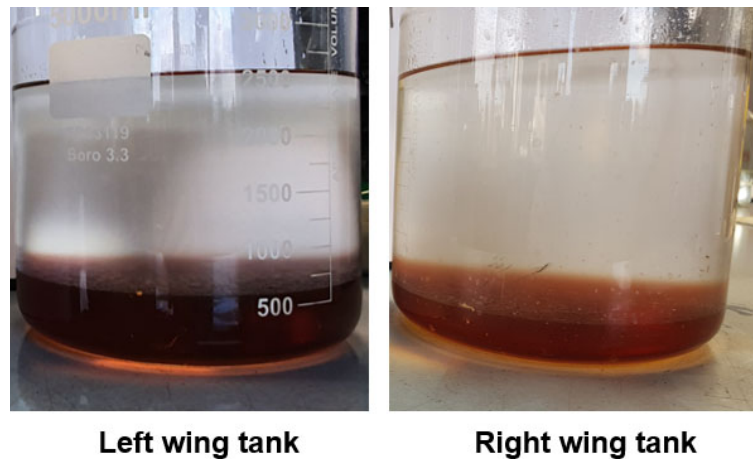
Figure 33

Fuel samples drained from left and right wing fuel tanks
