AIRCRAFT ACCIDENT REPORT 1/2021

Report on the serious incident to
Airbus A321-211, G-POWN
at London Gatwick Airport
on 26 February 2020

Air Accidents Investigation Branch

Report on the serious incident to
Airbus A321-211, registration G-POWN
at London Gatwick Airport
on 26 February 2020

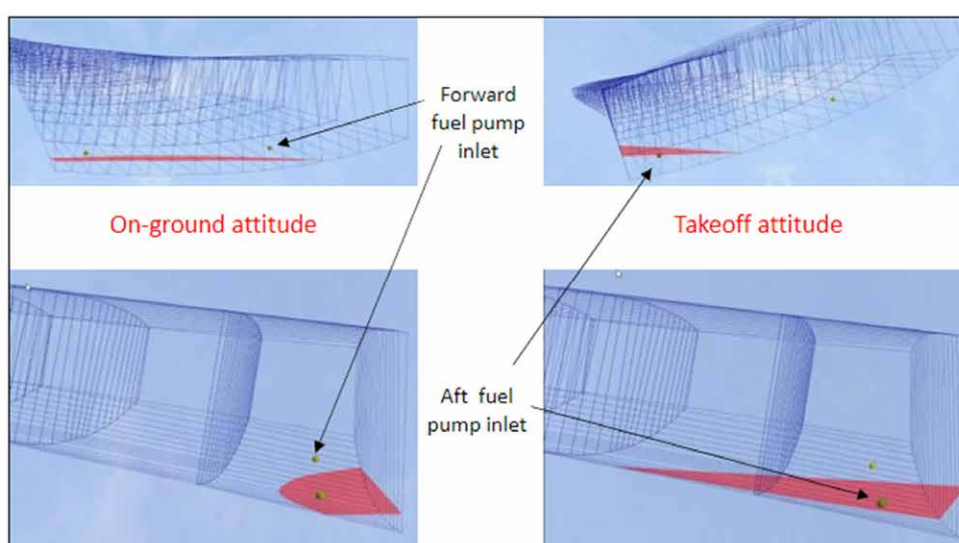
Figure 9

An assessment was made subsequently by the aircraft manufacturer which determined that the process used by the Base AMO would not have mixed the Kathon and fuel effectively. Fuel and Kathon must be agitated to mix effectively, but because they were added to the fuel tank at different locations (refuel coupling and overwing refuel aperture) no direct impingement occurred. As there was no other mechanism available to mix the two fluids, the amount of mixing would have been minimal. The assessment assumed a worse case of no mixing and, as shown in Figure 9, the level of 30 kg of Kathon at the lowest point of the tank was simulated (red surface in Figure 9). This level was then compared to the fuel pump inlet positions in the on-ground and takeoff attitude cases.

View of the left wing fuel tank at the root with the fuel pump inlet positions in relation to approximately 30 kg of Kathon. Left – on-ground (0°). Right – takeoff (15°) (images courtesy Airbus)

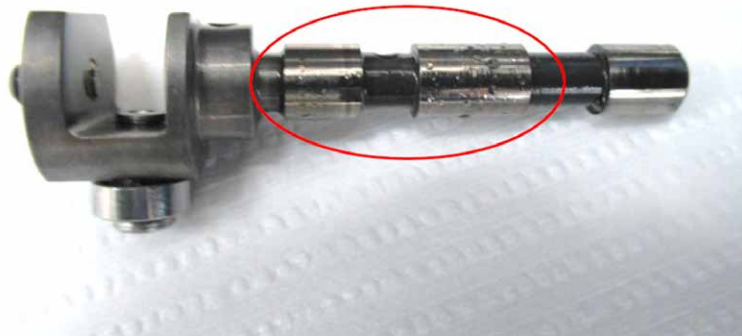
Figure 29

The HMU drive did not readily rotate when checked, and no torque check was attempted in order to prevent further damage to the unit. The unit was disassembled, and a few areas of a viscous, gelatinous substance were observed within (Figure 29).

Gelatinous residue (circled in red) on VBV pilot valve
(courtesy Woodward)

The colour of this residue varied between clear to very light yellow. Increased friction above what was considered normal was noted between almost all moving parts. The Delta P valve was seized and its drive pin was observed to be fractured (Figure 30).

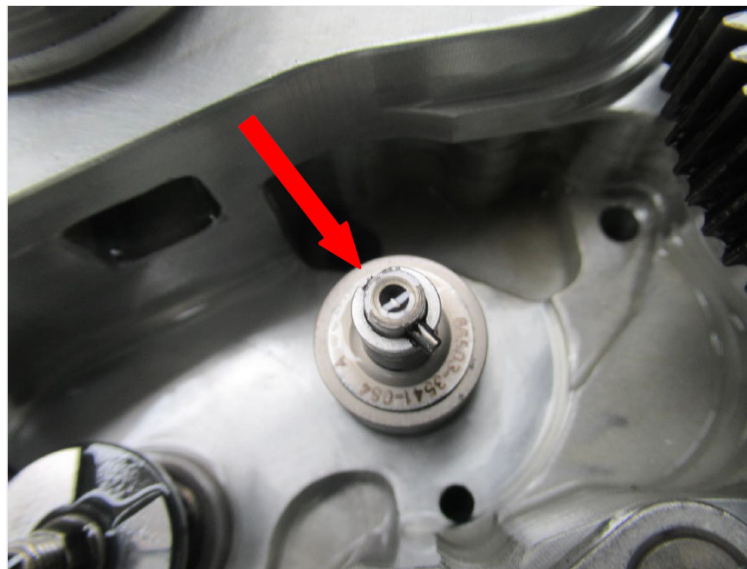
Figure 30

Fractured Delta P valve drive pin
(courtesy Woodward)

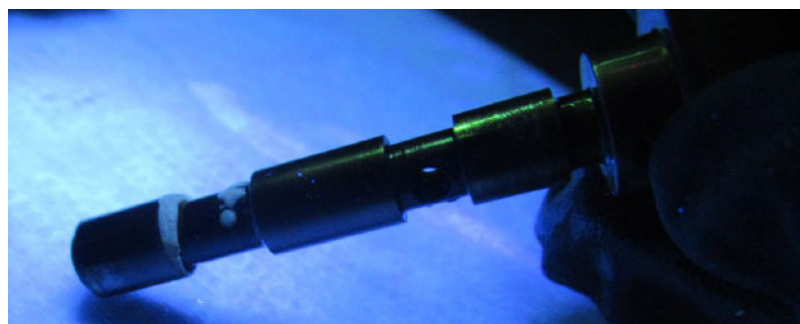
Figure 31

VBV pilot valve first-stage deposits under ultraviolet light
(courtesy Woodward)

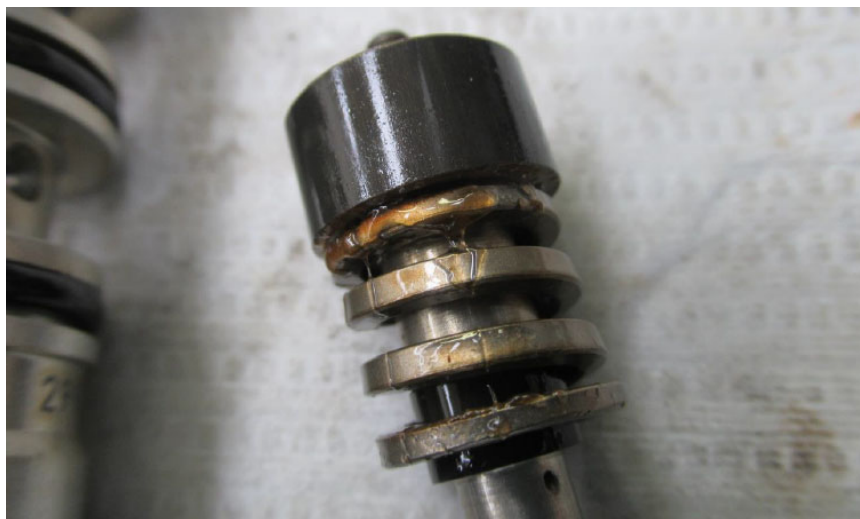
Figure 32

Brown, sticky deposits on low-pressure turbine case control turbine clearance valve (courtesy Woodward)
