# Runaway and near miss at Dereham station, Mid-Norfolk Railway, 10 December 2020

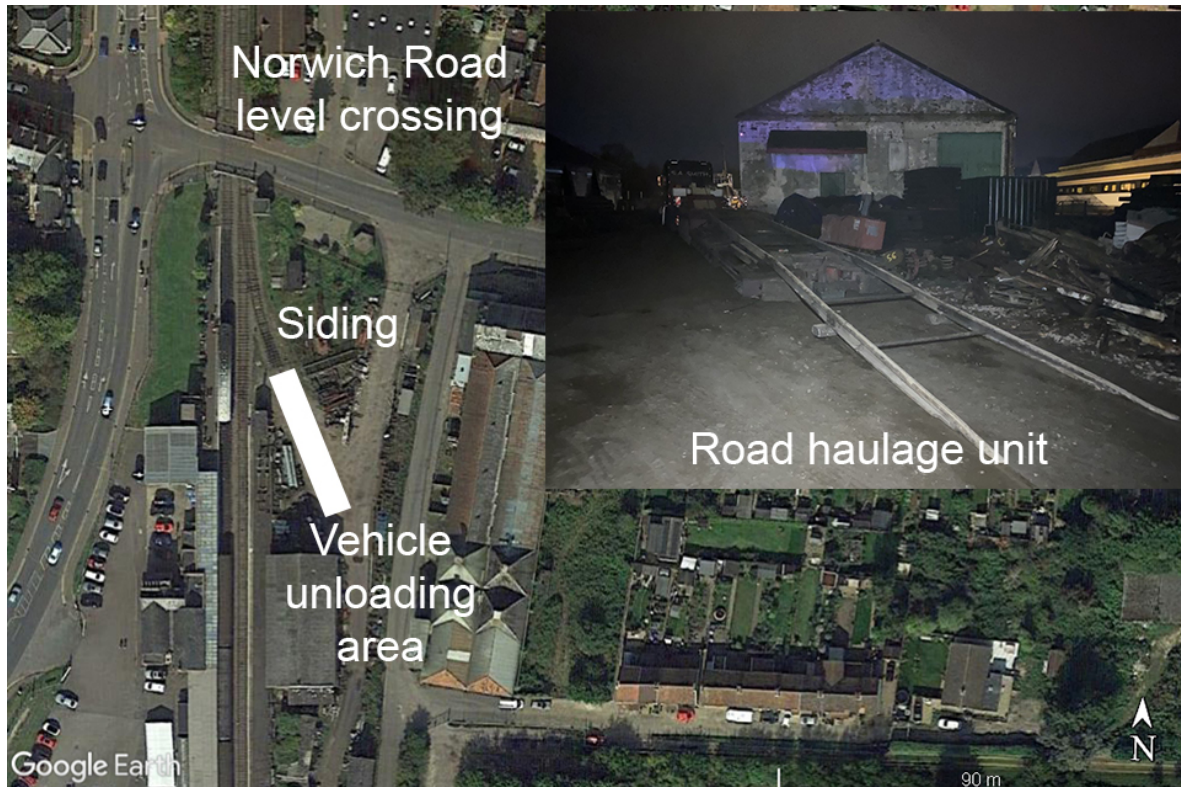
The vehicle ran uncontrolled for over 30 seconds, passing a stop board, running the wrong way through, and damaging, trailing points (which possibly slowed it down) and onto the running line where it collided with the level crossing gates. It came to a stop blocking the road. No-one was injured. However, CCTV shows one pedestrian crossing in front of the vehicle eight seconds before it arrived at the level crossing. Altogether, around 250 pedestrians and cyclists and 150 cars, vans and buses had used the level crossing during the time that the vehicle was being unloaded.

Dereham station showing where the vehicle was being unloaded, the siding, Norwich Road level crossing and the road haulage unit (inset photograph courtesy of Mid-Norfolk Railway)

As a result of its own investigation of the accident, Mid-Norfolk Railway has stated that it has suspended vehicle loading and unloading operations on the siding and proposes trackwork alterations that will remove direct access to the running line.

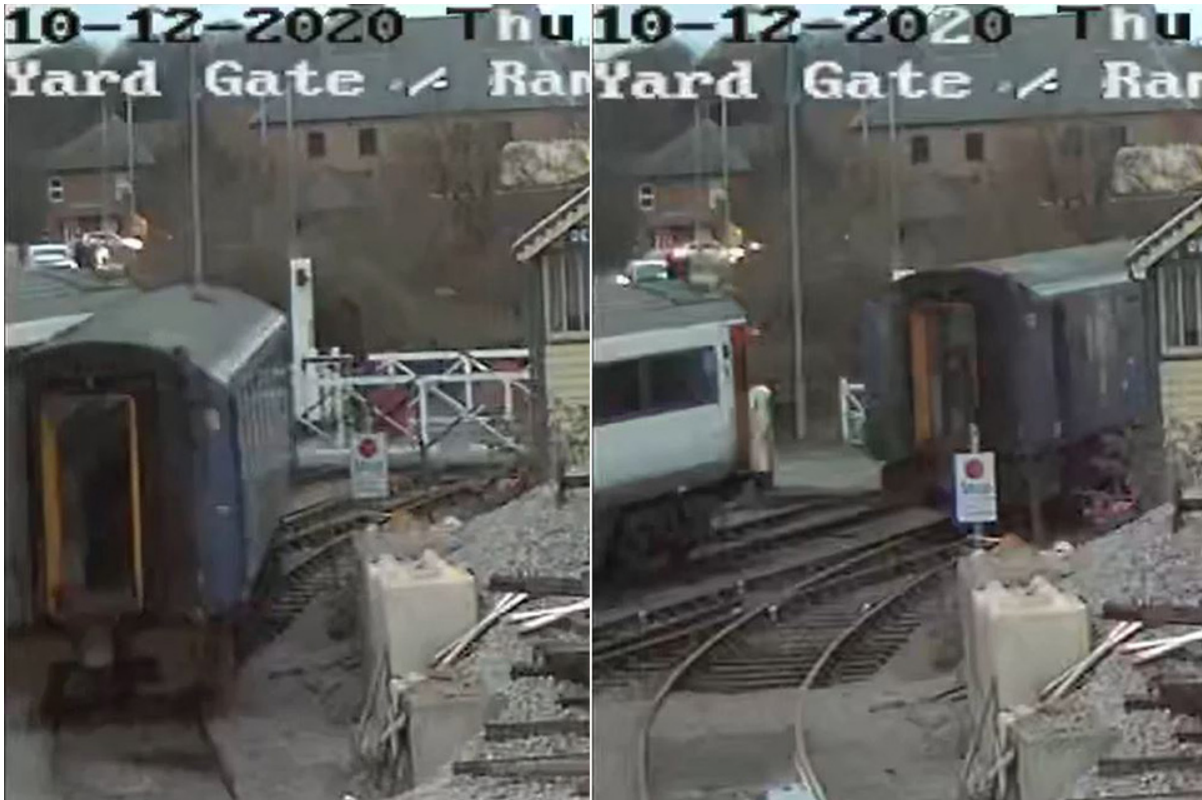
CCTV images of the vehicle runaway (photographs courtesy of Mid-Norfolk Railway)

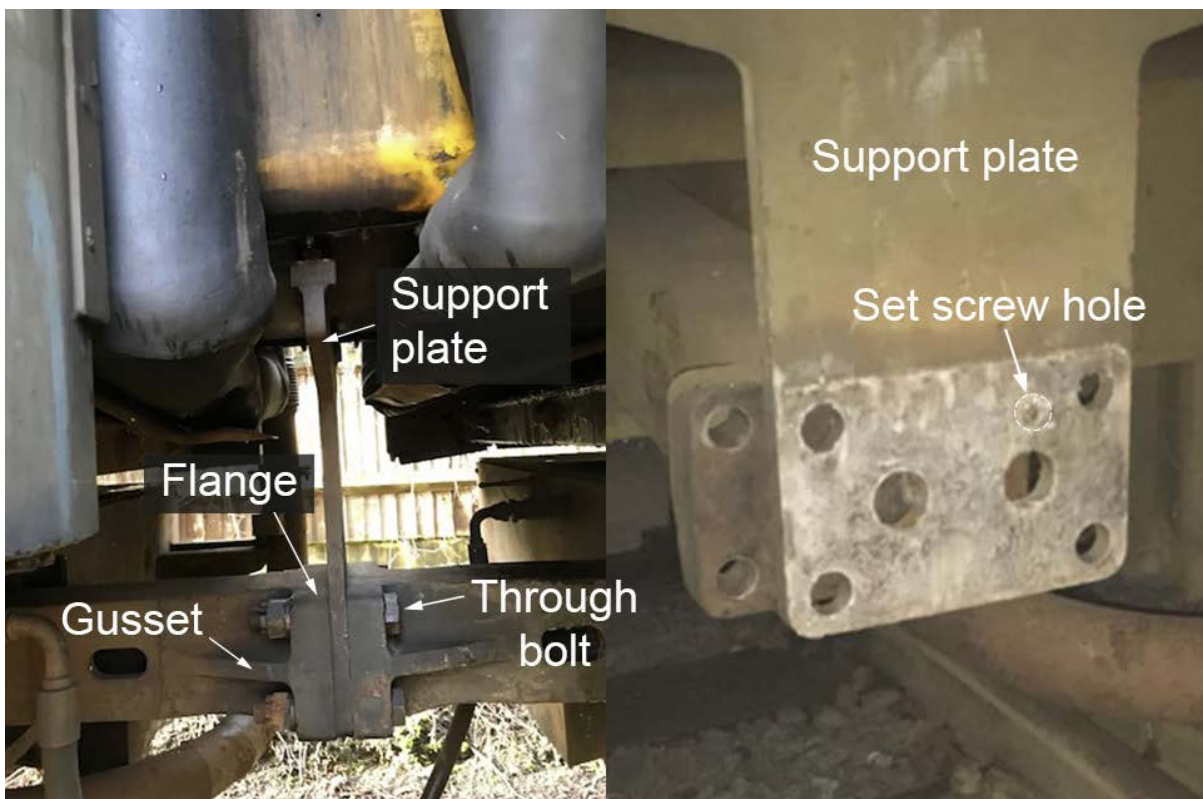
**Semi-permanent drawbars on a coupled Pacer unit. The image on the right shows the support plate and location of the set screw hole - taken after the plate had separated from the drawbar flange (photographs courtesy Mid-Norfolk Railway)**

The exact way in which the chain and winch rope became detached is uncertain. However, the wrapped chain probably slipped on the drawbar and the two gussets guided it over the flange. With the winch load now acting on the support plate, the single set screw failed, allowing the support plate to separate from the flange and the chain to fall.

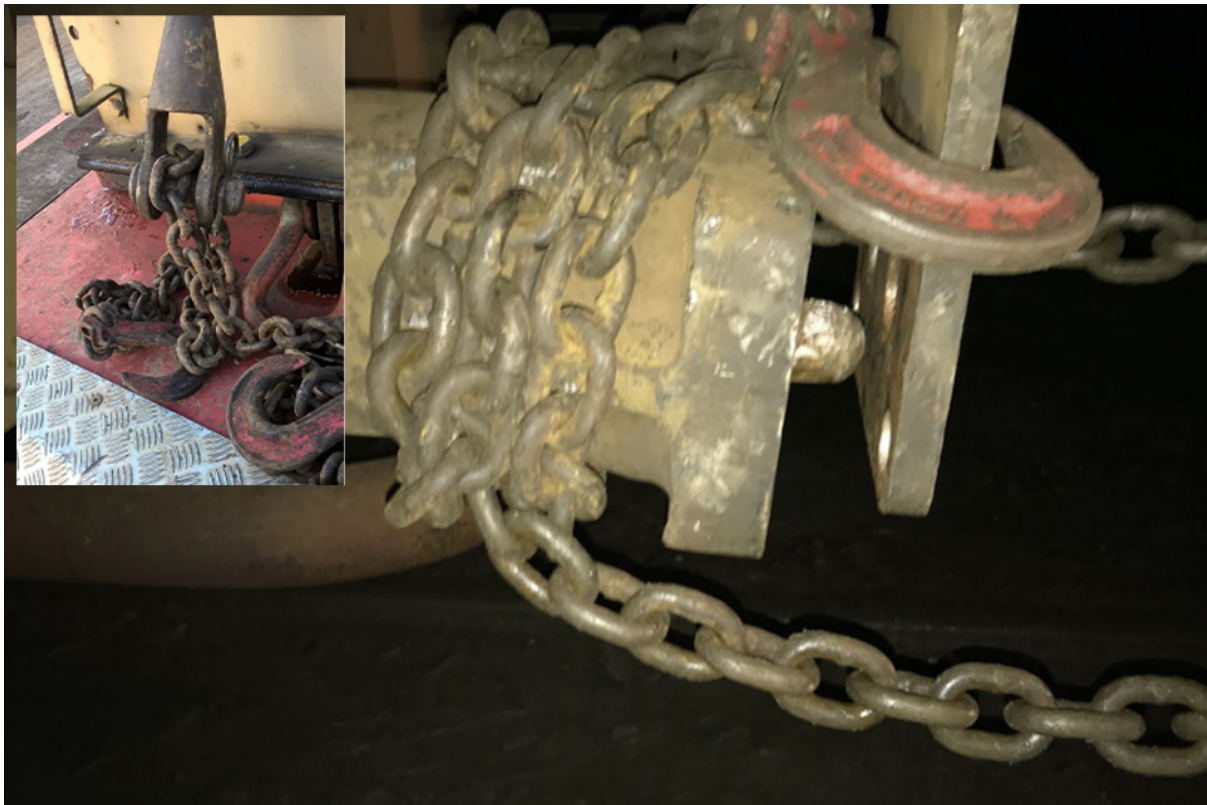
The accident occurred because the winch rope was connected to the Pacer vehicle by a chain in a manner that did not provide a secure means of attachment and, as a result, became free. There were no suitable arrangements for mitigating the consequence of this hazard.

**Re-creation showing the chain wrapped around the drawbar (photograph courtesy Mid-Norfolk Railway). Inset shows the open termination on the winch rope (photograph courtesy SA Smith)**
