Report on the investigation of the
fatal accident to a crew member on board
the scallop dredger

Olivia Jean (TN35)

north-east of Aberdeen, Scotland

28 June 2019

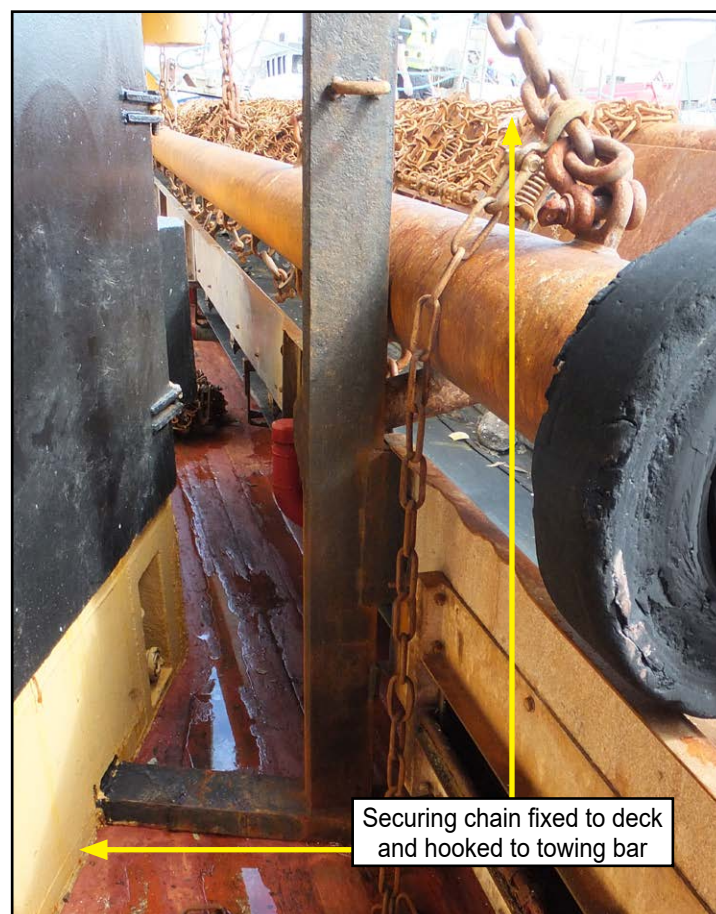
Figure 3: Starboard aft towing bar crutch and securing chain

The towing bars needed to be lifted to allow the crew to refit the safety chains, and to achieve this their securing chains needed to be unhooked. The deckhand unhooked the port towing bar's fore and aft securing chains, but the engineer inadvertently left the starboard towing bar's aft securing chain attached (**Figure 3**).

Puzzled by the situation, the skipper left the central control console and crossed the wheelhouse to the starboard window to take a closer look. He quickly realised that the aft securing chain was still attached to the towing bar and saw that the engineer had climbed on to the conveyor belt in readiness to connect the safety chains. On seeing this, the skipper decided to lower the towing bar to slacken the securing chain so that it could be unhooked.

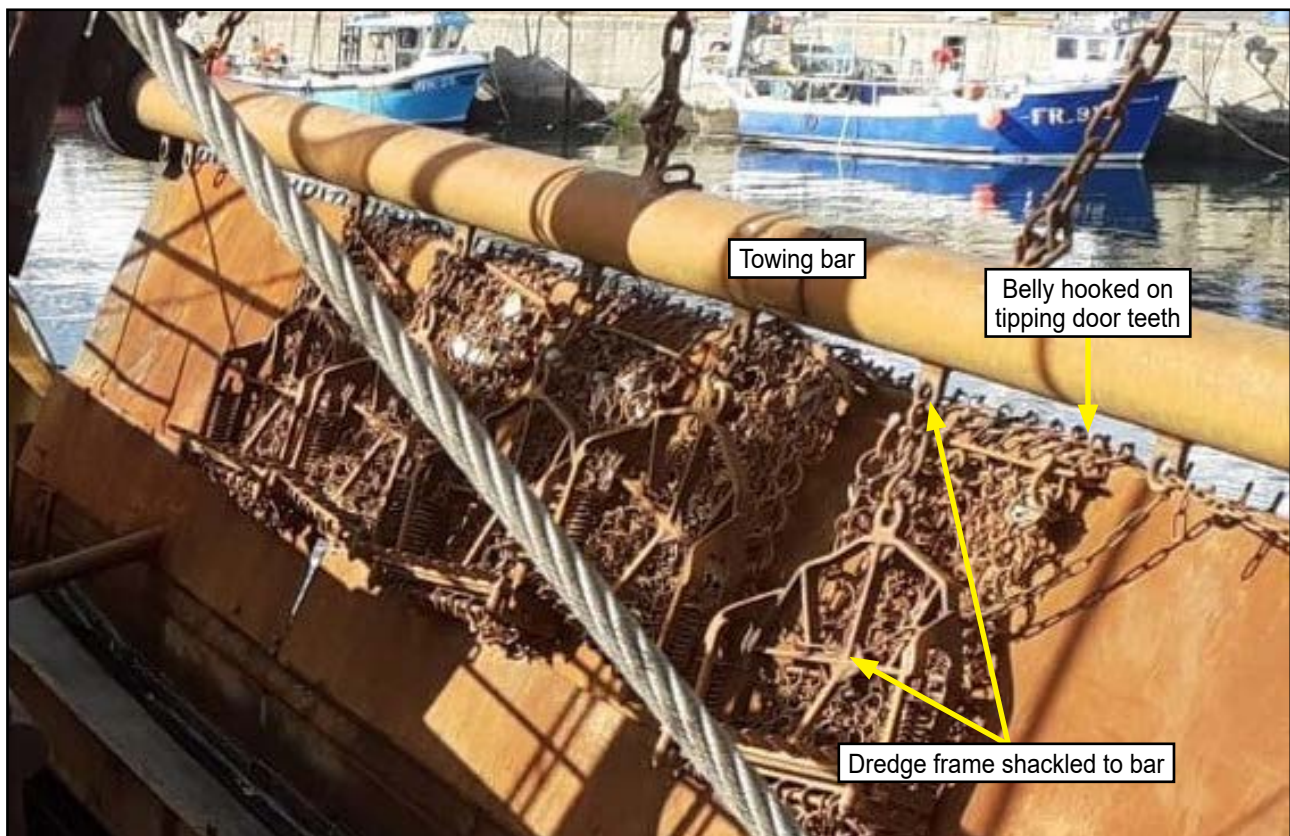
Figure 4: Towing bar resting on upturned tipping door

The skipper, in the wheelhouse, checked that the deckhand and engineer were standing clear of the dredge gear and then lowered the derricks by about 20° on both sides. This was to ensure that the towing bars would rest securely against the raised tipping doors when lifted (**Figure 4**). The skipper lifted the port towing bar first and the deckhand began to reconnect its safety chains. The skipper then turned his attention to the starboard towing bar. Again, seeing that the engineer was standing clear, the skipper began to lift the starboard bar. As he did so, its aft securing chain became taut and only the forward end of the towing bar began to lift. This caused the bar to rest at an angle against the tipping door (**Figure 5**).

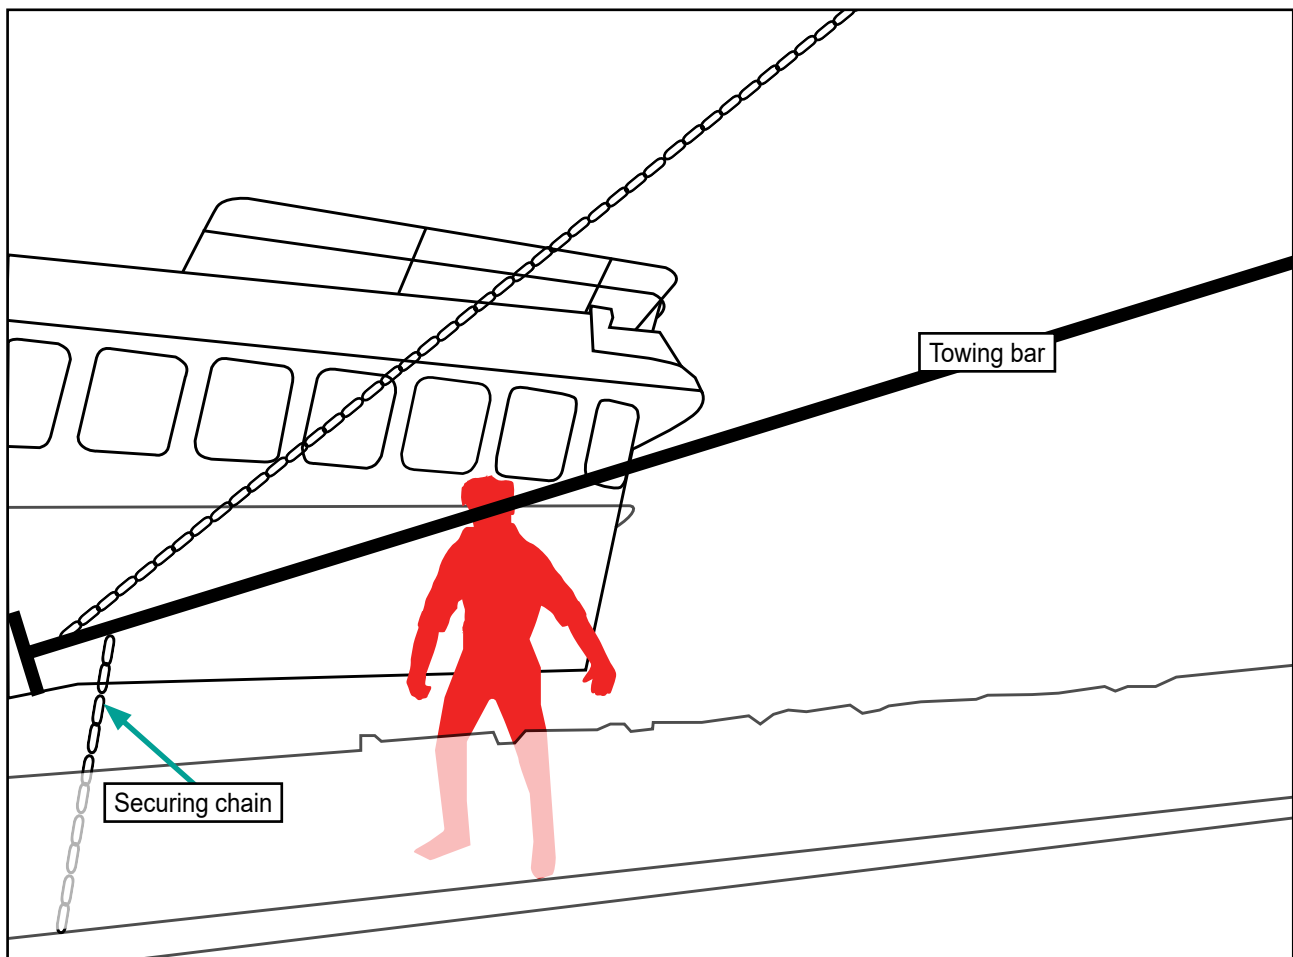
Figure 6: Engineer caught between towing bar and accommodation

While this was going on, the engineer had walked aft, out of the skipper's line of sight, and stepped into the narrow gap between the dredge gear and the vessel's accommodation superstructure. As he did so, he was struck on the head and pinned against the vessel's accommodation bulkhead by the swinging towing bar.

When the skipper attempted to lower the towing bar he noticed that it had not dropped properly, and stopped the winch. He shouted to the engineer through the centreline wheelhouse window but, when there was no answer, he went to the starboard side window, looked out, and saw the engineer trapped between the towing bar and the accommodation bulkhead (**Figure 6**). He dashed back to the central controls and lifted the towing bar to release the engineer. He also shouted to the deckhand on the port side of the deck, and instructed him to go and help the engineer. The skipper sounded the general alarm to alert the rest of the crew, then ran down into the accommodation and told them to get up and go onto the deck to help. He then ran onto the deck to see what was happening.

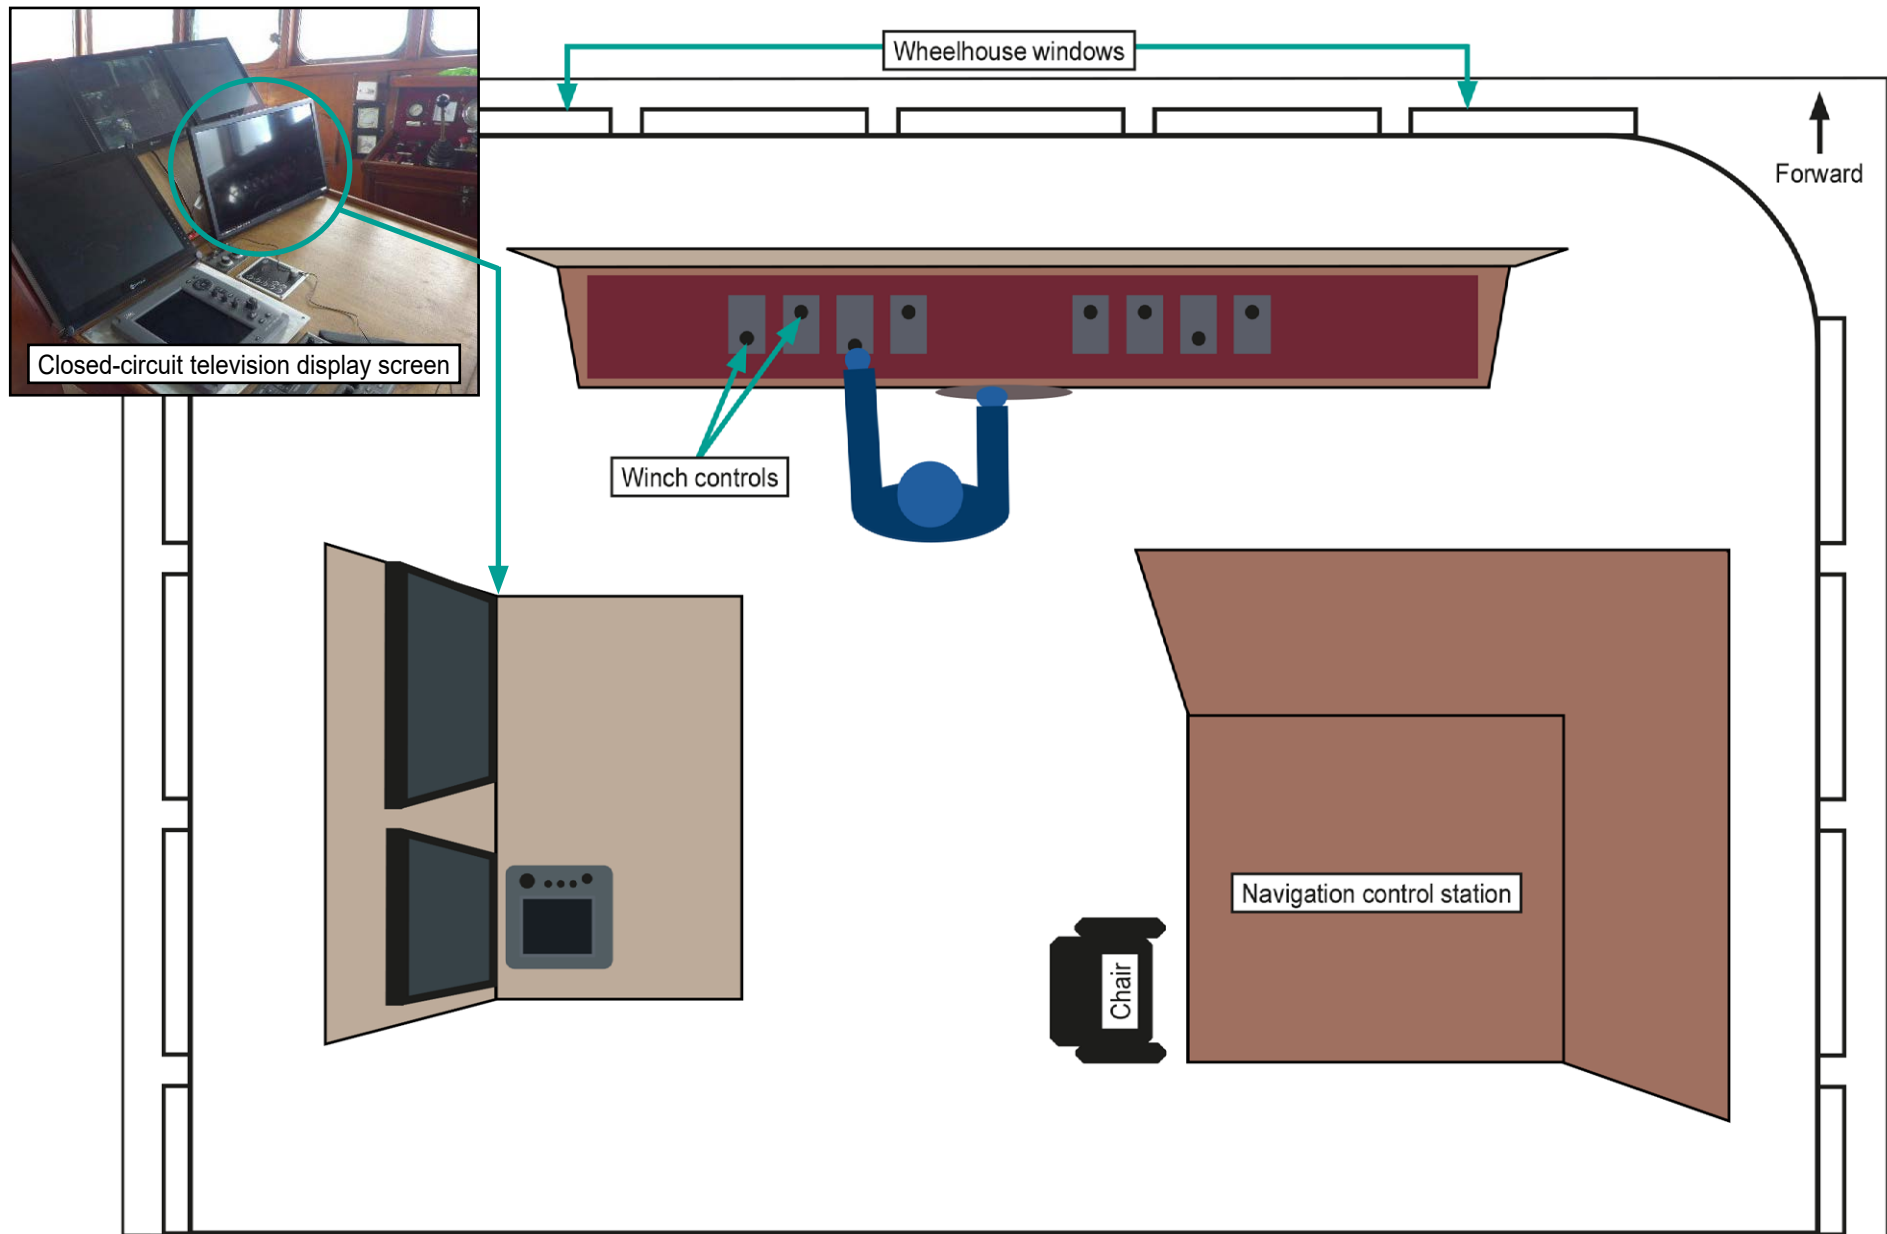
Figure 8: Position of closed-circuit television display screen in the wheelhouse

Shooting the gear, towing bar retrieval and stowing the gear were also identified in the risk assessment as hazardous activities that could result in head or crush injuries. The control measures to mitigate these risks included the use of hard hats and the provision of a closed-circuit television (CCTV) system that allowed the winch operator in the wheelhouse to view the blind spots at the after end of the working deck. The CCTV display screen was located on a console behind and to the left of the skipper working at the winch controls (**Figure 8**).

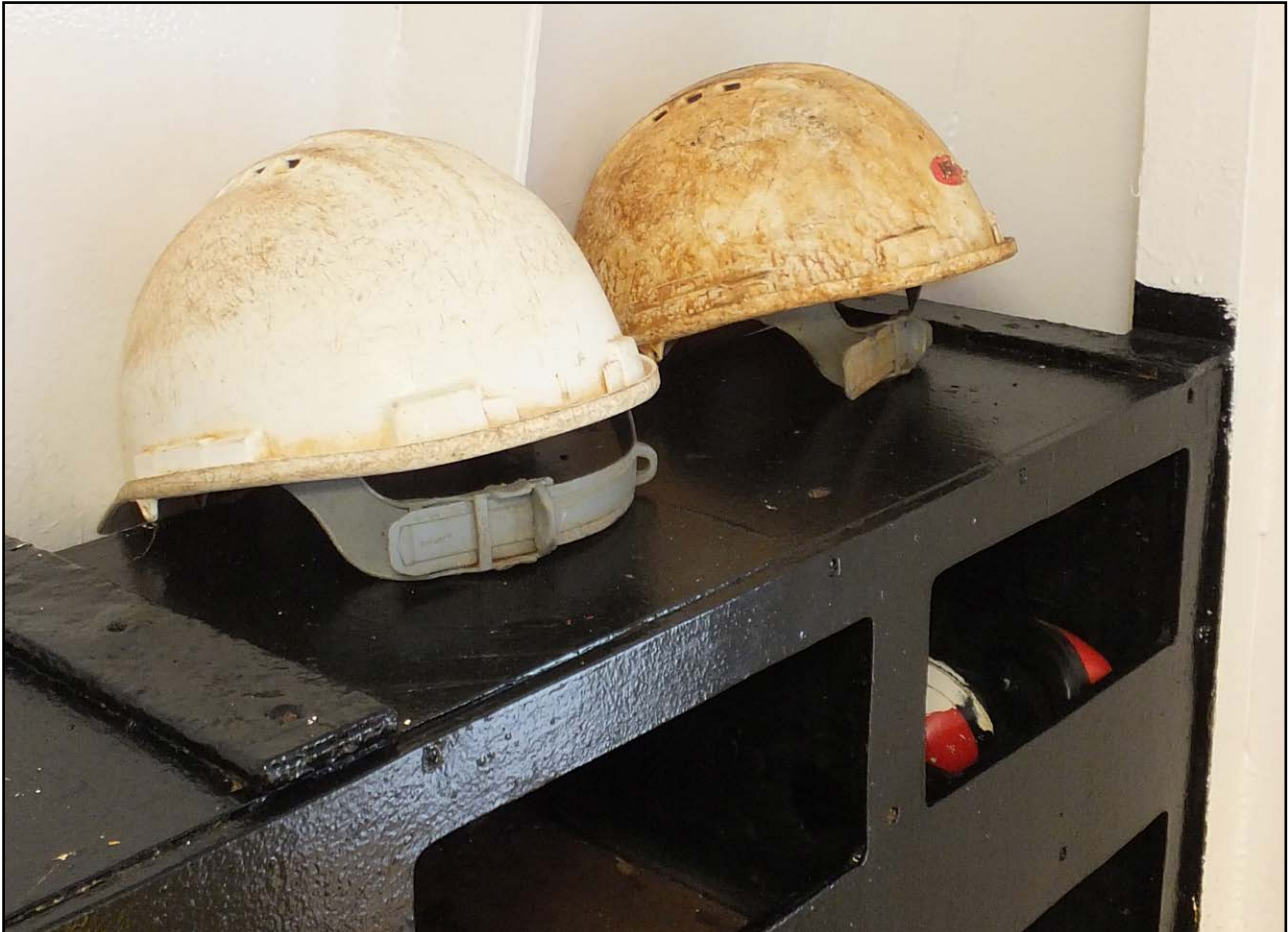
Figure 9: Crew hard hats on board *Olivia Jean*

The engineer and deckhand were not wearing hard hats at the time of the accident. It was evident that the hard hats held on board *Olivia Jean* had been used in the past (**Figure 9**), but the vessel's deck crew did not routinely wear them on deck at sea when shooting, hauling or stowing the gear.

It was evident from the condition of the vessel's hard hats (**Figure 9**) that the crew had used them in the past. However, they were not routinely worn on deck at sea when shooting, hauling and stowing the dredge gear. Given that the crew routinely wore other personal protection equipment, including auto-inflation lifejackets while working on deck, the reasons for not using the head protection during hazardous lifting operations at sea must have been more complex than a general reluctance to comply with recognised safety standards. The crew might have found the hard hats uncomfortable to wear or considered them a hindrance.

wearing a hard hat, particularly one designed to resist lateral deformation, it is likely that the extent of his injuries would have been reduced, and therefore his chances of survival increased.

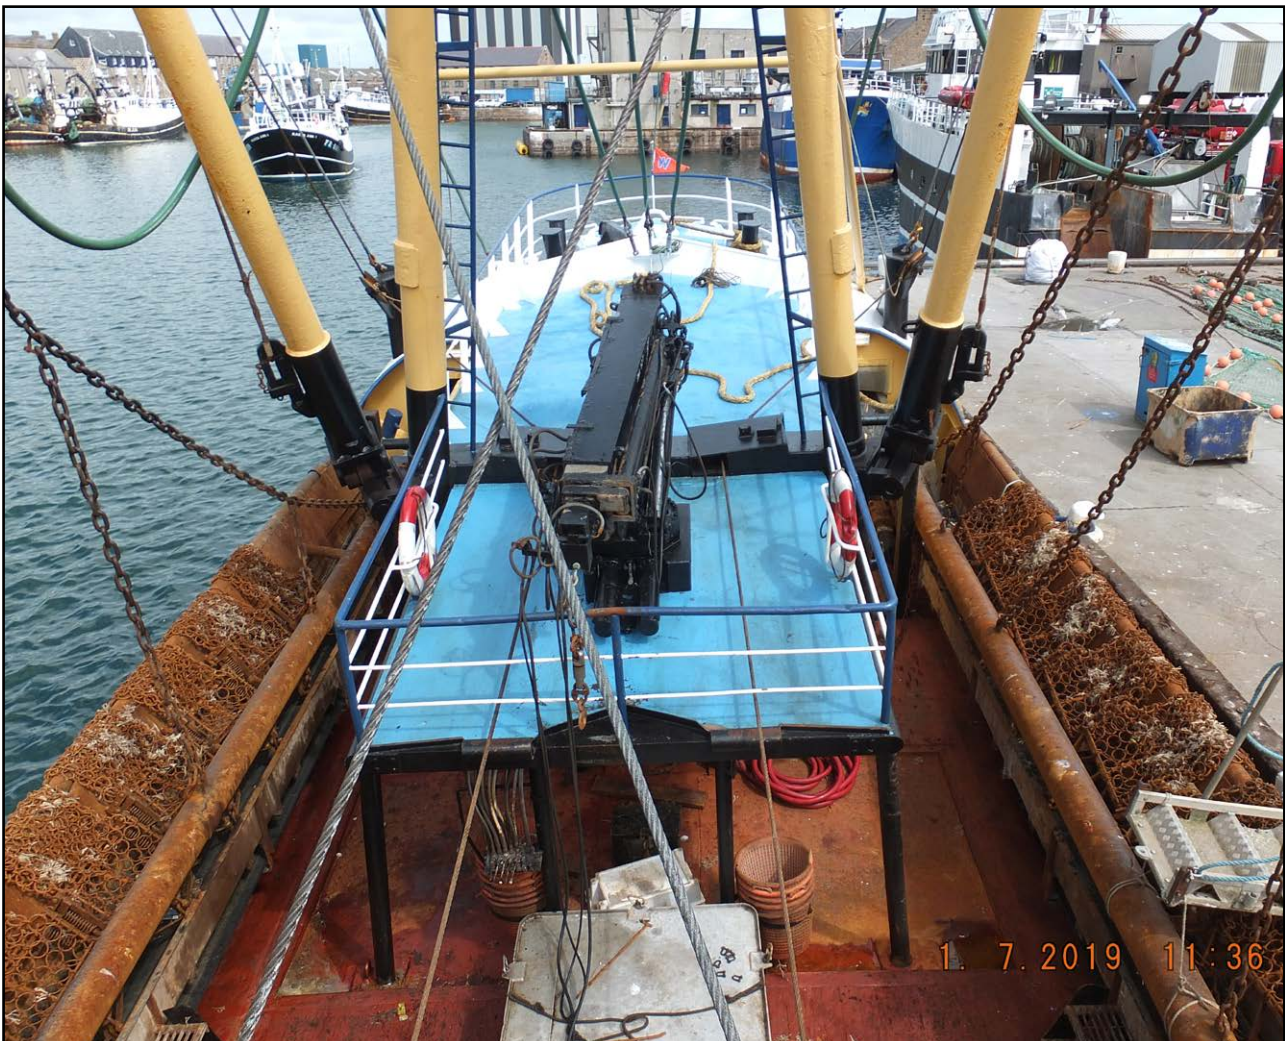
Figure 11: View from the wheelhouse winch controls of foredeck

Immediately prior to the accident, *Olivia Jean*'s deck crew were working independently of each other, and with the skipper focused on unsnagging the gear, he was almost totally reliant on the crew's experience, their understanding of the training they had been given, and their appreciation of what was expected of them. This might have worked effectively during routine hauling and shooting operations, but when things started to go wrong a much higher degree of oversight was needed. This might have been better achieved by nominating one of the deck crew to take the lead and coordinate the deck work. Establishing responsibilities and working relationships on board ships is a very important part of securing safe working practices, and promoting a culture of safety.
