**ACCIDENT**

<b>Aircraft Type and Registration:</b>	Europa, G-BXTD	
<b>No &amp; Type of Engines:</b>	1 Rotax 912-UL piston engine	
<b>Year of Manufacture:</b>	2000 (Serial no: PFA 247-12772)	
<b>Date &amp; Time (UTC):</b>	28 July 2020 at 1226 hrs	
<b>Location:</b>	Enstone Airfield, Oxfordshire	
<b>Type of Flight:</b>	Private	
<b>Persons on Board:</b>	Crew - 2	Passengers - None
<b>Injuries:</b>	Crew - None	Passengers - N/A
<b>Nature of Damage:</b>	Damage to right wing, undercarriage strut, flaps and fuselage aft of the wing	
<b>Commander's Licence:</b>	Airline Transport Pilot's Licence	
<b>Commander's Age:</b>	65 years	
<b>Commander's Flying Experience:</b>	20,076 hours (of which 91 were on type) Last 90 days - 37 hours Last 28 days - 21 hours	
<b>Information Source:</b>	Aircraft Accident Report Form submitted by the pilot and further inquiries made by the AAIB

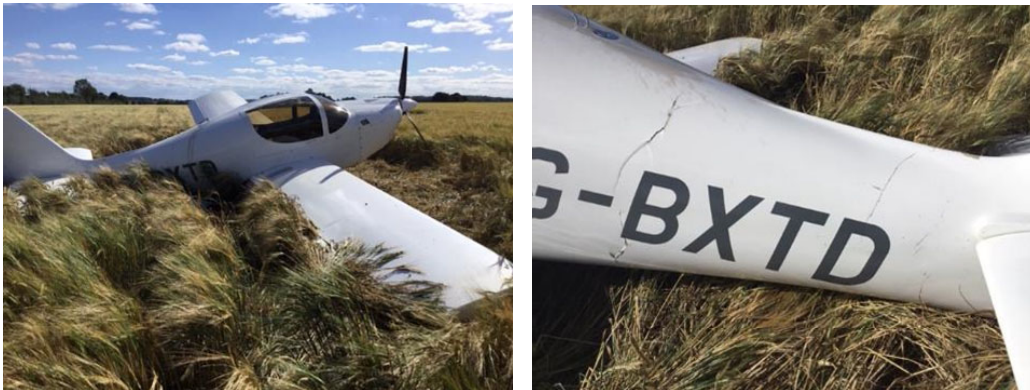
**Figure 1**

Measuring the length of the path through the crops revealed that the aircraft had travelled approximately 50 metres along the ground before stopping. The landing and subsequent turn damaged the aircraft's right undercarriage outrigger, wing, flap and aileron. Cracks were evident in the rear fuselage between the cockpit and tail (Figure 1) and the tail section below the left elevator was also cracked and the skin distorted. There was no damage to the cockpit area.

Aircraft final resting position and cracks evident in the rear fuselage section

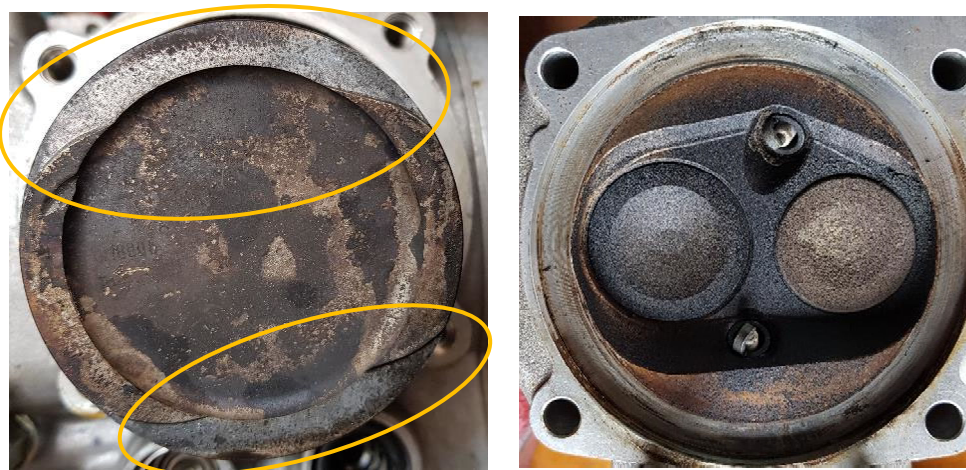
**Figure 4**

The No 4 piston had also been in contact with the cylinder head, creating cylinder head shaped dents in the crown (Figure 4).

Piston crown (left) showing dents made by the cylinder head (right)
