**SERIOUS INCIDENT**

<b>Aircraft Type and Registration:</b>	Cessna C208B Super Cargomaster, N967FE	
<b>No &amp; Type of Engines:</b>	1 Pratt & Whitney PT6A-114A turboprop engine	
<b>Year of Manufacture:</b>	1988	
<b>Date &amp; Time (UTC):</b>	23 September 2020 at 1716 hrs	
<b>Location:</b>	Terrance B Lettsome International Airport, Tortola, British Virgin Islands	
<b>Type of Flight:</b>	Commercial Air Transport (Cargo)	
<b>Persons on Board:</b>	Crew - 1	Passengers - None
<b>Injuries:</b>	Crew - None	Passengers - N/A
<b>Nature of Damage:</b>	Damage to both main wheels and to the right landing gear leg fairing and baggage pod	
<b>Commander's Licence:</b>	Commercial Pilot's Licence	
<b>Commander's Age:</b>	55 years	
<b>Commander's Flying Experience:</b>	1,878 hours (of which 174 were on type) Last 90 days - 143 hours Last 28 days - 44 hours	
<b>Information Source:</b>	AAIB Field Investigation

**Synopsis**

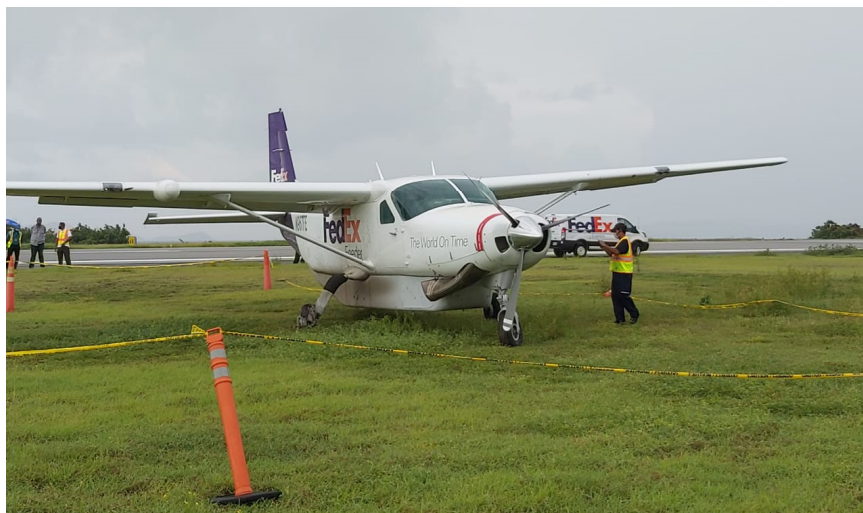
The aircraft landed on the centreline 795 m past the threshold (total landing distance available - 1,206 m). The right tyre burst on landing and the under-fuselage baggage pod contacted the runway. The aircraft travelled along the runway but as the speed reduced the pilot was unable to keep it on the centreline. The aircraft veered to the right onto the grass, coming to rest approximately 18 m to the north of the runway.

**Figure 2**  
N967FE after the incident

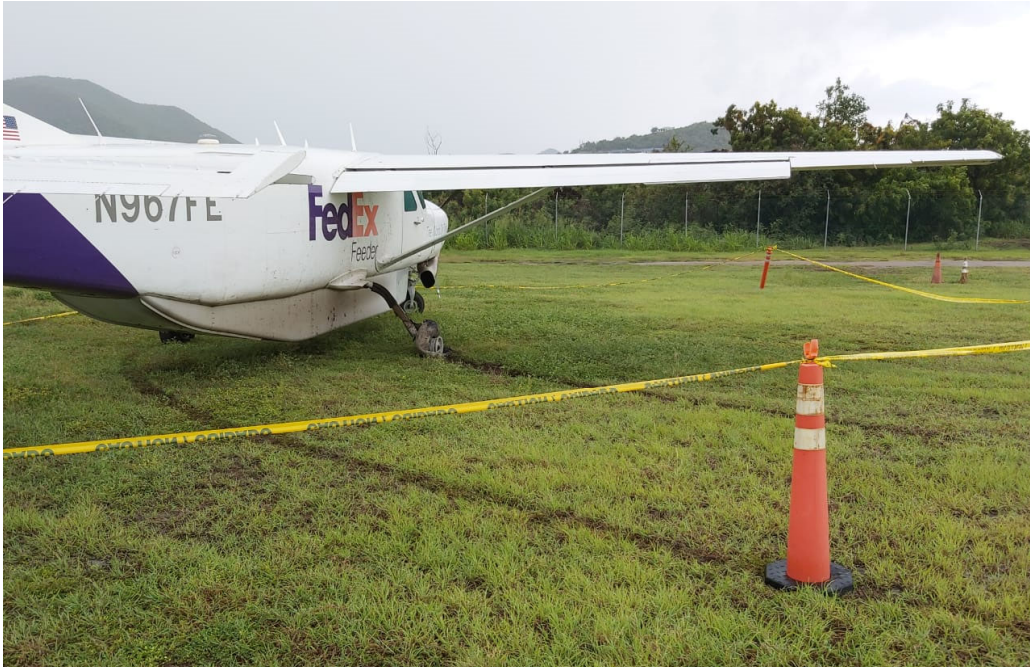
**Figure 3**

N967FE after the incident

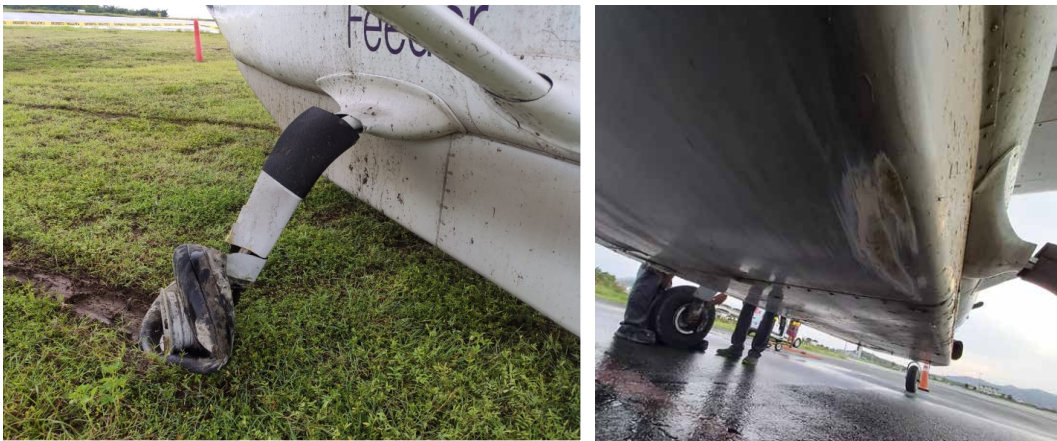
**Figure 4**

Damage to right wheel assembly and under-fuselage baggage pod

The aircraft was examined by the operator. Damage was found to the left and right main wheel assemblies, the right landing gear fairing, the right axle cover, the nosewheel steering bungee and the DME<sup>3</sup> antenna. A scrape mark was found on the aft of the cargo pod where it had contacted the runway but this was found to have only damaged the paint. A Hard Landing inspection was carried out, no structural damage was found.

Once the airframe damage was repaired, a subsequent engine run, on 7 October 2020, identified a lack of engine response to throttle movement. As part of fault finding, in accordance with the maintenance manual, the P3<sup>4</sup> line and P3 filter were replaced and the Py<sup>4</sup> line was blanked at the FCU<sup>5</sup> to eliminate it from the fault finding. This had no effect on the engine operation and as a result the FCU and the engine fuel pump assembly were replaced. These units had been fitted approximately six flying hours before the occurrence on 23 September 2020. Once the replacement components had been installed and tested the aircraft was returned to service.

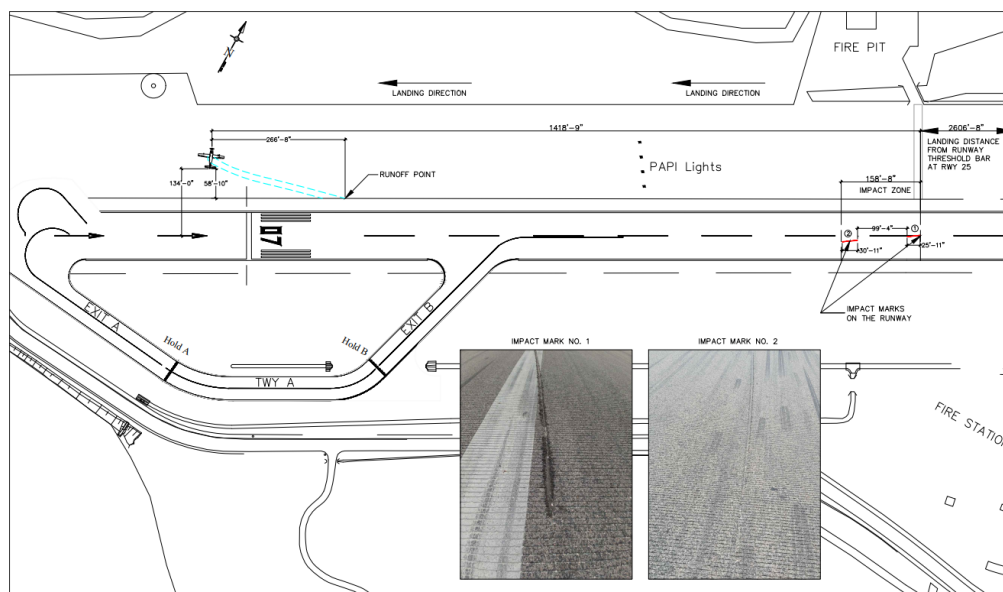
**Figure 5**

Aerodrome map showing initial impact marks and final position

The aircraft was making a visual approach to Beef Island Airport when the pilot reported that the aircraft entered a rain shower and he decided to go-around. However, he reported that the aircraft did not climb. The aircraft was seen on CCTV and by several witnesses flying level, at approximately 300 ft and high speed, along the runway before descending steeply to the ground. It landed firmly, two thirds of the way along the runway, leaving scrape marks on the runway surface, and then left the paved surface during the landing roll.

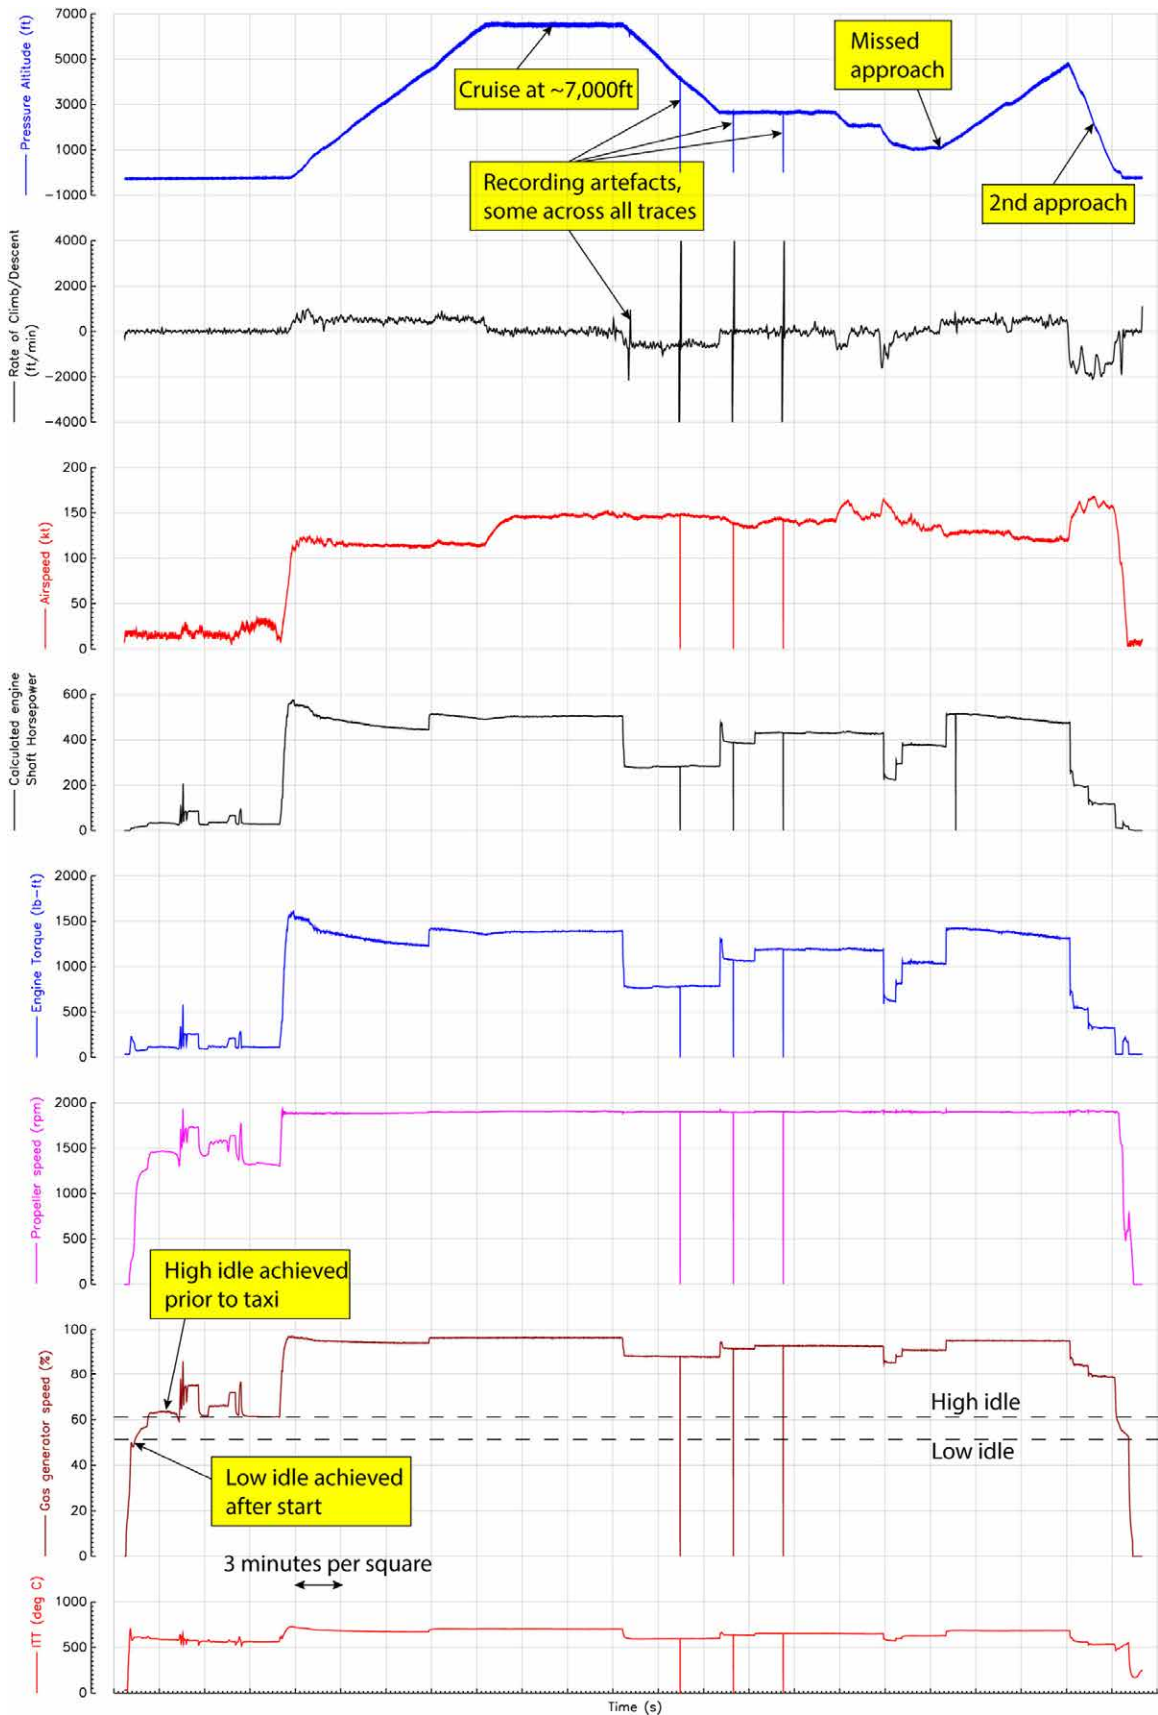
**Figure 6**  
ADAS+ data for the whole of the incident flight

Figure 6 shows a selection of the data for the whole of the incident flight, including the engine start and shutdown, that has been annotated to show the cruise, discontinued approach, visual approach and landing portions of the flight. Of note, the idle speed of the engine in the Cessna 208B Super Cargomaster can be selected by the pilot using the Fuel Condition Lever to either LOW IDLE or HIGH IDLE. LOW IDLE is used for ground operations, such as taxiing, whilst HIGH IDLE is used during flight. HIGH IDLE should be selected by the pilot prior to takeoff and LOW IDLE re-selected after landing. The position of the Fuel Condition Lever was not recorded but the data shows that the engine accelerated normally to LOW IDLE after start and that HIGH IDLE was achieved before taxi.

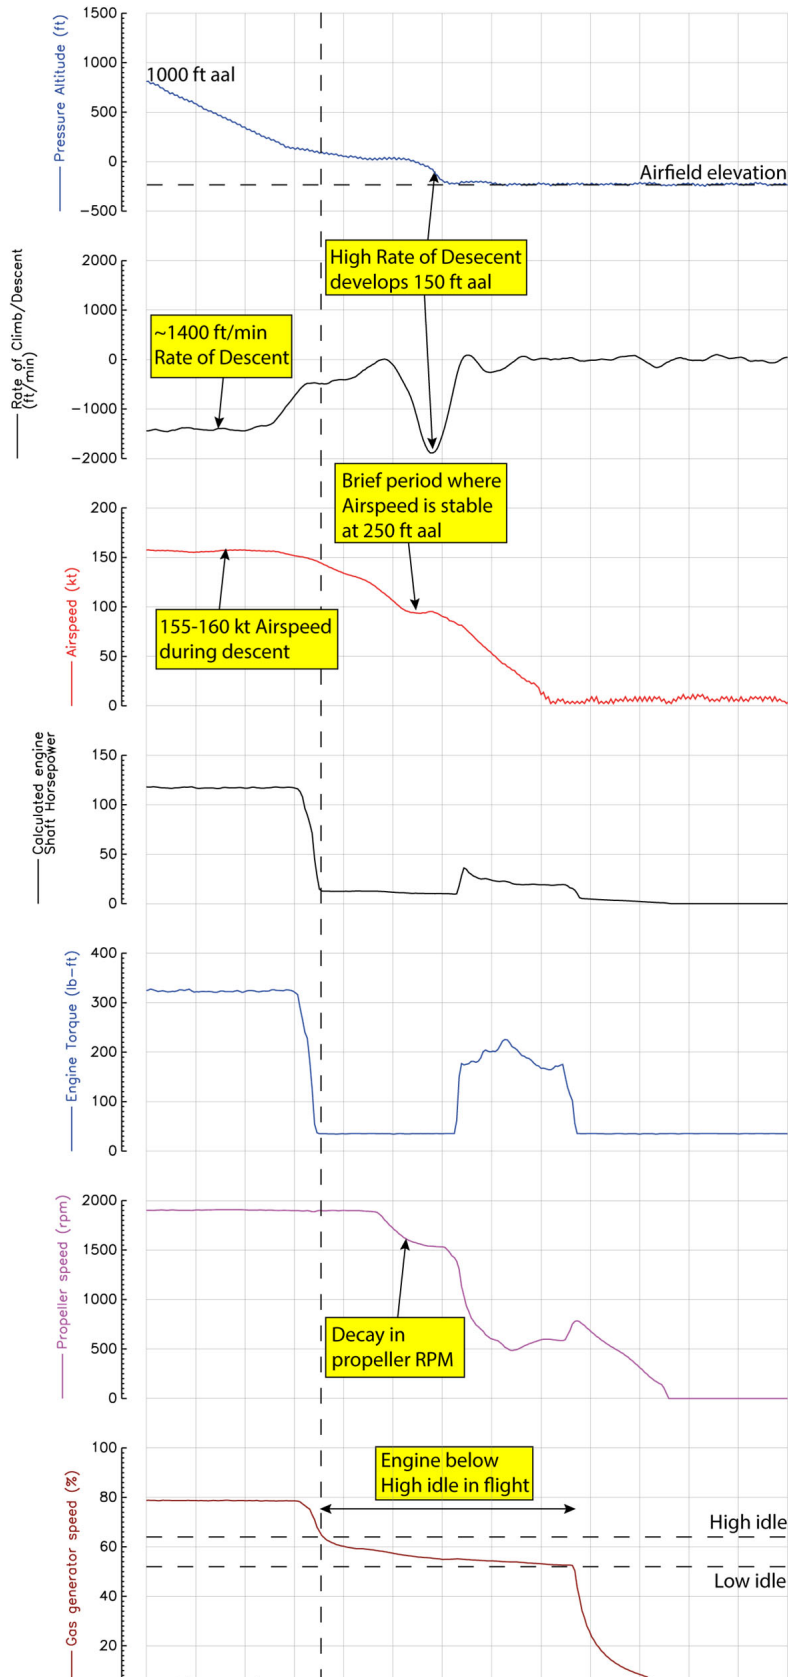
**Figure 7**  
ADAS+ data from 1,000 ft aal for the incident flight

After the discontinued approach, N967FE climbed to approximately 5,000 ft before a second approach was commenced. An expanded view of data for this approach, from 1,000 ft aal, and the subsequent landing at Beef Island Airport is shown in Figure 7. The data shows that N967FE descended at 155 - 160 kt, 15 – 20 kt less than the aircraft's  $V_{NE}$  of 175 kt<sup>2</sup>, with an average rate of descent of 1,400 ft/min until 350 ft aal. Approximately 30 seconds from landing, the power output from the engine substantially reduced, indicated by a reduction in gas generator speed and engine torque. The airspeed decreased and stabilised at approximately 95 kt and the aircraft flew level at 250 ft aal for a period of 10 seconds. However, the gas generator speed continued to decrease below the HIGH IDLE value expected in flight (62%) and propeller rpm also began to decay. Shortly afterwards, a high rate of descent, approaching 2,000 ft/min, developed as the aircraft passed through 150 ft aal. The gas generator speed, although not fully stabilised, was by this point decreasing towards LOW IDLE.

The position of the Emergency Power Lever, which would have allowed the pilot to directly modulate the fuel flow to the engine if deceleration of the engine was caused by a fuel control unit (FCU) malfunction, was recorded. This data shows that the Emergency Power Lever was not used to restore engine power.

The data also shows that on final approach there were no significant short-term changes in airspeed to indicate windshear.

Analysis of the data recovered from the aircraft showed that the engine was operating at a typical HIGH IDLE speed prior to takeoff and that the engine operated normally during the flight. However, during the approach the engine decelerated below HIGH IDLE. Being below HIGH IDLE in isolation would not have prevented the engine from accelerating if the pilot advanced the power lever. The possible causes for the engine to decelerate below HIGH IDLE include pilot selection of low idle, an FCU malfunction or a blockage of the pressure sensing lines.

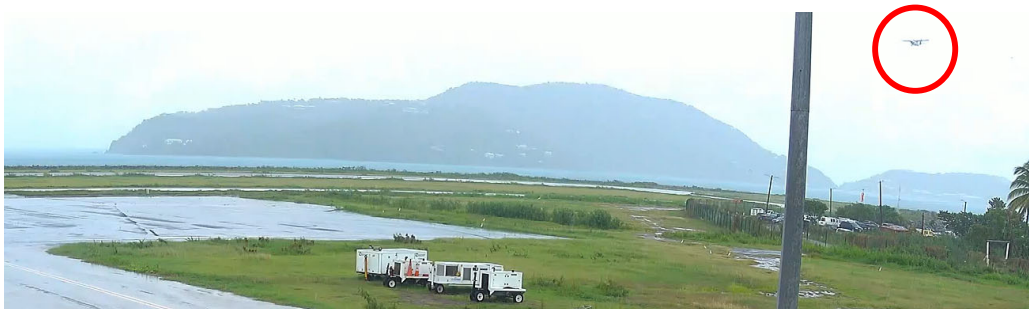
**Figure 8**  
CCTV looking East at time 1715:29 hrs

CCTV at the airfield captured N967FE approaching the airfield and the subsequent landing. Figure 8 shows the aircraft approaching from the east. Figures 9 and 10 shows the aircraft descending towards the western end of the runway. Figure 11 shows the touchdown with the aircraft banked to the right.
