## ACCIDENT

<b>Aircraft Type and Registration:</b>	DJI Phantom 4 RTK (UAS, registration n/a)	
<b>No &amp; Type of Engines:</b>	4 electric motors	
<b>Year of Manufacture:</b>	2020 (Serial no: 0V2GDC6RA30246)	
<b>Date &amp; Time (UTC):</b>	2 December 2020 at 1209 hrs	
<b>Location:</b>	Newtongrange, Dalkeith, Midlothian	
<b>Type of Flight:</b>	Commercial Operations (UAS)	
<b>Persons on Board:</b>	Crew - N/A	Passengers - N/A
<b>Injuries:</b>	Crew - N/A	Passengers - N/A
<b>Nature of Damage:</b>	Damage to motors, propellers, arms, landing gear and fuselage	
<b>Commander's Licence:</b>	Other	
<b>Commander's Age:</b>	50 years	
<b>Commander's Flying Experience:</b>	98 hours (of which 98 were on type) Last 90 days - 5 hours Last 28 days - 2 hours	
<b>Information Source:</b>	AAIB Field Investigation

## Synopsis

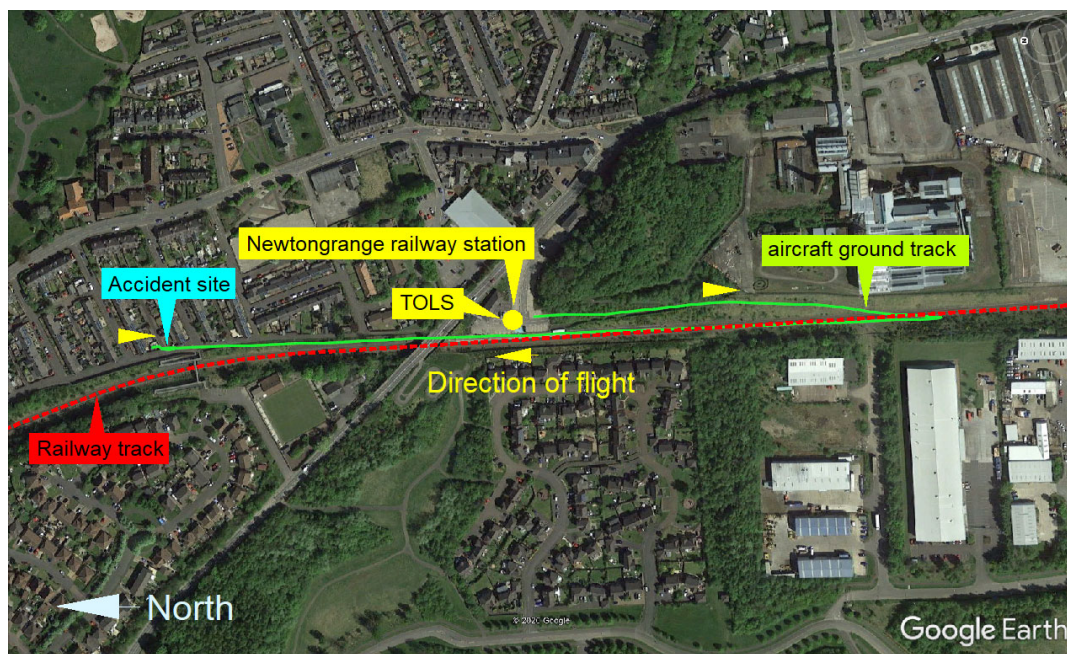
**Figure 2**

The aircraft took off at 1206 hrs (Figure 2) and followed the programmed route, whilst the pilot and observer monitored its progress. At 1209 hrs, the aircraft reached its northerly turning point, where it slowed and commenced its turn back towards the TOLS. This coincided with the aircraft's camera capturing a survey photograph of the railway track and houses below (Figure 3). Shortly after this, the pilot reported that the UAS controller emitted a short "beep". Whilst the observer continued to watch the aircraft, the pilot checked the controller, but no error messages were displayed. The aircraft then rapidly descended vertically. As the aircraft neared the ground, the pilot and observer lost sight of it and, shortly after, a series of error messages were displayed on the controller.

Aircraft ground track during the accident flight  
© 2020 Google, Image © Maxar Technologies

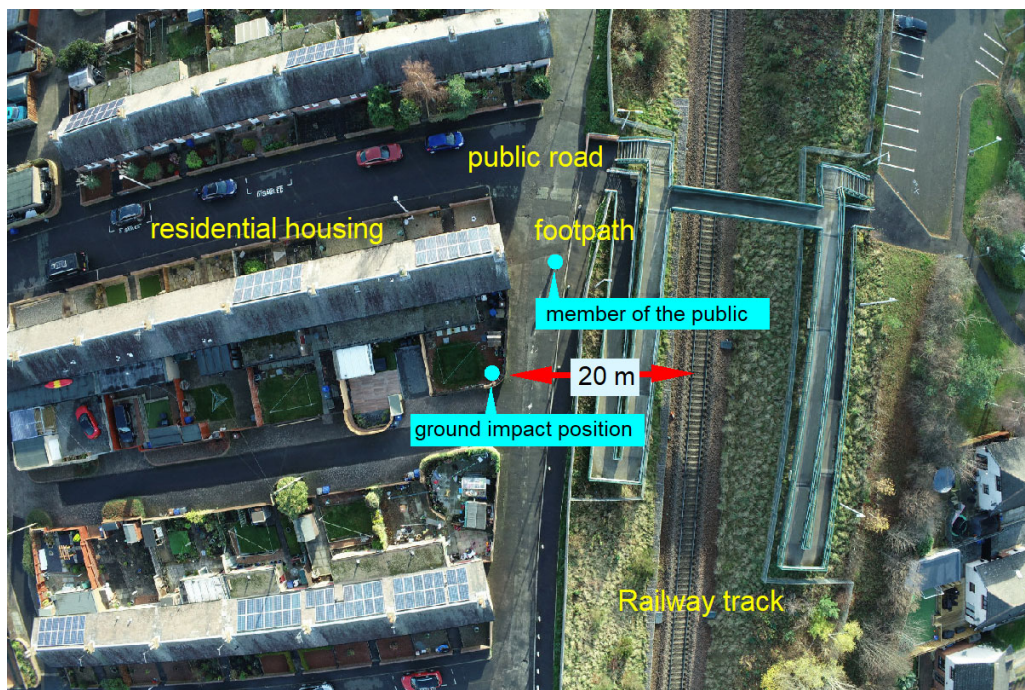
**Figure 3**

The pilot and observer subsequently found the aircraft in the rear garden of a terrace house (Figure 3) about 20 m from the railway track and below where the loss of control had occurred. The house was part of a large, densely populated housing estate and there were no people in the garden when the accident occurred. However, when the overhead image (Figure 3) was taken, a member of the public was 10 m from where the aircraft subsequently struck the ground.

Image captured by the aircraft shortly before the loss of control

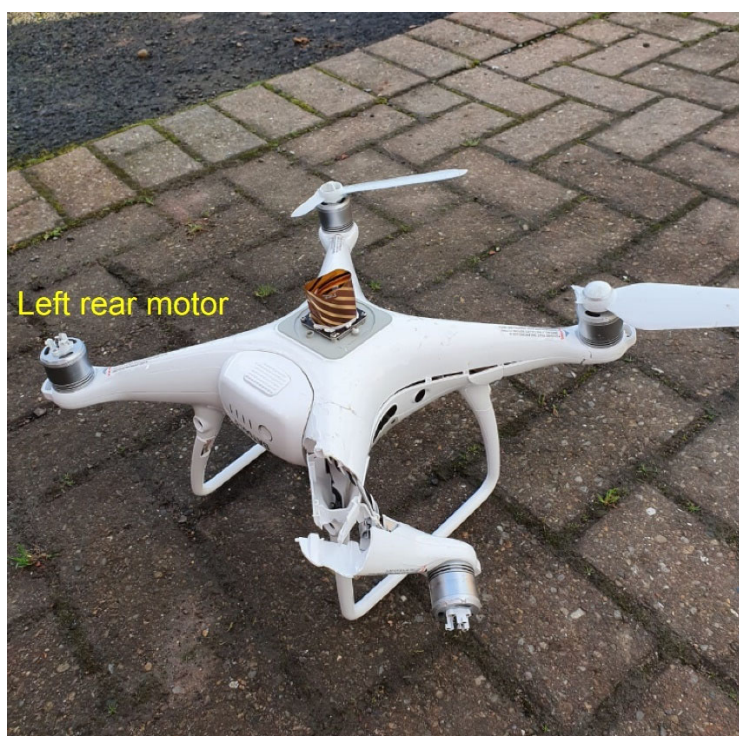
**Figure 4**

The aircraft's motors, propellers, arms, landing gear, camera and fuselage were damaged (Figure 4). Inspection of the aircraft's battery shortly after the aircraft was found, showed that it had about 50 % charge remaining. The left rear propeller had detached and was not found.

Aircraft after being recovered from garden
