Independent Peer Review of Engineering Advice - Grenfell Tower for MHCLG

Dr J M Roberts FREng BEng PhD FICE FStructE

Senior Director of Structural Engineering, Jacobs UK Limited

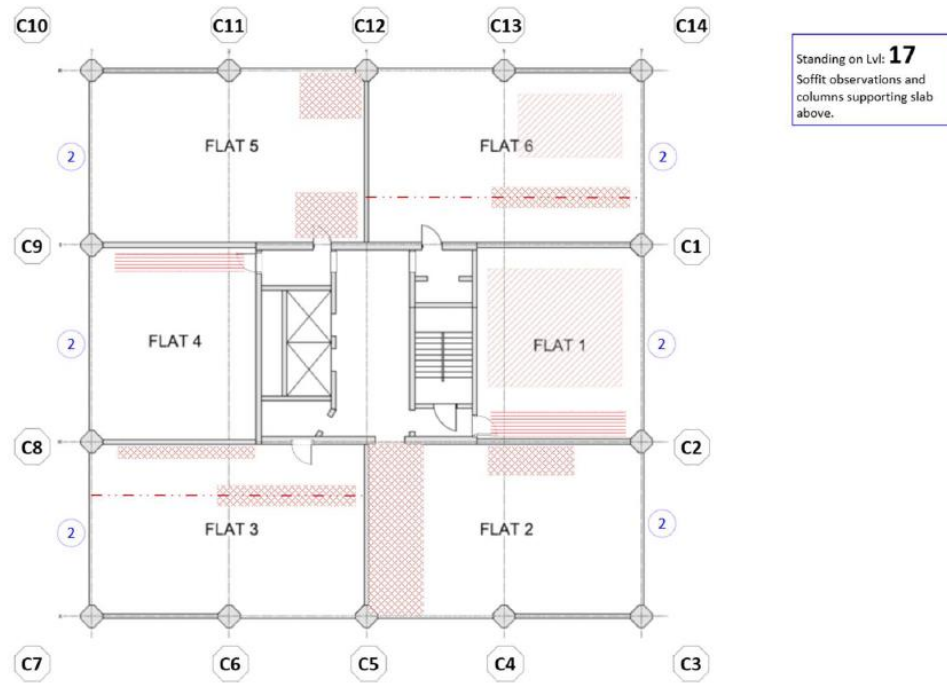
Figure 4. Example from Atkins February 2020 visual survey

77 As can be seen from the above example, the Atkins visual survey provides a more specific record of exactly where the damage on any particular floor occurs, as compared to the overall single classification of damage that has been used by RSK. Then, in Section 5.2.2. of the report Atkins explain that each individual damage zone can be associated with a group of elements from the standard “floorplate finite element mesh” which they show at their Figure 5.3.

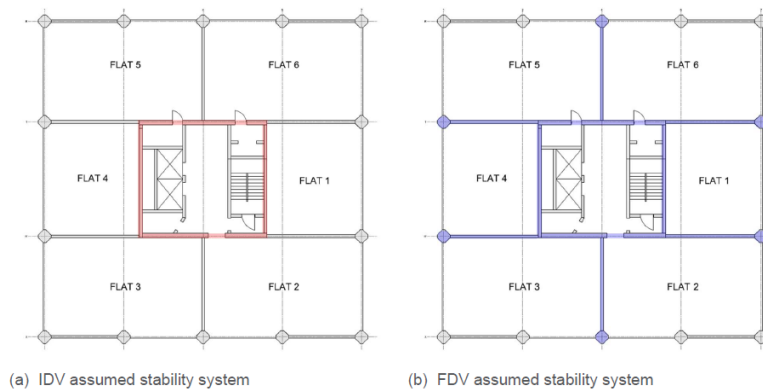
Figure 5. Stability system (above Level 4)

- 81 In my opinion the FDV model as shown on the right-hand side is correct, and, as such, should give a much “less conservative” result than the IDV⁵⁴ model shown on the left-hand side. It is important to note that the contribution of the concrete party walls to the global stability of the building is dependent largely on the effectiveness of the 6 columns⁵⁵ on the external perimeter below level 4. Atkins do not actually give any quantitative value for this increase in lateral stability – they merely state (correctly) that since the model assumed for the IDV assessment was shown to be satisfactory, then the model used for the FDV must obviously be satisfactory “by inspection”.
