Grenfell Tower

Final Design Validation

Ministry of Housing, Communities, and Local Government

5186876-ATK-XX-XX-RP-SE-000003

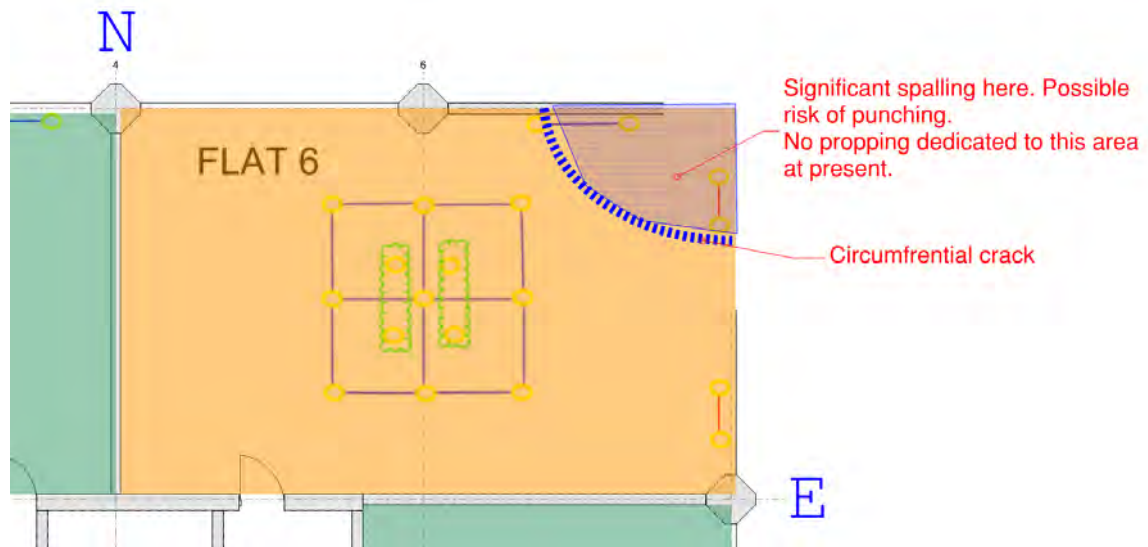
Figure 4.3 - Flat 6 – propping to soffit of eight floor and location of soffit damage (see Figure 4.2)

With respect to the 'Local soffit spalling' zone identified in Figure 4.2, this is illustrated in Figure 4.3 and photographed in Figure 4.4. The area in question is a corner portion of the suspended slab that has suffered significant damage to its soffit; a circumferential crack was also observed. In addition to the reduction in effective section thickness due to the level of spalling, the reinforcing bars have debonded. Additional Stage 2 propping was added to this region although it is understood that it will be replaced as part of the Stage 3 prop installation.

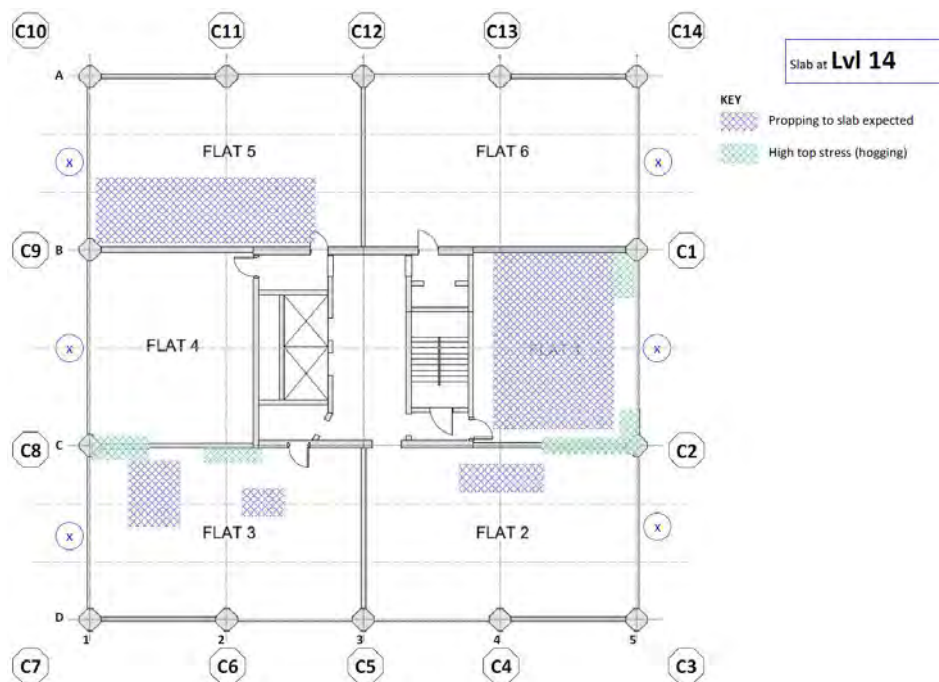
Figure 5.18 – Example of analysis findings

- the slab is unable to support its own weight and propping is expected to support it (blue hatching)
- the top of the slabs is overstressed (green hatching).

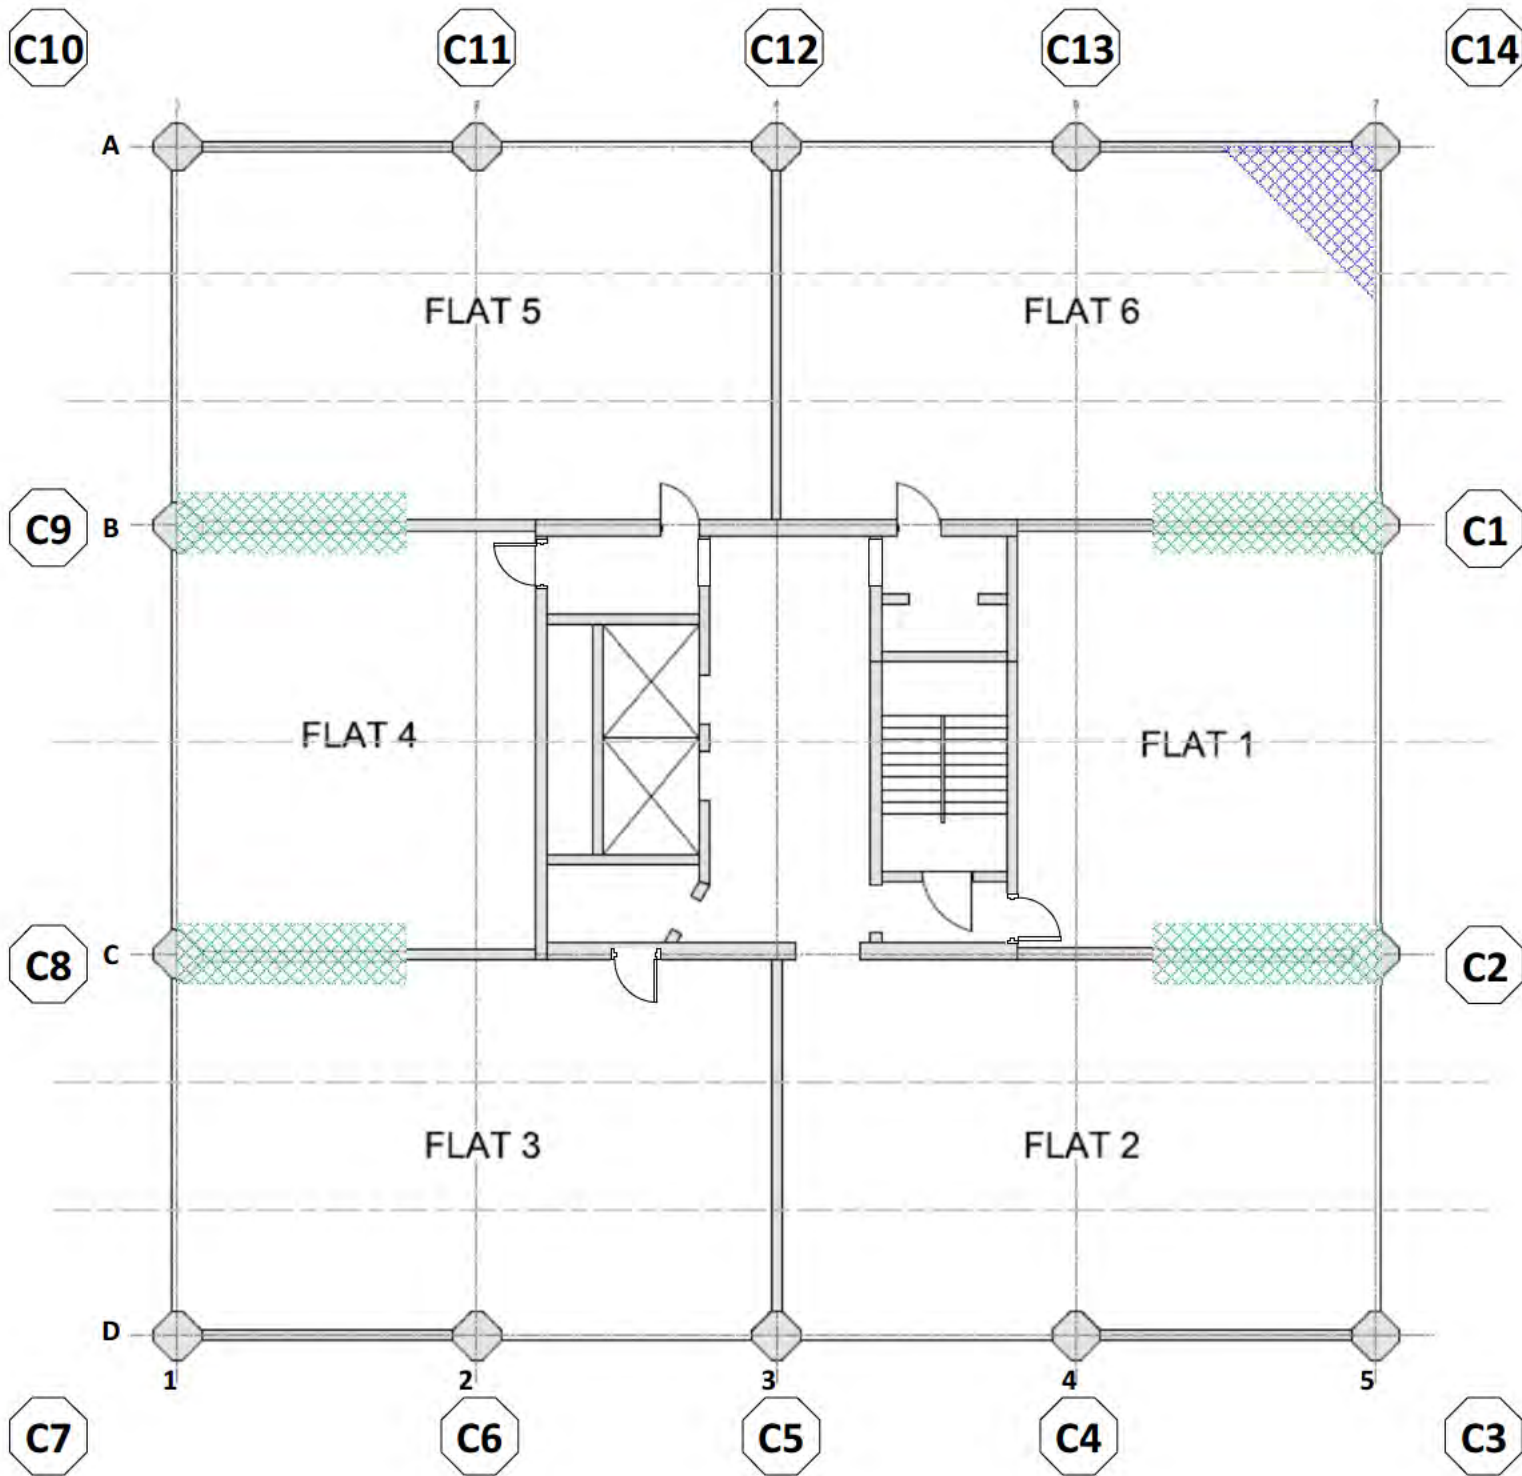
Slab at **Lvl 06**

High top stress (hogging) likely due to the fire damage; propping expected

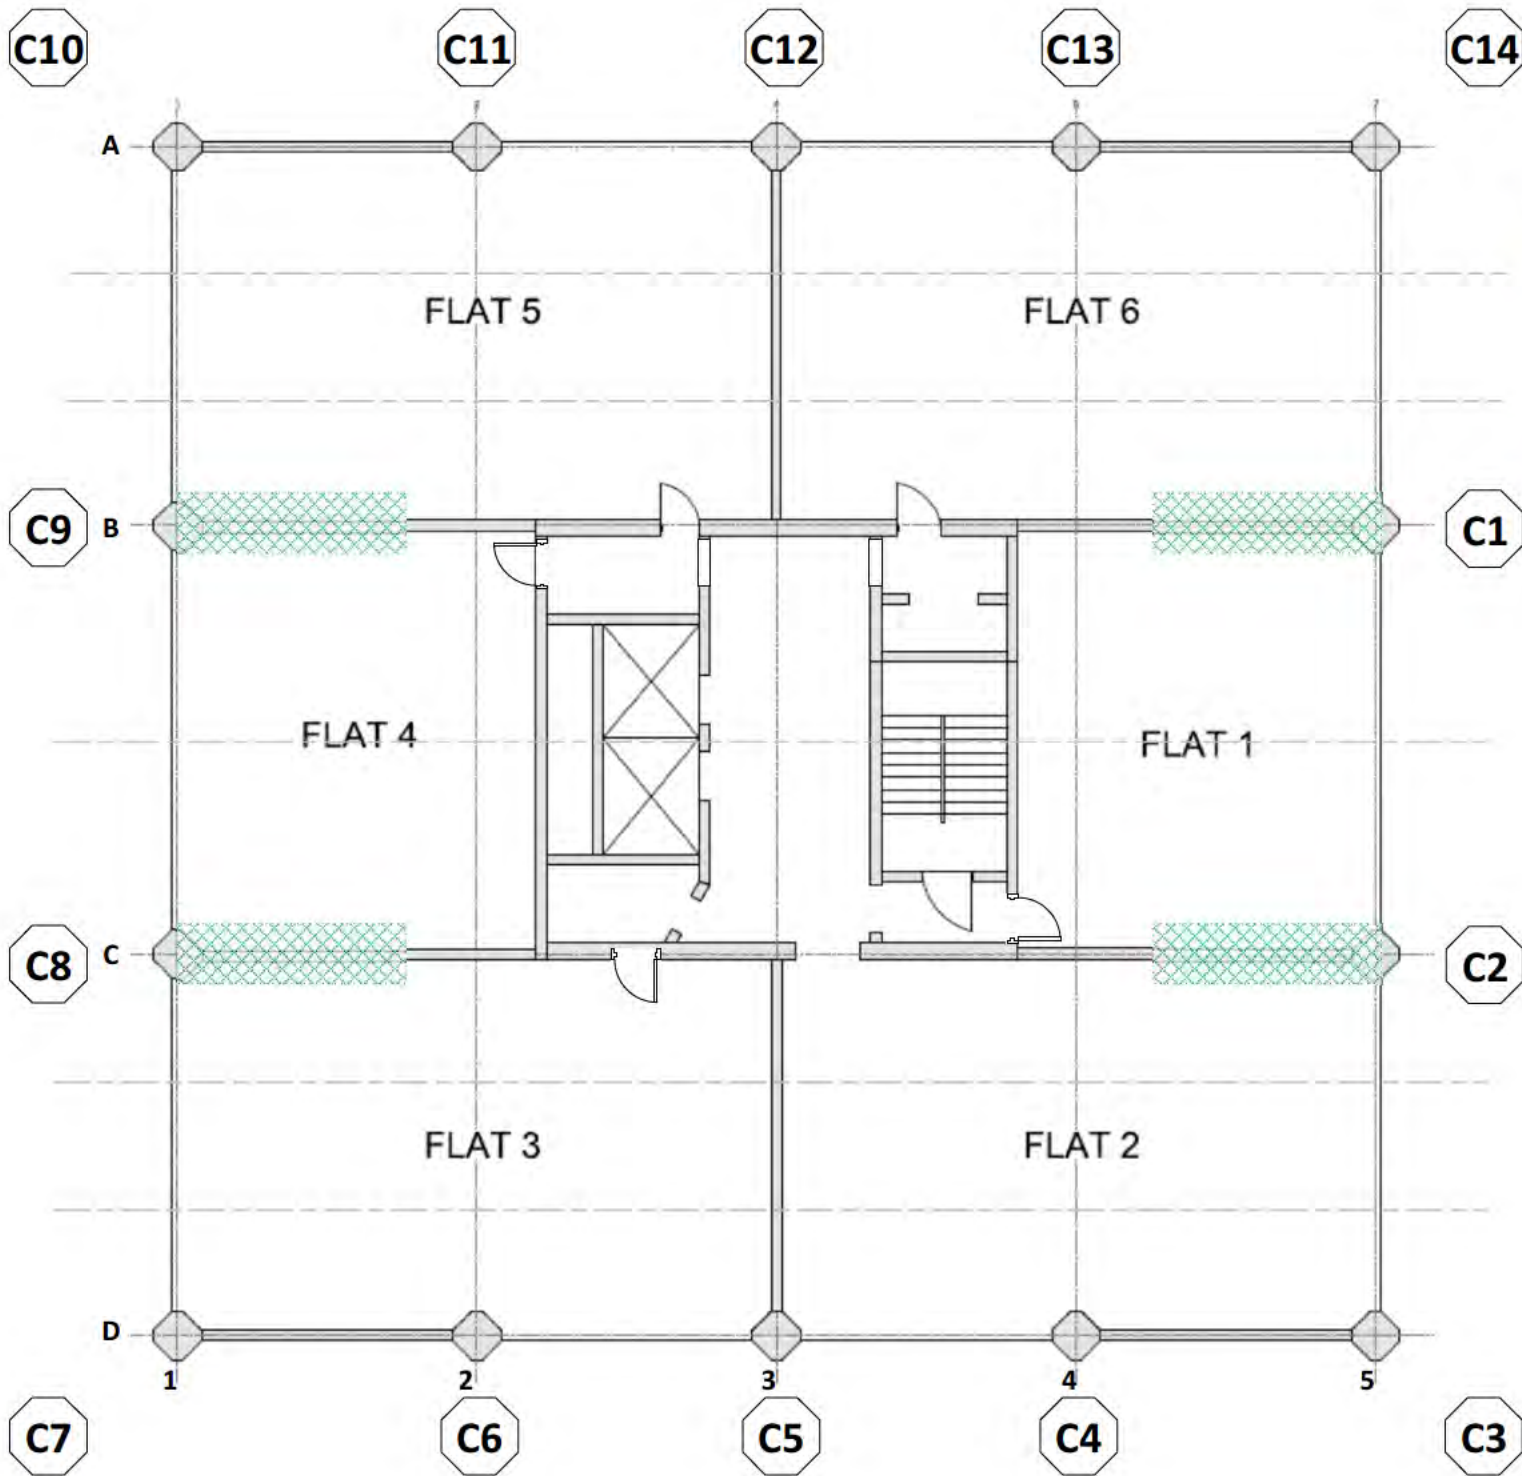
Slab at **Lvl 07**

High top stress (hogging) likely due to the fire damage; propping expected
