AAIB Bulletin

6/2021

Published 10 June 2021

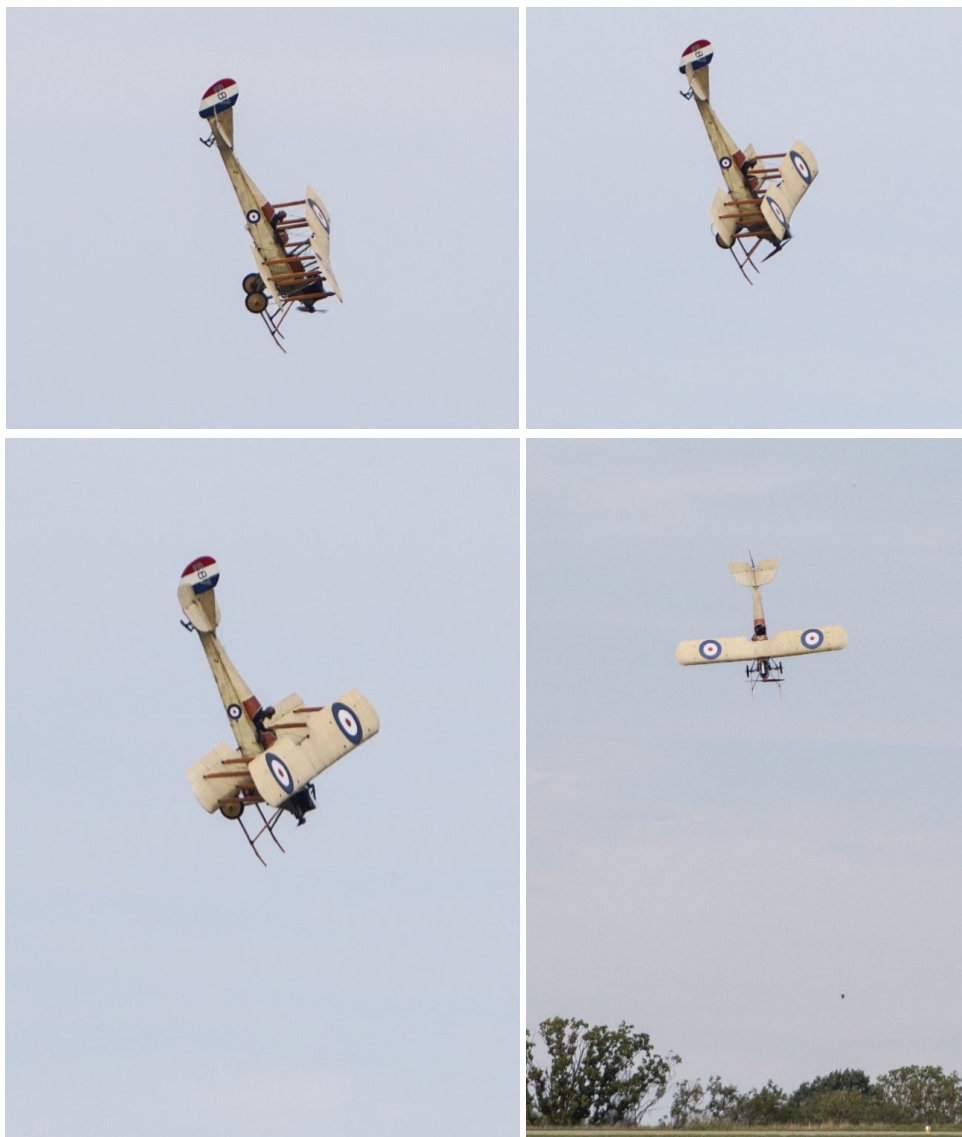
Figure 1

The control surface positions can be seen in the sequence of images in Figure 1. The ailerons appear to be neutral. The elevators appear to be trailing edge up suggesting the pilot was applying some aft control input. The rudder trailing edge was to the right (of the aircraft’s longitudinal axis) suggesting the pilot was applying some right rudder. It was not determined exactly how much elevator or rudder was applied but neither appeared to be at full deflection.

Four images of G-AWYI in the right descending turn showing control surface deflections (Used with permission and under copyright of the photographer)

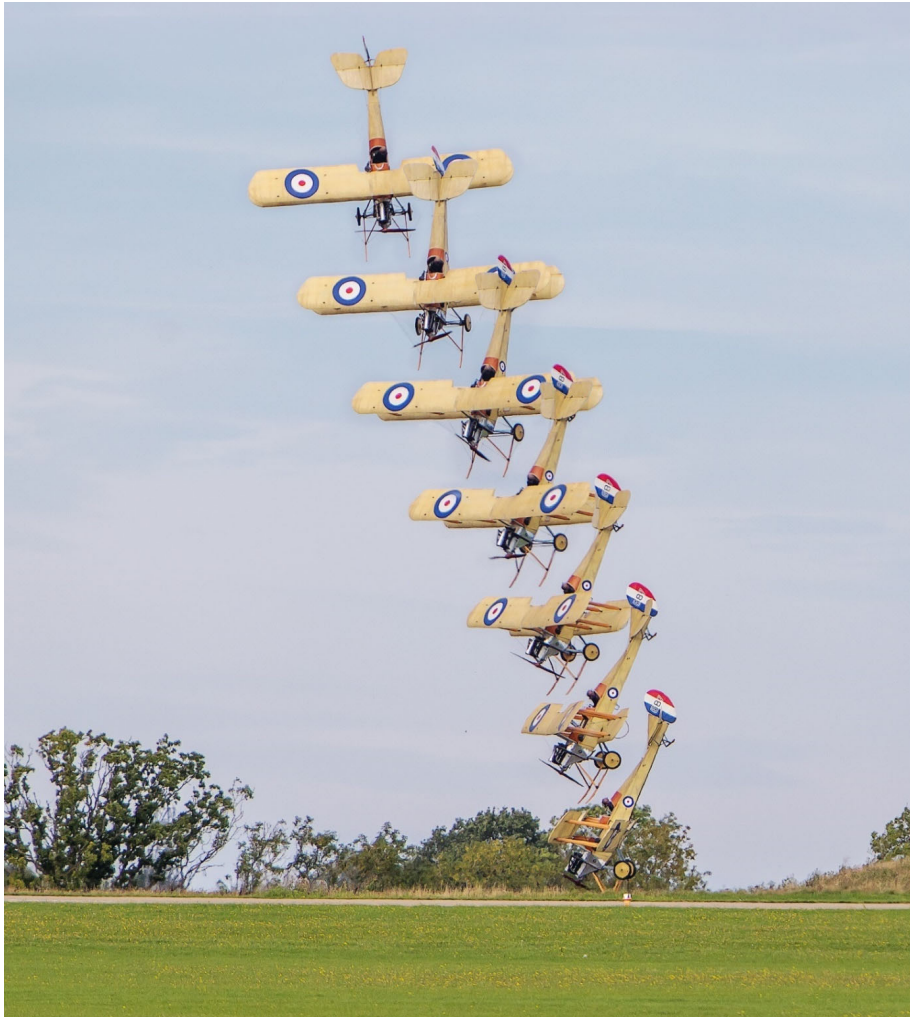
Figure 2

Collage of images of the aircraft continuing to rotate to the right as it descended
(Used with permission and under copyright of the photographer)

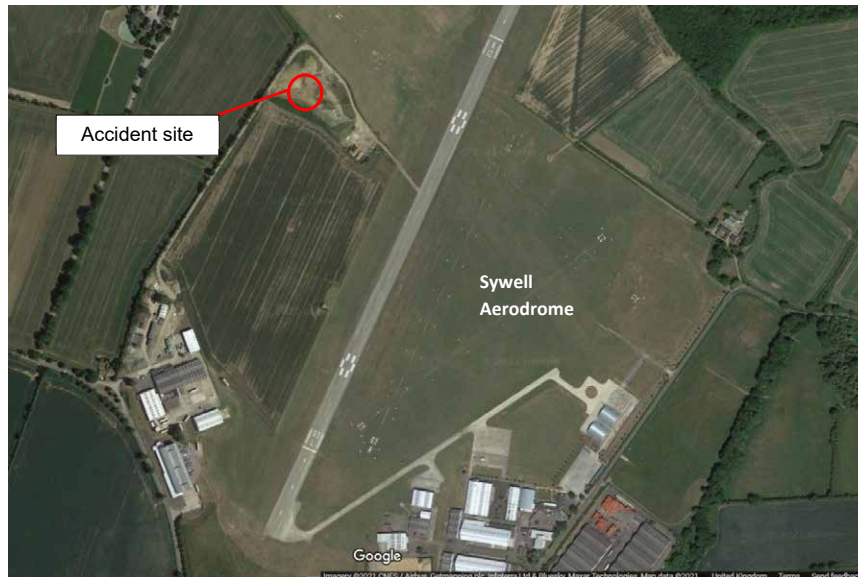
**Figure 3**

The wreckage of G-AWYI was located in a field inside the western boundary of the aerodrome (Figure 3). The ground was soft and contained several large mounds of waste earth and rubble from recent building work which restricted emergency vehicle access to the injured pilot and the aircraft.

Accident site at Sywell Aerodrome

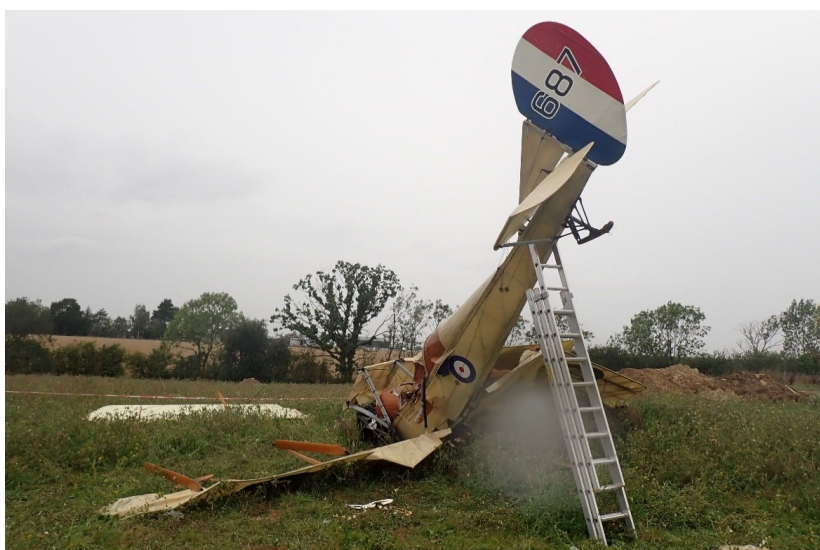
**Figure 4**

There were no ground marks to indicate the aircraft had slid or bounced on impact. The front section of the aircraft and the engine were embedded in the ground at a steep nose-down attitude (Figure 4). One blade of the fixed pitch, wooden propeller had snapped off and fragmented. The remaining blade had cracked radially around the root but was still attached to the hub. The aircraft's wooden skids were embedded in the soft earth and the landing gear was severely disrupted and partially detached from the fuselage. Due to the steep angle of impact, the aircraft's rear fuselage and tail remained high in the air and leaning to the left. The airframe structure around the rear cockpit and aft of the cockpit floor was bent and deformed by the force of the impact (Figure 5).

G-AWYI at the accident site

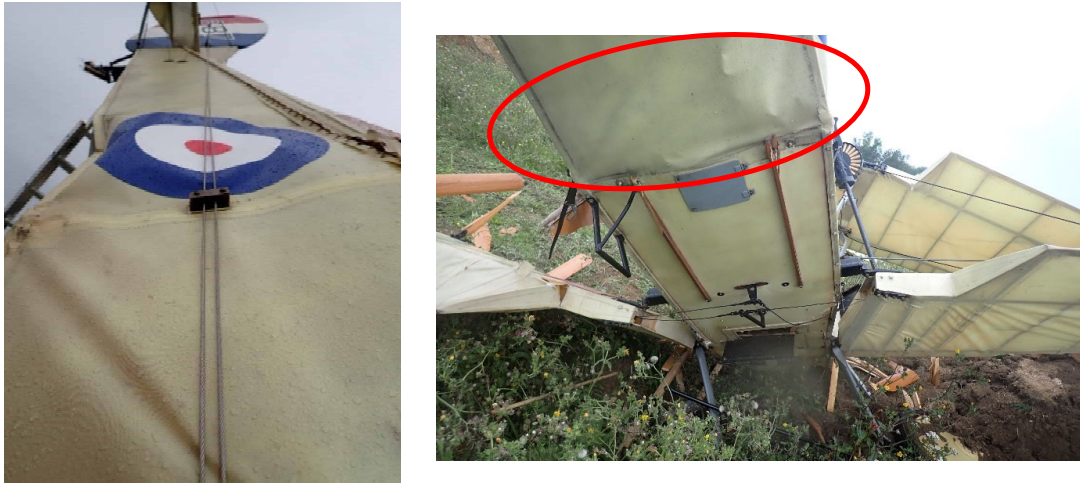
Figure 5

G-AWYI showing deformed fuselage structure

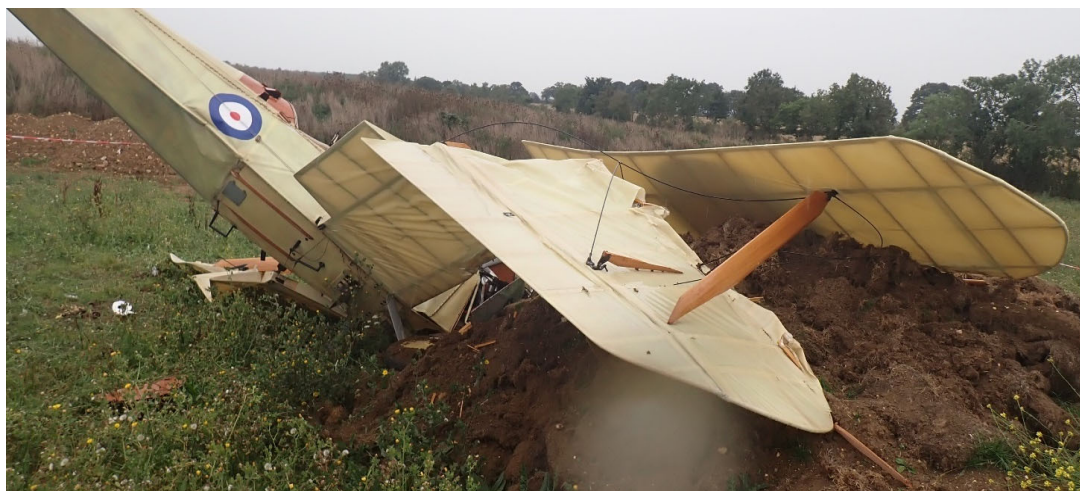
Figure 6

Evidence from the impact marks on the wings indicated the leading edges of the left wings struck the ground as the aircraft rotated to the right. The lower right wing hit a large mound of earth which snapped the wing in half along the chord line approximately a third of the way along its length from the fuselage. The upper right wing had also struck the mound of earth but had remained in one piece. The forward interplane struts on both the left and right side had snapped, (Figure 6). Although the rear outboard strut had snapped at the connection to the upper wing, the inboard strut remained unbroken and connected. The left upper wing was removed by the RFFS to make it easier to provide medical treatment to the pilot and to extract him from the cockpit.

Damage to the lower right wing

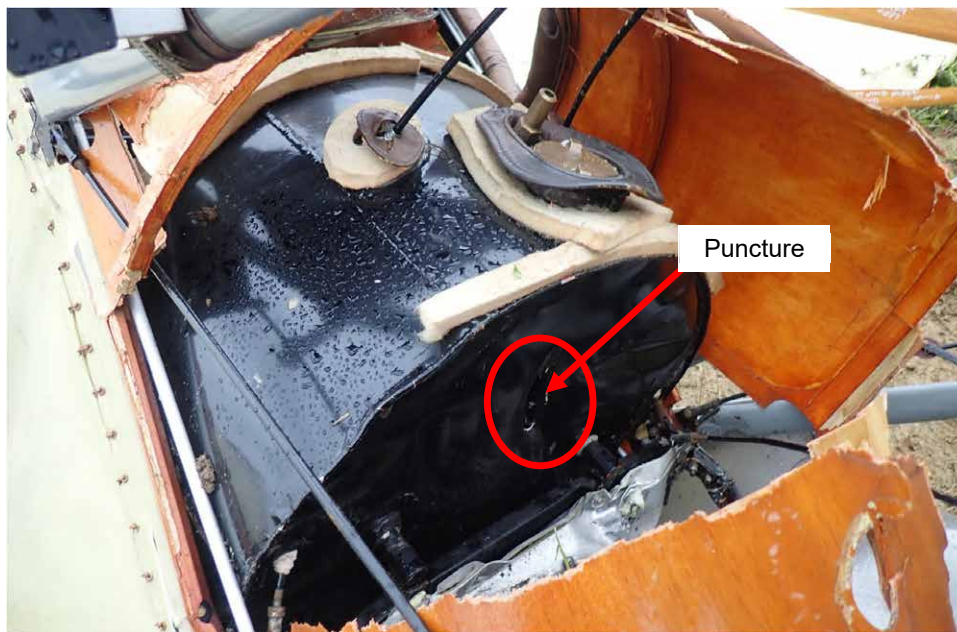
Figure 7

During the impact sequence the front fuselage had compressed and the engine block had become embedded in the ground. The fuel tank, positioned behind the engine, had been crushed and punctured causing the fuel to leak out (Figure 7). The front cockpit structure was severely damaged but the rear cockpit, where the pilot had been seated, sustained significantly less damage.

Fuel tank showing punctured surface

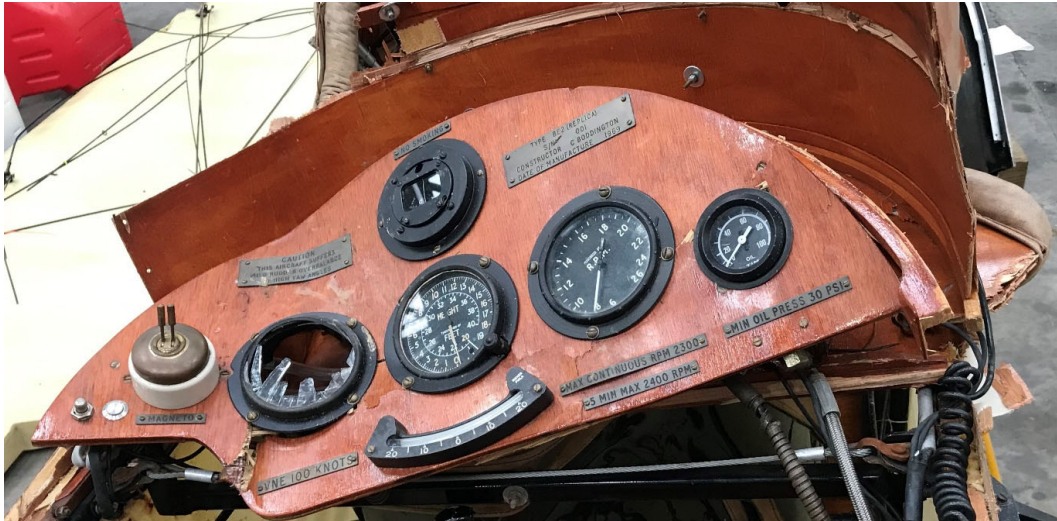
Figure 8

The rear cockpit instrument panel and support structure had broken away from the fuselage mounting and was hanging forwards into the front cockpit. The airspeed indicator on the left of the panel was dislodged, the glass face smashed, and the mechanism disrupted. The rest of the instruments were still in place and largely undamaged, although the panel was bent along a vertical axis to the left of centre (Figure 8). It is possible the pilot's head, face and mask had contacted the instrument panel as the aircraft hit the ground causing his facial injuries and the damage to the panel.

Rear cockpit instrument panel showing deformation

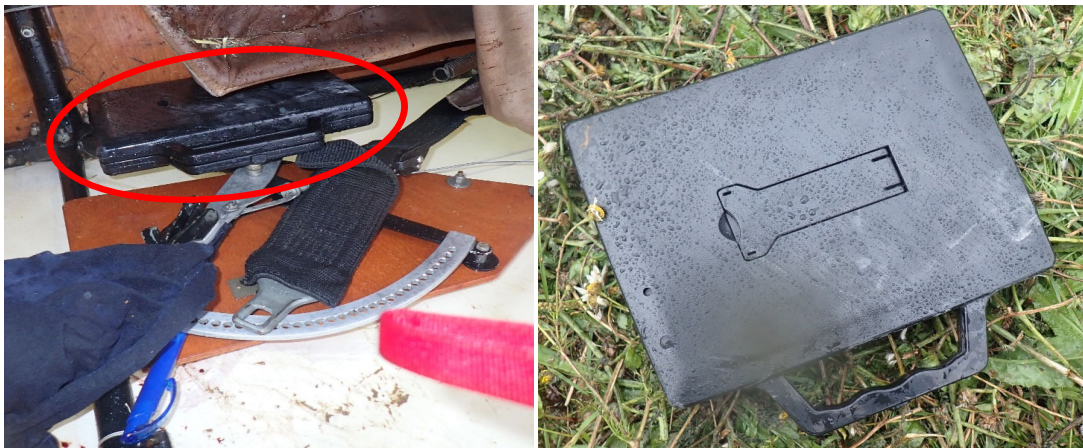
Figure 9

The base of the pilot's wooden seat cushion had cracked longitudinally but was still fitted over the metal bucket seat structure. A broken pen and a heavy black plastic solar charging panel were found on the cockpit floor, (Figure 9). The pilot later confirmed the solar panel had been placed in the canvass stowage compartment behind the pilot's head before the flight. Spare clothes and paper items were still contained in the canvass stowage bag.

Rear cockpit looking downwards showing solar panel case beside the seat

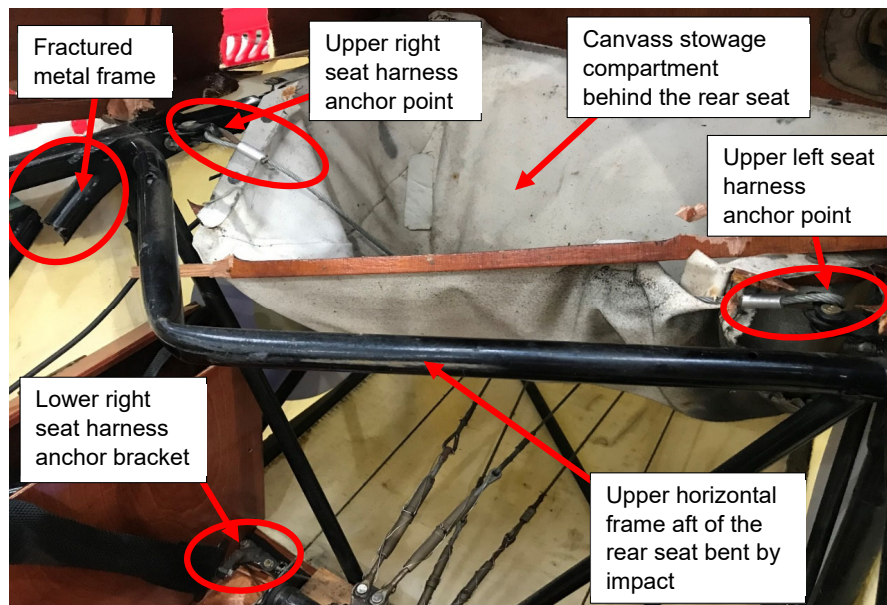
Figure 13

The upper, horizontal metal cockpit frame aft of the rear pilot's seat had bent (Figure 13) and the seat's mounting points were deformed.

Airframe damage behind the rear cockpit seat – view looking aft and to the left

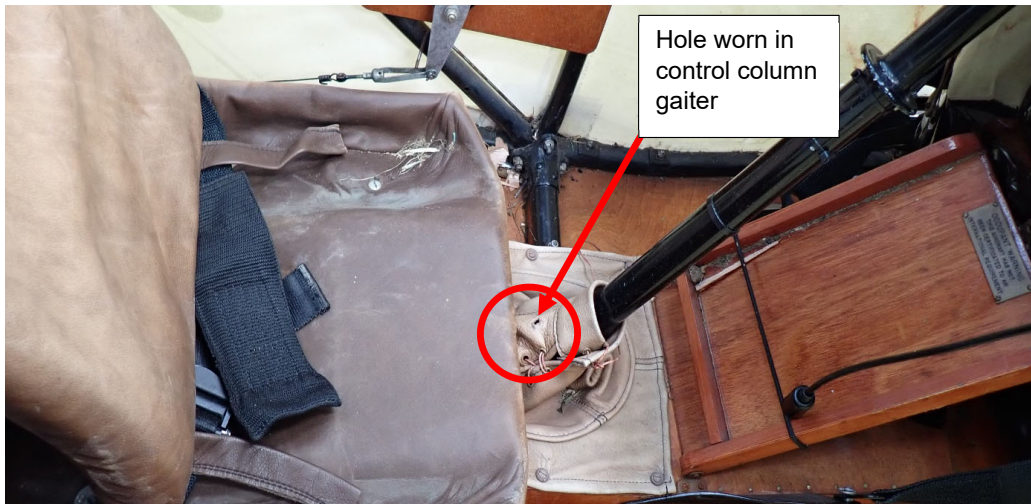
Figure 14

The position of the rear seat, after the accident, restricted rearward movement of the control column. A hole was found in the control column's leather gaiter where it had been worn away by contact between the control column and the seat (Figure 14).

Hole in the control column gaiter

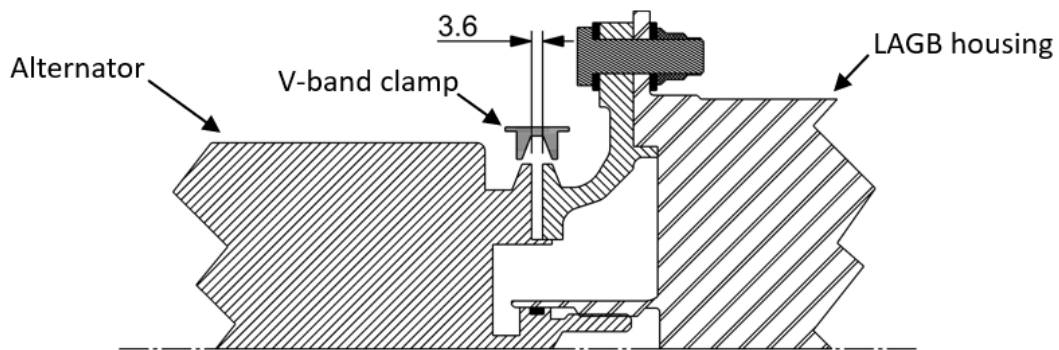
The manufacturer stated that the maximum possible clamping distance between the alternator and the interface spacer, when using the V-band clamp to attach them together, was 3.6 mm, (Figure 3(a)). The maximum clamping distance when attaching the alternator, V-band clamp and interface spacer to the LAGB as an assembly was 14.4 mm, four times greater than when using the V-band clamp (Figure 3(b)).

(a) Maximum clamping distance using V-band clamp, 3.6 mm

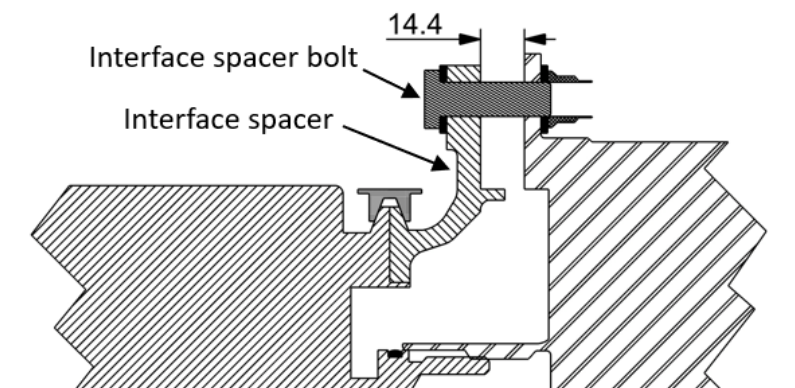
(b) Maximum clamping distance using interface spacer bolts, 14.4 mm

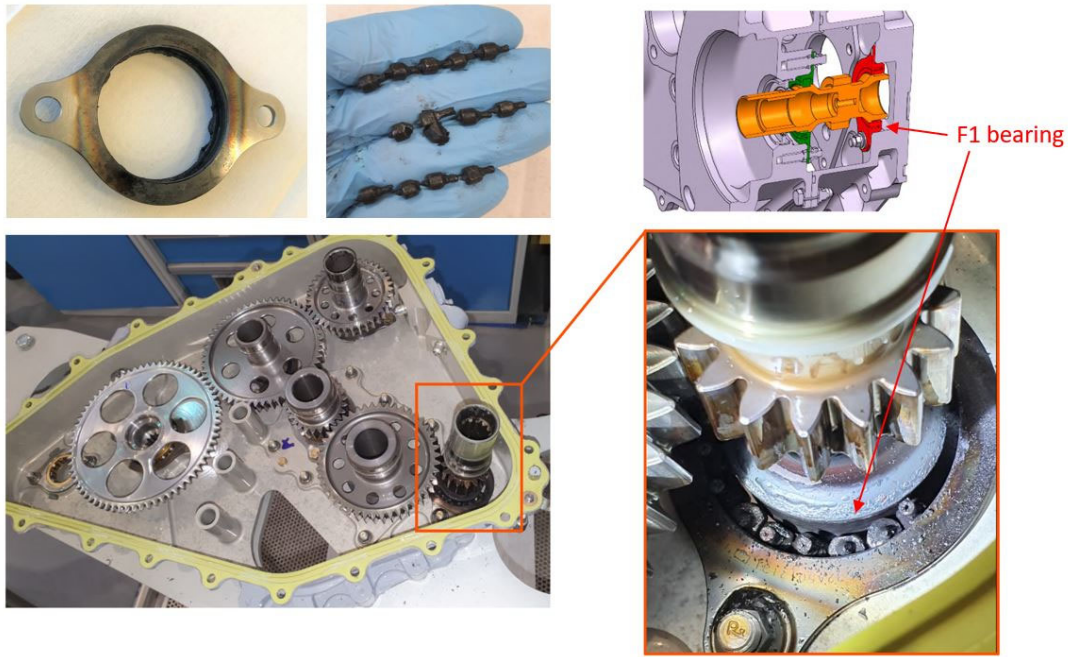
Figure 4

Failed F1 bearing in the LAGB (image used with permission of Airbus Helicopters)

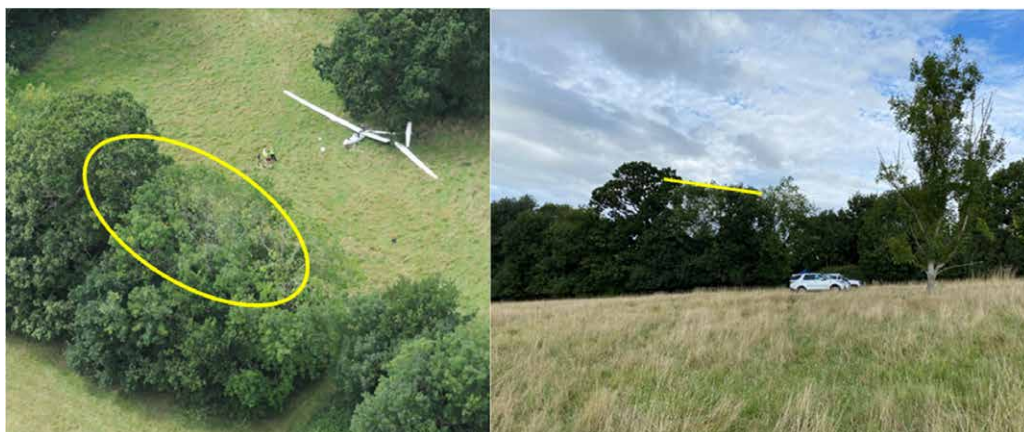
The wreckage of the glider was situated below the canopy of a large oak tree. Several large branches had broken and fallen on top of the wreckage, indicating that the glider had struck this tree. It was also apparent that the tops of some of the trees which formed the boundary with the adjacent field had been trimmed (Figure 12). Damage to the leading edge and lower surface of the outer right wing was consistent with it having struck the tops of these trees. This was subsequently confirmed by CCTV recordings.

Figure 12
Trees struck by the right wing from above (left) and from the adjacent field (right)

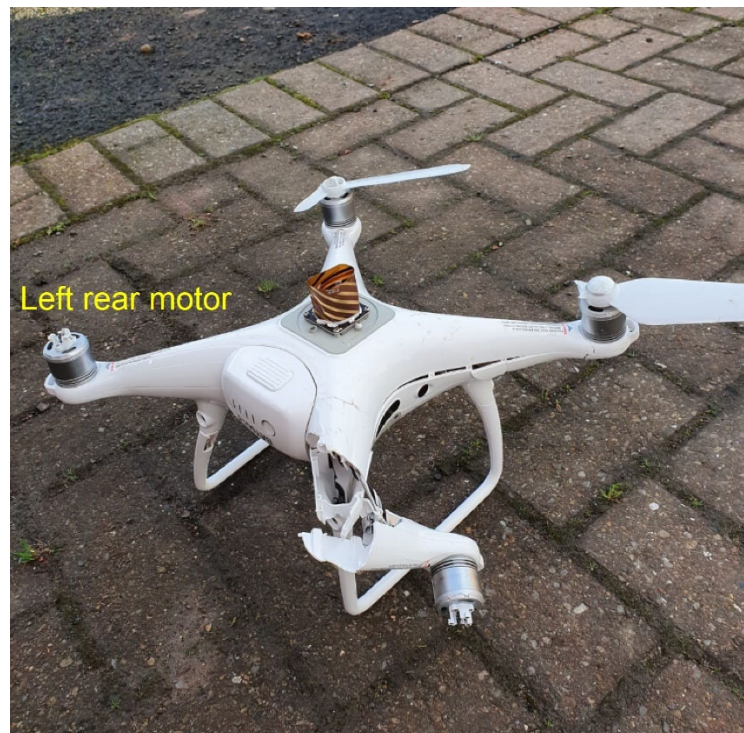
Figure 4

The aircraft's motors, propellers, arms, landing gear, camera and fuselage were damaged (Figure 4). Inspection of the aircraft's battery shortly after the aircraft was found, showed that it had about 50 % charge remaining. The left rear propeller had detached and was not found.

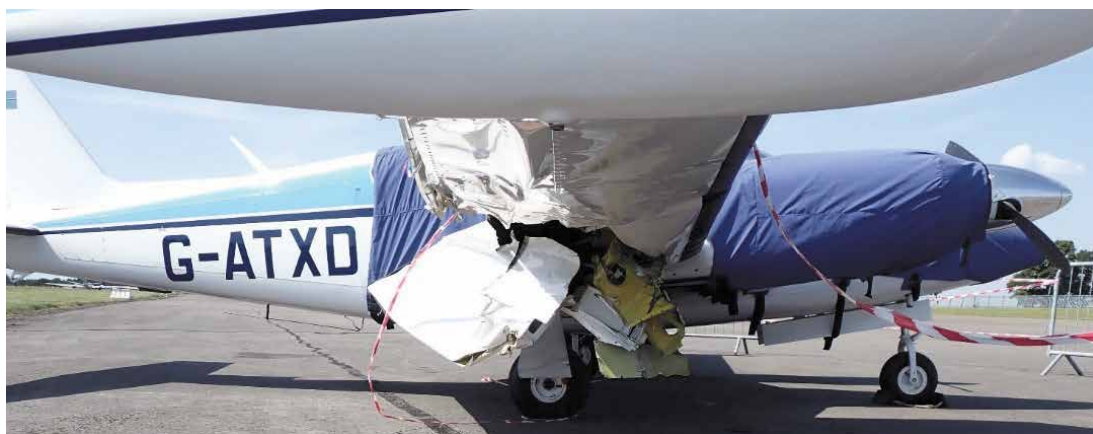
Figure 3

The aileron and lower surface of the right wing were severely damaged. There was also a substantial fuel leak.

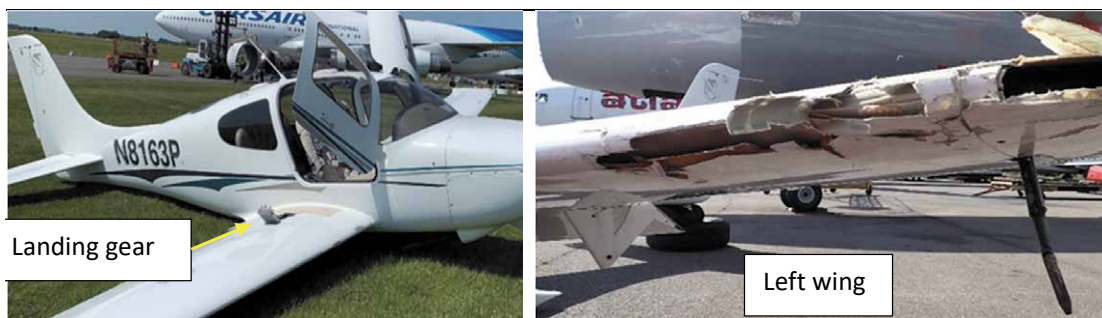
**Figure 4**

There was abrasion damage to the left-wing tip consistent with it having contacted a hard surface and scratches that were most likely caused by the torn metal on the right wing of G-ATXD. Damage to the propeller blades was consistent with them striking soft ground or stones. The right main landing gear had broken off from the mounting structure and punctured a hole in the top skin of the wing. The right main wheel had detached and abrasions on the tyre were consistent with it being abraded as the aircraft slid sideways across the apron. The nose landing gear was twisted but remained attached.
