Rail Accident Investigation Branch

Rail Accident Report

**Track worker struck by train near Roade,
Northamptonshire
8 April 2020**

Report 03/2021
June 2021

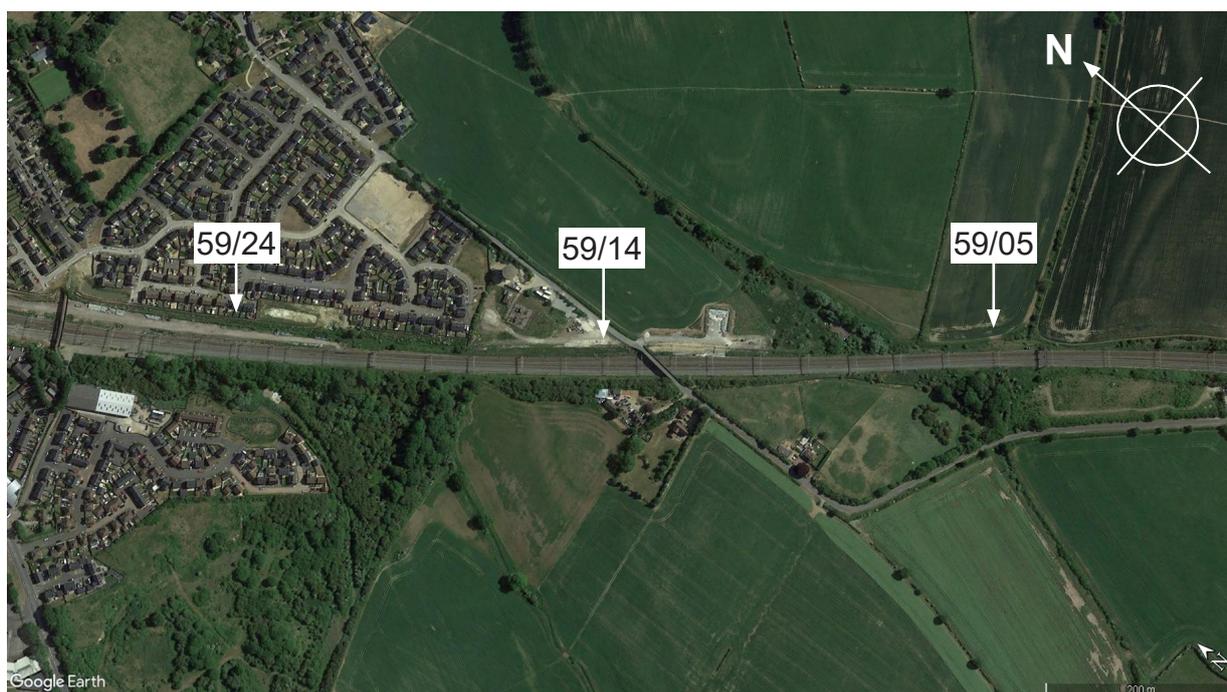
- 25 Isolations of OHLE equipment are implemented using the process defined in Network Rail Standard NR/L3/ELP/29987. In summary, once the arrangements are agreed between the staff taking the isolation and the Electrical Control Operator (ECO), the ECO will ensure that the relevant section is de-energised and issue a permit (referred to as form B) to the 'nominated person', authorising them to conduct a test to confirm this and undertake the work. The permit is retained by the nominated person for the duration of the work. At Roade, part of this process required portable earthing straps to be applied between the ATF wires at three Designated Earthing Points (DEPs) located on structures adjacent to the site of work. Figure 4 shows the locations of the DEPs used at Roade. The rule book requires this earthing activity to be done when the adjacent line is blocked to traffic.

Figure 4: Designated Earthing Point locations

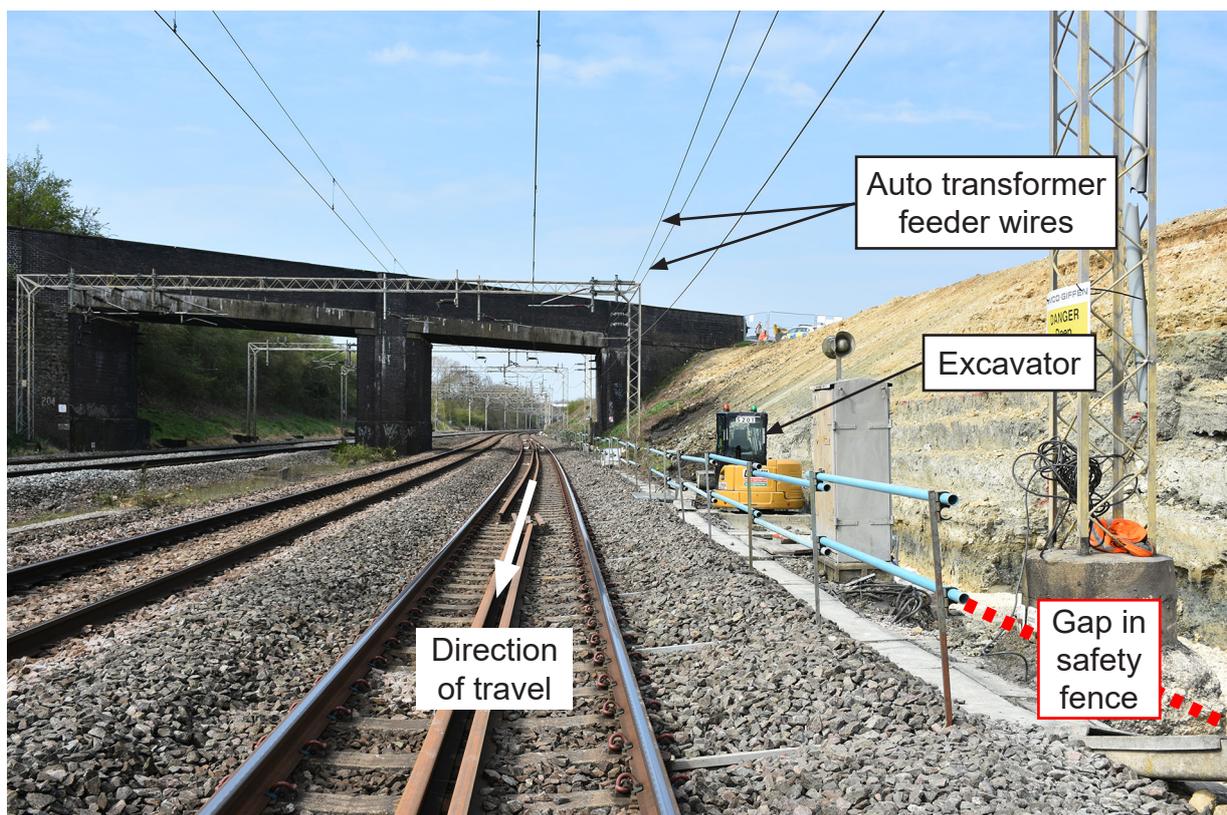
- 27 AmcoGiffen's documentation indicated that its plan was to protect staff from trains by implementing a fenced² safe system of work. It had begun to install temporary safety fencing 1.25 metres from the nearest rail, but due to the proximity of cable troughing and other obstructions, the fence was not complete. Four gaps were left in the length of fence between the overbridge and a set of temporary steps which had been installed south of the work site to create a safe access to the cutting. An alternative 'separated'³ safe system of work was planned to be implemented for the work at the site, until such time that the fencing was completed.

Figure 5: Image showing site looking north including safety fence and overhead line equipment

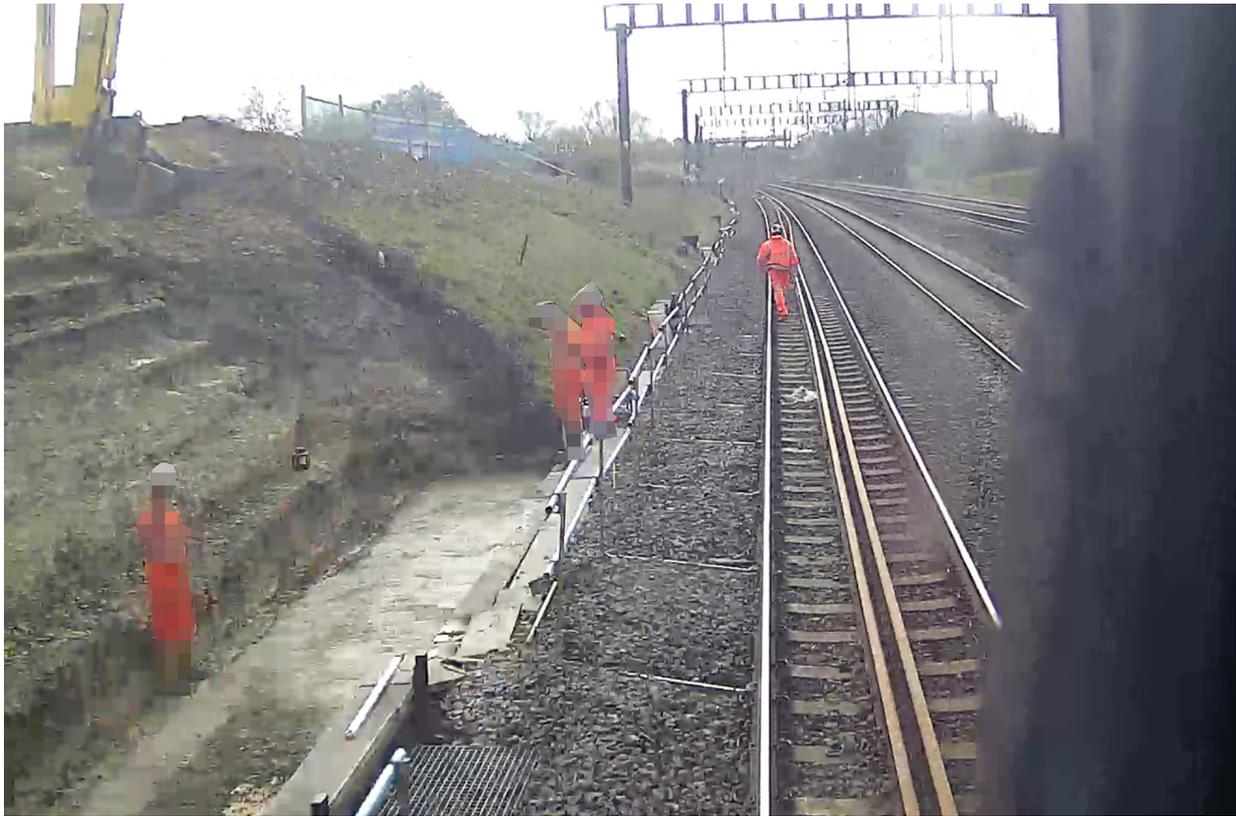
45 The immediate cause of this accident is clearly evidenced by footage from the train's forward-facing CCTV (figure 6).

Figure 6: Image from the forward-facing CCTV of train 2N30, immediately before the accident
