ACCIDENT

Aircraft Type and Registration:	Rotorway Executive 90, G-BVTV	
No & Type of Engines:	1 Rotorway RI 162 piston engine	
Year of Manufacture:	1995 (Serial no: 5243/6599)	
Date & Time (UTC):	4 November 2020 at 1030 hrs	
Location:	Landmead Farm Airfield, Oxfordshire	
Type of Flight:	Private	
Persons on Board:	Crew - 1	Passengers - None
Injuries:	Crew - 1 (Minor)	Passengers - N/A
Nature of Damage:	Main rotor blades destroyed and rotor mast bent; damage to the fuselage and landing gear	
Commander's Licence:	Private Pilot's Licence	
Commander's Age:	58 years	
Commander's Flying Experience:	1,674 hours (of which 142 were on type) Last 90 days - 28 hours Last 28 days - 6 hours	
Information Source:	Aircraft Accident Report Form submitted by the pilot

Synopsis

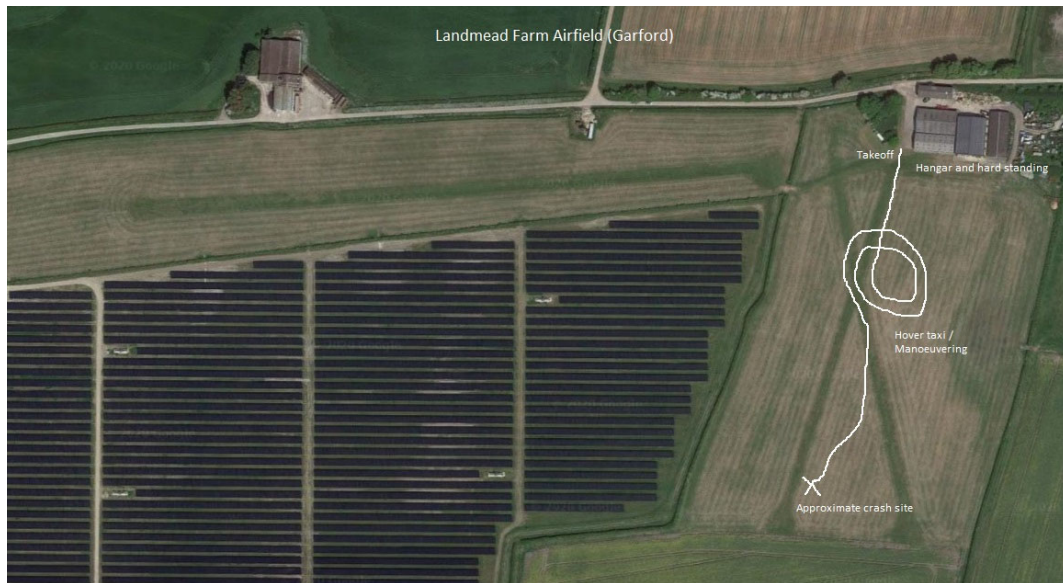
Figure 1

The pilot provided a sketch of the crash site relative to the departure point, shown in Figure 1.

Flightpath and crash site location sketch provided by the pilot

The sketch provided by the pilot and the damage to the helicopter were both consistent with a dynamic rollover having occurred. This was likely to have been initiated by the rear tip of the left landing gear skid catching the ground, while there was still sideways motion of the helicopter to the left. Based on the limited evidence available, it was considered unlikely that there was pre-existing damage to the landing gear leg which had contributed to this.

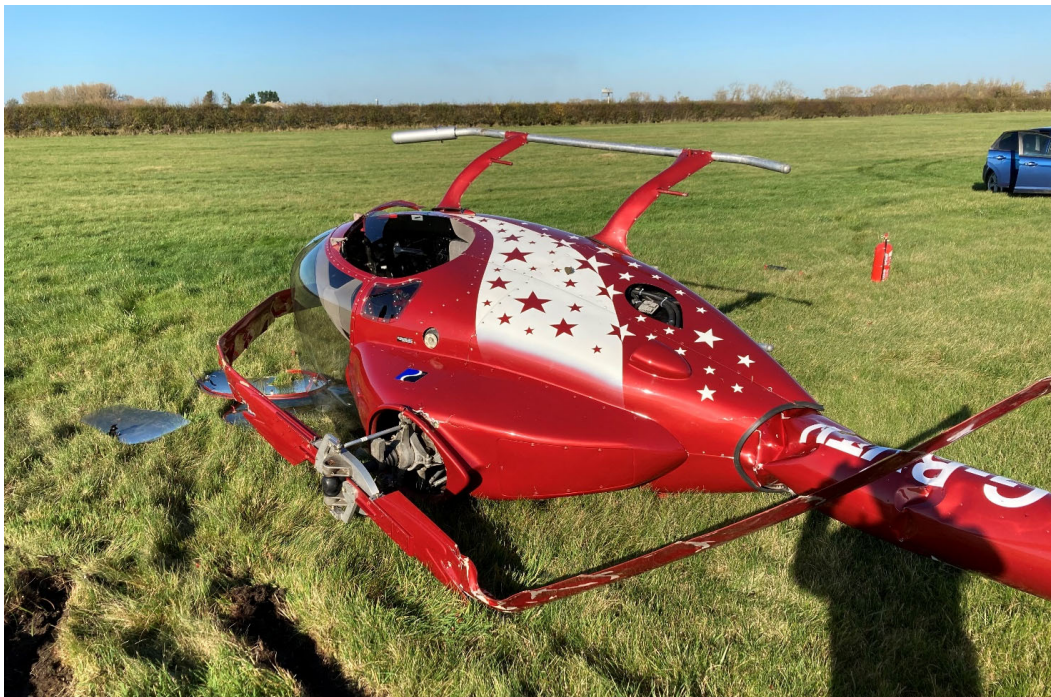
Figure 2

Image of the helicopter post-accident

The aircraft was recovered to a maintenance facility after the accident but was considered an insurance loss, so detailed examination of the airframe was not carried out. The main damage to the helicopter can be seen in Figure 2. The left skid was distorted and had fractured. The rear landing gear leg on the left side was also completely fractured close to the mounting point with the fuselage. The maintenance provider inspected the fracture surface of the leg tube and advised that there was no evidence to suggest that the fracture had progressed over a period of time, rather than being an immediate overload failure.
