ACCIDENT

Aircraft Type and Registration:	Cirrus SR 22, N8163P	
No & Type of Engines:	1 Continental IO-360 SER piston engine	
Year of Manufacture:	2004 (Serial no: 1391)	
Date & Time (UTC):	31 July 2020 at 1203 hrs	
Location:	Cotswold (Kemble) Airport, Gloucestershire	
Type of Flight:	Private	
Persons on Board:	Crew - 1	Passengers - 2
Injuries:	Crew - None	Passengers - None
Nature of Damage:	Damage to landing gear, propeller and left wing on N8163P and damage to the right wing on a parked aircraft	
Commander's Licence:	Private Pilot's Licence	
Commander's Age:	67 years	
Commander's Flying Experience:	698 hours (of which 199 were on type) Last 90 days - 5 hours Last 28 days - 1 hour	
Information Source:	Aircraft Accident Report Form submitted by the pilot and enquiries by the AAIB

Synopsis

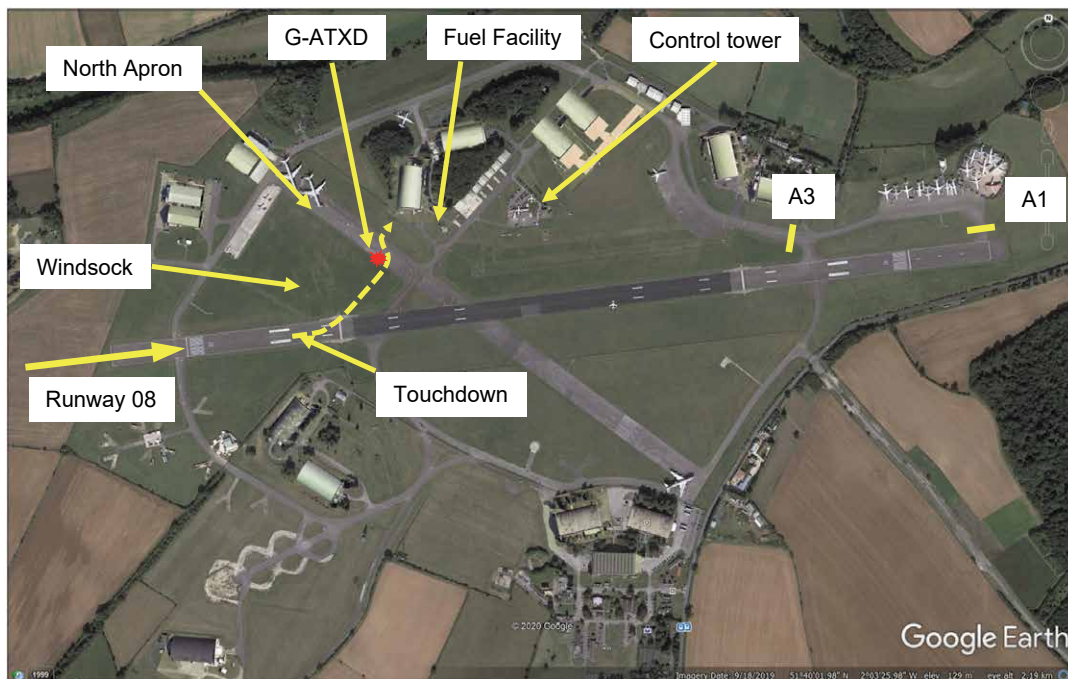
Figure 1

Cotswold (Kemble) Airport and track of N8163P

N8163P was still airborne when it reached the first touchdown zone markings. The left wing was then seen to drop and contact the runway. The aircraft touched down on the grass and travelled along the ground at an angle of approximately 45° to the left of the runway heading until it reached the North Apron where it collided with a parked Piper PA-30 aircraft, G-ATXD (Figure 2).

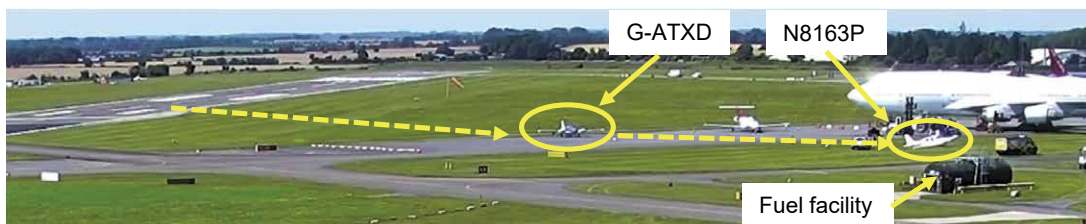
Figure 2

Track of N8163P

During the collision, the left wing of N8163P struck the right wing of G-ATXD causing N8163P to slew to the left and travel sideways across the apron. N8163P finally came to rest on the grass between the apron and the fuel facility. All the occupants were helped to safety by the AFRS, who were quickly on the scene.

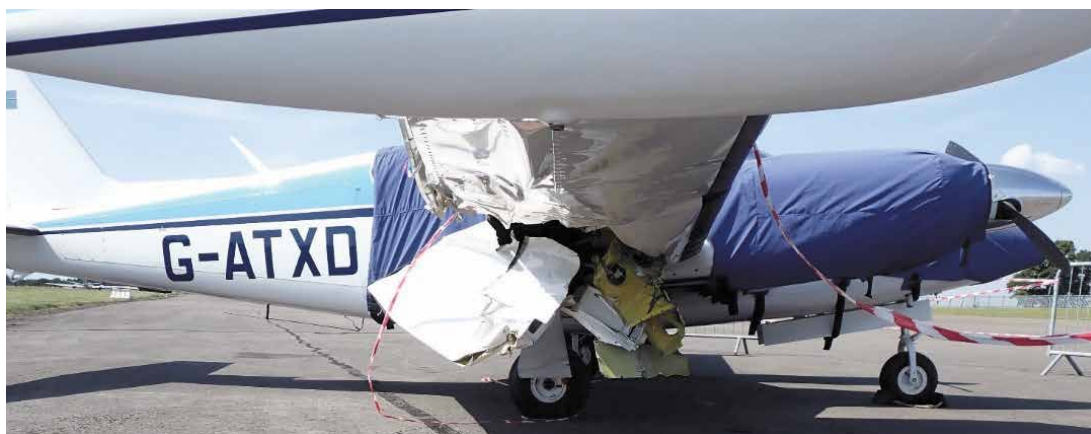
Figure 3

The aileron and lower surface of the right wing were severely damaged. There was also a substantial fuel leak.

Damage sustained to Piper PA-30, G-ATXD

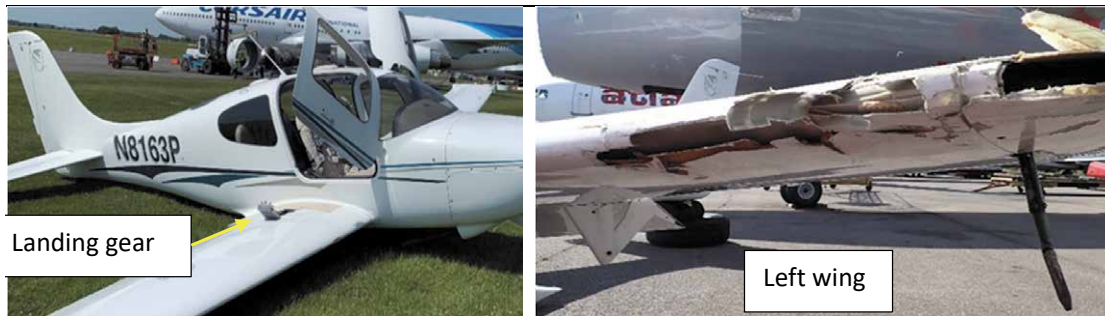
Figure 4

There was abrasion damage to the left-wing tip consistent with it having contacted a hard surface and scratches that were most likely caused by the torn metal on the right wing of G-ATXD. Damage to the propeller blades was consistent with them striking soft ground or stones. The right main landing gear had broken off from the mounting structure and punctured a hole in the top skin of the wing. The right main wheel had detached and abrasions on the tyre were consistent with it being abraded as the aircraft slid sideways across the apron. The nose landing gear was twisted but remained attached.

Damage sustained to Cirrus SR22, N8163P

As the pilot checked the rate of descent to delay touching down, it is likely that it was the handling of the aircraft at low speed, while countering the effects of the crosswind, that resulted in the loss of control. The CCTV recording and abrasions to the wing tip show that the left wing struck the runway before the aircraft touched down on the grass. It is possible that the damage to the propeller occurred at this time, but it more likely occurred after the left main landing gear collapsed.

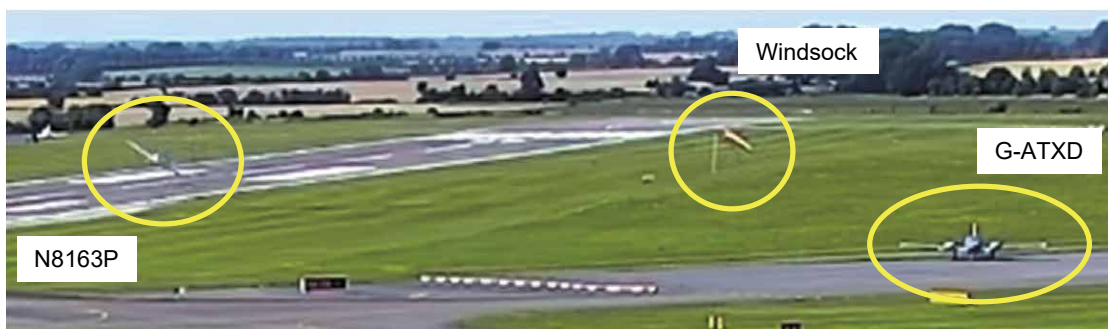
Figure 5

The weather reported by the airport was CAVOK, temperature 29°C, with the wind from 080° at 14 kt. Analysis of a Closed Circuit Television (CCTV) recording of the movement of the windsock, sited between the touchdown markers and the apron, showed the instantaneous wind to be approximately 160° and 15 kt when the aircraft crossed the threshold (Figure 5). While there was some movement of the windsock, there was no visual evidence of gusts.

From a CCTV recording, the attitude of N8163P appeared normal as it crossed the threshold when it then appeared to fly parallel with the runway. As it reached the first set of touchdown markers the left wing dropped and contacted the edge of the runway before the aircraft settled on its landing gear on the grass (Figure 5). The aircraft continued to travel across the grass on a heading approximately 45° to the left of the runway heading.

Still from CCTV footage of N8163P as the left wing dropped

The pilot reported that the approach was stable. The windsock close to the threshold showed that there was a relatively steady crosswind of around 15 kt, which was within the aircraft’s crosswind limit of 21 kt. It is, therefore, unlikely that the wing drop occurred because of a gusting crosswind.

This accident highlights the importance of making an early decision to go-around and to allow sufficient time for aircraft landing ahead to clear the runway. On this occasion clearance to land at ‘the pilot’s discretion’ was not given until the aircraft reached the threshold. Following the loss of control, the wing tip struck the ground and the pilot would not have known the extent of the damage to the aircraft; therefore, it would have been a safer option to stay on the ground.
